LUIZ BANDEIRA BRIDGE: ASSESSMENT OF A HISTORICAL RC BRIDGE

Abstract (100-200 words):

Keywords: RC bridge; Assessment; Material characterization; Mechanical characterization; Inspection; Dynamic Analysis; Safety analysis;

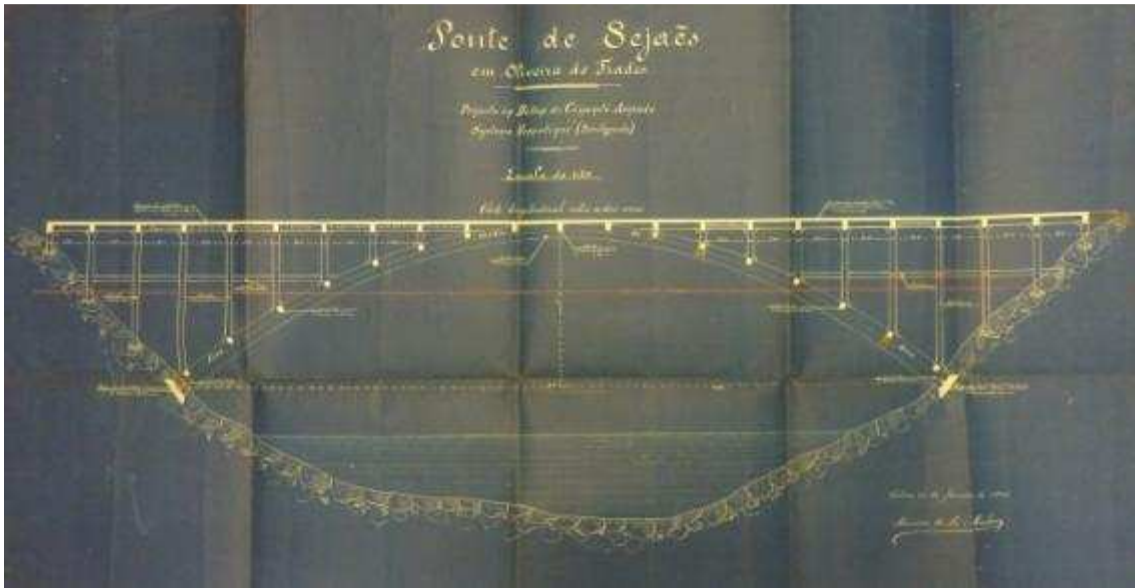
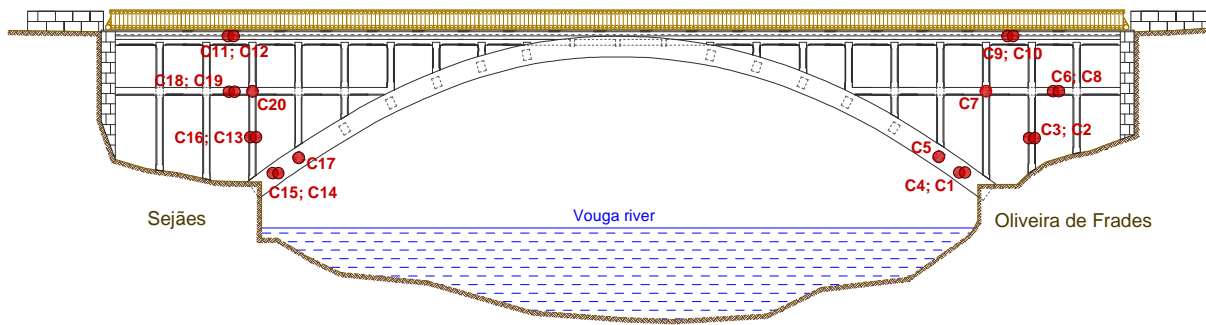
Fig. 4: (a) Original geometry (drawings from archives of *Fonds Bétons armés Hennebique*, 1906); (b) Sketch of the current geometry obtained from the geometrical survey.

The geometrical survey of the current state was performed by laser distance meter, tape measure, camera and ruler and was compared with the existing drawings from EP (Estradas de Portugal, S.A. - road authority in Portugal, 1995) and the original drawings. No significant discrepancies were noted between the geometrical surveys performed and those of EP. Several discrepancies in terms of the geometrical cross-sections were found when the geometrical survey performed was compared with the original drawings. This was expected since the bridge was submitted to rehabilitation in 1951, as mentioned previously.

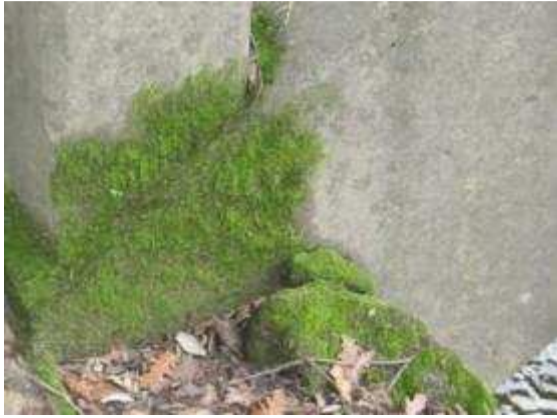
The bridge is subject to extensive biological growth due to the ideal conditions to the development of these organisms. The biological growth observed at the bridge included: algae, moss, lichens and higher plants. In particular, the columns and mid height transverse beams are in good condition with only some biological growth and leaching present.

Fig. 5: (a) Biological growth (moss) observed on bridge; (b) Concrete spalling and corrosion of the reinforcement; (c) Deposits (leaching) observed on columns; (d) Damage to abutment due to the presence of water.

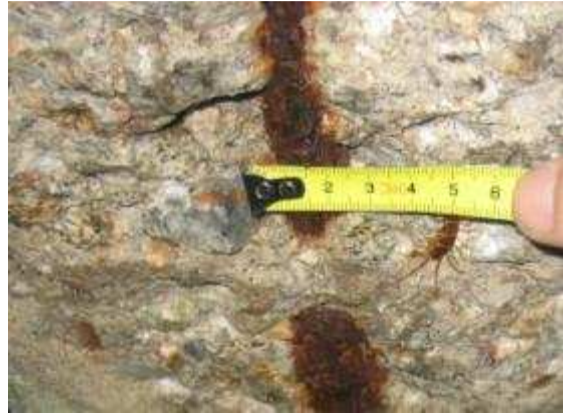
(b)

The deck slab and ribs are generally in poor condition with extensive areas of cracking and exposed corroded, reinforcement. Spalling is an indirect effect caused by the reinforcement expansion due to corrosion. There are also problems with non-structural components, namely metallic elements embedded into concrete with no corrosion protection and leaking water pipes. Moreover, poor detailing of non-structural components were also found for instance iron pipe mountings embedded directly into concrete with no protection.

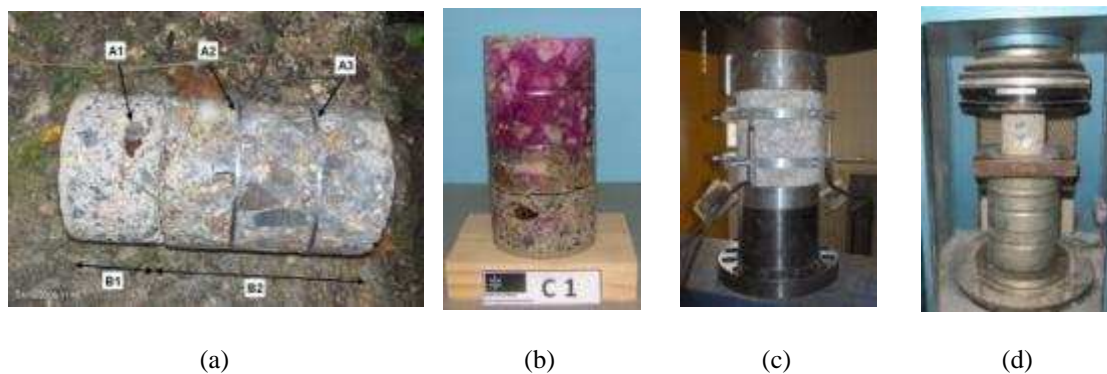
The results for carbonation reflect those obtained for porosity. The carbonation depth for the original concrete deck varied between 110 mm and 130 mm. For the remaining structural elements, the depth of carbonation is almost null. This leads to believe that part of the original concrete cross sections was removed during rehabilitation. The concrete used for the rehabilitation showed depths of carbonation between 2 and 30 mm.

Fig. 11: (a) View of concrete core after extraction. Note the different type of concretes, and the steel plate reinforcement used in the initial construction; (b) Carbonation depth measurements; (c) Modulus of elasticity testing; (d) Compressive strength testing

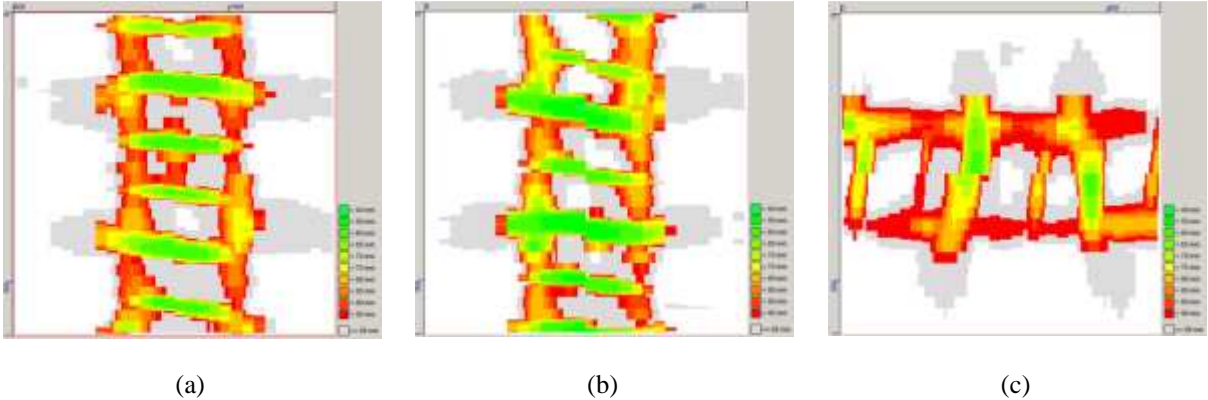
The results from the two adjacent faces of the same column (positions 1 and 2) and the beam of position 4 from the rebar detector are presented in **Fig. 13**. In these pictures the reconstitution of the existing rebars are presented, namely: the location of the rebars, both principal and stirrups, and an estimative of the concrete cover and the rebar diameter. Relatively to the values of the diameter, it was found that the reinforcement by the use of jacketing is constituted by a longitudinal rebar in the four corners, with a similar diameter in both beams and columns between 16 and 20 mm, and a series of stirrups apart by 10 mm, approximately. The concrete cover at the level of stirrups is around 22 mm with coefficient of variation (CoV) equal to 27%, while being 51 mm (CoV=14%) in the longitudinal ones.

Fig. 13: Results from the tests made with the rebar detector. Column (a) position 1, (b) position 2 and (c) beam, position 4

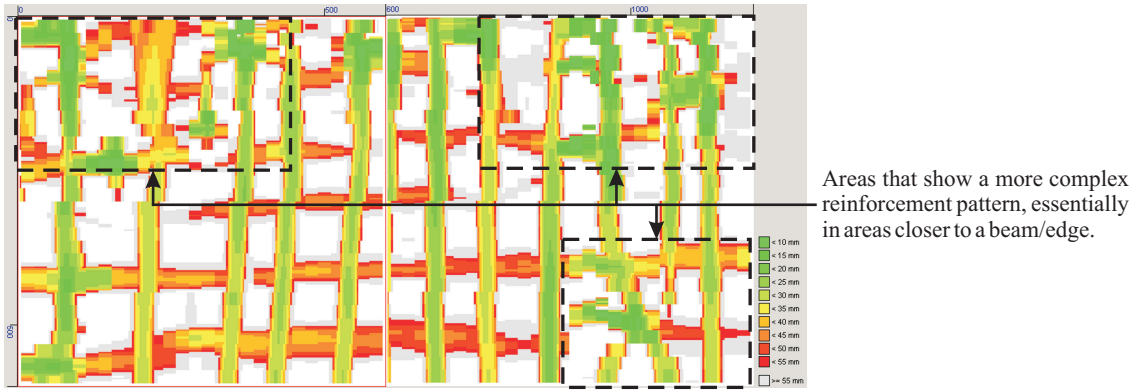
illustrated in **Fig. 14**, representing the inferior reinforcement from the bridge deck. One can observe a rather regular spacing between the rebars in both directions, essentially in the middle of the map.

This fact can be observed in three areas pointed out in **Fig. 14** where they exhibit a more complex pattern caused by the superimposition of rebars from the deck and from the beams. Additionally, the estimative of the final rebar diameters carried out by the detector exhibits a large uncertainty, verified by the coefficients of variation calculated. Due to the age of the structure (around a hundred years) some elements can already show signs of corrosion, which can in part explain such high variation coefficients. The variation of the concrete cover below the reinforcement was significantly lower, below 20%. Finally, the diameter estimated by the equipment, which is the result of a preliminary manual adjustment of the diameter and the cover thickness, presents two deficiencies: firstly, it increases significantly the thickness of the concrete cover and, secondly, assigns modern commercial diameter for rebar, which may not coincide with the diameters used at the time of construction of this bridge.

Fig. 14: Reinforcement mesh obtained from the bottom of the bridge deck (position 5)

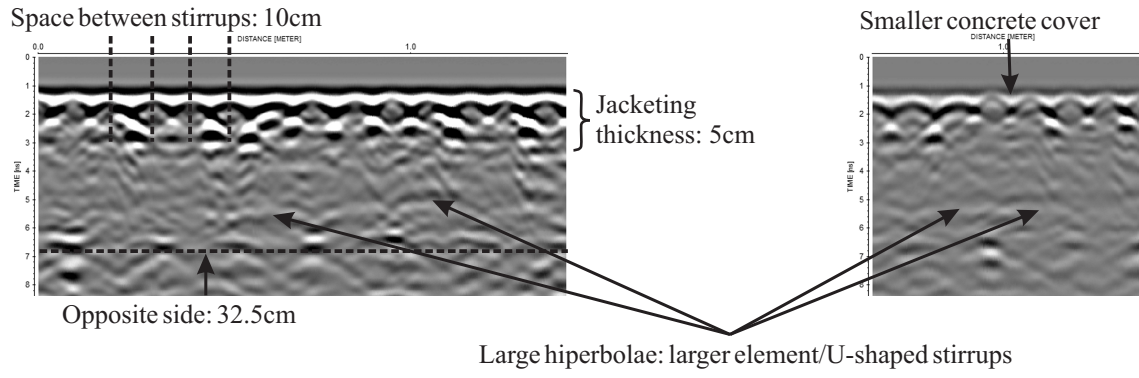
Relatively to the profile carried out in position 11 (see **Figs. 15** and **12**), one can observe the reinforcement close to the surface is constituted by rebars, 10 cm apart, with a rather regular cover, with an average thickness around 25 to 30 mm. The radargram on the right shows a slightly smaller concrete cover. The opposite side of the column was detected around 6 ns, which resulted in an average wave velocity around 12 cm/ns. In the radargrams it is still possible to observe a second reinforcement line at 1.5 ns of depth, which seems to correspond to the original reinforcement of the column. This observation allowed to define, through these measurements, a thickness around 5 cm for the jacketing, which was further confirmed by direct measurement on cylindrical samples. With the value of the jacketing it was possible to confirm the dimensions

of the original cross-section of the beam as 22×22 cm, which is rather close from the dimensions in the real project (20×20 cm).

Fig. 15: Results from georadar in the column (position 11)

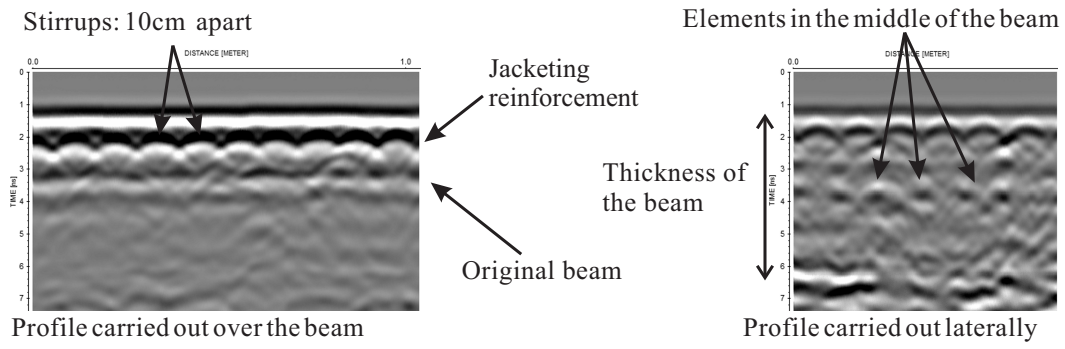
The radargrams illustrated in **Fig. 16** represent two profiles carried out from two sides in a transversal beam. The profile carried out from the top shows the jacketing stirrups (10 cm apart), as well as some evidence of the original beam dimensions. In the radargram on the right, additional signals were observed in the center of the beam, which probably represent vertical elements in the original beam, such as a 3rd stirrup.

Fig. 16: Results from georadar in one of the transversal square beams (positions 7 e 8)

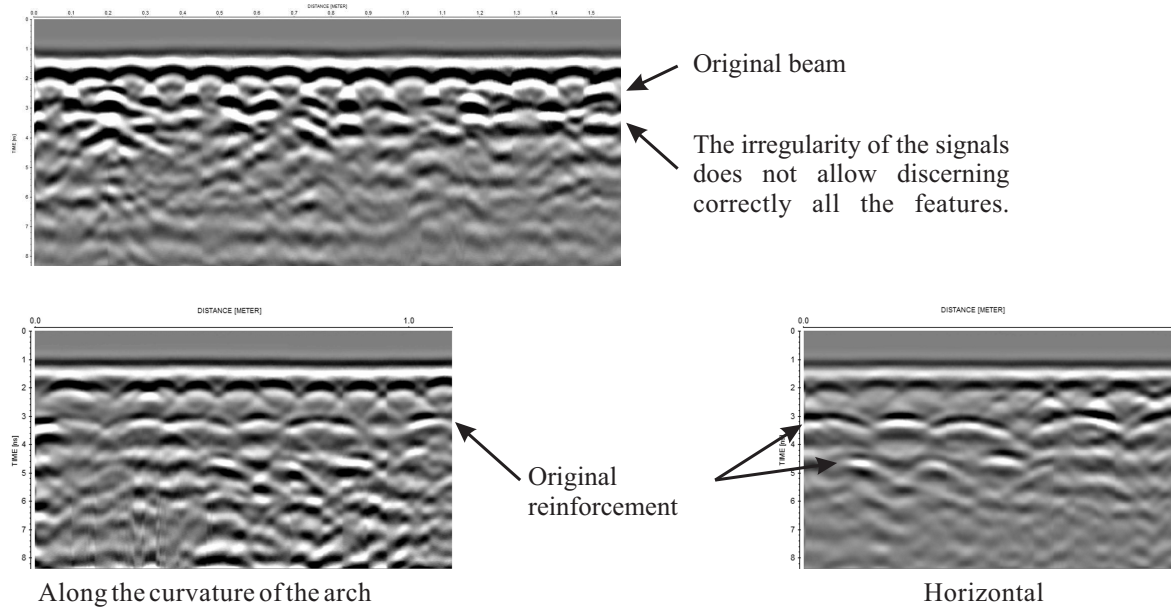
Lateral readings were also executed, along the curvature of the arch and horizontally. The resultant radargrams are illustrated in **Fig. 17**. In both the radargrams are evident at a depth of 2 ns the signals coming from the original reinforcement of the structure, which are clearly different from those produced by the rebars from the jacketing layer, exhibiting a wider signal, pointing towards a metallic element larger than an ordinary rebar. However, these signals seem to be further apart than the ones found in the column and beam analyzed. Additionally, the signals appear to be slightly differently spaced in both radargrams. While on the one in the left the signal seems almost continuous, on the right the same signal appear more apart. That difference can be related with the orientation of the characteristic plates. Additionally, in this last radargram it is possible to observe a third layer of signals associated with the original reinforcement in the opposite side of the arch. The signals coming from the original reinforcement are 12 cm apart, approximately, which means that the arch had, originally, a significant concrete cover thickness laterally, around ¼ of the total thickness of the arch, with the current dimensions.

Fig. 17: Results in the starting of the arch (position 9), laterally

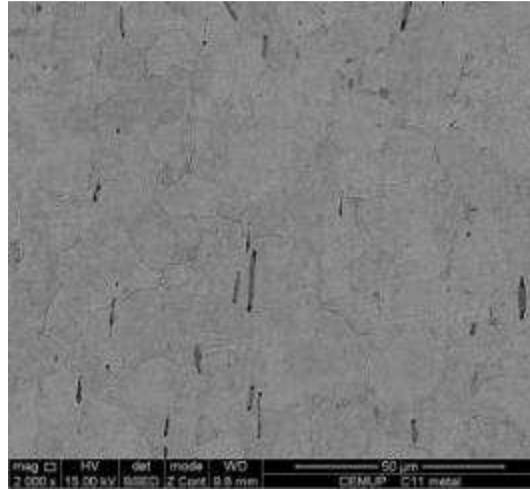
The steel plate removed from concrete specimen C7 (see section 3.1) was subjected to a chemical analysis by X-ray fluorescence spectrometer and a basic carbon element test. The results are presented in **Table 5**. The carbon content reveals that steel is mild. The sample was then polished and observed in SEM. The micro-structure is typical of a mild steel containing an appreciable amount of manganese sulphide inclusions, as shown in the micrograph obtained (see **Fig. 20**).

Fig. 20: Micrograph of the steel
