## **Statistical Assessment of Damage to Churches Affected by the 2010-2011 Canterbury (New Zealand) Earthquake Sequence**

Keywords: church; seismic performance; post-earthquake assessment; collapse mechanism; damage assessment form

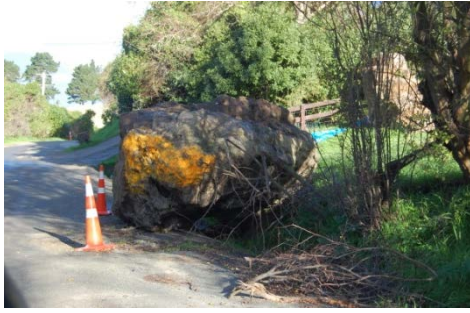
(a) example of a boulder that rolled downhill

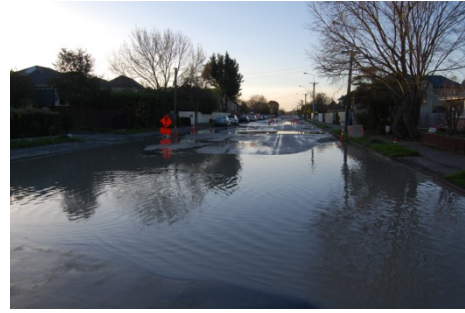
(b) liquefaction in the Christchurch City centre

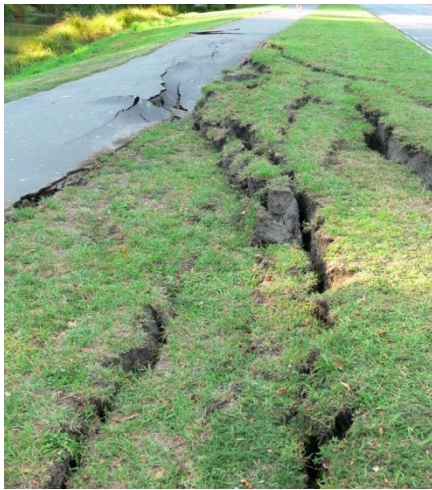
(c) lateral spreading along the Avon River

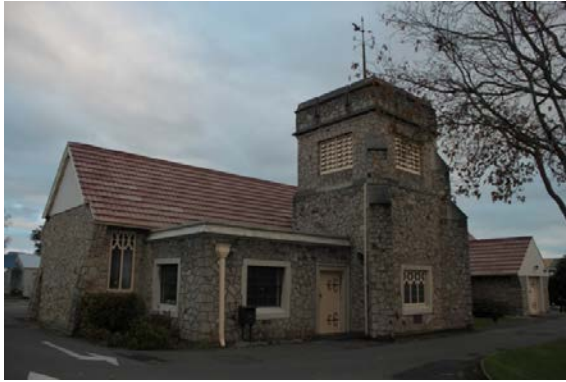
(a) *green* tagged (St. Martin's, stone, Middleton)

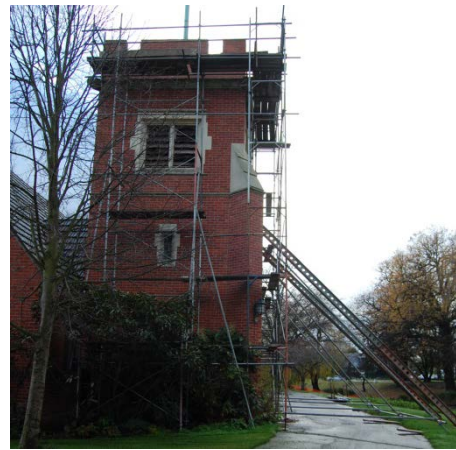
(b) *yellow* tagged (St. Andrew's College, brick, Papanui)

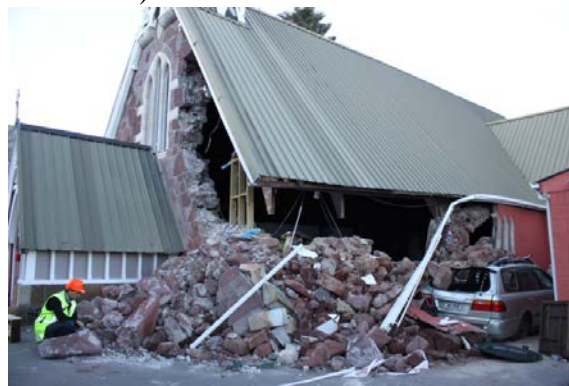
(c) *red* tagged (Holy Trinity, stone, Lyttleton)

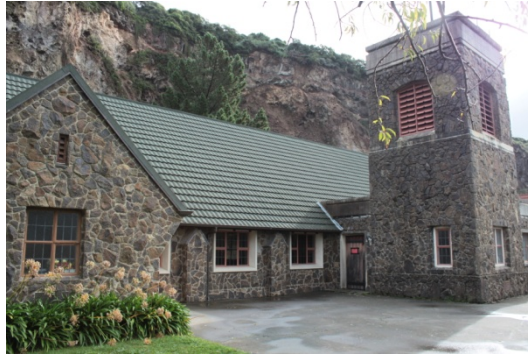
Figure 14 – Example of an undamaged church classified *red* due to instability of the slope shown in the background (All Saints, stone, Sumner).

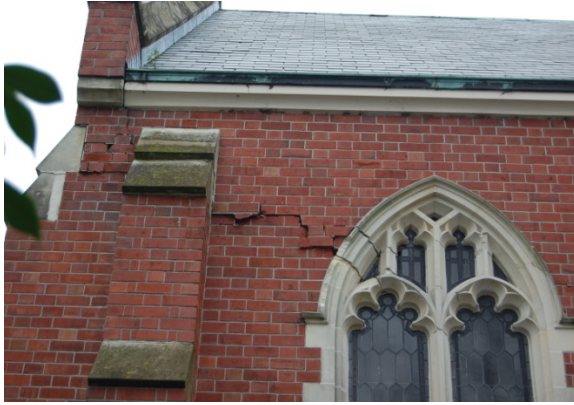
(a) shear damage in the longitudinal walls (mechanism 6), outside (Nazareth's House church, brick, Sydenham)

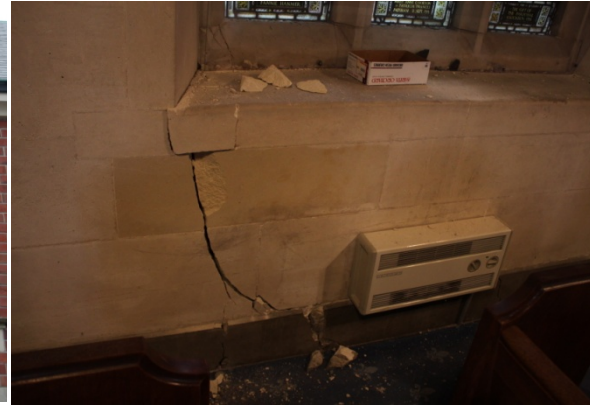
(b) shear damage in the longitudinal walls (mechanism 6), inside (St. Barnaba's, stone, Fendalton)

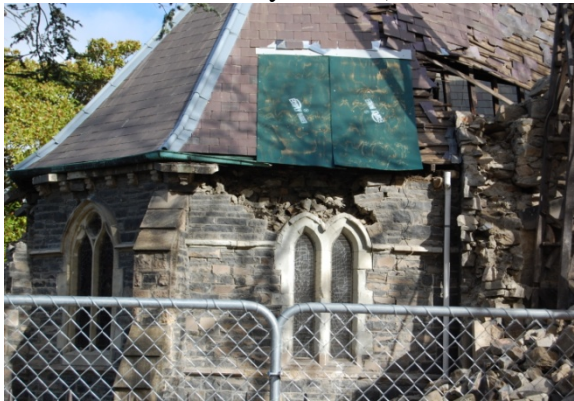
(c) hammering of the roof (mechanism 19), outside (St. John's, stone, Latimer Square)

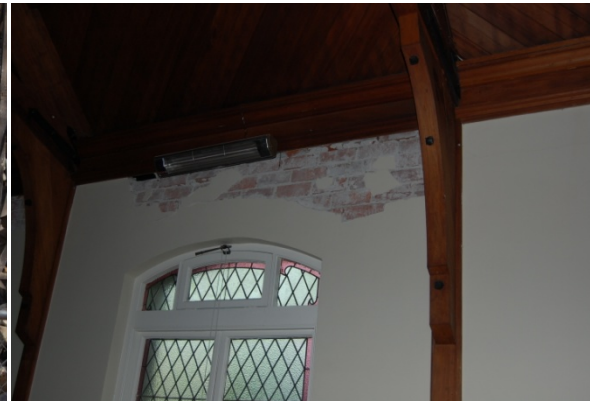
(d) hammering of the roof (mechanism 19), inside (Shirley Methodist, brick, Shirley)

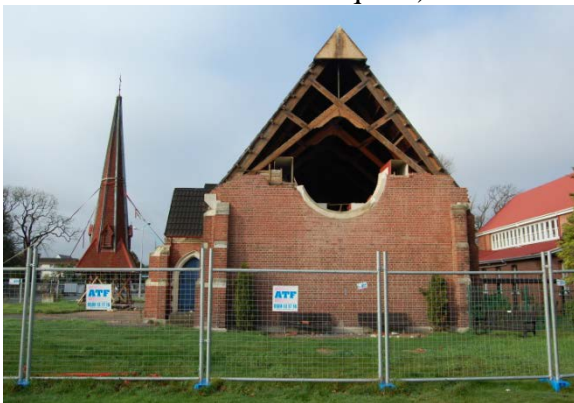
(e) overturning of the top of the facade (mechanism 2), outside (Chinese Methodist, brick, Papanui)

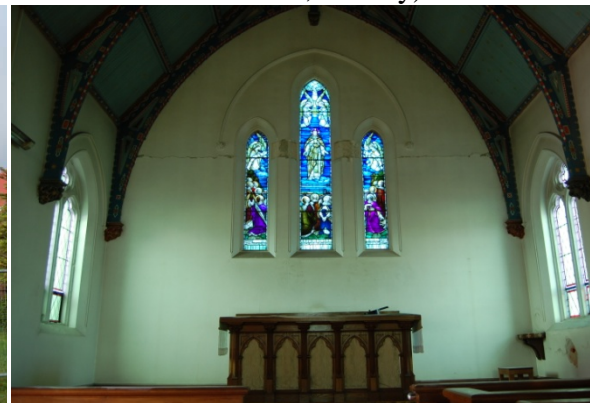
(f) overturning of the top of the facade (mechanism 2), inside (St. James, stone, Riccarton)
