Analysis and restoration of ancient masonry structures

Guidelines and Examples

PAULO B. LOURENÇO

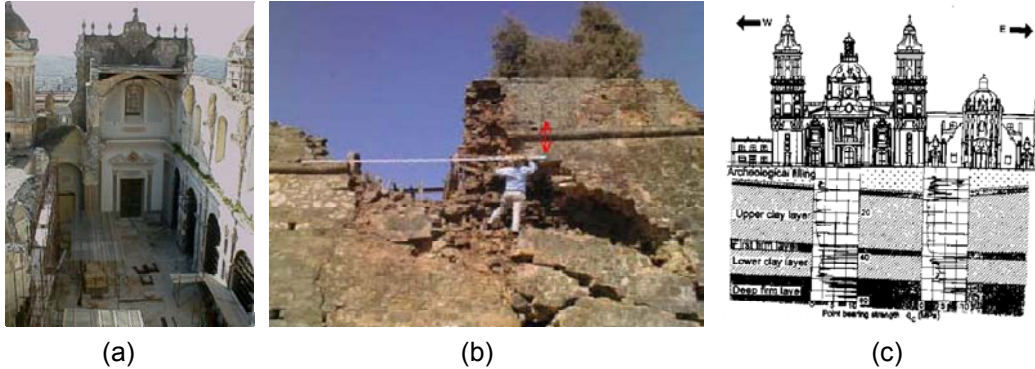
Figure 1 - Selected examples of collapse and damage in ancient constructions:
 (a) Cathedral of Noto, Italy; (b) Castro Marim wall, Portugal;
 (c) Cathedral of Mexico-City, Mexico

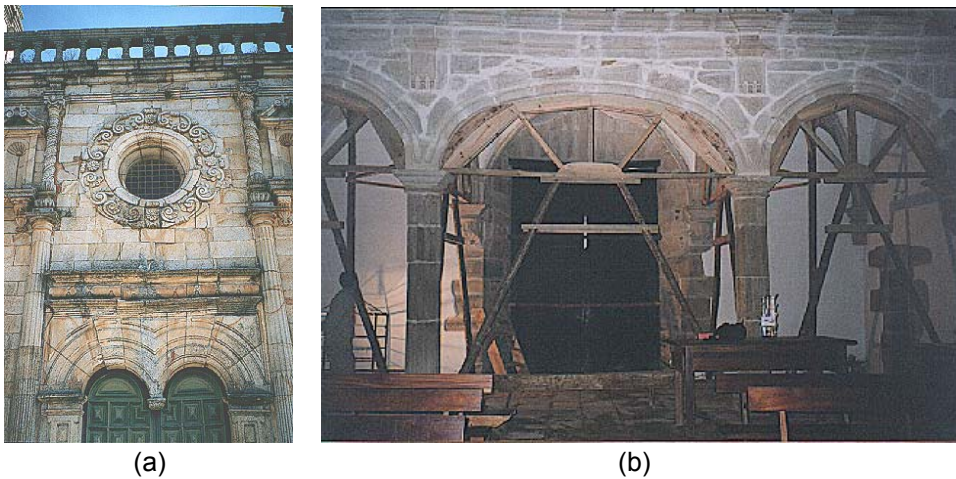
The damage of the structure is localized in the main façade and in the choir. Some additional minor cracking visible in other areas of the structure did not seem alarming. The façade features large movements, vertically, in the vicinity of the twin arch, and horizontally, towards the outside, around the opening and at the top central part, see Figure 3a. The interior face of the wall does not show any sign of horizontal displacements and, with the use of a boroscope it was possible to check that the wall is made of two leaves, separated by approximately 0.10 m in the vicinity of the opening. The choir features heavy cracking of the arches and vaults, see Figure 3b. It is separated from the façade, except in the brackets, and the columns are out of plumb 2.6% (around 0.08 m).

Figure 3 - Aspect of Saint Christ church before the remedial measures: (a) damage in the façade and (b) temporary support of the choir

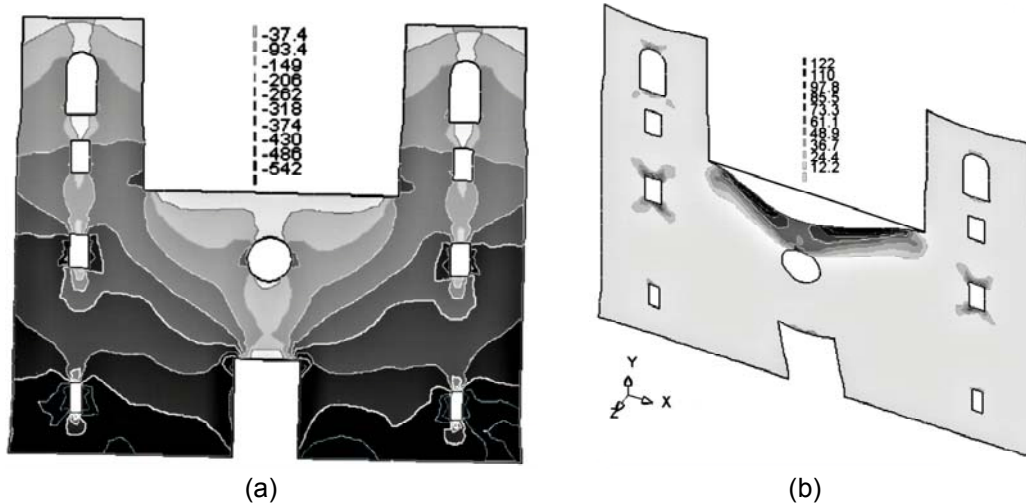
The results of the analysis, assuming linear elastic behaviour of the material, are given in Figure 4a, in terms of maximum principal stresses. Under the most unfavourable hypothesis that all permanent loads are applied simultaneously and not in agreement with the construction phases, it is observed that the maximum value of the tensile stresses and the compressive stresses are extremely low, respectively +0.11 (tension) and -0.54 (compression) N/mm². This analysis demonstrates that, under the assumption of a homogeneous material for the façade, the structure should not present any damage due to vertical loading. For this reason, the analysis of the structure under combined actions (vertical and horizontal) seemed necessary.

Figure 4 - Results of the structural analysis for Saint Christ church in terms of maximum principal stresses ($\times 10^{-3}$ N/mm³) on the deformed homogeneous structure: (a) plane stress analysis; (b) shell analysis.

From these results it was concluded that the assumption of a homogeneous material is incapable of justifying the damage exhibited by the structure, even with the action of the horizontal forces equivalent to the seismic load. For the purpose of a non-linear dynamic analysis, the wall was modelled with two different leaves: granite ashlar with an average thickness of 0.30 m and shale masonry with an average thickness of 1.20 m, with their respective elastic properties.

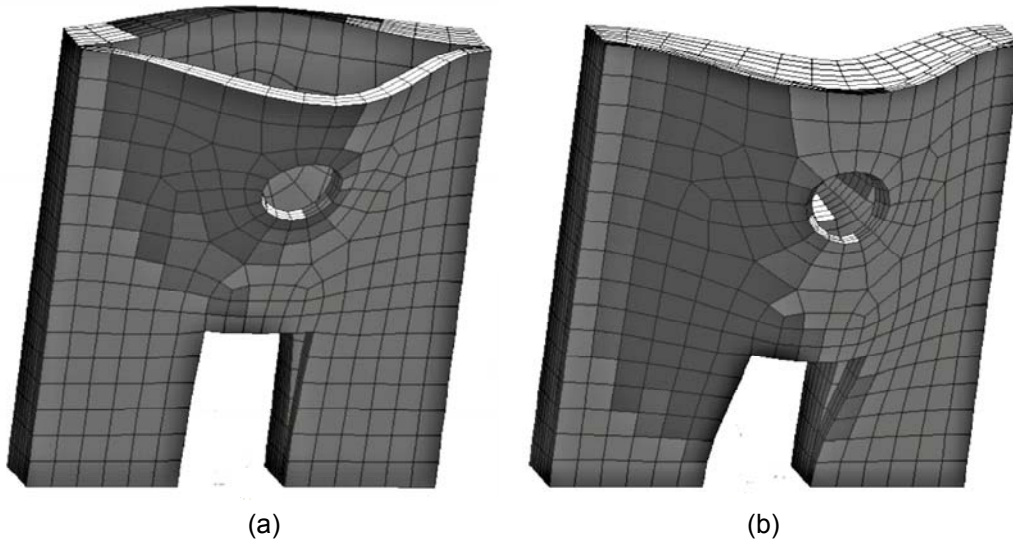
Raleigh damping was assumed, the usual damping coefficient ξ equal to 5% was adopted and a base acceleration was generated according to the Portuguese Code. As the dynamic properties of the two leaves differ substantially, separation of the leaves will occur. Figure 5 presents some examples of the deformed structure throughout time. It was possible to obtain different configurations of separation between the two leaves (in the top and centre of the wall). For example, Figure 5a shows the walls moving in opposite directions and Figure 5b shows the walls moving in the same direction, with small separation at the top and large separation around the opening. This last form of separation seems to be in good agreement with the damage exhibited by the façade.

Figure 5 - Deformed meshes for heterogeneous non-linear dynamic contact analysis at different time steps, for Saint Christ church.

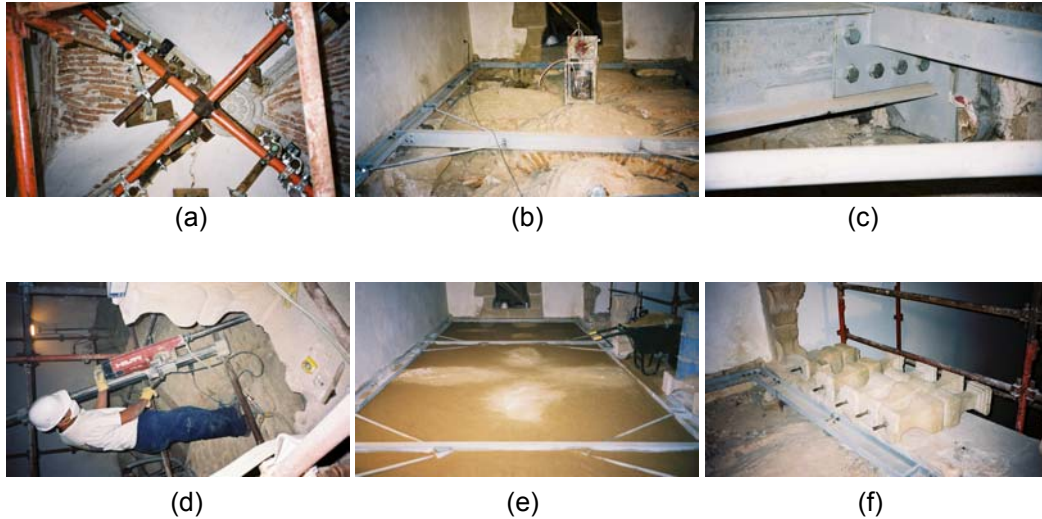
The conclusions of the numerical analyses of interest for the definition of the intervention are that (a) the damage was due to seismic action and (b) there were two misconceptions in the construction of the church (façade and choir). Therefore, it is only necessary to correct these errors with proper façade wall tying and adequate connection between the choir and the external walls.

Figure 6 - Details of the works carried out, for Saint Christ church.

Keeping these conclusions in mind, remedial measures were proposed to ensure proper monolithic behaviour between the choir and the external walls, and to connect the external leave to the inner leave. This was achieved with ties inside the vault filling, for architectural reasons. It is noted that the selection of materials was careful, including the use of stainless steel, special mortars and non-intrusive grouting anchors (with sleeve). Figure 6 illustrates different aspects of the works.

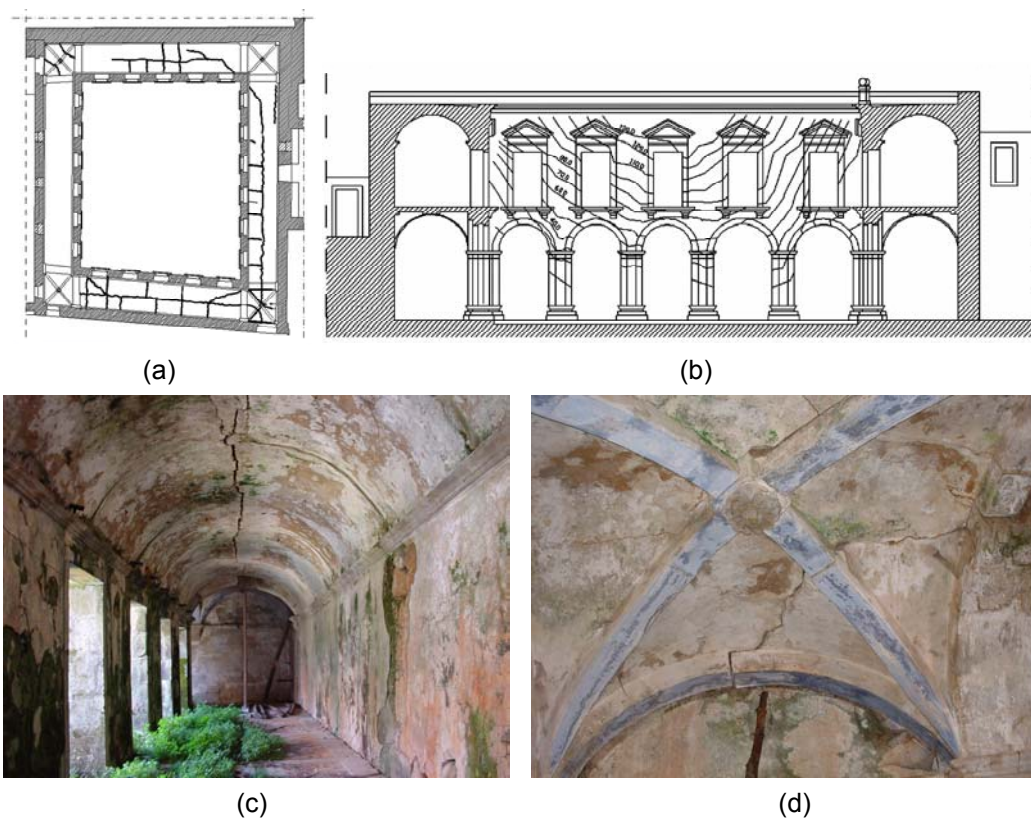
The largest and widest set of cracks occurs in the barrel vaults of the 2nd level, as well as in two corners. The cracks occur mostly in the longitudinal direction, even if some transversal cracks also occur, up to a crack opening of 40 mm. The vaults of the first level exhibit also cracks, up to a crack opening of 15 mm. One wing is supported on temporary wooden poles. The walls exhibit widespread cracking at the 2nd level and almost no cracking at the 1st level. With the exception of a few localized areas, cracking is minor (crack openings in the range of 1 to 5 mm). Vertical displacements up to 35 mm were measured at the key of the crossed vaults of the 1st level. But all the walls of the cloisters exhibit large horizontal movements that lead to the separation between the vaults and the walls, in a clear lack of verticality. The out-of-plumb displacement of the internal walls reaches values of up to 0.18 m. Several brackets supporting the crossed vaults of the first level show signs of compressive crushing. The tilting movement of the walls can explain

this. The absence of connection between the infill of the crossed vaults and the walls resulted in a very localized area to transfer the load, i.e. only the brackets. Also, a significant number of bricks show deterioration, particularly around the cracked areas. This occurs in both levels and can be explained by frost-thaw cycles and water infiltration, as the amount of rainfall per year in the region is high and the temperatures in the winter are excellent for ice formation (daily cycles with $\pm 0^\circ$). Other perturbing signs, less relevant from the structural point of view, include damage of the stone due to freeze-thaw cycles and overall biological colonization. Figure 7 details typical observed damage.

Figure 7 - Damage in the Salzedas' cloister: (a) mapping of cracks in the 2nd level; (b) out-of-plane displacements of an internal wall; (c) aspect of vault in the 2nd level; (d) aspect of corner in the 2nd level.

The conclusions of the study were that: (a) the non-symmetry between the internal and external walls of the cloister result in movements in the direction of the court, as observed in the construction; (b) a linear elastic analysis of the construction results in very limited displacements (in the order of the millimeter) and moderate stress values (maximum tensile stress of +0.25 MPa and maximum compressive stress of -0.6 MPa). The large displacements observed in the construction require a geometrical and physical non-linear analysis; (c) in order to obtain horizontal displacements in the order of the observed in the structure, it is necessary to consider the soil-structure interaction. It seems therefore that the foundations play a key-role in the observed damage; (d) the high movements recorded in the construction and the deterioration of the brick vaults indicate that the safety level of the structure is not compatible with any use and remedial measures are necessary.

The following measures will be undertaken: adjustable propping; removal of vaults infill (1 + 0.5 wings); elevation of the vaults (1 + 0.5 wings). Restoring the verticality of one inner wall and one corner; replacement of fractured brackets; relocation of the key stones and joints filling; placement of ties and strengthening with CFRP (1 + 2 x 0.5 wings); refill vaults with selected silty soil; water-proofing and drainage of the terrace; repointing of joints in walls; temporary closure of the openings.

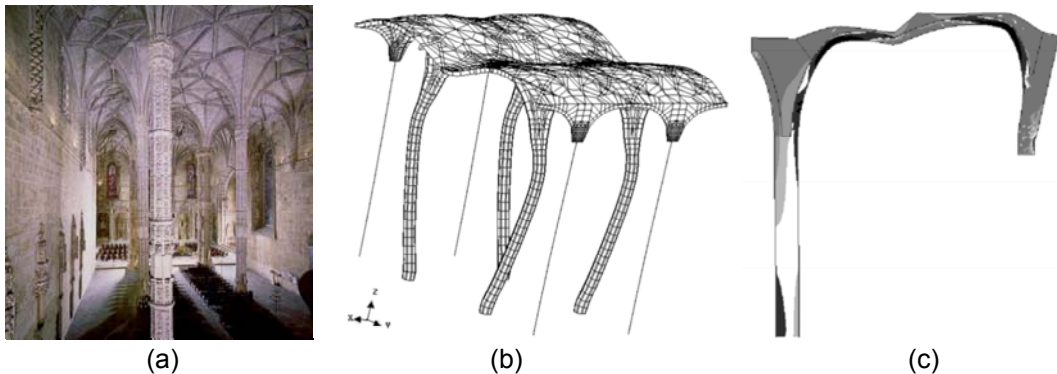
Figure 8 – Monastery of Jerónimos: (a) aspect of the nave; (b) model of the nave; (c) model of the transept.

The analysis carried out allowed to conclude that: (a) collapse of the nave occurs with a failure mechanism involving the columns and the vault; (b) collapse of the transept occurs with a failure mechanism involving the external walls and the vault; (c) the compressive strength of masonry is a key factor for the response; (d) the safety of the

structure seems low, when compared with similar constructions; (e) the columns of the nave are rather slender. It is stressed that the Church has been in use for some hundred years with moderate damaged ribs, and moderate tilting of the columns and sidewalls. Given the cultural importance of the construction, the safety of the users, the seismic risk and the accumulation of physical, chemical and mechanical damage, complementary NDT was proposed. The analyses carried out and the new proposed NDT results are fundamental for the definition of further action and the possible implementation of a monitoring program.
