Damage Inspection in Churches – The Canterbury Earthquake (New Zealand) Experience

João Leite¹, Jason M. Ingham², Paulo B. Lourenco³

KEYWORDS: masonry; churches; seismic behavior; damage assessment; indexes; fragility curves

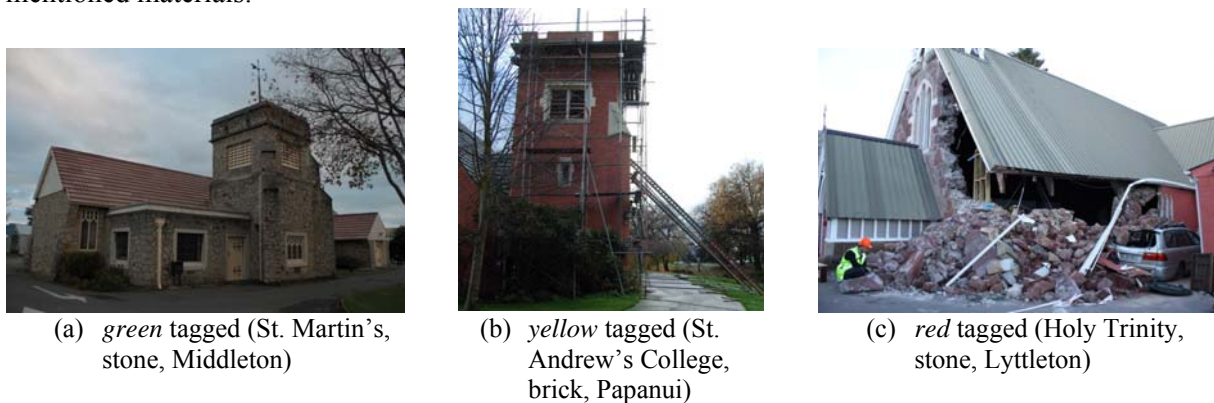
Figure 3. Examples of damaged churches.

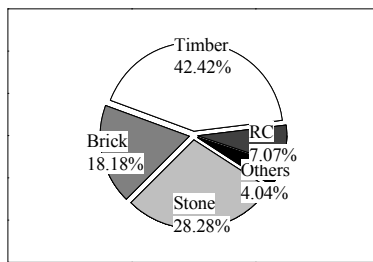
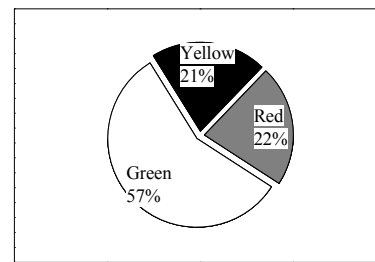
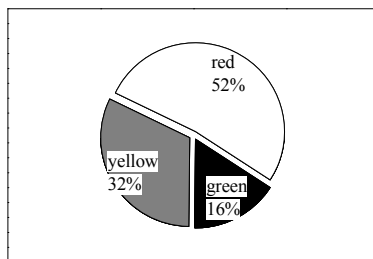
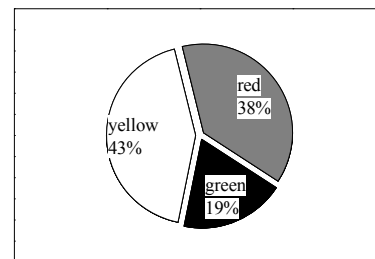
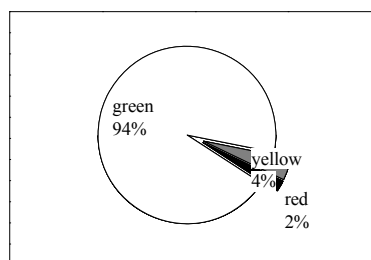
As shown in Figure 5 (a), the three major construction typologies for churches in the Canterbury region are timber, stone masonry and brick masonry, with about 10% of the buildings using other materials. More than half of the surveyed churches (57%) received a green placard from the structural inspectors (see Figure 5 (b)).

Given the different dynamic characteristics of the three principal church typologies found in the Canterbury region, the results are presented for each individual typology and comparing these findings with the overall results. More than half of the stone churches (52%) were assigned a red placard and only 16% of the churches had a green placard assigned (see Figure 5 (c)). The brick churches were less damaged than the stone churches, but also exhibited poor performance during the earthquakes. Figure 5 (d) shows that a red placard was assigned to 38% of the churches, while a yellow placard was assigned to 43% of the churches. The percentage of red placards assigned for this typology was smaller than the percentage assigned for the stone churches, but the sum of red and yellow placards was similar for both masonry typologies and exceeded 80%. The timber churches had the best overall performance (see Figure 5 (e)), with no structural damage and 94% of the churches were assigned a green placard. The single red placard assigned to a timber church was due to external cause while the yellow placard was due to non-structural damage like cracking of the inside or outside plaster.

Figure 5. Damage statistics for the assessed churches.

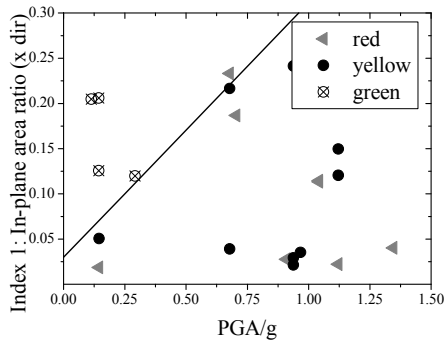
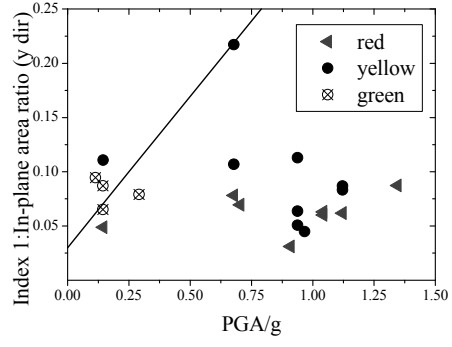
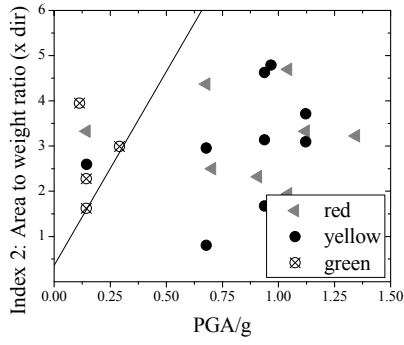
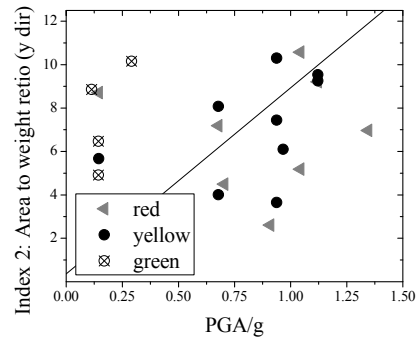
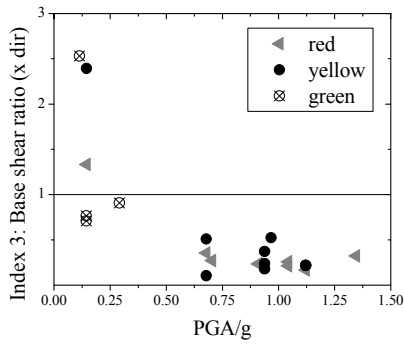
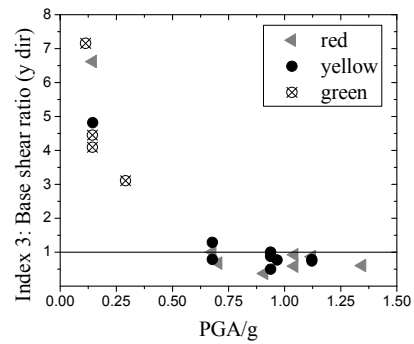
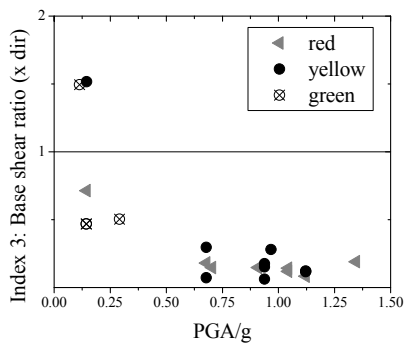
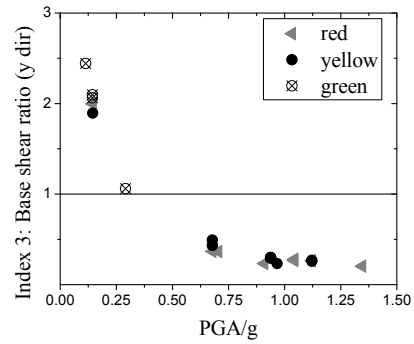
Figure 7. Clay brick churches: (a) index 1: In-plane area ratio in the x (transversal) direction; (b) index 1: In-plane area ratio in the y (longitudinal) direction; (c) index 2: Area to weight ratio in the x (transversal) direction; (d) index 2: Area to weight ratio in the y (longitudinal) direction; (e) index 3: Base to shear ratio, taking cohesion into consideration, in the x (transversal) direction; (f) index 3: Base to shear ratio, taking cohesion into consideration, in the y (longitudinal) direction; (g) index 3: Base to shear ratio, considering zero cohesion, in the x (transversal) direction; (h) index 3: Base to shear ratio, considering zero cohesion, in the y (longitudinal) direction.

Figure 7 presents the scatter plots of each index and the recorded horizontal PGA of the 22 February 2011 event for clay brick churches, as well as the proposed thresholds from Figure 6. Direction X and Y correspond, respectively, to the transversal and longitudinal directions regarding the main nave. The threshold for the first index is excellent, with all the green tagged churches above or near the line and only one yellow and one red church incorrectly identified. The yellow tagged church had only minor cracking with the exception of a large shear crack on one longitudinal wall of the main nave. There were also unstable nonstructural elements inside that could collapse during a stronger aftershock, which led the structural inspector to classify the church as yellow. The red tagged church was also a particular case, as it had pinnacles overhanging from the transversal walls and therefore was unstable even for a low PGA. These elements were severely damaged or partially collapsed compromising the connection between the transversal and longitudinal walls. The thresholds for index 2 and 3 also have acceptable results. The X (or transverse) direction provides better results in all three indexes, and this is the critical direction. The indexes are consistent even if they are not directly correlated. Index 3 exhibits the worse performance if cohesion is taken into consideration, with better results obtained for a zero cohesion, see Figure 7 (e) (f) (g) (h).

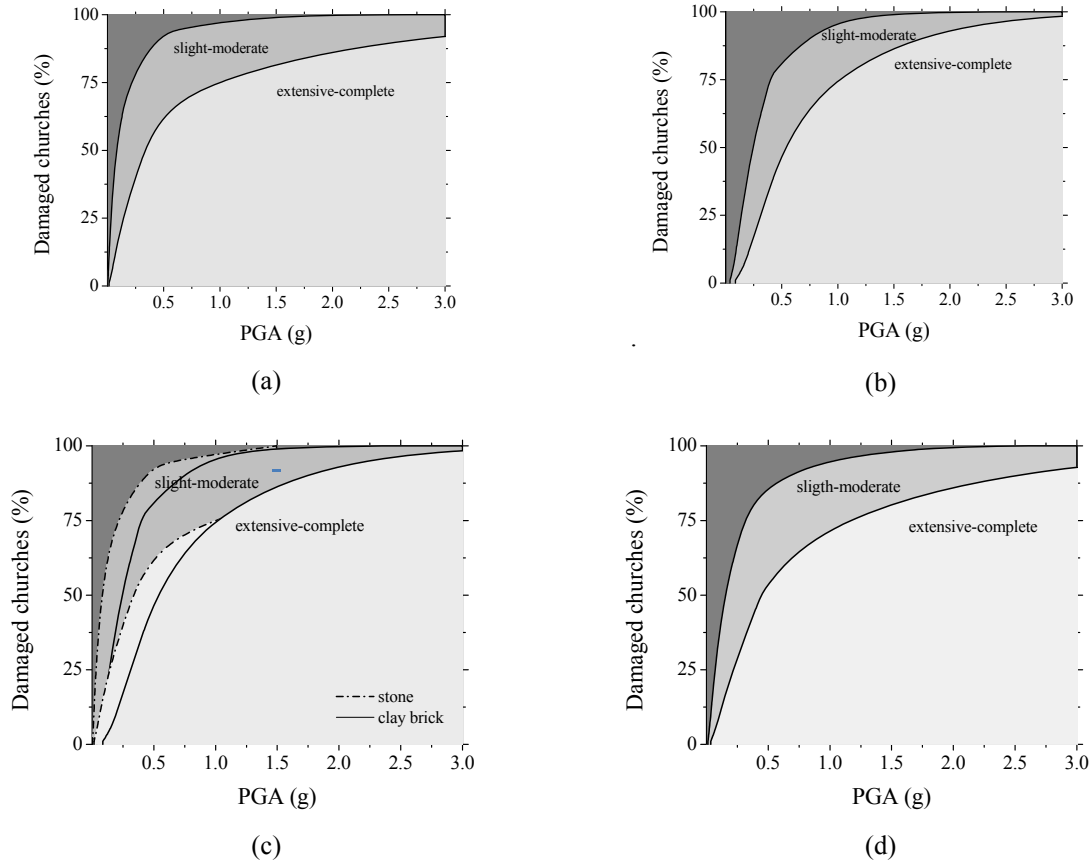
Figure 9. Fragility curves: (a) stone churches; (b) clay brick churches; (c) stone and brick; (d) all churches.

It is now assumed that the values of 5%, 50% and 95% quantiles are the lowest expected, the average, and the highest expected damage. For stone churches, it is expected that 50% receive a *yellow* tag for a PGA of 0.1g and a *red* tag for a PGA of 0.35g. For clay brick churches, it is expected that 50% receive a *yellow* tag for a PGA of 0.25g and a *red* tag for a PGA of 0.55g. For stone churches, it is expected that they all receive a *yellow* tag for a PGA of 0.65g and a *red* tag for a PGA of 3g. For clay brick churches, it is expected that they all receive a *yellow* tag for a PGA of 0.95g and a *red* tag for a PGA of 2.2g. Finally, for stone churches, it is expected that *yellow* tags appear for any seismic event and *red* tags appear for PGAs over 0.05g. For clay brick churches, it is expected that *yellow* tags appear for PGAs over 0.07g and *red* tags appear for PGAs over 0.15g.

In general for masonry churches, *yellow* tags are not expected for PGAs lower than 0.05g and *red* tags are not expected for PGAs lower than 0.1g. For PGAs of 0.15g and 0.5g, half of the churches are expected to be *yellow* and *red* tagged, respectively. For PGAs of 1g and 3g, all churches are expected to be *yellow* and *red* tagged, respectively.
