Visual assessment and diagnosis of a timber railway station warehouse in Foz do Tua

ABSTRACT

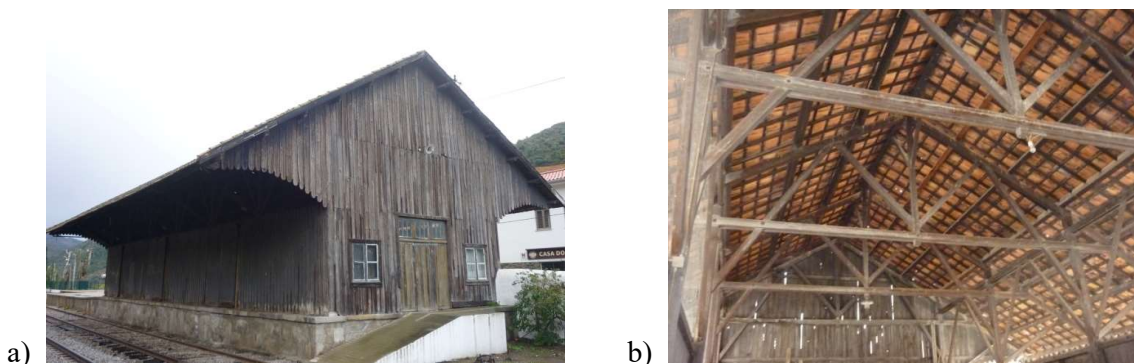
Figure 1: Timber warehouse: a) main façade and lateral façade oriented to the railways; b) view of the roof by the interior.

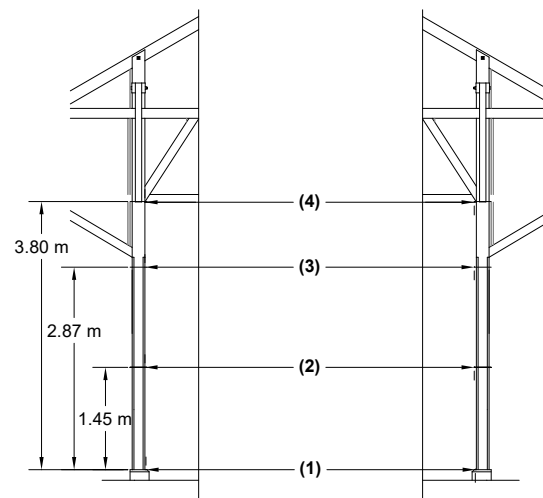
Figure 2: Location for measurement of the columns' deformation.

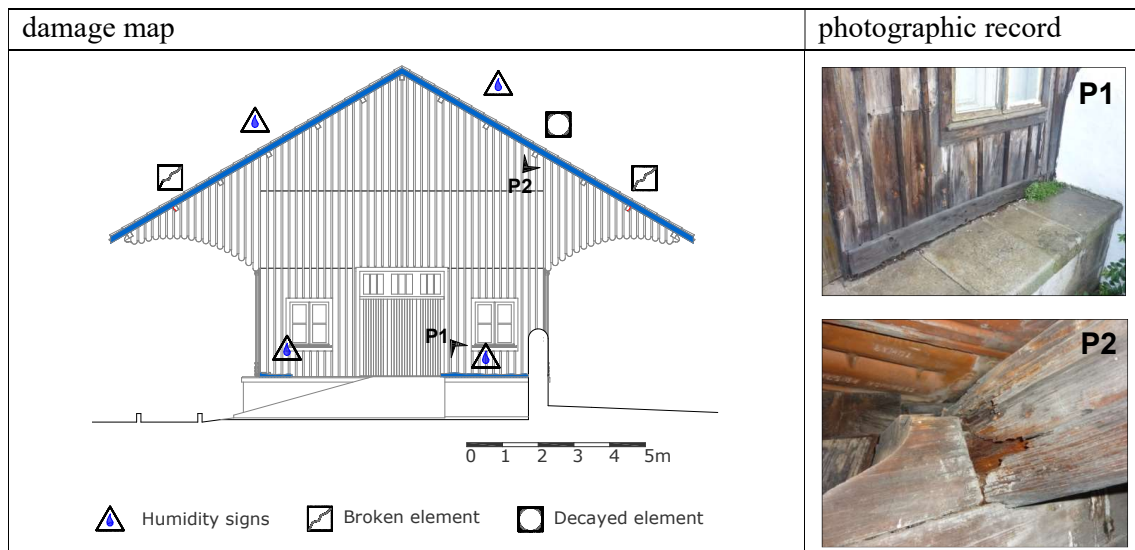
The damage map for the front façade (Figure 3), evidences the presence of humidity in the roof elements and in the ground walls, as well as broken elements. High level of decay was found on a purlin connected to the façade truss, due to water accumulation resultant caused by incorrect position of the roof tiles. It was also observed that the cladding was decayed at the base of the building, due to rising damp, also evidencing warping and splitting due to the water content variation.

Figure 3: Damage maps for the front façade (exterior).

the cladding. Decay was found in roof elements (purlins) in zones where water accumulation occurred due to poor maintenance of the roof (misplaced or broken tiles). Taking into account the results from the visual inspection and diagnosis made to the warehouse, it is found that the structure may be maintained if no modifications are made to the use of the building or no significant loading is introduced. Regarding localized damages, elements from the timber cladding in contact with the ground must be replaced, whereas repair of the doors lintel from the lateral façades must be considered. Furthermore, there is need to consider a timber prosthesis for the end section of a purlin, which had loss of cross-section due to severe decay. Due to the state of conservation of the columns, it is recommended to determine if it is necessary to strengthen or replace those elements, due to its deformation and damage at the base sections. This analysis should comprise the numerical modeling of the structure regarding its current level of deformation and assuming the increment of load expected for the intended new use. In any case, the connection between columns and the granite foundation blocks should allow for an impermeability solution and the broken tiles should be replaced in order to avoid further local moisture induced damages.

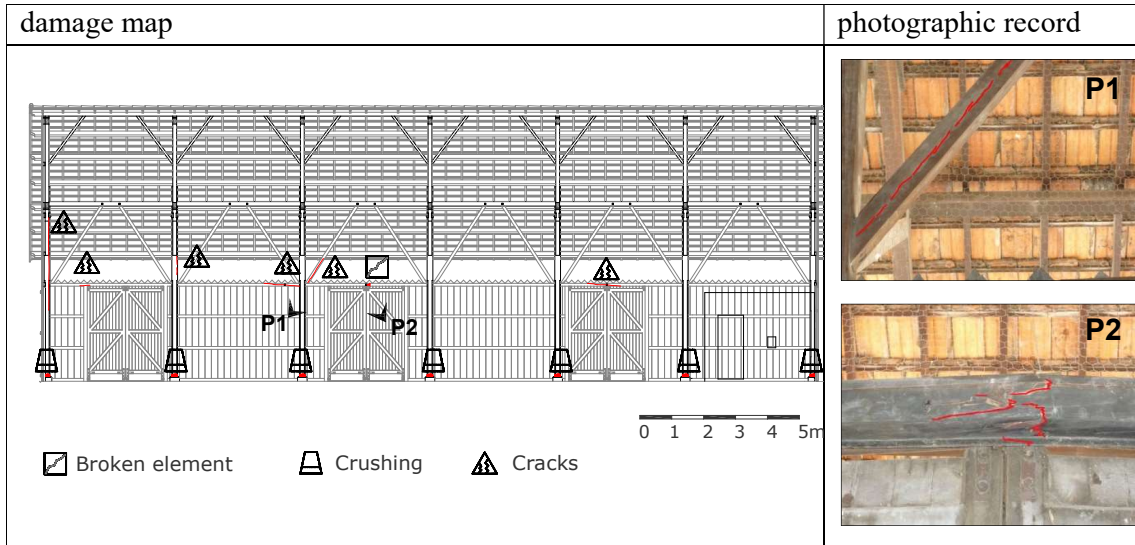
The damage map for the lateral façade facing the river is presented in Figure 4. Localized crushing of the wood fibers on the base section of the columns was visible. This damage resulted from the deformation of the timber columns, leading also to end splits associated to perpendicular to the grain stresses. More detail on the type of cracks can be obtained in Franke *et al.* (2015).

Drying cracks were detected in the diagonals, as well as cracks in elements with pit misaligned with the longitudinal axis. Drying cracks were not considered structurally significant as their depth was minor. However, the presence of pit in a structural element is a parameter that often leads to downgrading in a visual grade.

The cracks found in the lintels of the lateral doors were caused due to stress concentration in the segment where a metallic dowel was introduced (used for supporting the door). These used based cracks occurred by bending failure evidencing rupture of the fibers in the tensioned zone and kink bands on the compression zone (Franke *et al.*, 2015).

Evidences of damaged cladding and signs of humidity (discoloration) in both cladding and columns were visible at the base section of the building.

Figure 4: Damage map for the lateral façade (facing the river, interior).

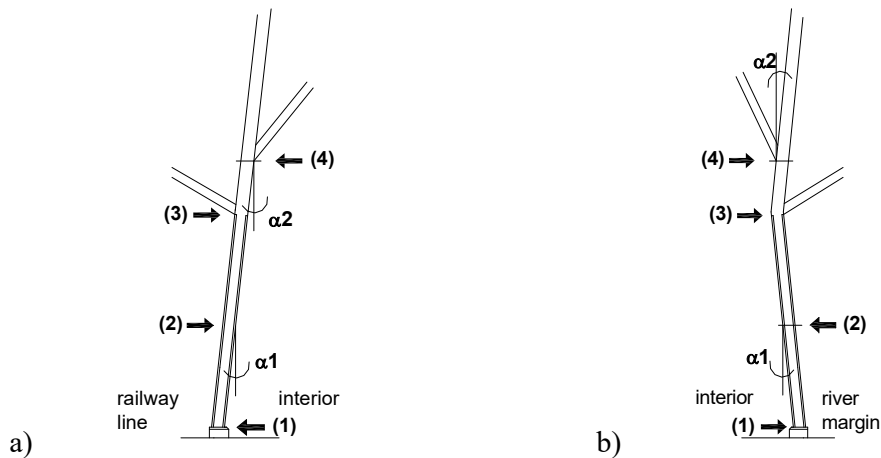
Regarding the distance between columns supporting the same truss (Figure 2), it was found that an average value of 7.60 m is found at level 1. However, columns are inclined to the interior of the building, being distanced in average less 9 cm at level 2 and less 15 cm at levels 3 and 4. Inclination of the columns was more significant on the railway line façade. Also on that façade, the columns had the same inclination direction along its height with a small decrease in inclination from the bottom (α_1) to the top measurements (α_2) with mean values of 2.4° and 0.5°, respectively (Figure 5.a). Meanwhile, for the façade facing the river, the columns had two inclination directions, with mean values of 1.0° and 0.7°, respectively for α_1 and α_2 (Figure 5.b). In both cases, the inflection point is located at the connection of the exterior diagonal with the column. On the longitudinal direction of the warehouse, measurements were made to assess the deformation of the columns and no significant inclination was found in that direction.

Figure 5: Representation of columns' deformation, facing: a) railway line; b) river margin.

The timber columns presented a slight inclination towards the interior of the building. This inclination led to crushing of the timber fibers on the columns supports and end splits induced by perpendicular to the grain stresses. Inclination of the columns was caused by an eccentricity between connection points of the diagonals and the column, which introduced significant localized bending stresses. Cracks found along the timber elements were mainly due to moisture induced effects (drying and shrinkage). However, were considered not relevant for the global structural behaviour of the analyzed structure. Significant cracks were found in the door frames due to bending failure caused by the presence of a metallic dowel that supported the doors' locking system.
