# Experimental investigation of the structural response of adobe buildings to lateral loading before and after the implementation of compatible grout repairs

Rogiros Illampas<sup>1</sup>, Rui A. Silva<sup>2</sup>, Dimos C. Charmpis<sup>3</sup>, Paulo B. Lourenço<sup>4</sup> and Ioannis Ioannou<sup>5</sup>

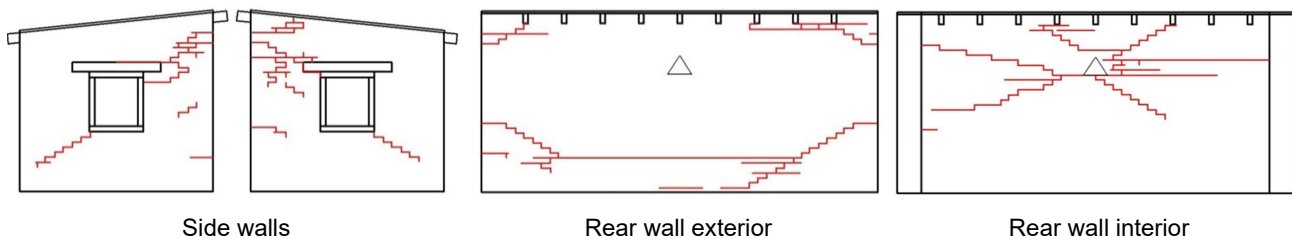
The original, undamaged model was subjected to a sequence of ten loading cycles. This resulted to severe cracking of the rear and side walls (Fig. 2). The localization of damage at the aforementioned areas implies a non-uniform load distribution within the members of the structure, verifying that the lack of a roof diaphragm in unreinforced adobe masonry buildings precludes integral box action.

Diagonal shear cracks radiating from the corners of the windows occurred at the side walls loaded in-plane. The rear wall that was loaded out-of-plane sustained horizontal cracking along its base. Horizontal and diagonal cracks were also noted at the interior of the same wall, at the area where the load was imposed. Damage was characterized by loss of cohesion at the brick-mortar interfaces, rather than failure of the masonry materials themselves. Crack opening during the loading phase was significant, reaching 20 mm at some areas. In addition to masonry cracking, sliding of the roof rafters due to failure of the bonding gypsum mortar was observed.

**Figure 2.** Crack pattern recorded after the completion of the initial static lateral loading test cycles.

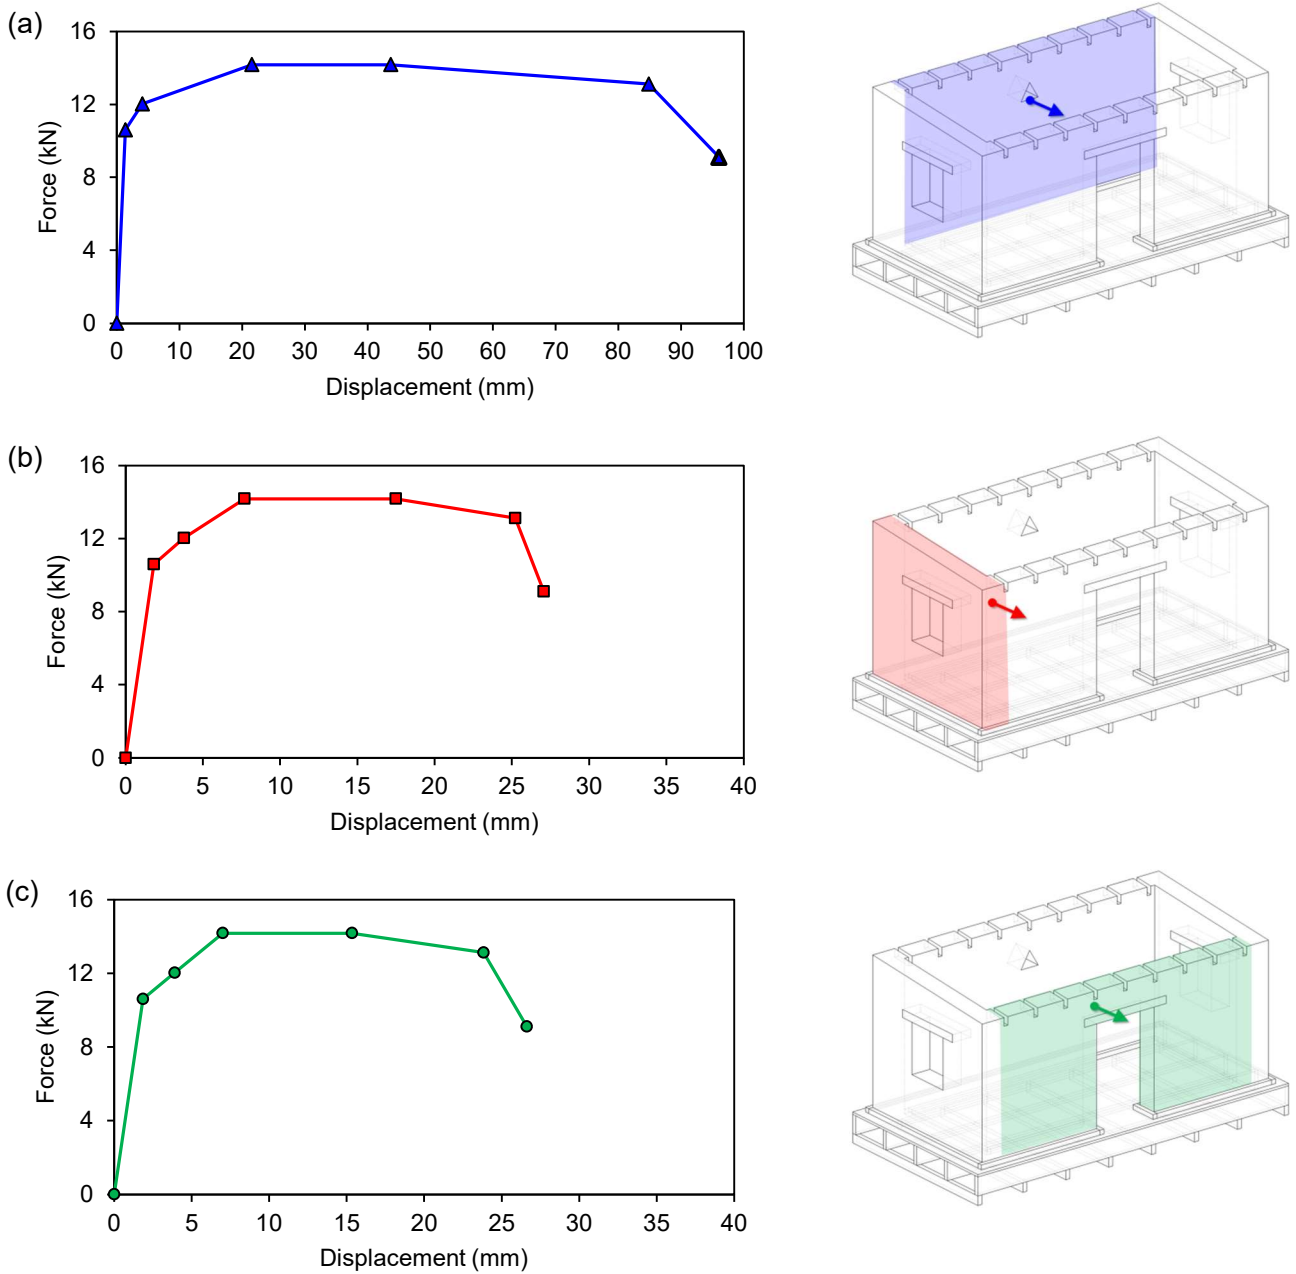
**Figure 3.** Force-displacement data envelopes for the rear (a), side (b) and façade (c) walls obtained from the initial load testing of the original model building. The positions where displacement measurements were carried out are shown in the corresponding pictures and the characteristic data points ( $\blacktriangle$ ,  $\blacksquare$ ,  $\bullet$ ) which have been used to form the force–displacement envelopes are noted in the diagrams.

The initial maximum lateral resistance of the tested structure was 14.2 kN and accounts for approximately 30% of its self-weight. The recorded force-displacement data (Fig. 3) imply a nominal yielding point at a load magnitude of 10.6 kN and a displacement level of 1.8 mm. From this point onwards, stiffness degradation and cracking damage started to develop. Up to approximately 12 kN, a rather uniform deformation distribution was noted, as the walls exhibited coinstantaneous translation sustaining lateral displacements  $< 4$  mm. When the imposed force increased above the aforementioned value, homogenous response of the structural system was lost and differential movement of the walls and roof members took place. After the load-bearing capacity was exceeded, a rocking mechanism was formed due to splitting of the two side walls, as a result of extensive

crack propagation. Subsequently, the overall lateral resistance fell to a residual value of 9.1 kN. At this stage, the ultimate out-of-plane translation measured at the rear wall's upper central section was 96 mm, while the displacements generated at the upper part of the side and façade walls were in the region of 26 mm.

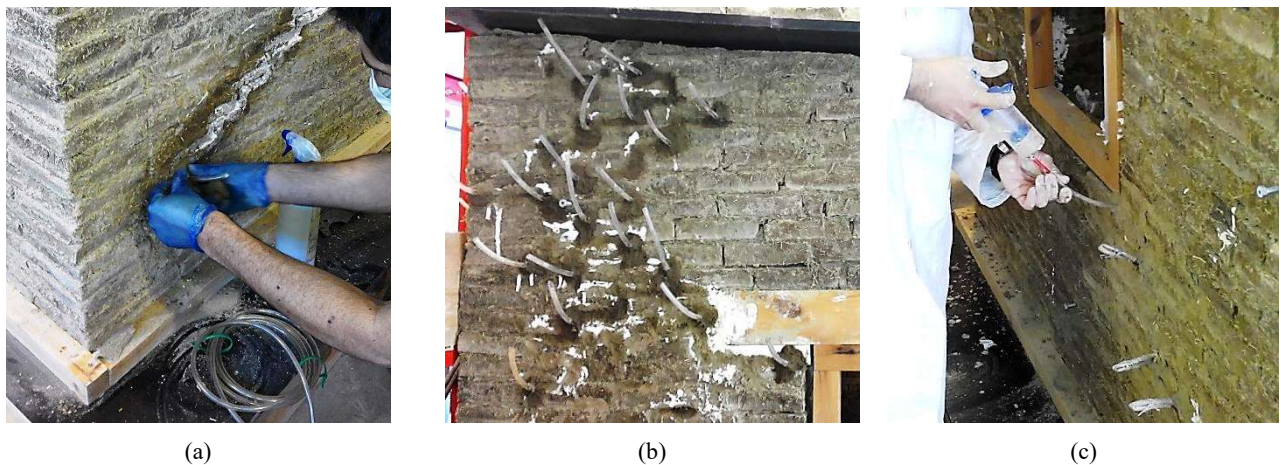
**Figure 4.** Crack repair procedure: installation of plastic tubes along crack paths (a), sealing of cracks with earth mortar (b) and injection of clay-based grout (c).

The grout was injected at all recorded crack paths and at the abutments of the roof rafters. Initially, cracks were cleaned from loose debris using pressurized air. Flexible plastic tubes with 5 mm diameter that extended up to the mid-thickness of the masonry were then inserted every 50-100 mm along the length of the cracks (Fig. 4a). Earth mortar was used for setting the plastic tubes in place and for sealing the external surfaces of the cracks (Fig. 4b). The grout was injected into the fissures via the plastic tubes using a 100 mL syringe (Fig. 4c). In each case, the injection procedure started at the bottom-end of a crack, moving upwards, until all tubes

along the failure path had been filled with grout. Prior to the application of the grout, water was injected to mitigate water adsorption from the grout by the masonry.

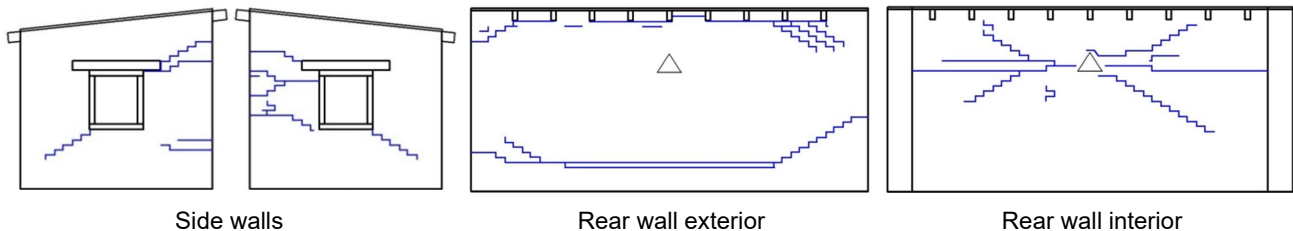
Comparing the crack pattern recorded before and after the repair intervention, it is noted that grouting did not significantly alter the distribution of damage within the masonry walls (Fig. 5). Again, diagonal cracking was observed at the side walls and a major horizontal crack occurred along the base of the rear wall. In addition, horizontal and diagonal cracks were formed at the interior of the rear wall due to overstressing at the loading area. However, in the repaired structure horizontal cracking also occurred at the upper exterior part of the rear wall, below the abutments of the roof rafters. This is possibly because the clay-based grout injected in this region produced better bonding between the adobes and the timber elements, enabling a more efficient transfer of stresses to the masonry and preventing sliding at relatively low levels of loading. Lateral loading led to significant crack openings, ranging from 4 to 25 mm. Despite the concentration of damage at approximately the same wall sections, cracking did not propagate through the injected failure paths. Instead, new cracks developed through adjacent mortar joints. In all cases, bonding failure at the interfaces between the adobe bricks and the mortar or the grout was observed. Failure of the grout material itself or mitigation of damage to the masonry constituents was not recorded.

**Figure 5.** Crack pattern recorded after the completion of static lateral loading tests on the repaired structure.

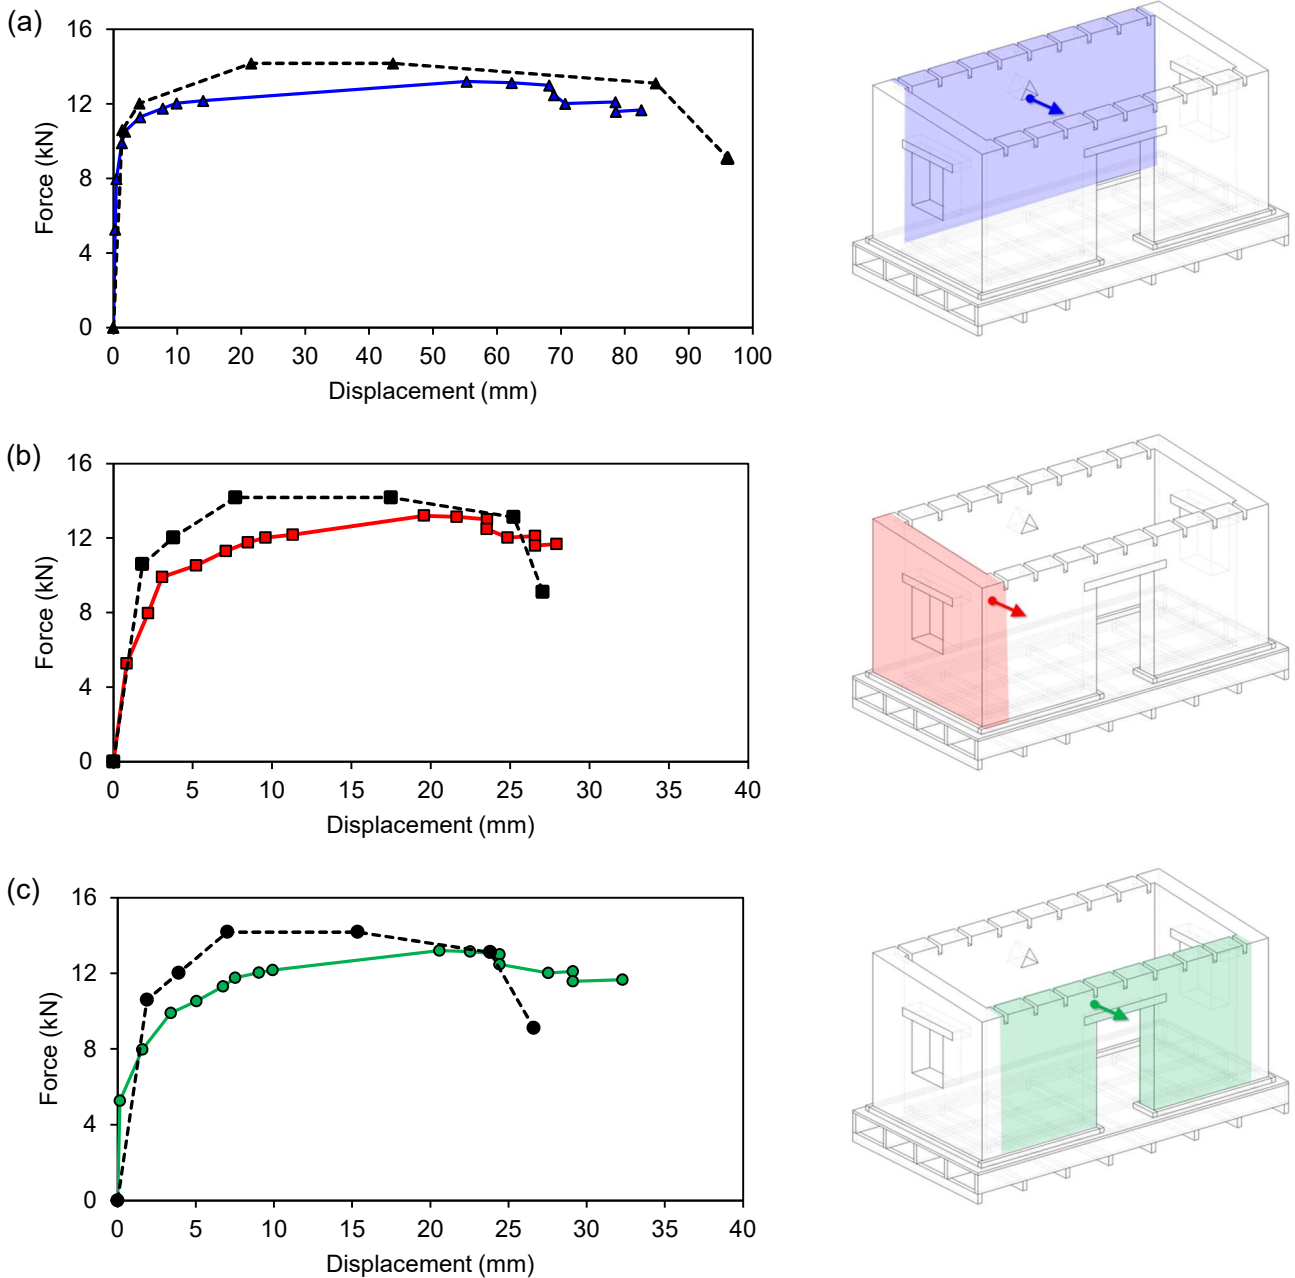
The force-displacement response obtained from the tests conducted after the grout repairs is compared against corresponding data for the original building in Fig. 6. Grouting succeeded in recovering a significant portion of the structure's original strength. The maximum lateral force sustained by the repaired building was 13.2 kN and accounts for 93% of the initial load-bearing capacity. This is also 45% higher than the residual strength recorded at the end of the first ten loading cycles. The members of the repaired structure exhibited a homogeneous response to loading up to a lateral translation of 9 mm, corresponding to a 12 kN imposed force. Grouting reinstated the initial stiffness of the rear and side walls and increased the out-of-plane stiffness of the façade. The response noted in the latter case is possibly associated with the improved connection between the masonry and the roof that was achieved via the injection of grout at the rafters' abutments. This enabled a more effective distribution of loads to all parts of the building, leading to consistent structural response up to the point where the tensile capacity of the masonry sections supporting the roof was exceeded and horizontal cracking developed. After this stage, rapid damage propagation was observed and significantly large differen-

tial displacements of the walls were generated. At the final test cycle, a residual capacity of 11.6 kN was recorded. The ultimate displacements measured at the upper sections of the rear, façade and sidewalls were 83, 32 and 28 mm, respectively.

**Figure 6.** Comparison between the force-displacement data envelopes recorded at the rear (a), side (b) and façade (c) walls following the testing of the original (dotted lines) and the repaired (continuous lines) building. The positions where displacement measurements were carried out are shown in the corresponding pictures and the characteristic data points ( $\blacktriangle$ ,  $\blacksquare$ ,  $\bullet$ ) which have been used to form the force-displacement envelopes, are noted in the diagrams.

The high strength recovery rate hereby achieved is primarily attributed to the efficient repair of the in-plane resisting elements (i.e. side walls). Indeed, data reported in the literature verify that clay-based grouts can re-instate the shear resistance of cracked earth masonry [2, 6]. Shake table tests carried out on an adobe house also repaired with the injection of unstabilized clay-based grout resulted to 54% strength recovery and 30% stiffness recovery [7]. These values are considerably lower compared to the outcomes obtained in this study.
