CIB2007-426

Social Housing Building Stock Renewal Needs: A Case Study

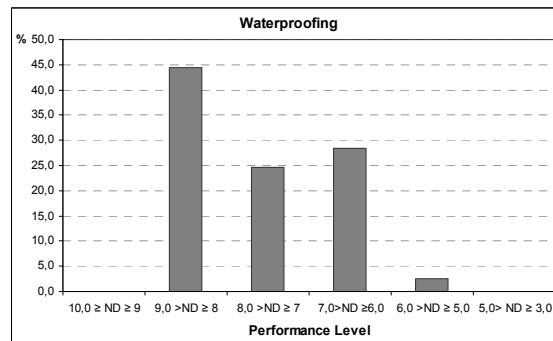
Fig. 1- Waterproofing distribution performance level

The mean value obtained to the envelope waterproofing is due to the general good performance of the flat roofs. The worse results are from some cases of punctual lack of waterproofing of this element and to several cases of bad framework waterproofing. These two situations imply the appearance of dampness in the interior face of the external walls.

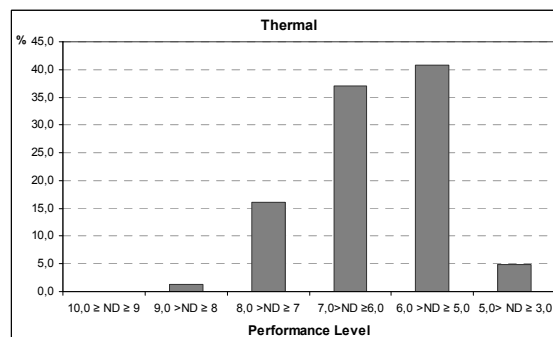
Fig. 2- Hydrothermal distribution performance level

The hydrothermal conditions evaluation was principally conditioned by the general bad thermal performance in winter and with the frequent appearance of condensation in the ceilings and in the interior walls of the apartments.

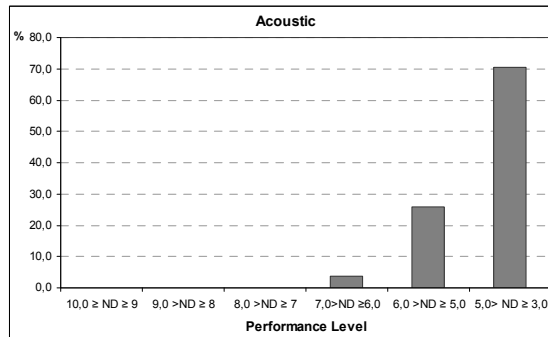
Fig. 3- Acoustic comfort distribution performance level

As referred it was attributed in general the no satisfy evaluation to acoustic conditions, in all the parameters: internal and external sound air transmission and percussion sound transmission. The lack of sound isolation is the reason of these bad conditions.

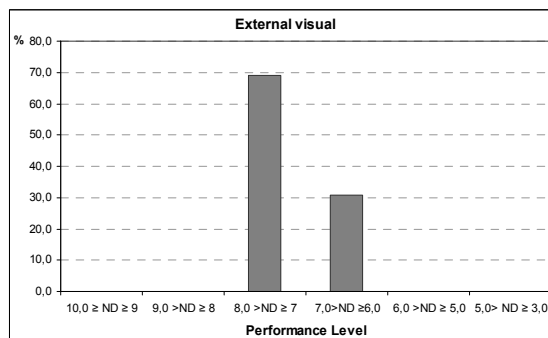
Fig. 4- External visual aspect distribution performance level

In spite of the external façades have significant areas by different kind of cracks and vegetable organisms. The external visual aspect of the housing blocks doesn't seem be among the main requirements of the inhabitants.

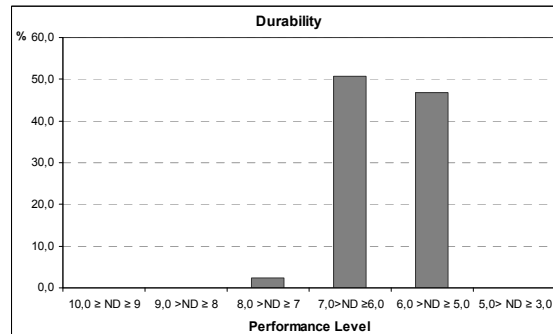
Fig. 5- Durability and maintenance facilities distribution performance level

Relatively to maintenance facilities it is relevant to refer that only one of the buildings, constructed in 2004, have installed a metallic stair to permit de access to the flat roof. In all of the others this access is done with portable stairs. Any external façade has installed systems to permit easier and safer maintenance activities during service life.

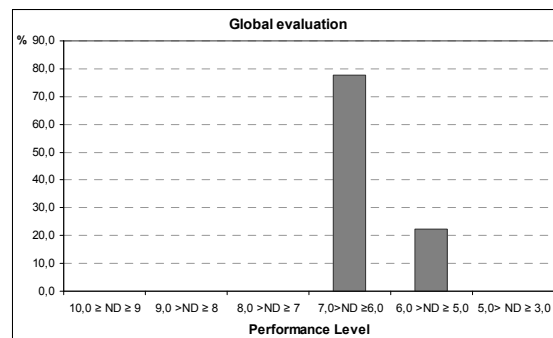
Fig. 6 – Building global distribution performance level

The buildings global evaluation is satisfy in 77,8% of the interview's results and in the others 22,2 % is satisfy less.
