# To the Issue of Assessment of the Technical Condition of Underground Structures of Buildings

**Abstract:** A survey and assessment of the technical condition of basement and semi-basement structures in public buildings aged 60 to 130 years were conducted to evaluate their suitability for use as basic shelters. Based on the survey results, the most adverse impacts were identified, including changes in groundwater levels, improper building operation, and the characteristic damages to underground structural elements. Structural solutions were proposed to eliminate the consequences of these damages. The reviewed cases indicate that the vertical and horizontal waterproofing systems used during construction cannot perform their function throughout the building’s entire life cycle. When designing new buildings, waterproof materials should be used for the enclosing structures of underground premises. While this may have a higher initial cost than membrane or coating waterproofing, considering life-cycle costs, it can provide a positive economic effect and improve the quality and comfort of the indoor environment.

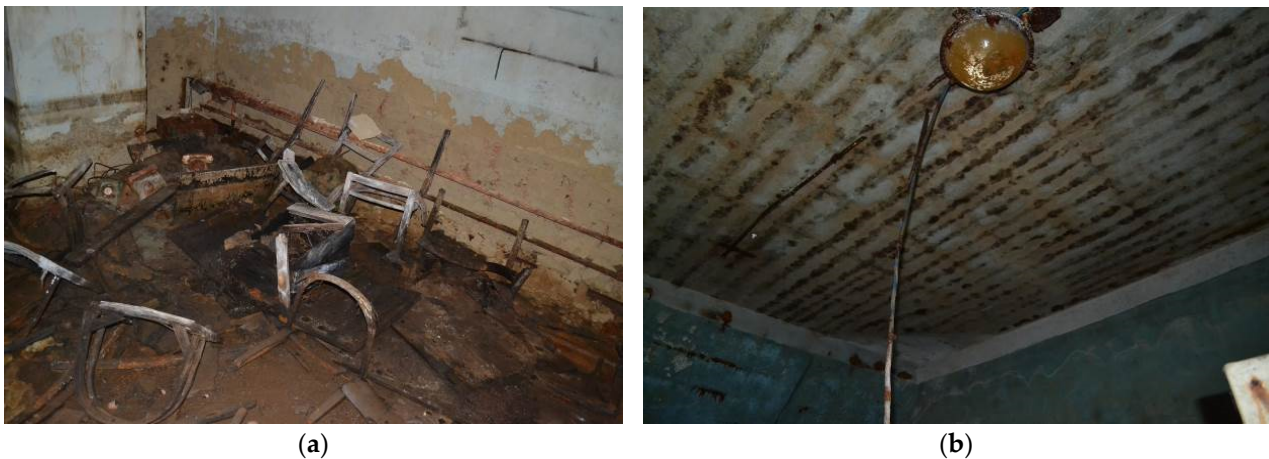
The primary defect of the shelter is water permeability. During inspection, the water level was between 20 and 30 mm, but the humidity plaster indicates that the water level was about 600 to 700 mm (Figure 1a). This level of flooding is attributed to both the failure of the external drainage system around the building and the water permeability of the prefabricated and monolithic reinforced concrete enclosing structures of the floor and walls. According to the provided design, the drainage system was installed as a ring drain 6–7 m below the ground surface, beneath the foundation slab. The drainage system consists of round asbestos-cement pipes with slits every 30 cm, laid in trays and covered with coarse and medium sand. The pipe slope is approximately  $i = 0.005$ . Wells are constructed at the corners of the shelter and along the middle of its long sides.

**Figure 1.** Primary defects of the inspected basement shelter that has been out of operation: (a) damage to the finishing layer and erosion of the shelter's wall and floor structures due to prolonged water exposure and saturation; (b) corrosion damage to the reinforcement of precast reinforced concrete roof panels, formation of corrosion-induced crack, deterioration of protective plaster, and efflorescence.

The long-term semi-flooded condition of the basement has led to the following damages (Figure 1): destruction of the floor structures (such as rotting and others); corrosive wear of metal network structures—ventilation, heating, water supply, electricity, and sewage systems; corrosive damage to the working reinforcement of the prefabricated reinforced concrete ceiling panels (corrosion thickness 1–2 mm, bulges, damage to protective plaster, and efflorescence); accumulation of semi-rotted debris—remnants of furniture and equipment.

The condition of the load-bearing building structures can be assessed as condition 3—unsuitable for normal operation, while the condition of all the networks is condition 4—emergency, destroyed.

Thus, to restore the operation of the basement, the following measures have been recommended [21]:

1. Installation of low-voltage safe lighting (for wet conditions);
2. Cleaning up debris and remnants of the floor, corroded networks, and damaged plaster;
3. Restoration of water collection sumps; alternatively, installing 80 mm gravel fill and a new 60–80 mm reinforced concrete floor with water collection pits from which water should be pumped out and diverted outside the basement, preferably into a storm sewer;
4. Restoration of ventilation (both exhaust and supply). If the basement's purpose changes, natural aeration can be arranged.

5. Restoration of drainage and external dewatering systems.
6. Roof repair of the basement:
  - Removal of soil fill;
  - Restoration of waterproofing (applying new waterproofing or asphalt concrete screed);
  - Installation of a 300 mm thick polystyrene concrete insulation,  $\gamma_o = 100\text{--}150 \text{ kg/m}^3$ ;
  - Asphalt concrete screed with a thickness of  $\delta = 60\text{--}80 \text{ mm}$ ;
  - Filling with clay and soil mixture with a 400–500 mm thickness.
7. Restoration of heating in the basement.
8. Restoration of water supply and sewage networks.
9. Restoration of interior finishing.
10. Restoration of furniture and furnishing of the premises.

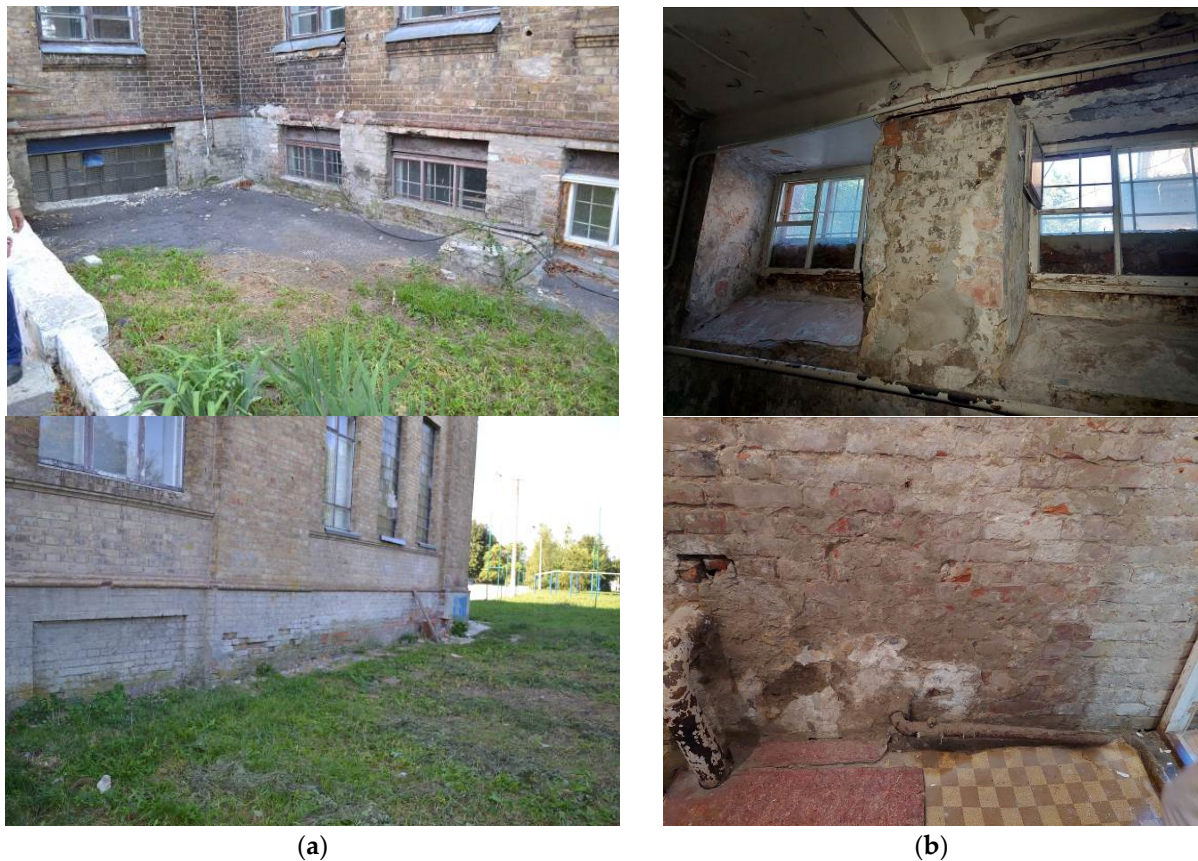
The blind area around the building is in poor condition and unfit for use (Figure 2a). The layout of the surrounding area contributes to the accumulation of atmospheric water and its localized infiltration into the foundation base, resulting in the formation of a water-logged area. External engineering networks and wells are located around the building but are no longer used. Their poor technical condition has led to water accumulation in these areas. A mechanical suffusion of the soil was observed, causing subsidence of the asphalt blind area around the building.

**Figure 2.** Relevant defects of the inspected historical gymnasium building in the Poltava region: (a) the pavement around the building is in an unfit condition, and the site grading promotes the accumulation of atmospheric water, leading to its localized infiltration into the foundation base; (b) deterioration of the interior wall surfaces in the basement due to capillary moisture rise, resulting in plaster damage and efflorescence formation.

Dampness was detected on the basement walls (Figure 2b). Frost-induced damage was recorded in areas where rain gutters were previously damaged and in the dampened plinth areas due to the water-logged sections around the building. Furthermore, neither the foundations nor the building itself is suited for subsidence-prone soil conditions (the foundations lack reinforcement, there are no monolithic reinforced concrete belts, the load-bearing walls are not reinforced, and other factors).

To ensure the building's continued safe operation, it is recommended that the old engineering networks within a 30 m radius of the building be inspected. Any damaged engineering networks should be dismantled, and the surrounding area should be improved. Vertical grading around the entire building, sloping away from the structure, should be performed, and a blind area at least 2 m wide with a clay barrier should be constructed.

To restore the horizontal waterproofing layer of the load-bearing brick walls, it is recommended to inject hydrophobic solutions into the structure at the level of the first-floor slab in a continuous strip, as detailed in [22].

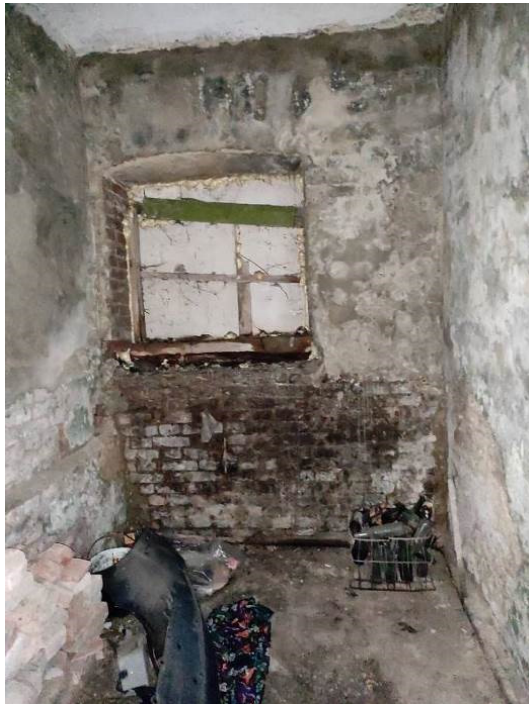
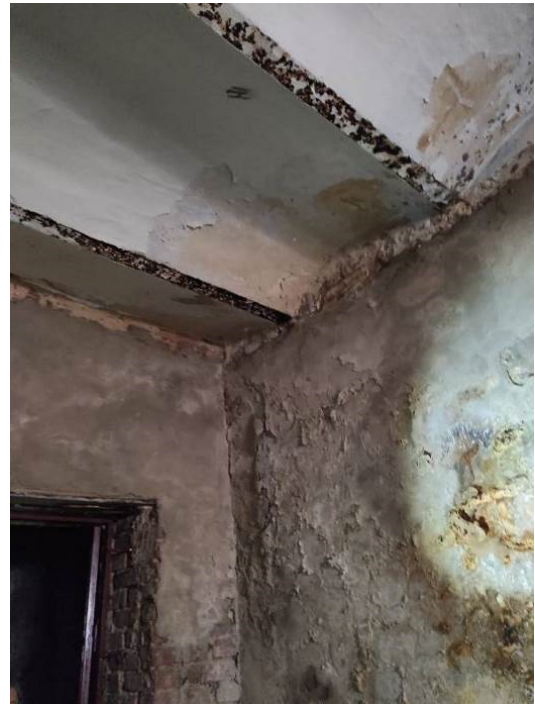
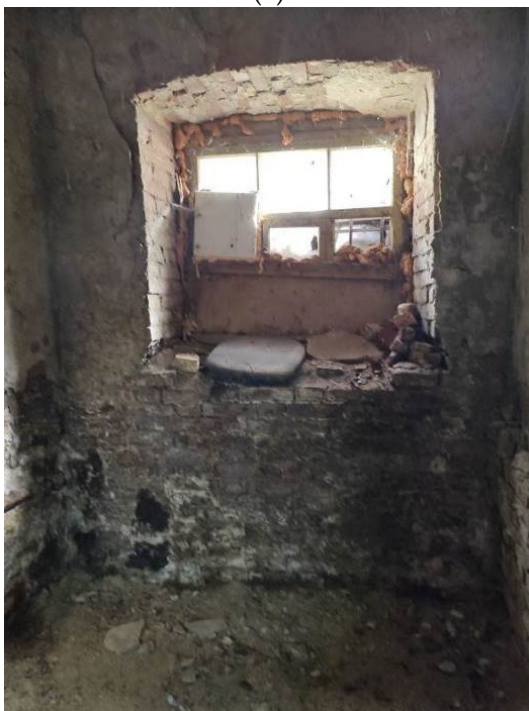
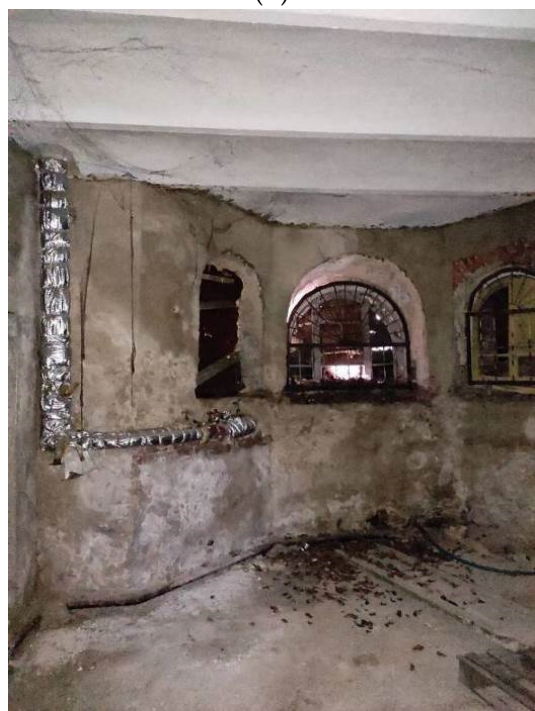
**Figure 3.** Primary defects of the basement in the administrative building in Poltava: (a) deterioration of the interior wall surfaces in the basement, with efflorescence appearing on the walls; (b) corrosion damage to the basement ceiling structures, along with efflorescence on the wall surfaces; (c) destruction of the brick masonry of the basement walls; and (d) disruption of the air-moisture balance within the premises.

Corrosion of the steel beams is most pronounced in axes 4–6, where significant dampness of the load-bearing brick walls was also observed. Above the basement ceiling, a wooden floor has been laid over the ballast backfill.

The walls are brick, with wedge-shaped arches above the doors and windows. The facades on sides 6-1 and A-E are plastered and painted, while the courtyard facades feature exposed brickwork (painted in axes E-A). Due to a disruption in the thermal and moisture regime, the basement walls and part of the first-floor walls are affected by mold and mildew.

**Problems:** The disruption of the air–moisture regime has led to corrosion of the steel ceiling beams and mold formation on the walls. The destruction of the external waterproofing layer in the soil has caused the degradation of the brickwork, leading to mold formation and other issues.

To restore the operational characteristics of the building's underground part, the following works are recommended:

1. Repair the utilities around the building.
2. Dig a trench along the foundation.
3. Clean the wall of dust, dirt, and irregularities.
4. Apply an adhesive primer.
5. Install vertical waterproofing using coating methods.
6. Backfill with clay soil of optimal moisture, compacted in layers.
7. Install asphalt pavement with a clay barrier.

The interior finishing repairs involve removing the plaster layer, cleaning the wall, applying antiseptic treatment, and reapplying cement–sand plaster.

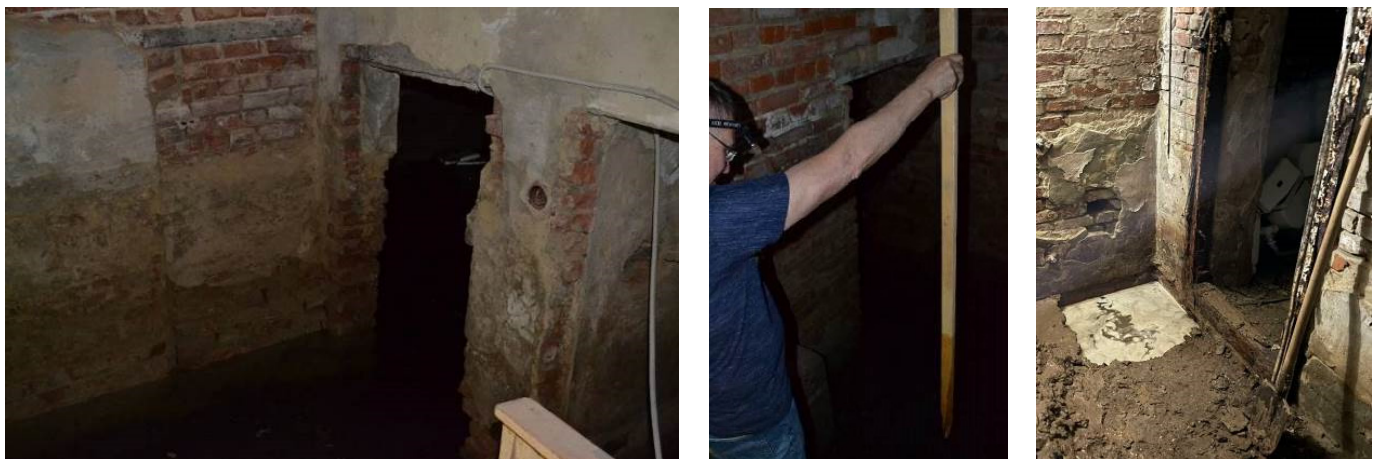
**Figure 4.** Flooding of the school basement rooms: destruction of the lime matrix in the joints and moisture saturation of the brick structures in the basement.

The condition of the foundations was examined through excavation pits in the basement (Figure 4). It was determined that the foundations of the load-bearing walls are strip-type, made of rubble stone and brick, and laid directly on natural soil. The width of the foundation base is 700 mm and 500 mm, with a foundation depth of 500 mm and 600 mm from the basement floor and 2700 mm to 2800 mm from the ground surface to the basement floor.

No vertical or horizontal waterproofing of the foundations was found. The overall technical condition of the foundation structures is satisfactory.

Cracks in the load-bearing wall are caused by the saturation of the loess subsidence layer, which leads to a significant decrease in the soil's mechanical properties. As a result, the foundation base became overloaded by more than 30%.

The overall condition of the building is assessed as transitioning from satisfactory (condition 2) to unsuitable for normal use (condition 3). At the same time, the condition of most load-bearing structures is rated as satisfactory, but some (in particular, the sub-basement reinforced concrete slab, some parts of which have 100% wear of the working reinforcement (Figure 5), and the waterproofing of certain sections of the basement walls) are rated as condition 3, meaning unsuitable for normal use.

2. Considering the degradation of loess soils due to water exposure over the last 30–40 years, it makes sense to install gypsum markers on the walls and monitor crack openings every quarter. If cracks are detected, measures should be taken to increase the rigidity of the wall structures, including installing tie rods, frame braces, portal ties, or others, according to a specially developed project.

5. Prevent any impact or damage to the additional steel supports under the staircase stringers.
6. Increase the width of the foundation’s waterproofing perimeter to 2.5 m, directing drainage away from the building.

12. If the building’s deformations continue, the foundations should be strengthened using the well-proven method of reinforcing the loess soil layer with soil-cement elements [35].

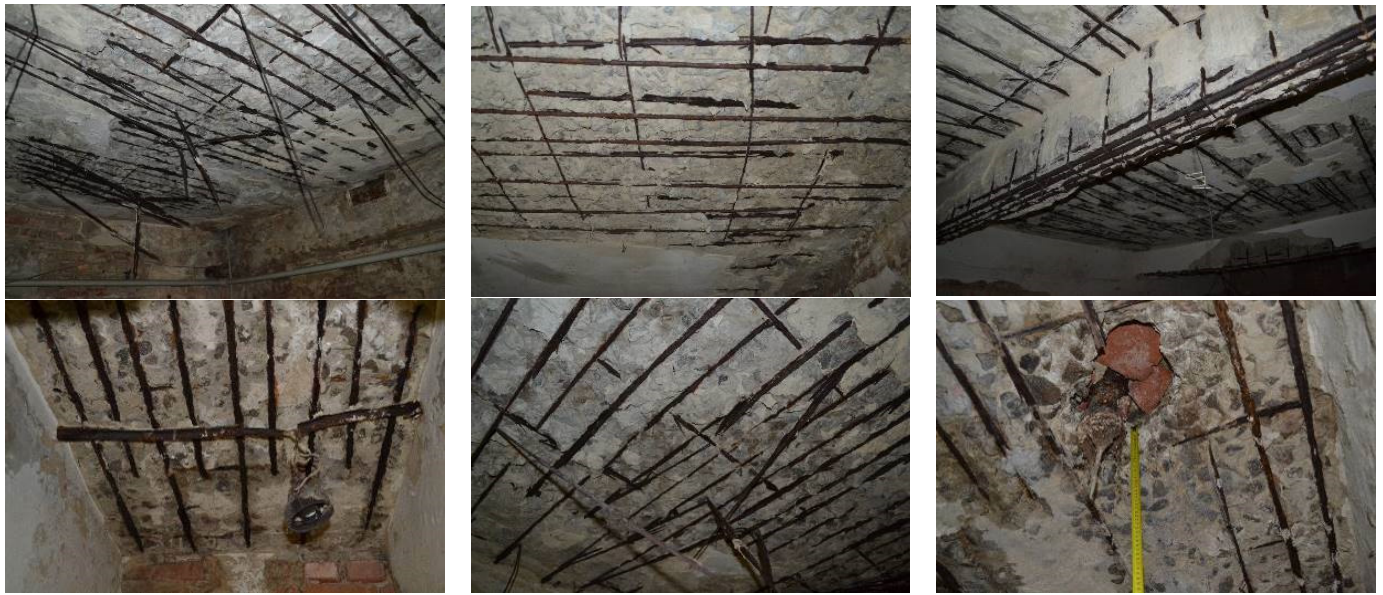
The floor above the basement (Figure 5) consists of a reinforced concrete slab approximately 140 mm thick. The groundwater level was found to be 2.8–2.9 m from the surface, with fluctuations up to 1 m higher (Figure 4). This is significantly affected by leaks from water-bearing networks. In some areas, due to the absence of organized drainage, atmospheric water accumulates and infiltrates the loose backfill soil.

**Figure 5.** General view of the sub-basement slab: corrosion damage to the reinforcement bars of the floor slabs and destruction of the concrete protective layer.

3. The basement slab with 100% wear of the working reinforcement should be reinforced by installing steel frames along the walls and beams to strengthen the slab. Anchors should be glued into holes and secured with nuts and locknuts. Corrosion

4. Corroded reinforcement should be cleaned with steel brushes, and the protective layer of concrete should be restored by plastering with a cement–sand mortar.

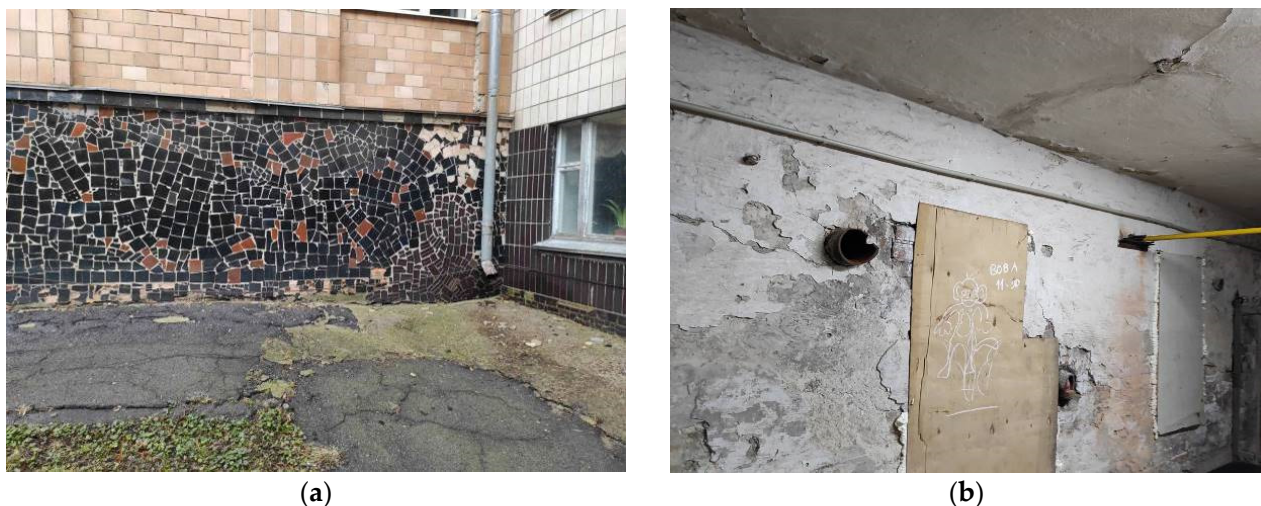
**Figure 6.** Specific defects of the academic building: (a) damaged pavement around the building, allowing water to flow through the wall and flood the basement; (b) deterioration of the basement wall surfaces due to plaster damage and efflorescence formation.

The foundations under the load-bearing walls are strip foundations on natural soil made of prefabricated reinforced concrete elements (FL slabs and FBS blocks). The foundation depth varies from 2.7 to 3.7 m, depending on the terrain. Visual inspection revealed localized chips, spalling, damage to the plinth’s plaster layer, and local damage to the waterproofing perimeter. There are no foundation deformations that would disrupt the building’s normal operation. The technical condition of the foundations is classified as satisfactory.

The recommended works for restoring the operational parameters of the underground part of the building are as follows:

1. Excavation of a trench along the foundation with a depth of 3000 mm and a width of 1000 mm, with slope bracing.
2. Cleaning the wall of dust, dirt, and uneven surfaces.
3. Application of an adhesive primer.
4. Installation of vertical waterproofing using a coating method.
5. Installation of vertical insulation for the foundation using extruded polystyrene foam (e.g., TECHNONICOL CARBON ECO) ( $35 \text{ kg/m}^3$ ) with a thickness of 150 mm, applied with contact adhesive.
6. Installation of PLANTER-geo profiled membrane.
7. Backfilling with clay soil of optimal moisture content, with layer-by-layer compaction.
8. Installation of an asphalt blind area with a clay lock.

The repair of interior finishes includes removing the plaster layer, cleaning the wall, applying antiseptic treatment, and applying cement–sand plaster.

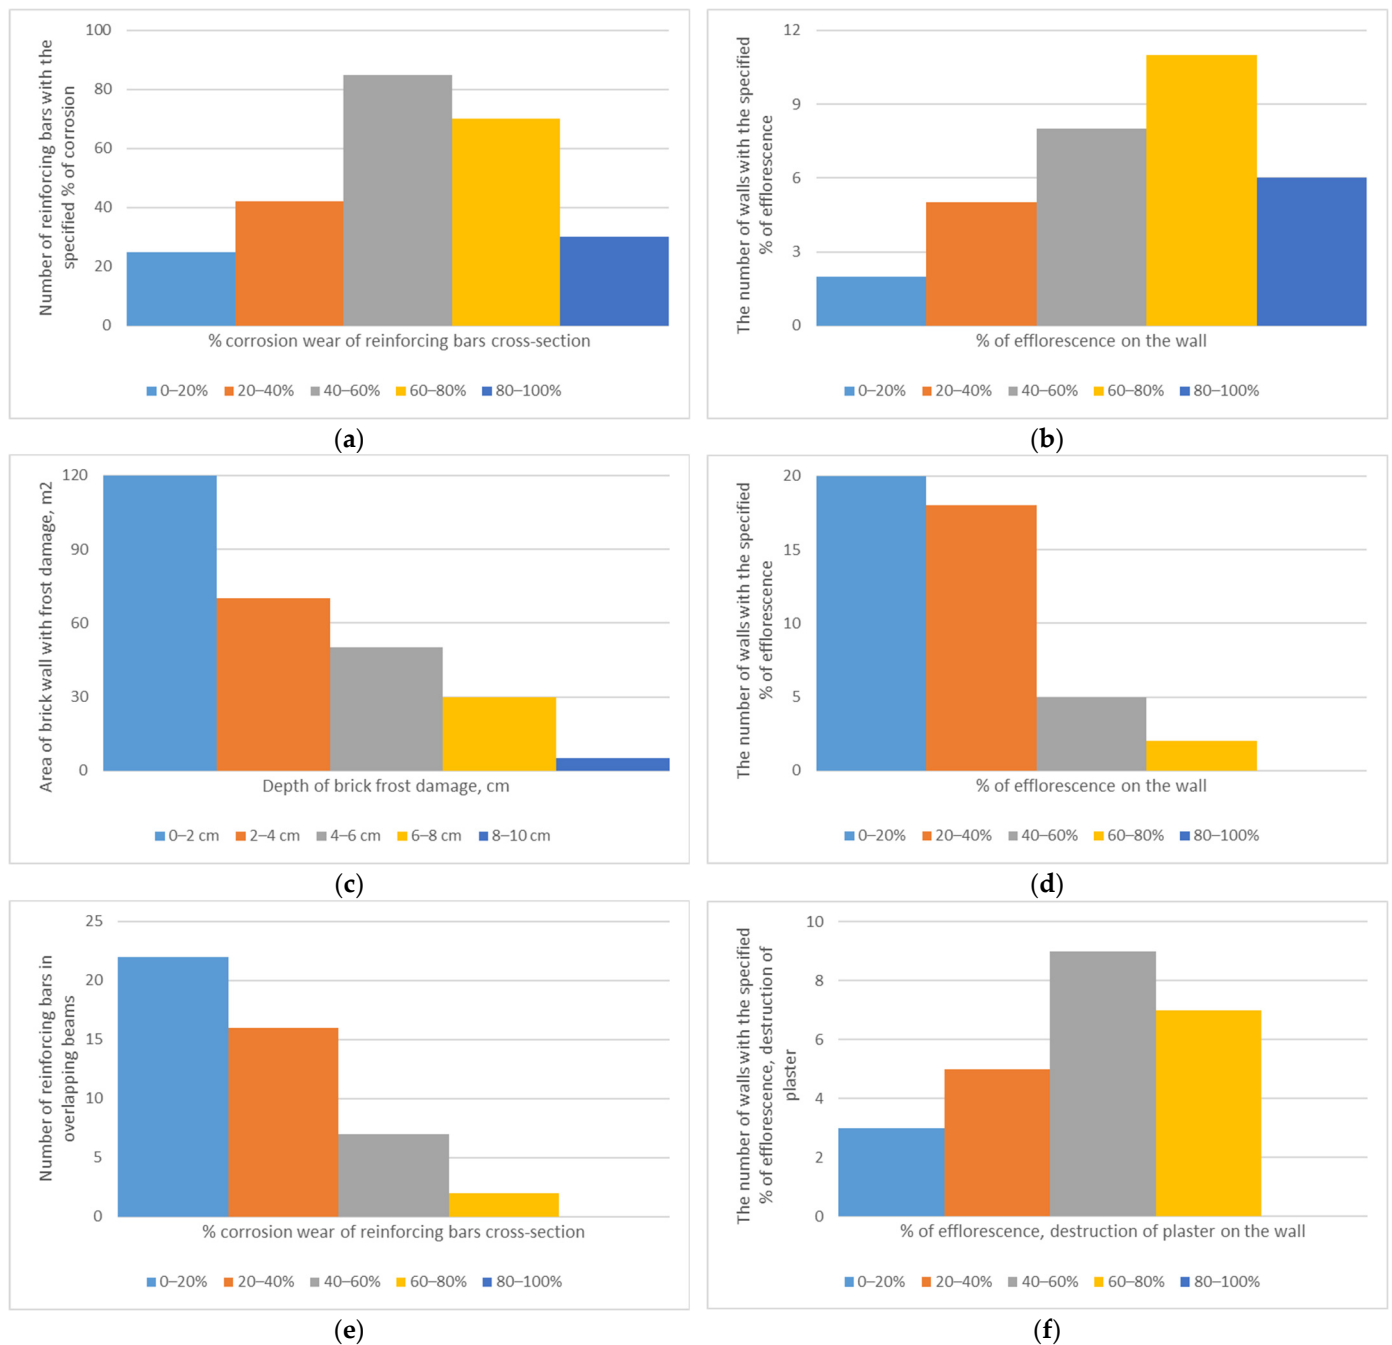
**Figure 7.** Analysis of damage recurrence in the inspected basement premises: (a) distribution of corrosion wear of reinforcement bars in the structures of the non-operational shelter; (b) distribution of efflorescence area on the wall surfaces of the non-operational shelter; (c) distribution of frost-induced brick deterioration depth relative to the defect area on the walls of the gymnasium building in the Poltava region; (d) distribution of efflorescence area on the wall surfaces of the basement premises in the gymnasium building in the Poltava region; (e) distribution of corrosion wear of the reinforcement bars in the basement structures of the administrative building; and (f) distribution of efflorescence area on the wall surfaces of the basement premises of the administrative building.

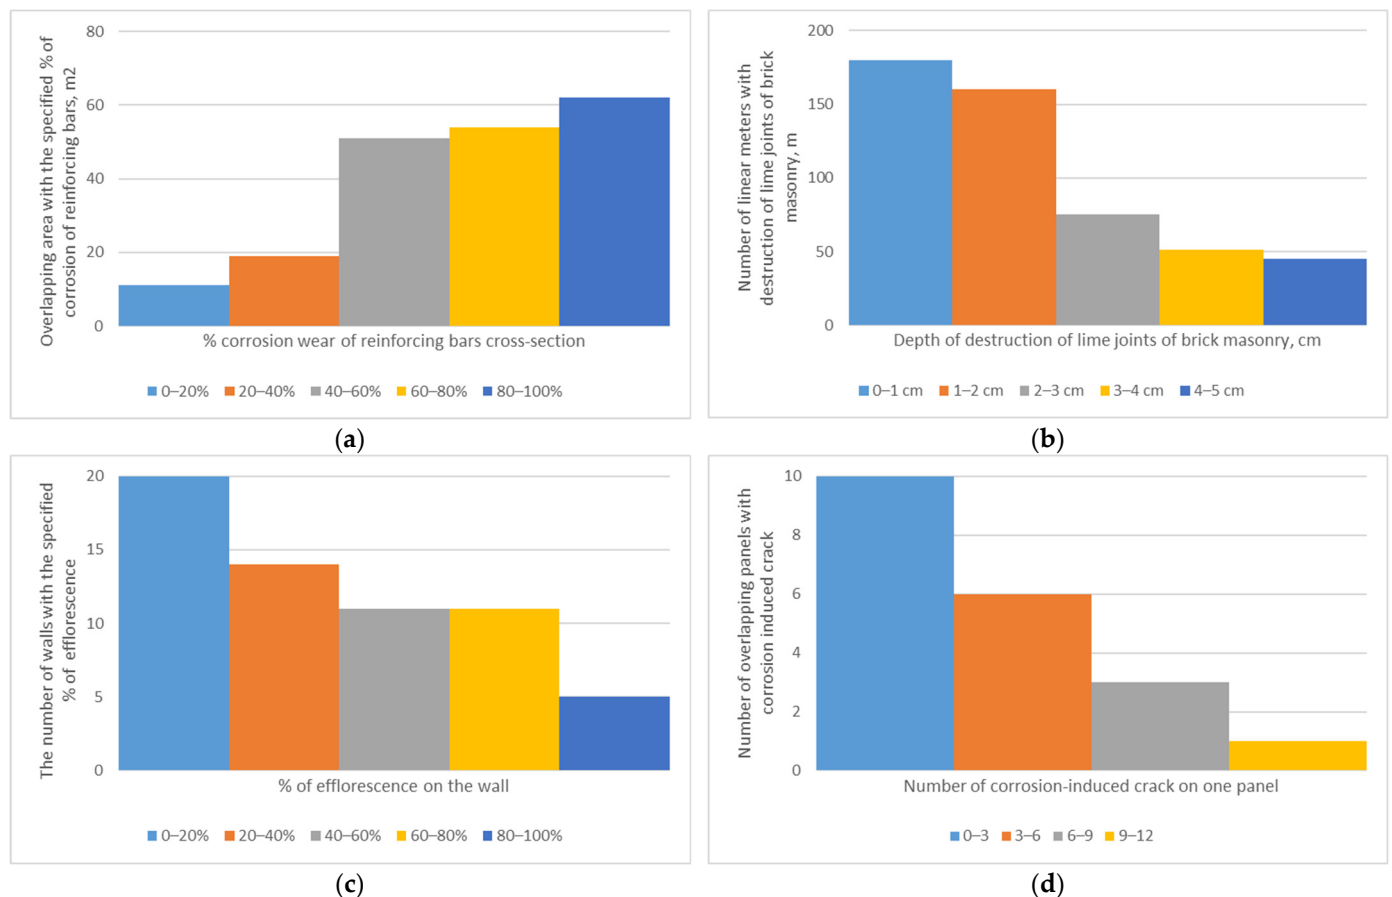
- The basement structures of a two-story school (Section 3.4) exhibit significant damage to the reinforcement bars of monolithic floor slabs. The histogram indicates that the vast majority (>90%) of the bars have corrosion wear exceeding 50%, while the depth of limestone matrix leaching is predominantly within 1–2 cm (Figure 8a,b);

- An analysis of histograms based on the basement structures of a university (Section 3.5) reveals that most efflorescence on the walls is localized, affecting less than half of the surface and appearing as isolated spots. As for the damage to the protective concrete layer caused by the expansion of corrosion products, floor panels with significant damage (more than five defects) are rare, occurring in only 3–4 panels out of 20 (Figure 8c,d).

**Figure 8.** Analysis of damage recurrence in the inspected basement premises: (a) distribution of corrosion wear of reinforcement bars in the floor slabs of the two-story school building; (b) distribution of the depth of mortar joint leaching in the brick walls of the basement part of the two-story school building; (c) distribution of the area of efflorescence on the wall surfaces of the basement premises of the university building; and (d) distribution of damage to the floor slabs of the basement premises of the university building.
