ADVANCED MASTERS IN STRUCTURAL ANALYSIS
OF MONUMENTS AND HISTORICAL CONSTRUCTIONS

Master's Thesis

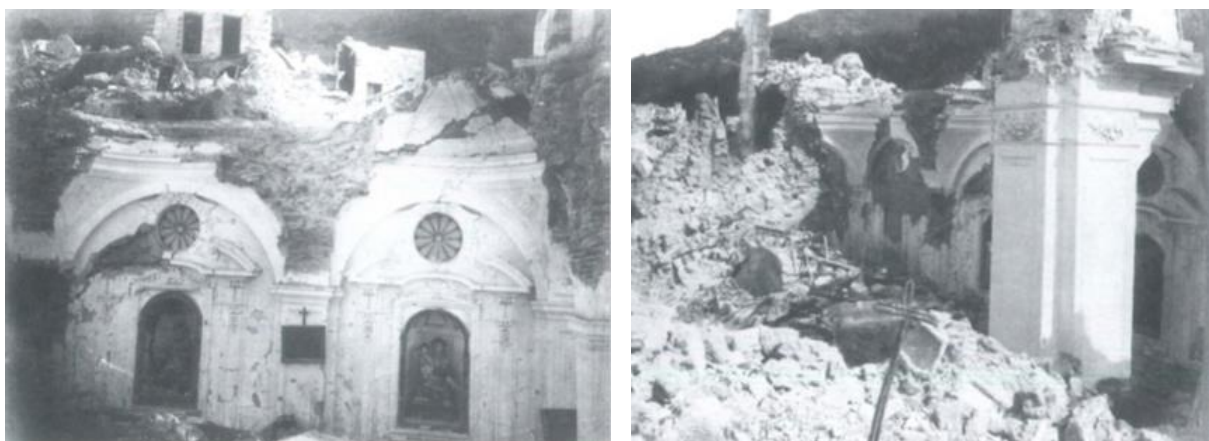
Figure 2.3 Interiors of the original church after the 1883 earthquake, private collection G. Fiorentino. Source: (Luongo et al. 2006)

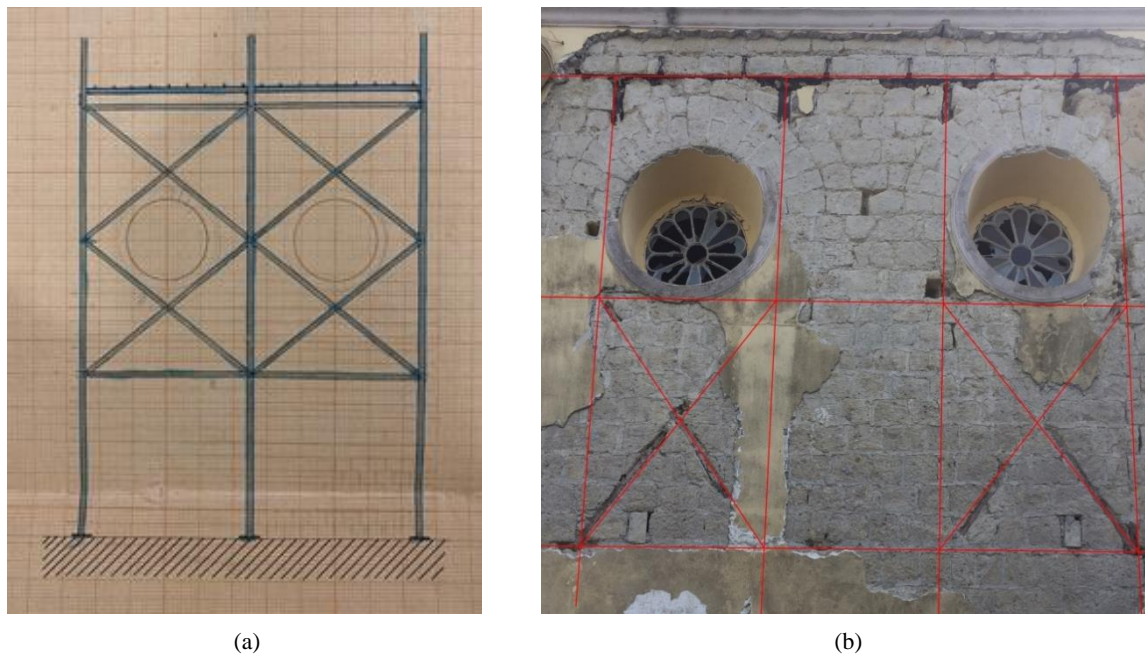
Figure 2.6 Original drawing of the structural organization of the iron frames (a) and *in-situ* survey result (b) for the lateral wall. Source (a): (“Archivio di Stato di Napoli, Corpo Reale Genio Civile, fascio 342, incart. 3” n.d.). Source (b): (Casapulla et al. 2019b)

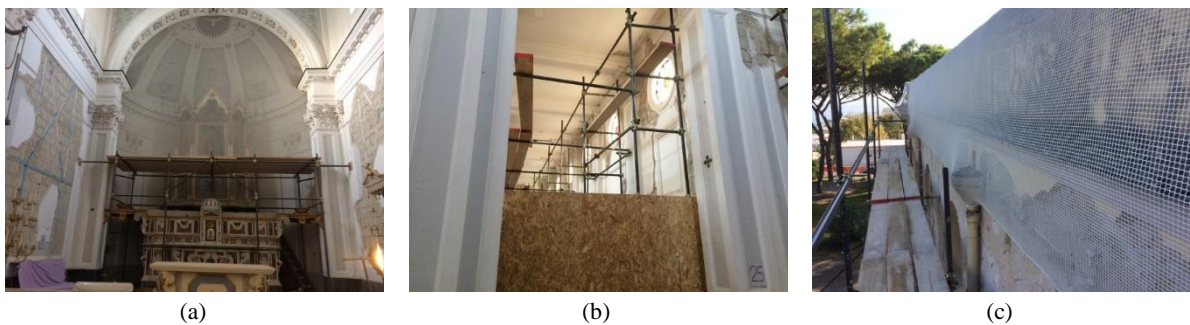
Figure 2.7 Provisional interventions, installation of tube and coupler scaffolding in the apse (a) and in the aisles (b), and application of safety-nets (c)

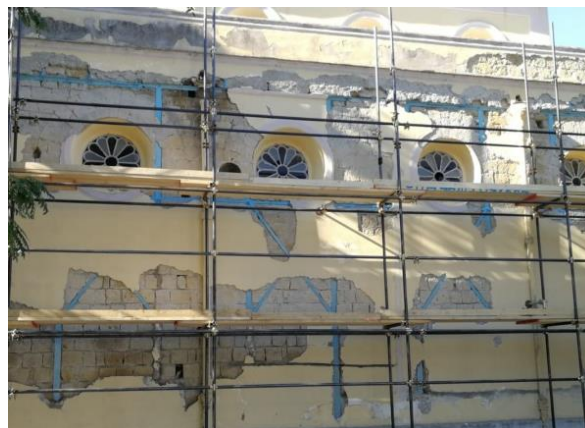
Figure 2.8 Anti-rust protection of the iron frames of the external walls

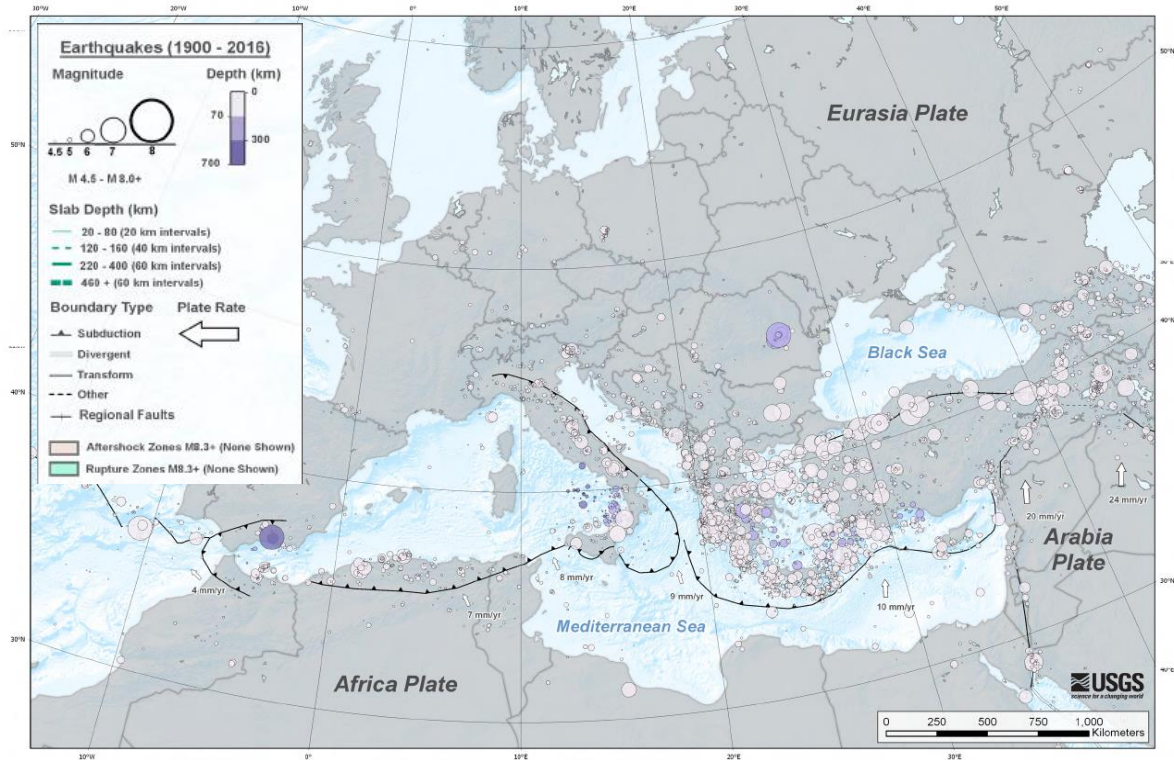
Figure 2.13 Map of the major earthquakes occurred in the Mediterranean Region and its vicinity in the range period between 1900-2016. Source: (USGS n.d.)

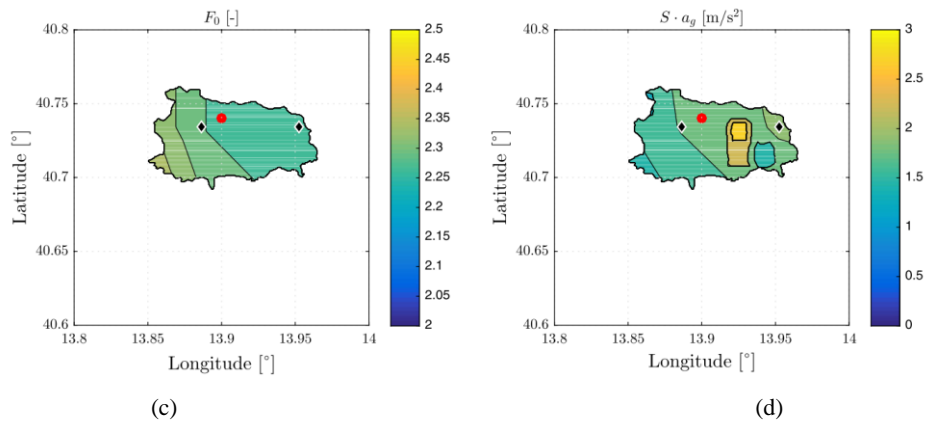
Figure 2.15 a_g (a), T_c^* (b), F_0 (c), $S \cdot a_g$ (d) with 10% probability of exceedance in 50 years (return period 475 years) according to Italian Building Code (NTC 2018) for the Ischia island. The red dot indicates the epicenter of the seismic event of the 21st August 2017. The black squares indicate the location of the nodes of the seismic mesh. Source: (Briseghella et al. 2019)

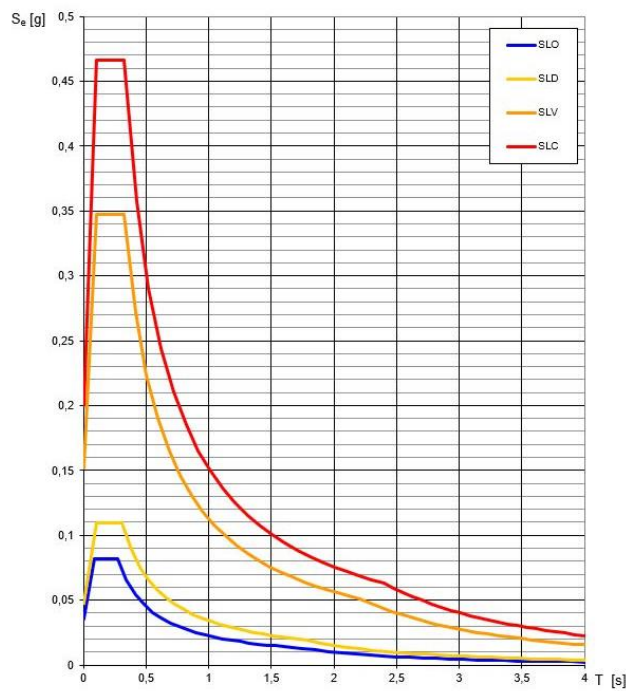
Figure 2.16 Elastic spectrum responses in acceleration for the church site considering the various limit states

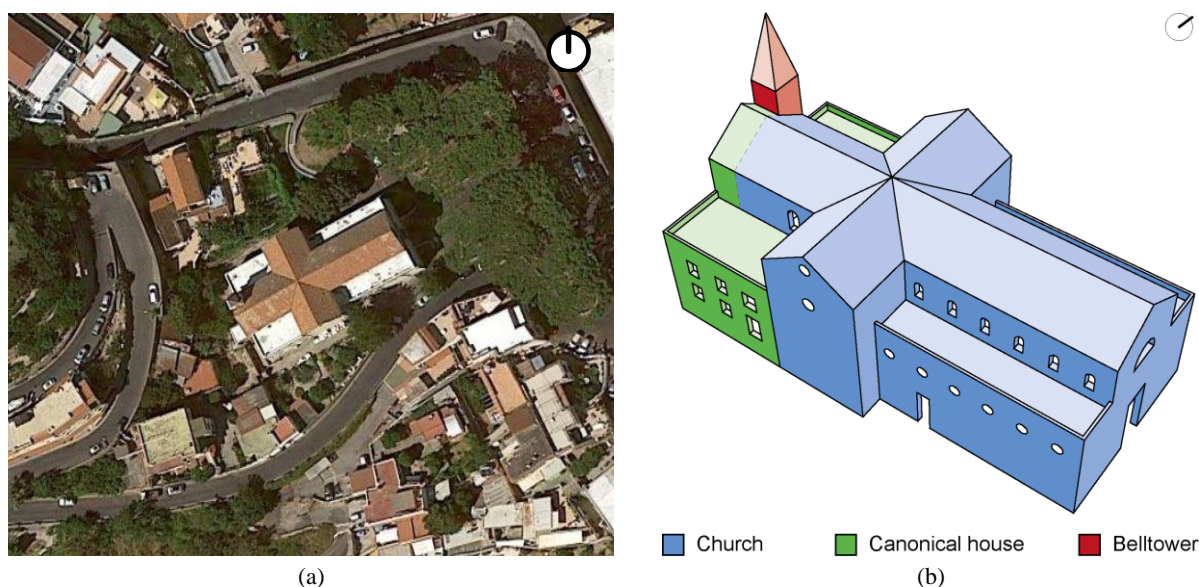
Figure 3.1 Aerial of the location of the church (a) and volumetric representation of the church (b). Source (a): GoogleMaps

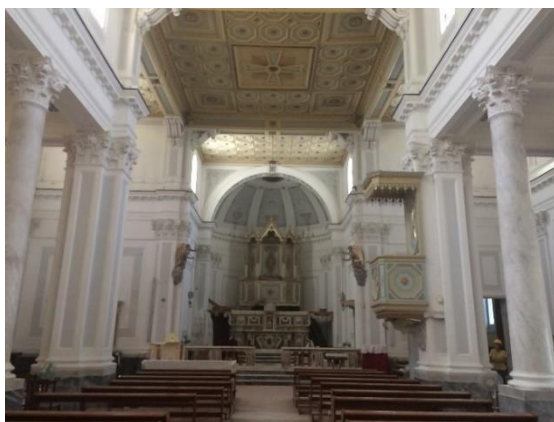
As can be observed from the plan view, the church is composed by three longitudinal naves, a central one (Figure 3.7a) spanning 8.38 m, and two lateral ones (Figure 3.7b), defined by two rows of five columns and a pier, spanning around 3.70 m. The central nave meets the transept in the cross-shaft and the presbyterial section is composed by the apse, located on the top of a three-stair staircase, with a semicircular wall supporting a half dome.

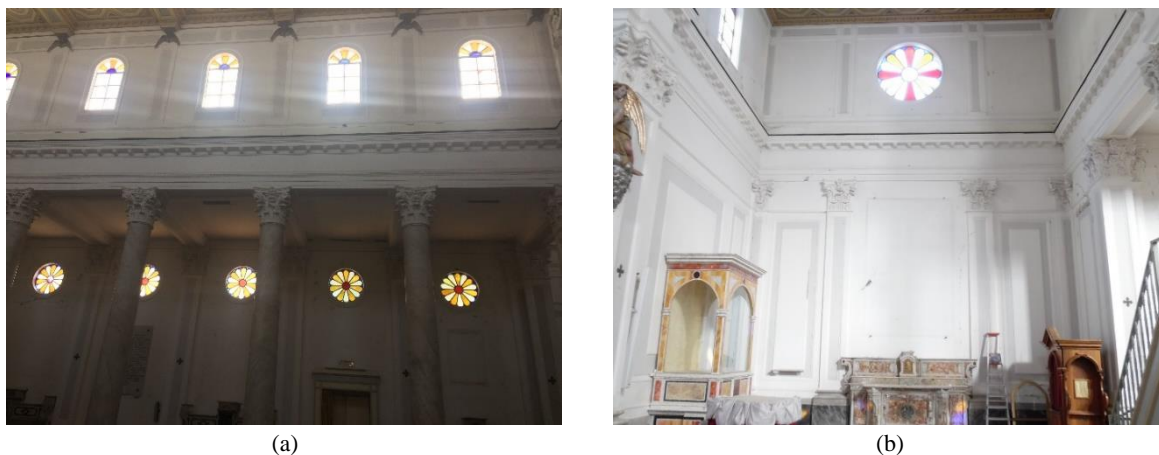
Figure 3.8 Openings layout in the external walls of the lateral and central naves (a) and in the north-western branch of the transept (b)

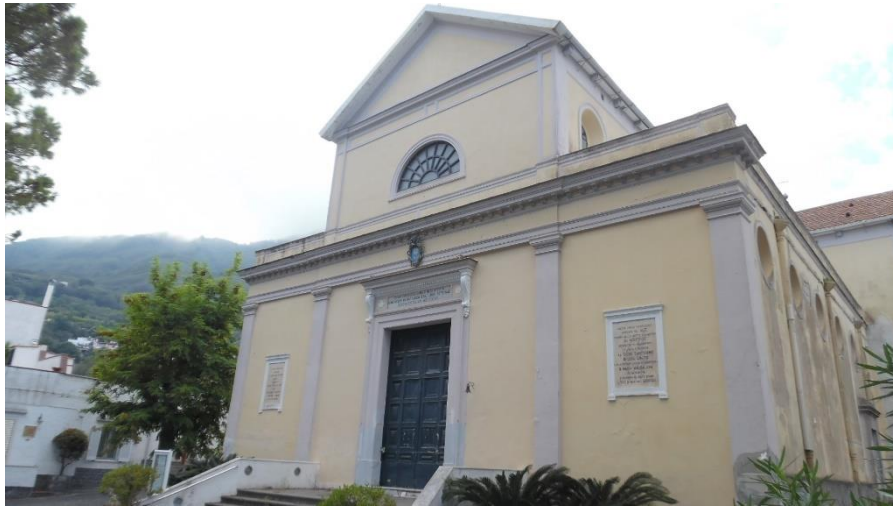
Figure 3.10 Front façade of the church

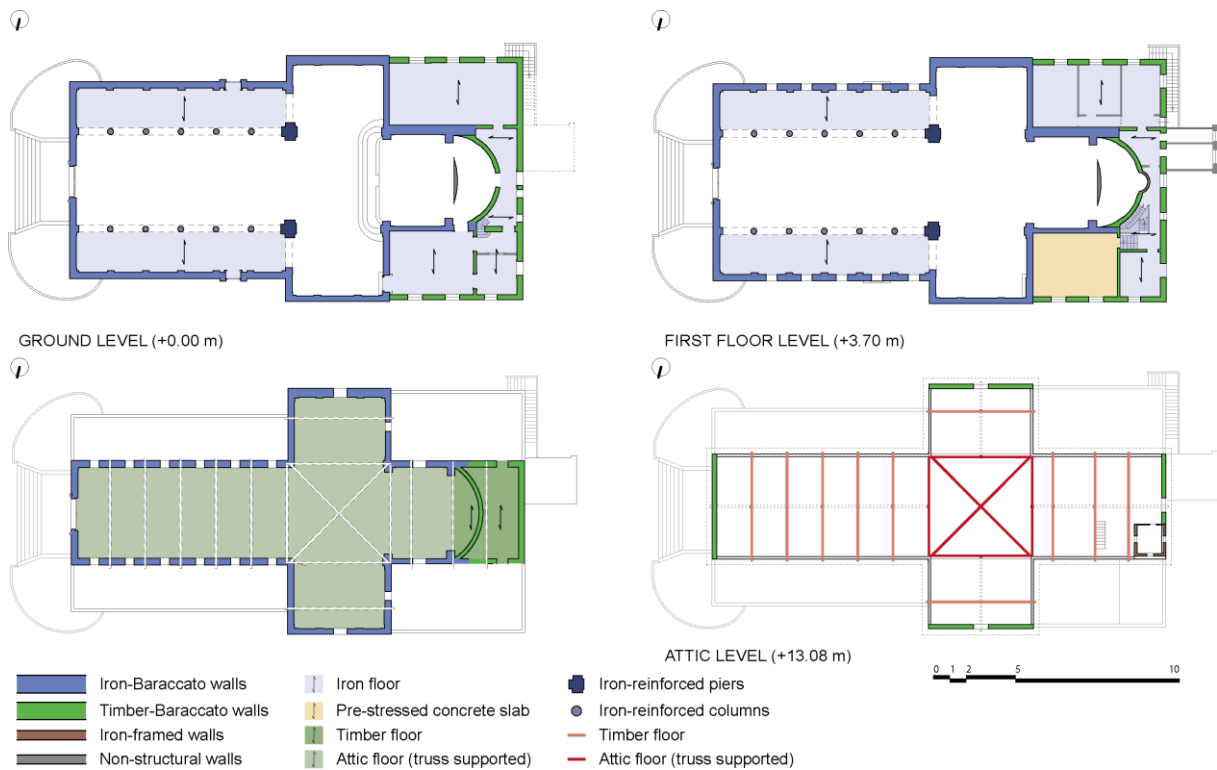
Figure 3.11 Material and structural elements identification⁵

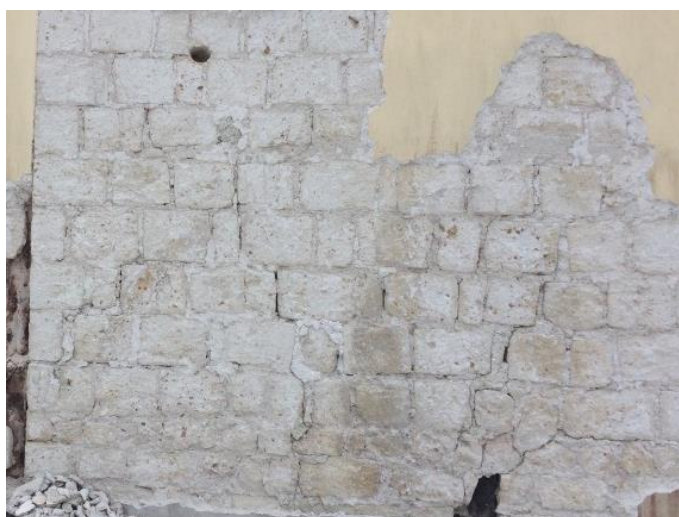
Figure 3.13 Picture of a masonry portion of one of the lateral walls of the apse

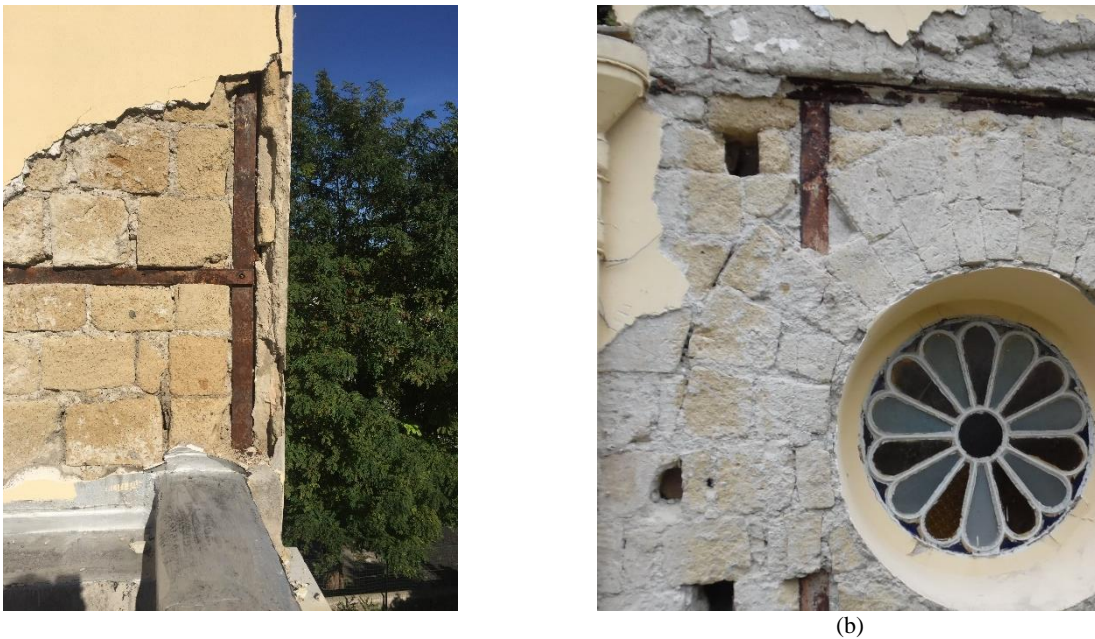
Figure 3.15 Arrangement of the masonry units around the iron frames (a) and use of small thickness stones to cover the vertical iron elements (b)

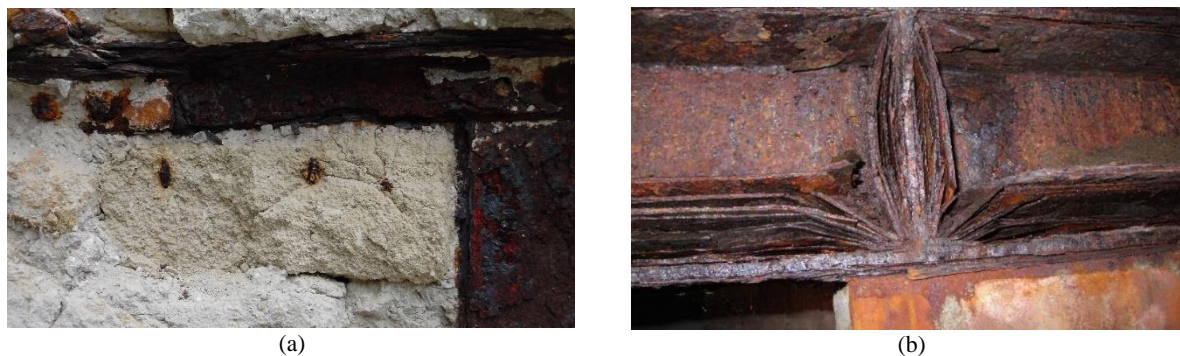
Figure 3.16 Layered corrosion of an horizontal iron element (a), typical delaminated corrosion of a wrought iron element

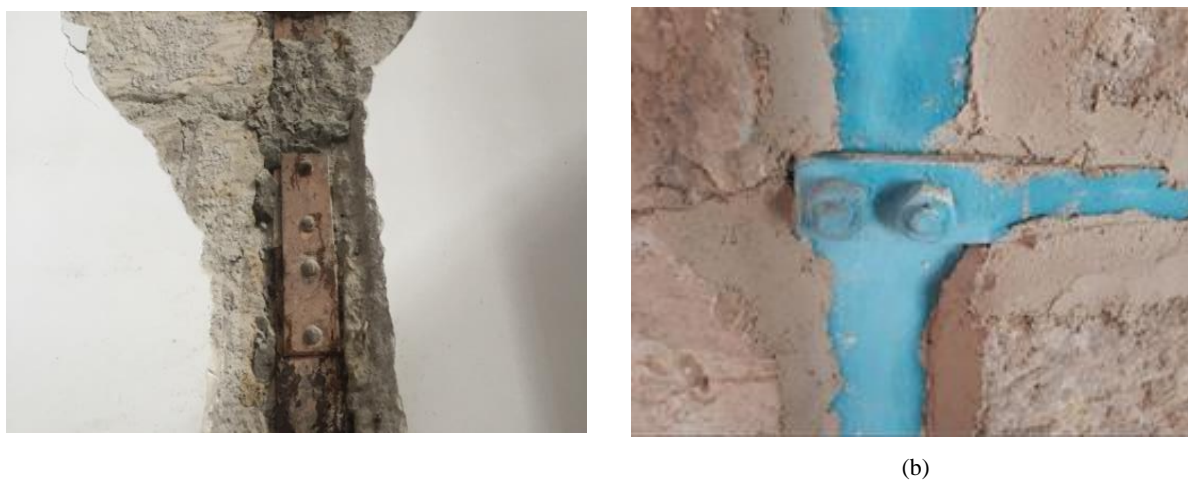
Figure 3.17 Example of riveted (a) and bolted (b) connections between the iron elements of the church

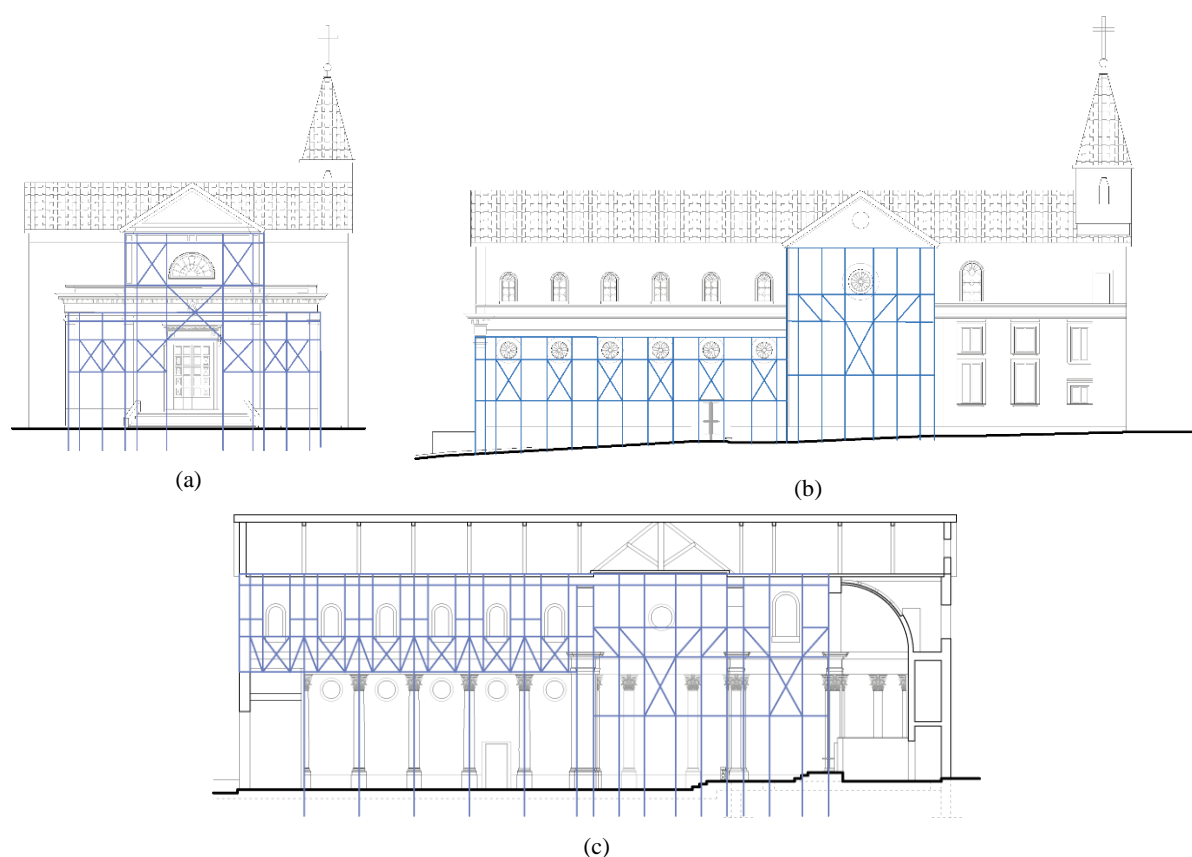
Figure 3.19 Layouts of the iron frames of the system: front façade (a), lateral façade (b), upper wall of the central nave (c)

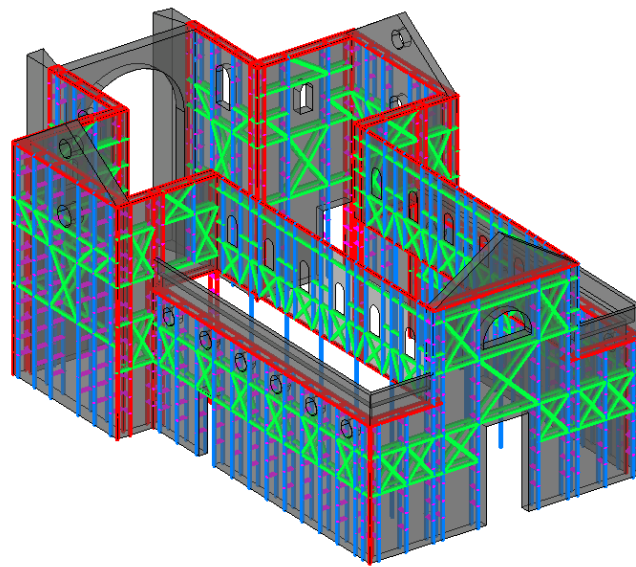
Figure 3.20 Spatial representation of the surveyed iron frames

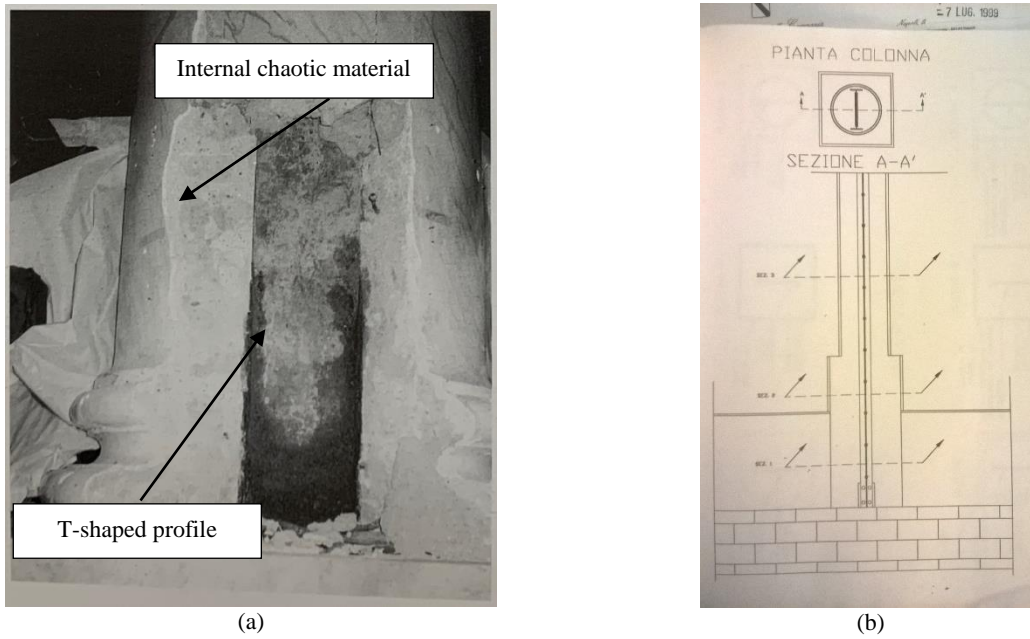
Figure 3.22 Literature information about the internal composition of the columns, historical picture (a) and historical drawing of the cross-section (b). Source (a): (Polverino 1998). Source (b): (“Archivio di Stato di Napoli, Corpo Reale Genio Civile, fascio 342, incart. 3” n.d.)

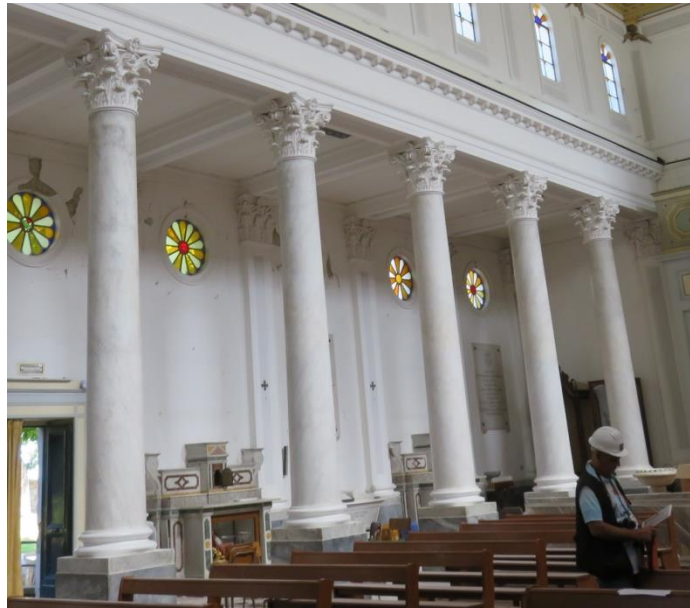
Figure 3.24 Unresolved node of the connection between the columns, the central nave second floor wall and the iron floor of the side aisle

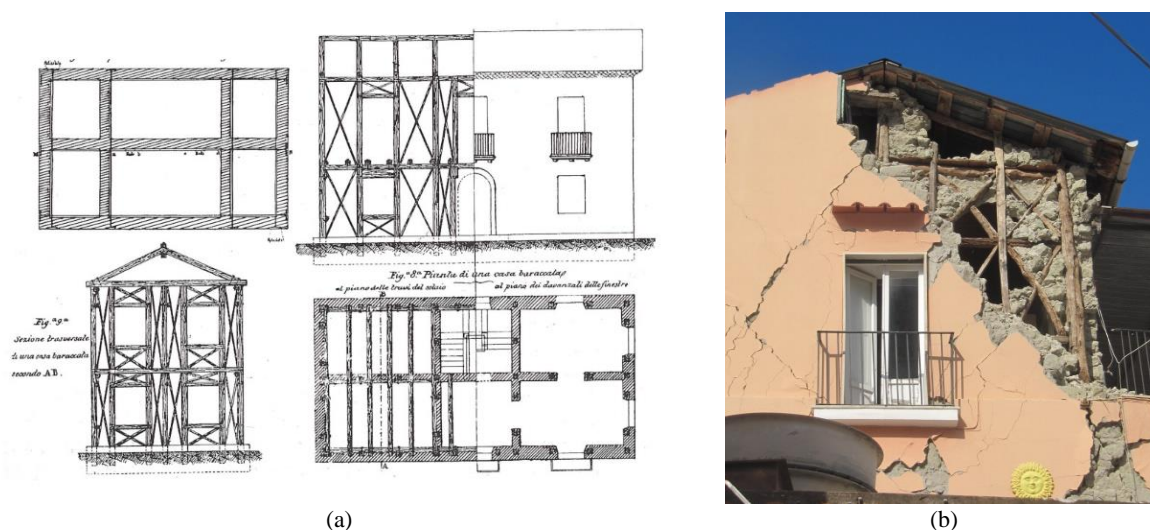
Figure 3.25 Historic drawings of the traditional *timber-Baraccato* system (a) and an example of its use in a building located in Casamicciola Terme (b). Source: (Casapulla et al. 2019a)

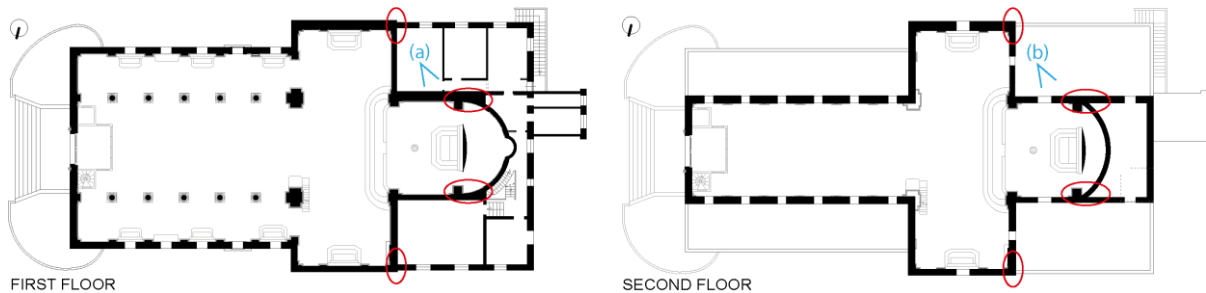
Figure 3.30 Connection points of the Baraccato systems and location of the points of inspections

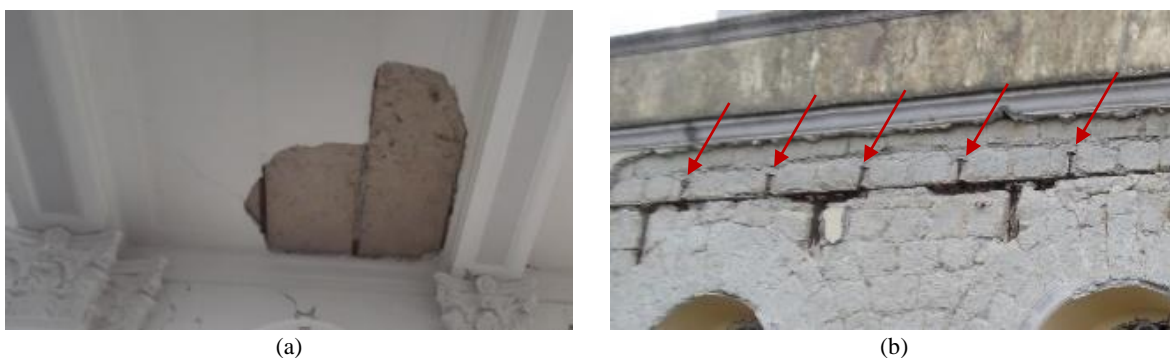
Figure 3.32 Direct observation spots for the metallic structure of the lateral naves floor slabs

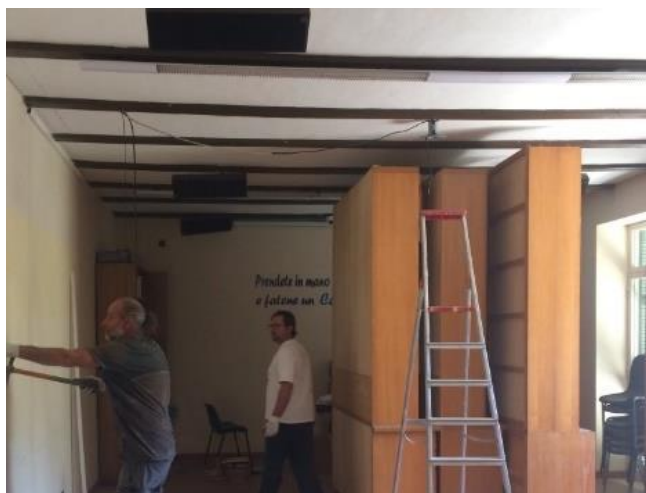
Figure 3.34 Intrados of the iron floor of the parish room in the canonical house

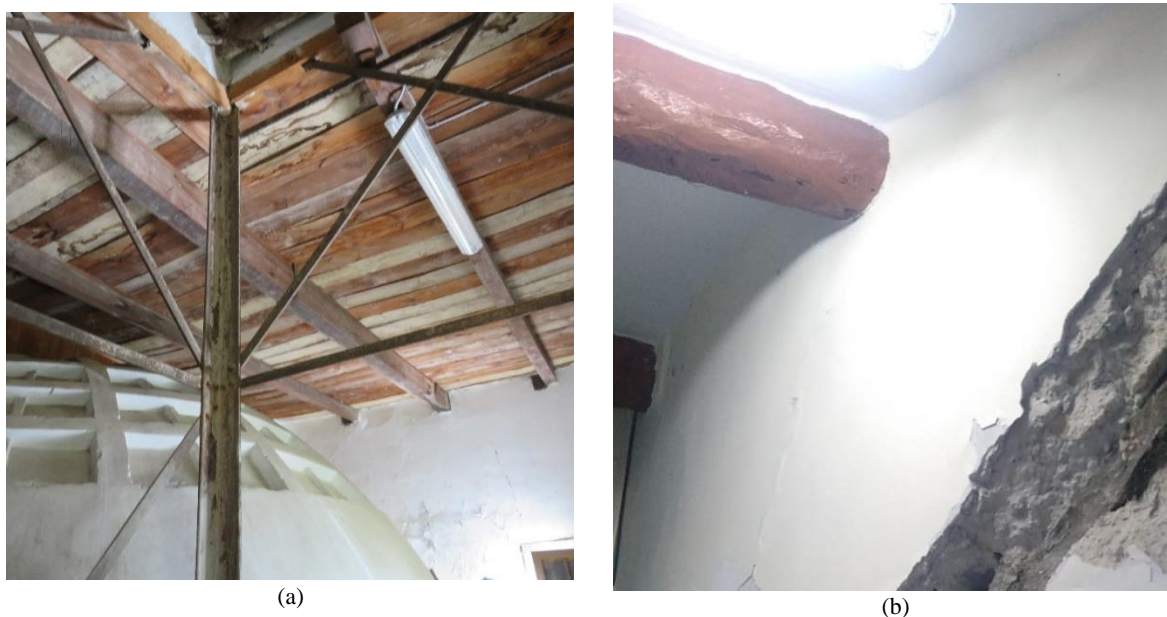
Figure 3.35 Timber floors observed in the resulting space behind the apse at the roof level (a) and at the ground level (b)

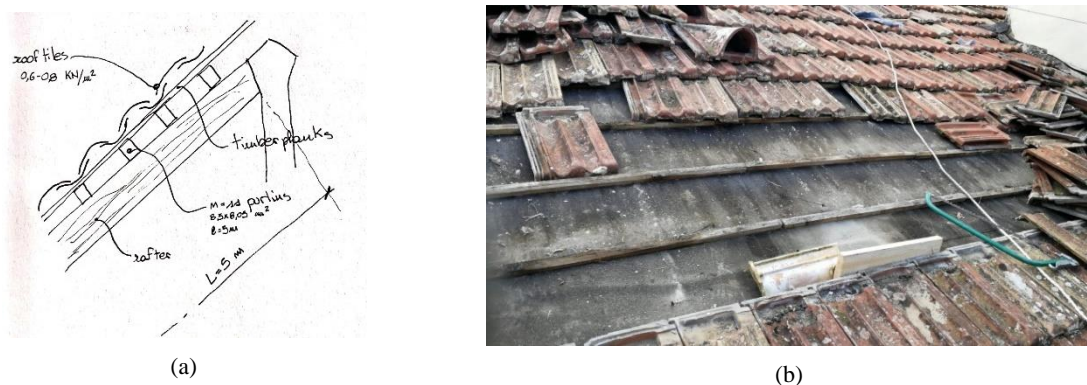
Figure 3.39 Sketch of the roof stratigraphy (a) and a picture of the external layers of the roof (b)

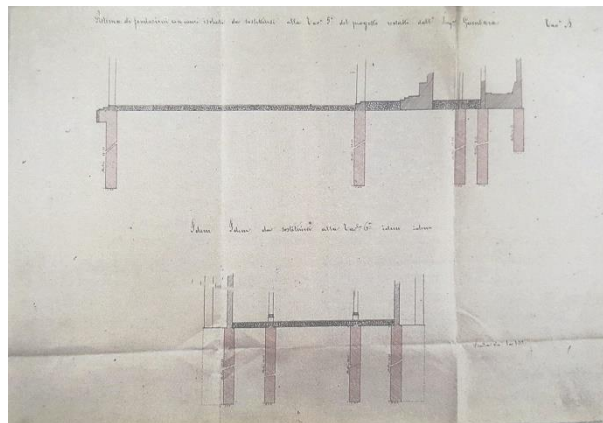
Figure 3.40 historic drawing of the foundation system of the Eng. Gambara (“Archivio di Stato di Napoli, Corpo Reale Genio Civile, fascio 342, incart. 3” n.d.)

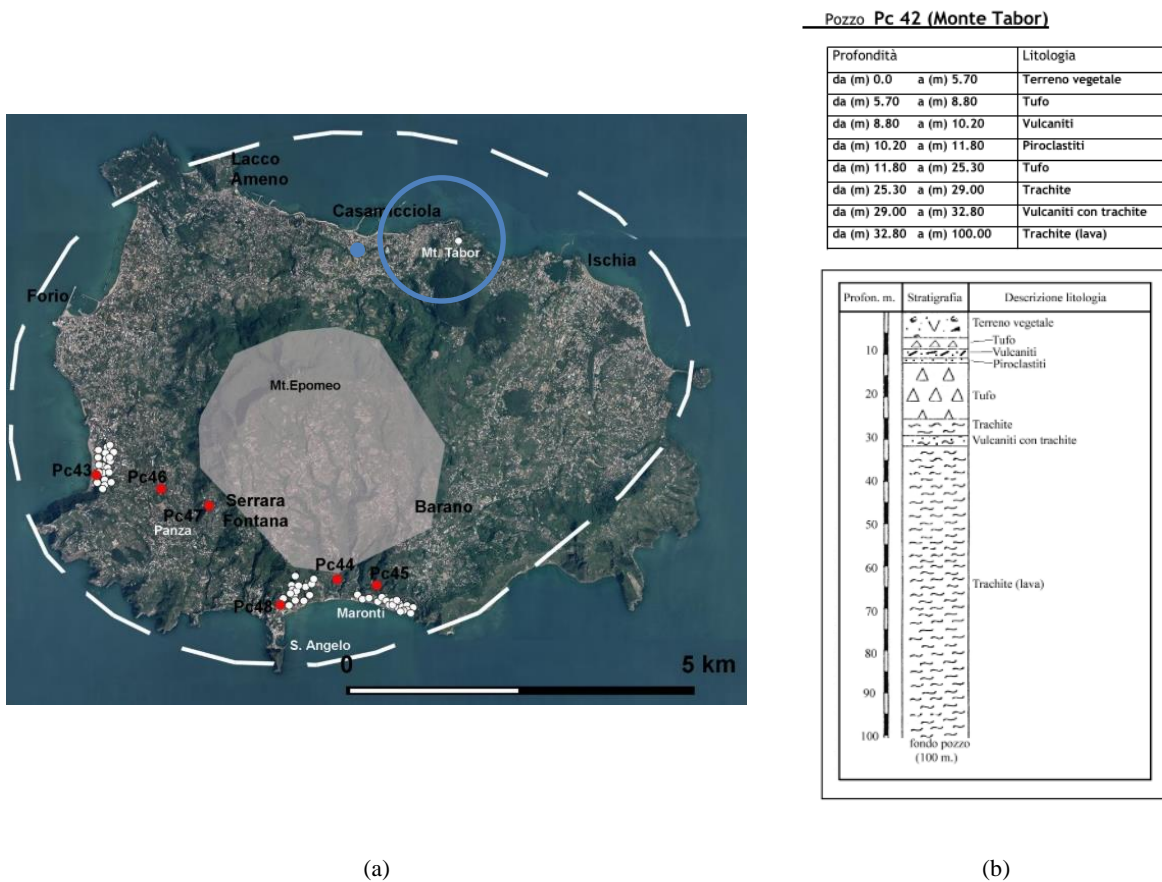
Figure 3.41 Location (a) and results (b) of some perforations performed between 1939 and 1950 from the society SAFEN for INGV. The small blue dot indicates the approximated location of the church and the big blue circle indicates the pit which results are presented in (b). Source: (INGV n.d.)

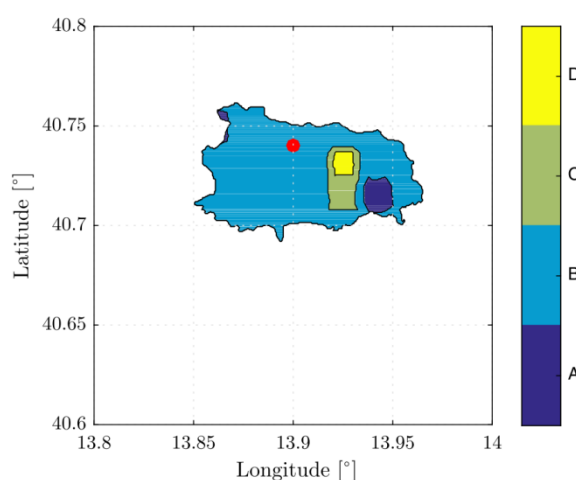
Figure 3.42 Map of the soil classes for Ischia island according to the Italian Building Code (NTC 2018) or the Eurocode 8 (EC-Standards 1998) estimated using the shear wave velocity $V_{s,30}$ in Italy from Global $V_{s,30}$ Map Server of the USGS. Source: (Briseghella et al. 2019)

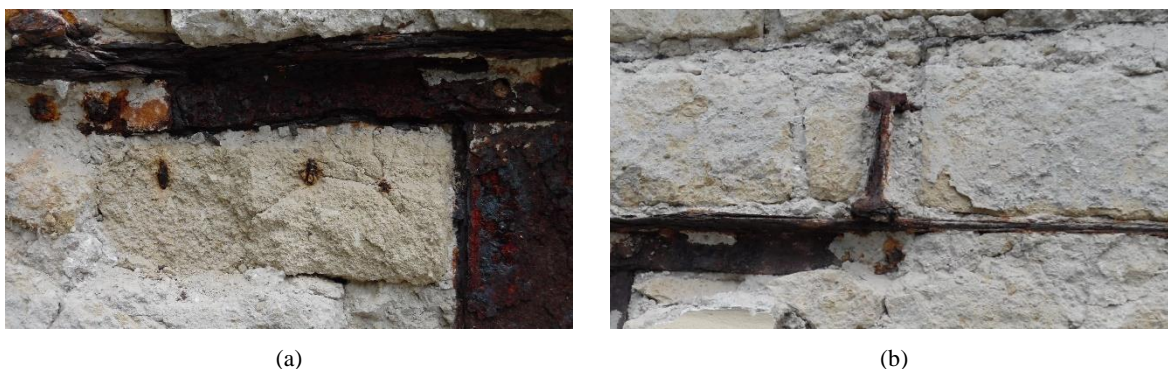
Figure 3.44 Corroded iron vertical and horizontal elements of an iron frame of the church nave wall (a) and the rusting beam end of a floor beam covering the side aisle (b)

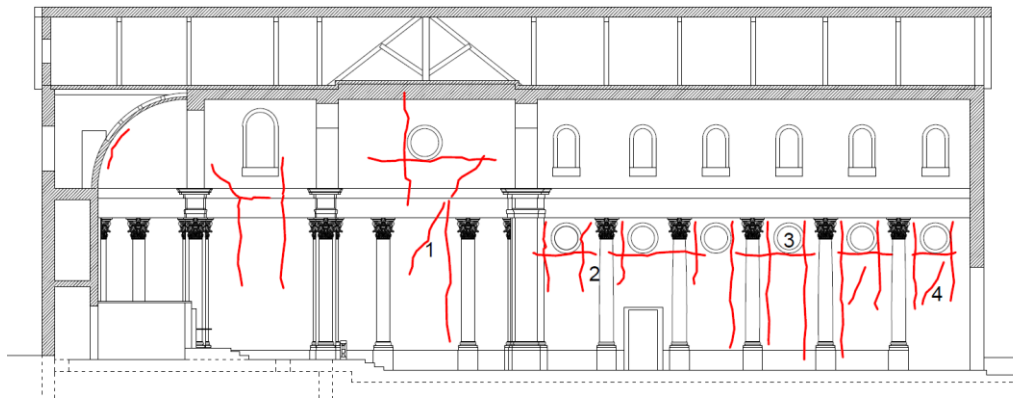
Figure 3.45 Crack pattern of the longitudinal section

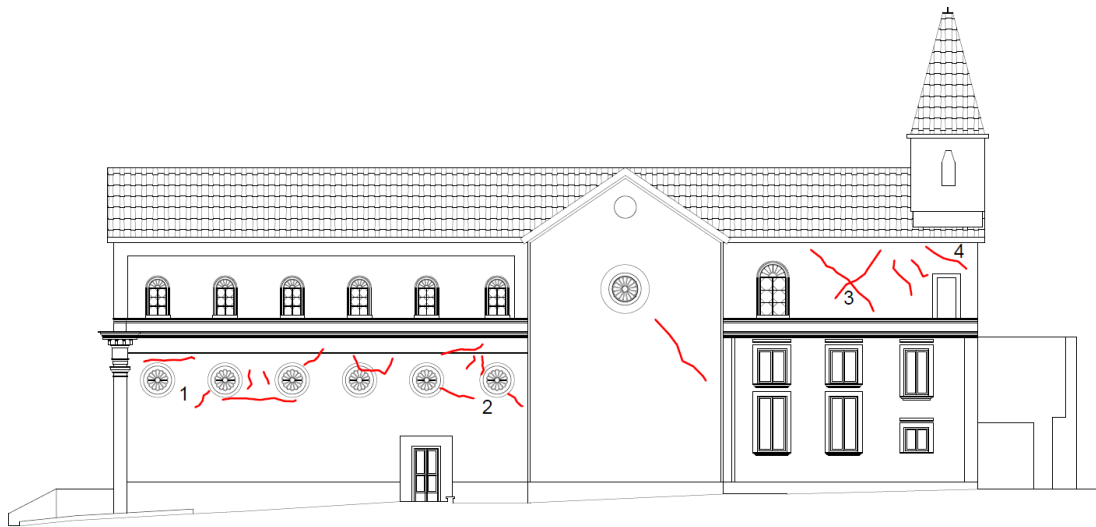
Figure 3.46 Crack pattern of the North façade

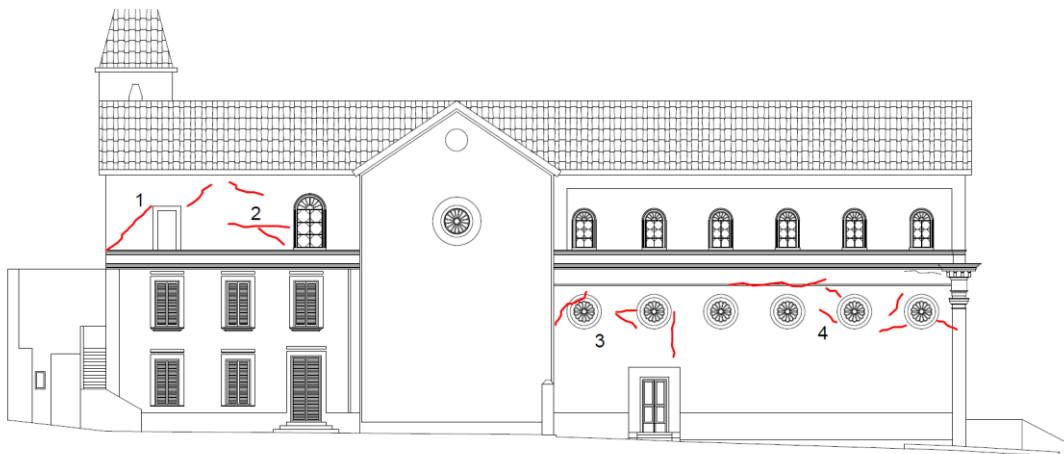
Figure 3.47 Crack pattern of the South façade

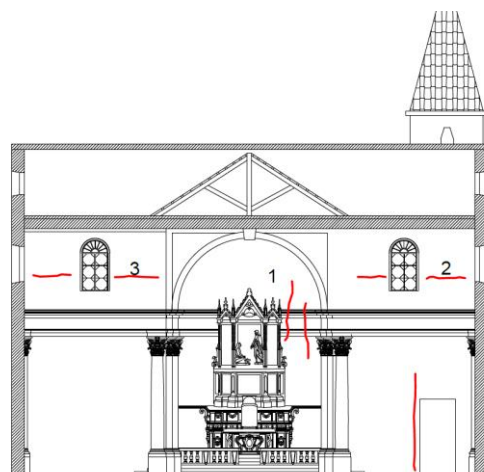
Figure 3.48 Crack pattern of the transversal section

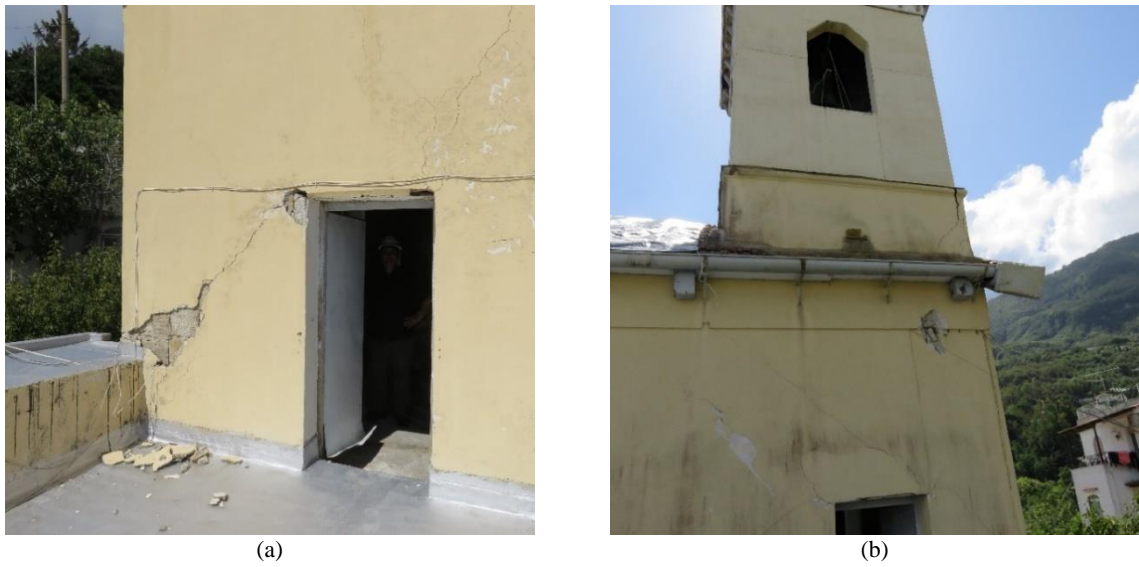
Figure 3.49 Details of the diagonal cracks developed in the South façade at position 1 (a) and in the North façade at position 4 (b)

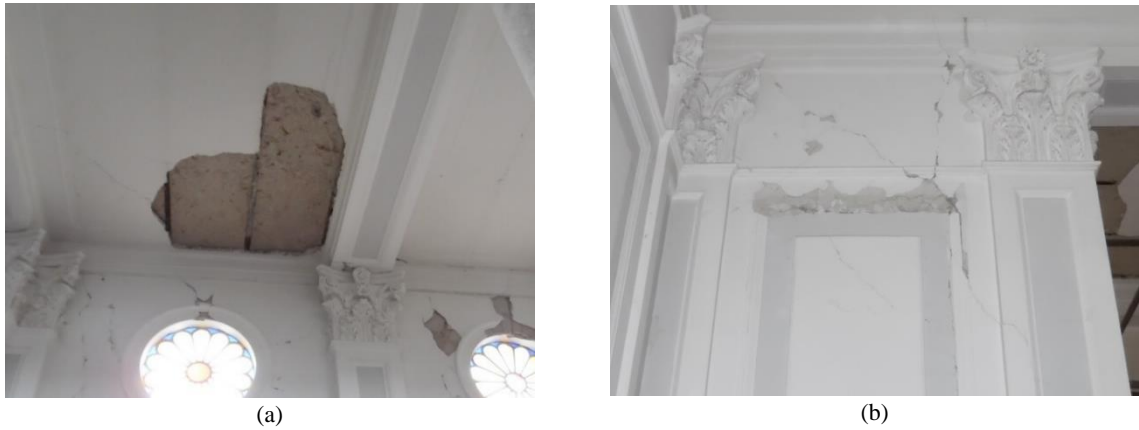
Figure 3.50 Plaster detachment from a ceiling (a) and cracking of a stucco decoration of a capital (b)

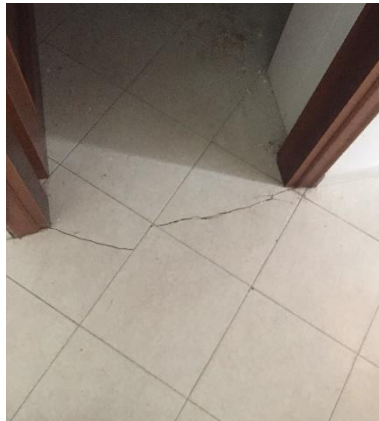
Figure 4.1 Horizontal crack in the WC floor witnessing the autonomous response of the services block

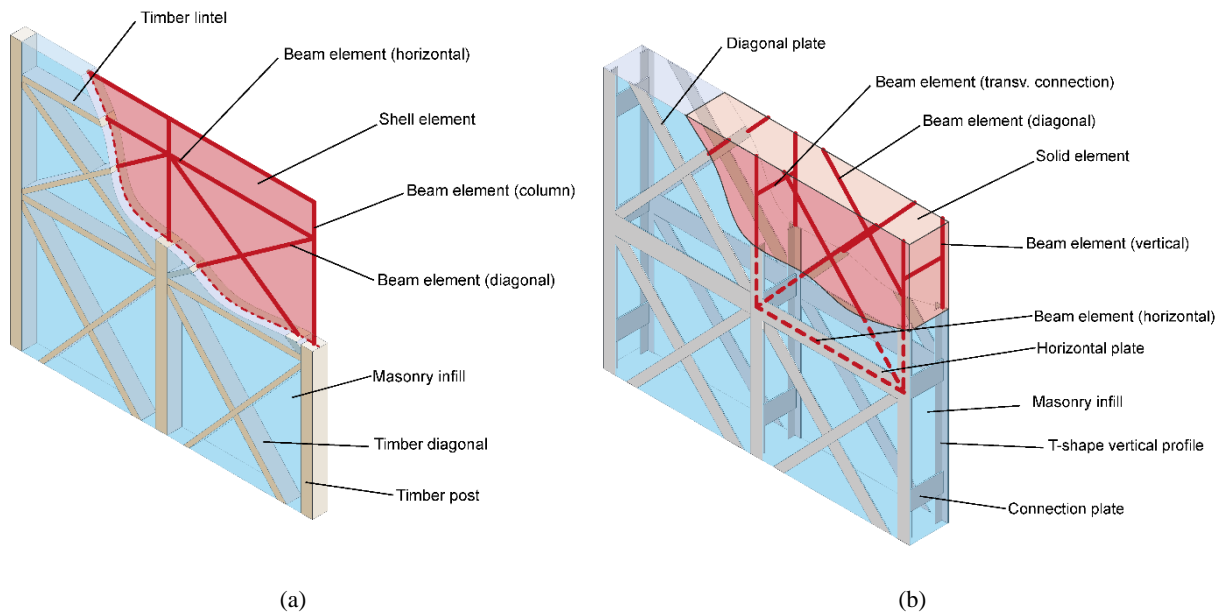
Figure 4.4 Modelling strategy schemes for *timber-Baraccato* (a) and *iron-Baraccato* (b) walls

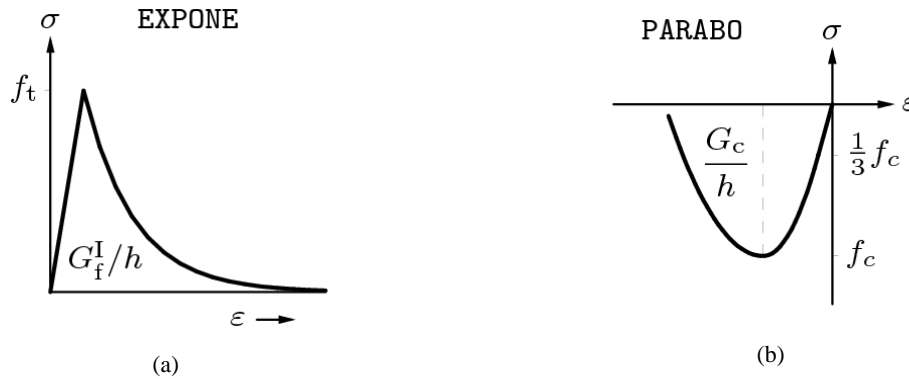
Figure 4.11 Stress-strain diagrams adopted for the behavior of masonry in tension (a) and in compression (b) (DIANA FEA BV 2019)

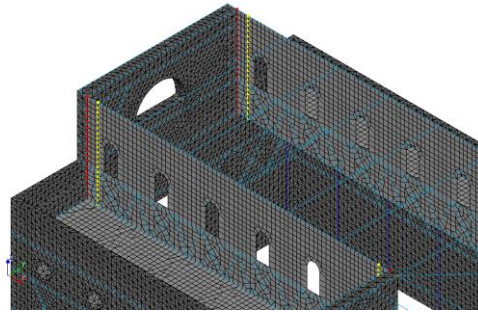
Figure 4.12 Internal tying between the solid and the shell walls of the church, in red the *master node* and in yellow the *slave node*

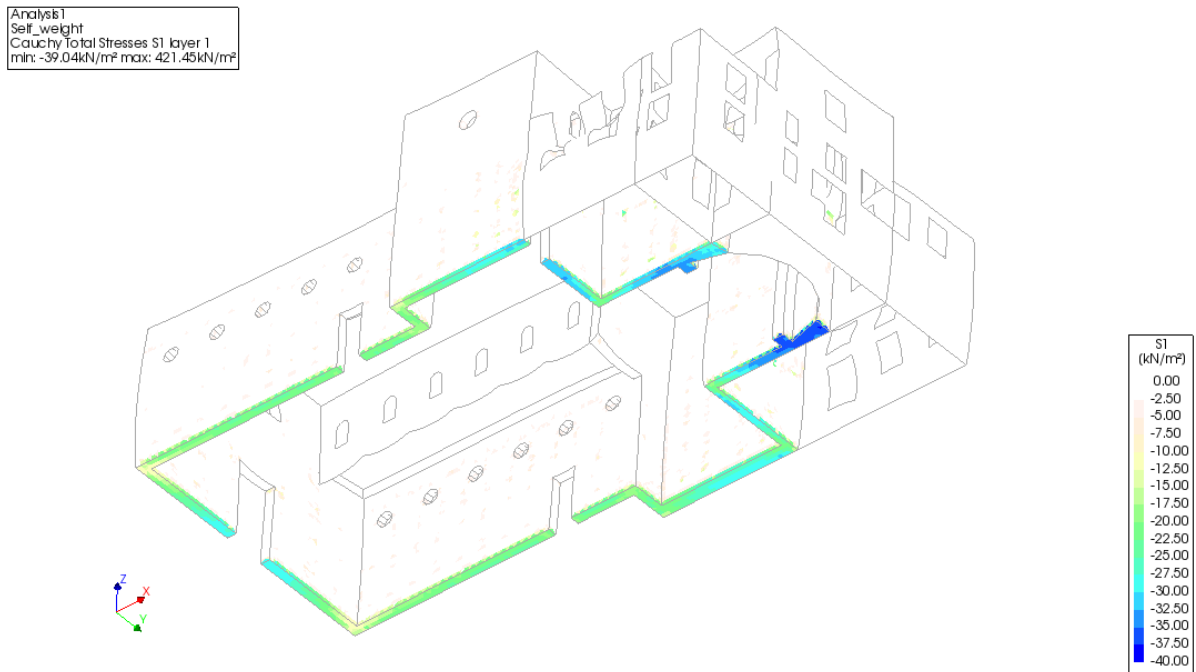
Figure 4.13 Structural linear static: distribution of the maximum compressive principal stresses (S1) at the base of the masonry walls

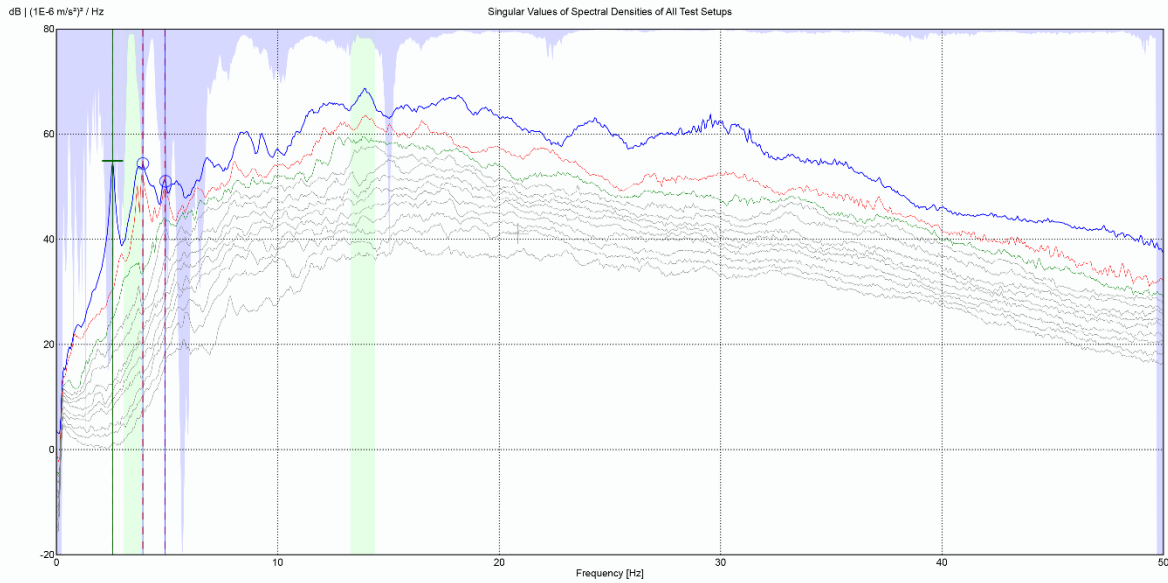
Figure 5.7 Spectral density diagram¹⁰
