ADVANCED MASTERS IN STRUCTURAL ANALYSIS
OF MONUMENTS AND HISTORICAL CONSTRUCTIONS

Master's Thesis

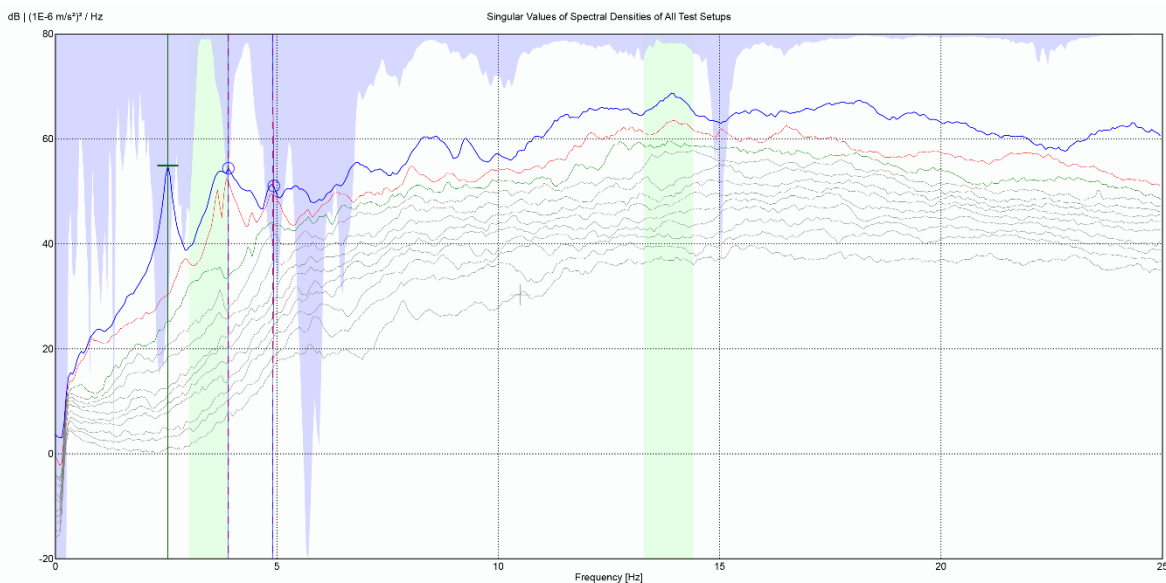
Figure 5.9 Spectral density diagram in the range 0-25 Hz for the peak-picking procedures

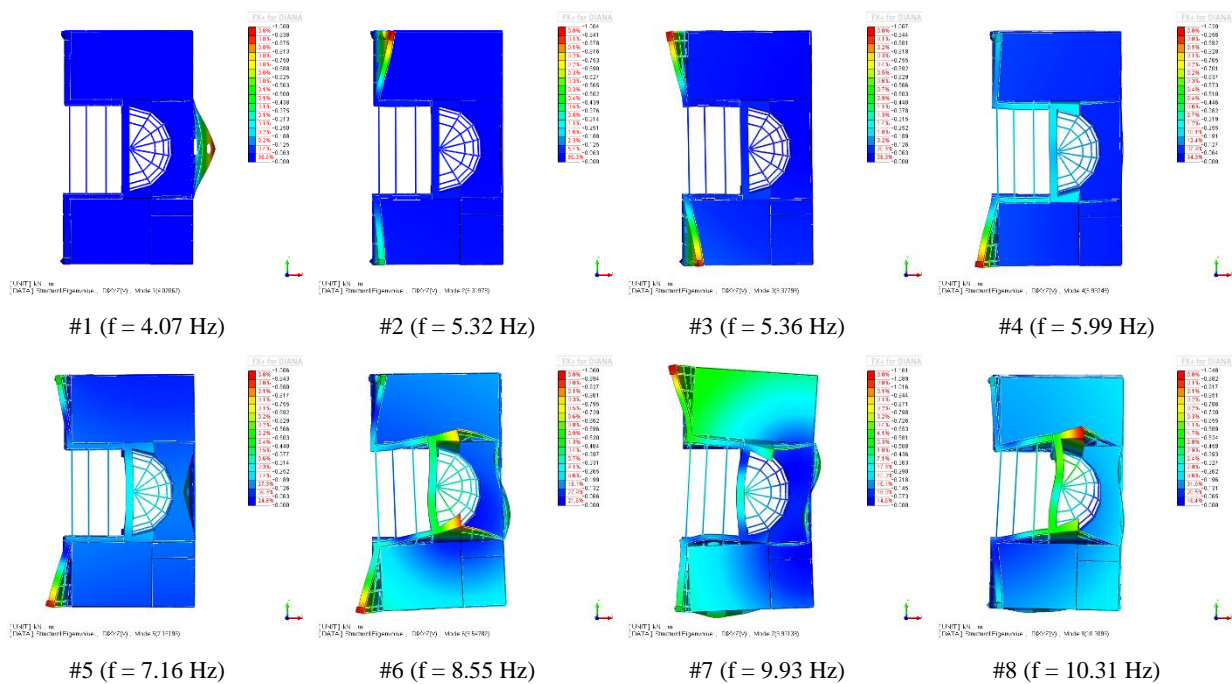
Figure 5.16 First eight modal shapes of the Model_timber model

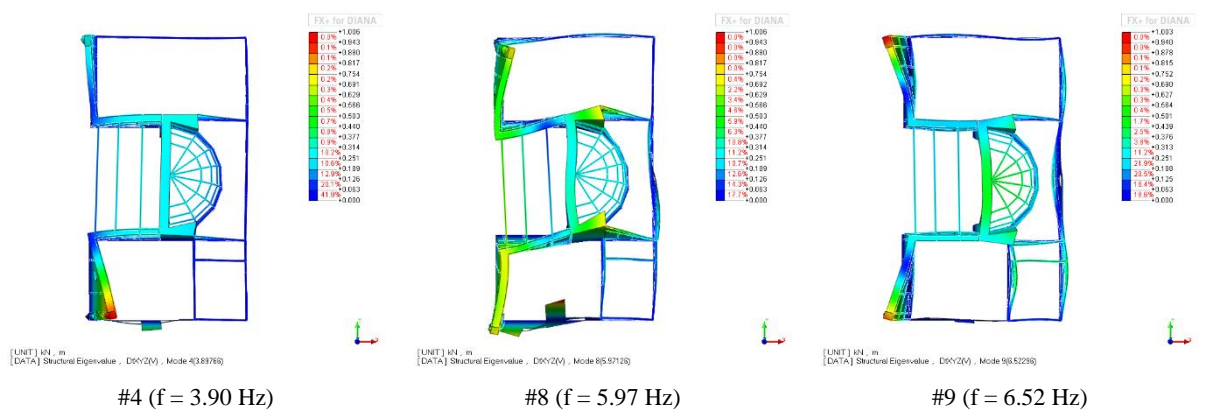
Figure 5.17 Global model of the model Model_timber_01

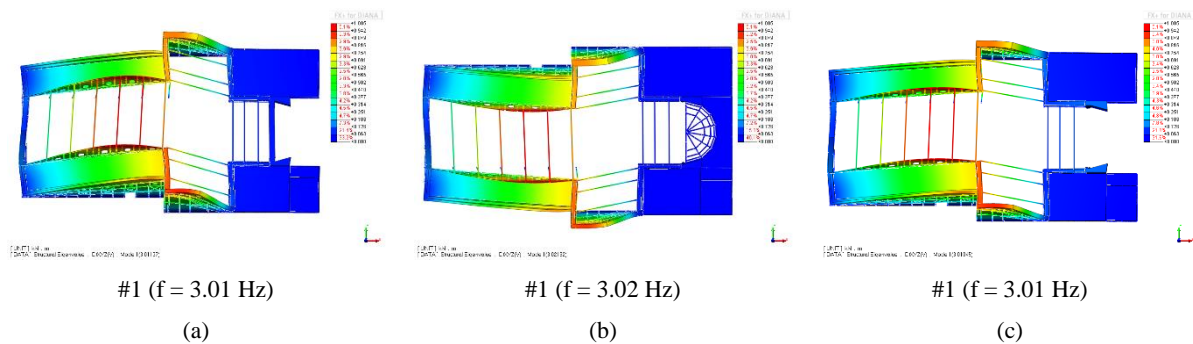
Figure 5.18 First global modal shapes of the models G: Model_iron+timber_G_a (a), Model_iron+timber_G_b (b), Model_iron+timber_G_c (c)

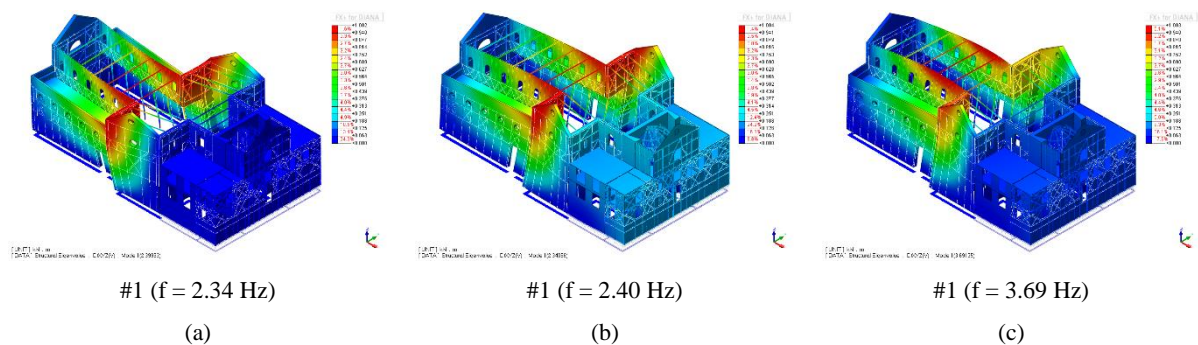
Figure 5.19 First global modal shapes of the models F: Model_iron+timber_F_a (a), Model_iron+timber_F_b (b) and Model_iron+timber_F_c (c)

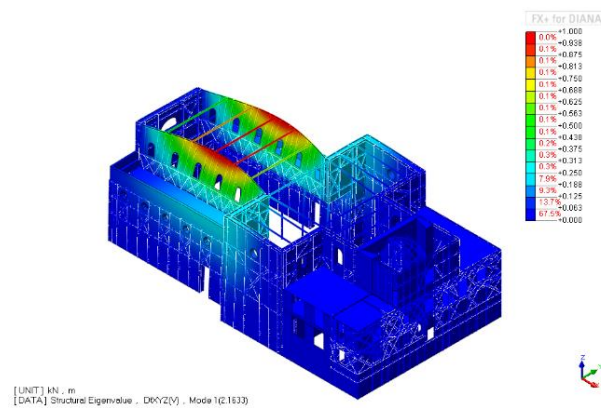
Figure 5.20 First global mode of the model with the distributed mass of the roof (#1, $f = 2.16$ Hz)

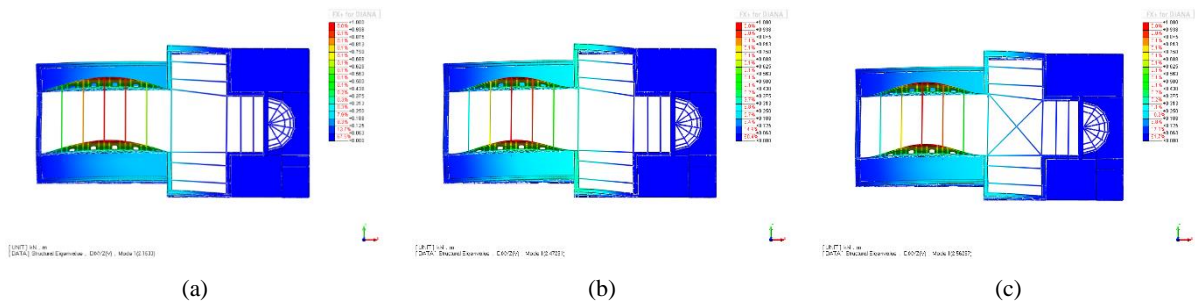
Figure 5.21 Roof ties modelled as *truss* elements: original model (a), model with rigid link of the walls (b) and model with rigid links and cross-shaft diagonal ties (c)

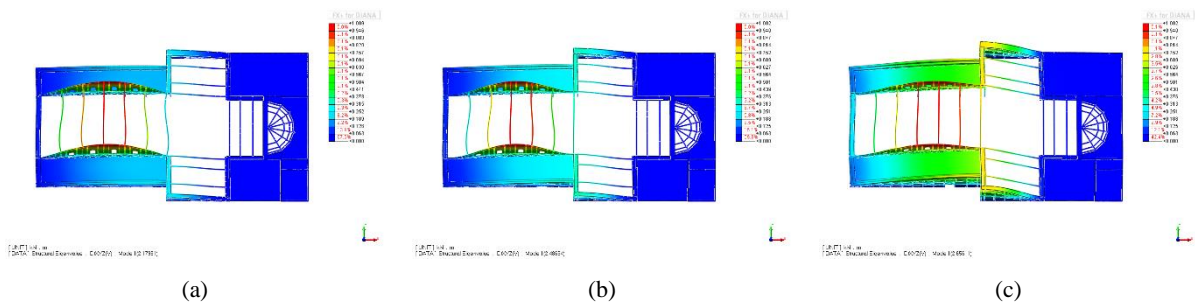
Figure 5.22 Roof ties modelled as *beam* elements: original model (a), model with rigid links of the walls (b) and model with beams sections equal to an INP600 (c)

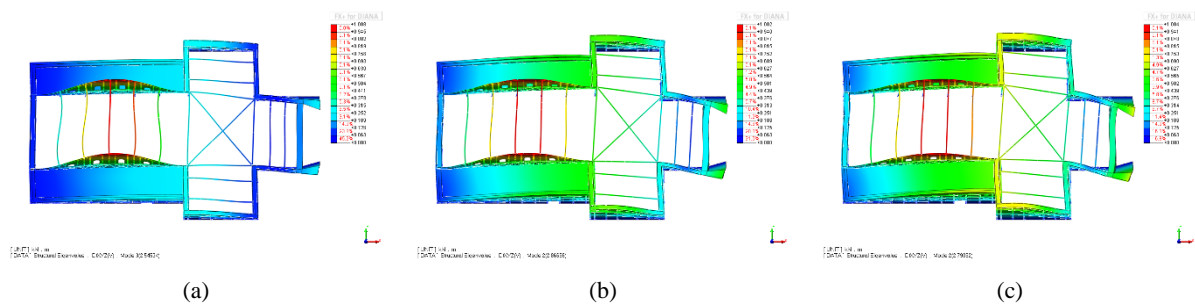
Figure 5.23 Main body of the church model with roof ties and rigid links: with diagonal bracings in the cross-shaft (a), INP600 section of the beams (b) and INP600 sections and 1 m thickness of the longitudinal nave wall (c)

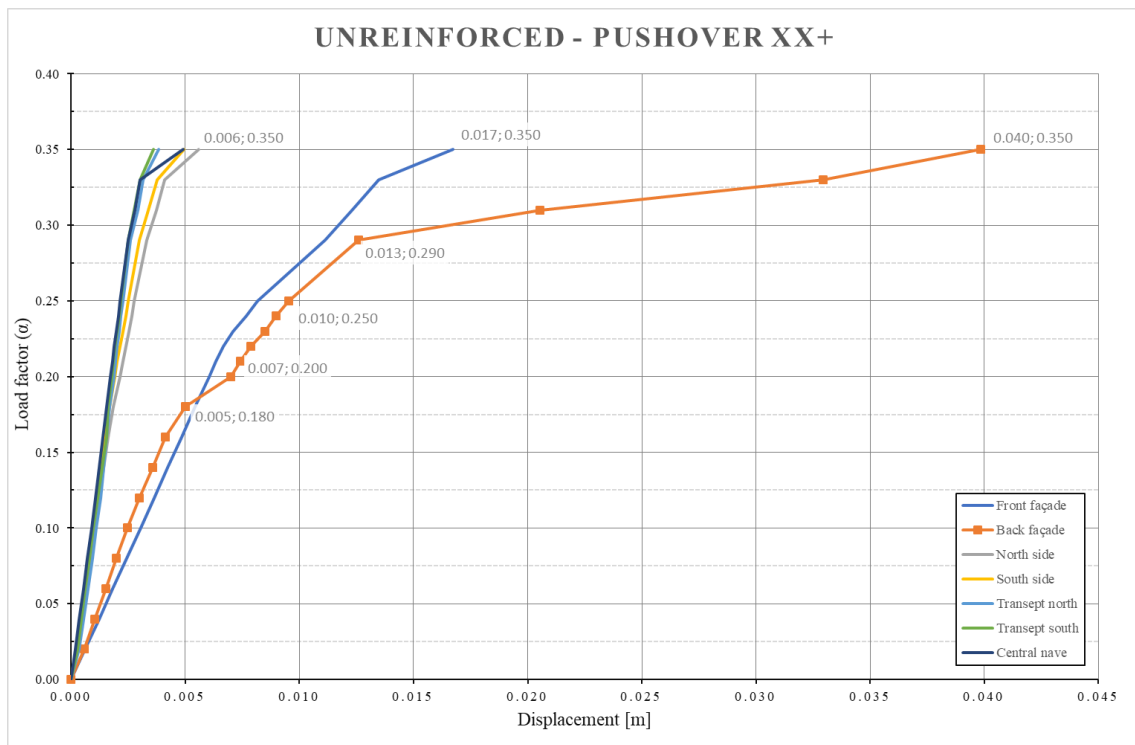
Figure 6.2 Pushover curves for the unreinforced model in the longitudinal direction (XX+)

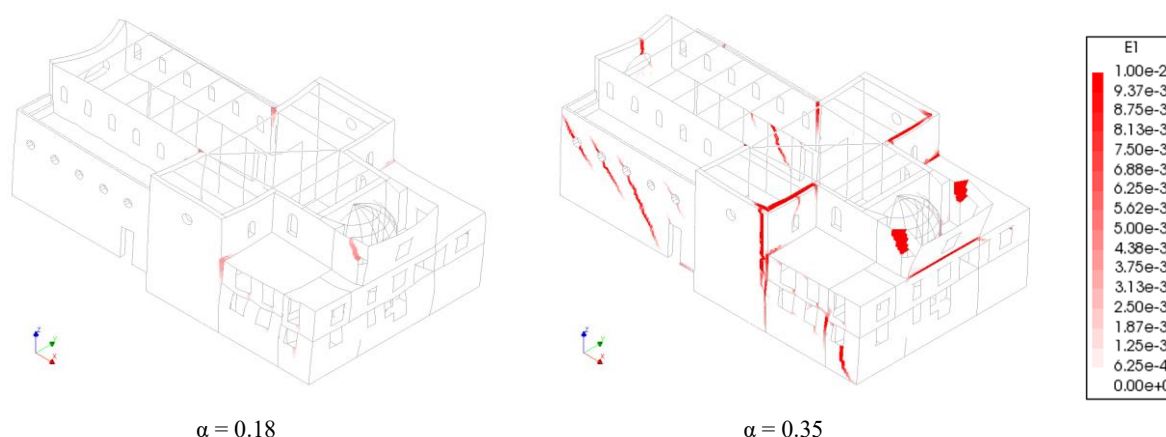
Figure 6.3 Principal strain distribution in the masonry walls at the development of the first damage ($\alpha = 0.18$) and at the collapse ($\alpha = 0.35$)

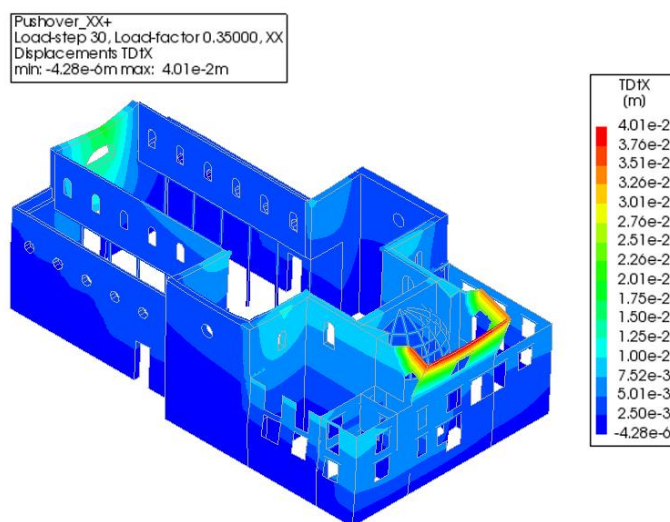
Figure 6.4 Total displacement in the x-direction plot of the unreinforced model (XX+) at the last load step ($\alpha = 0.35$)

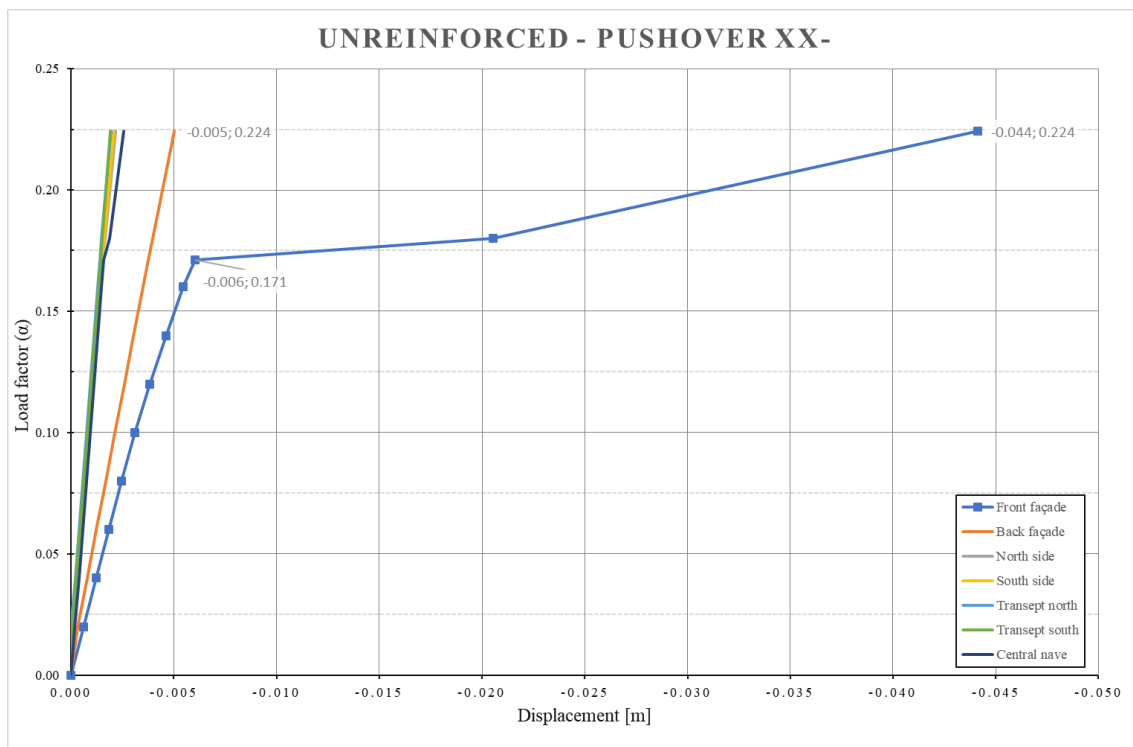
Figure 6.5 Pushover curves for the unreinforced model in the longitudinal direction (XX-)

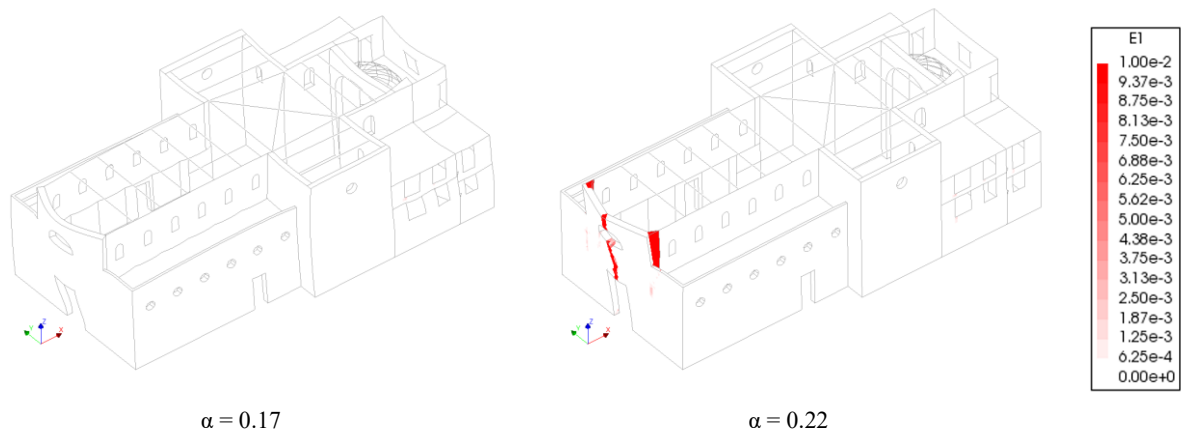
Figure 6.6 Principal strain distribution in the masonry walls at the development of the first damage ($\alpha = 0.17$) and at the collapse ($\alpha = 0.22$)

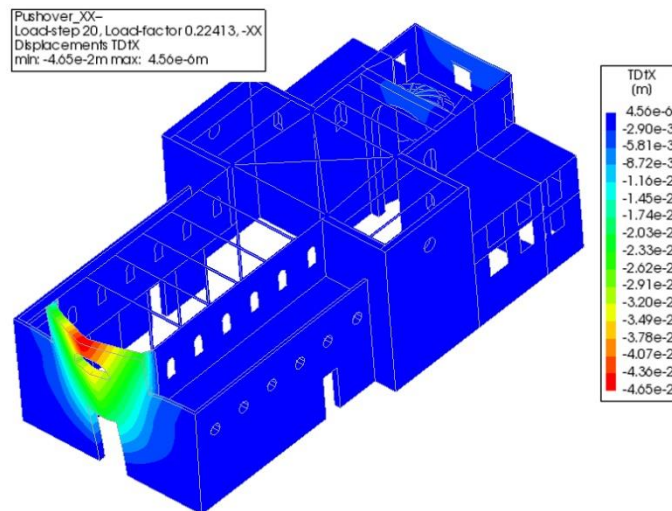
Figure 6.7 Total displacement in the x -direction plot of the unreinforced model (XX-) at the last load step ($\alpha = 0.22$)

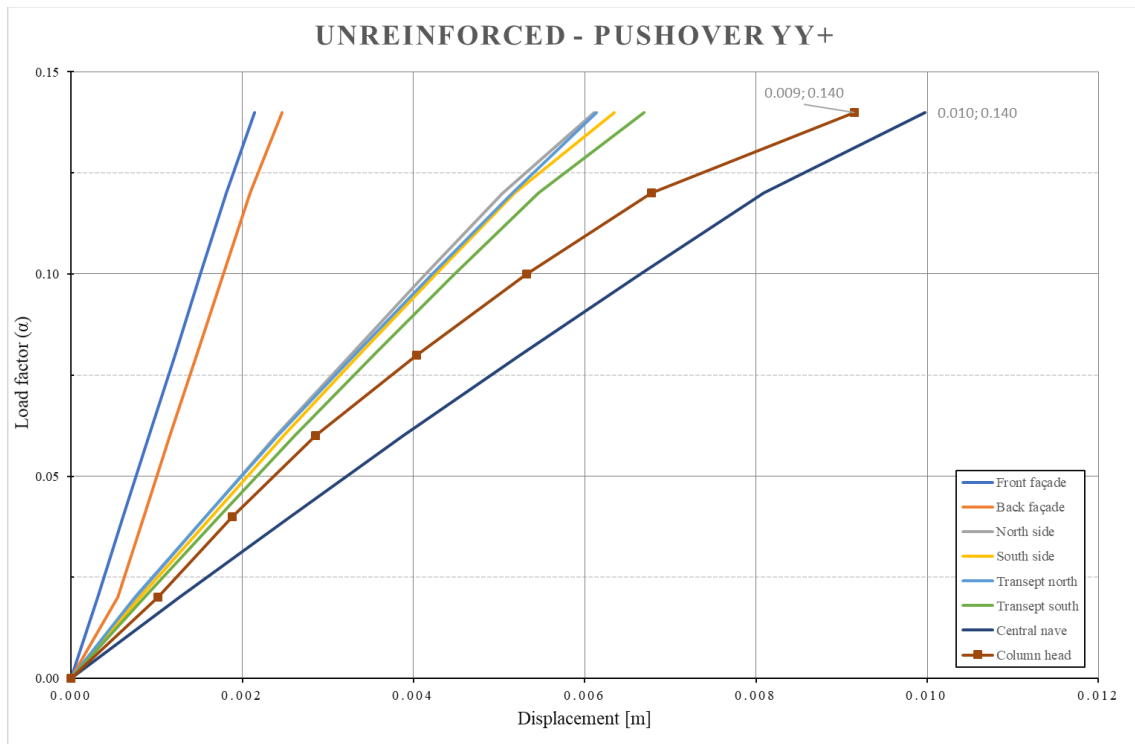
Figure 6.8 Pushover curves for the unreinforced model in the transversal direction (YY-)

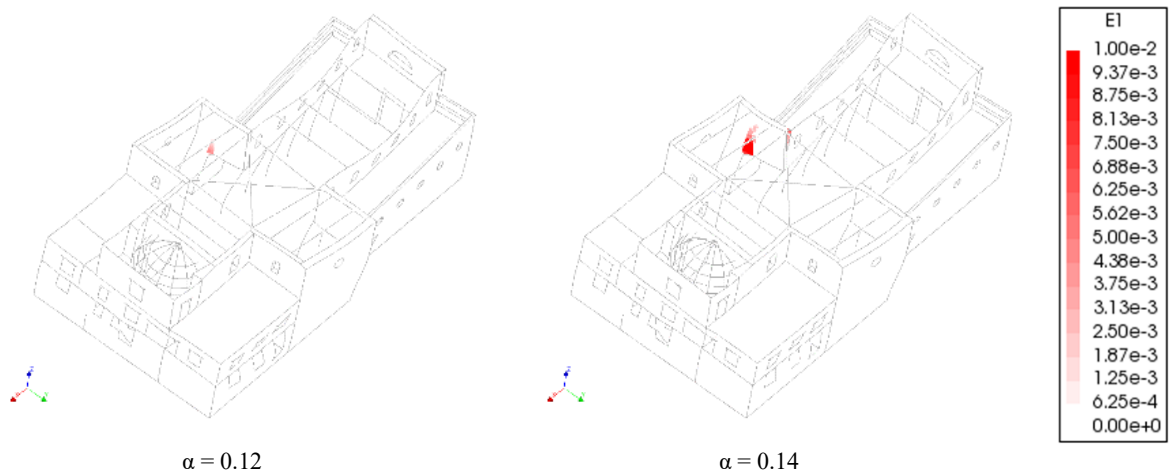
Figure 6.9 E1 plot evidencing the development of a vertical crack dividing the north-eastern wall of the transept

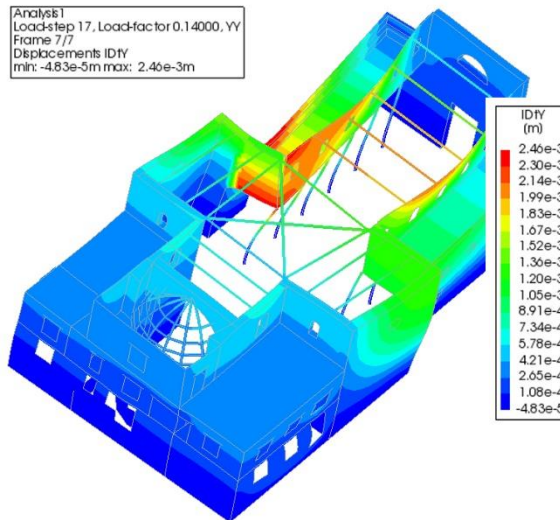
Figure 6.10 Incremental displacement in the x-direction plot of the unreinforced model (YY+) at the last load step ($\alpha = 0.14$)

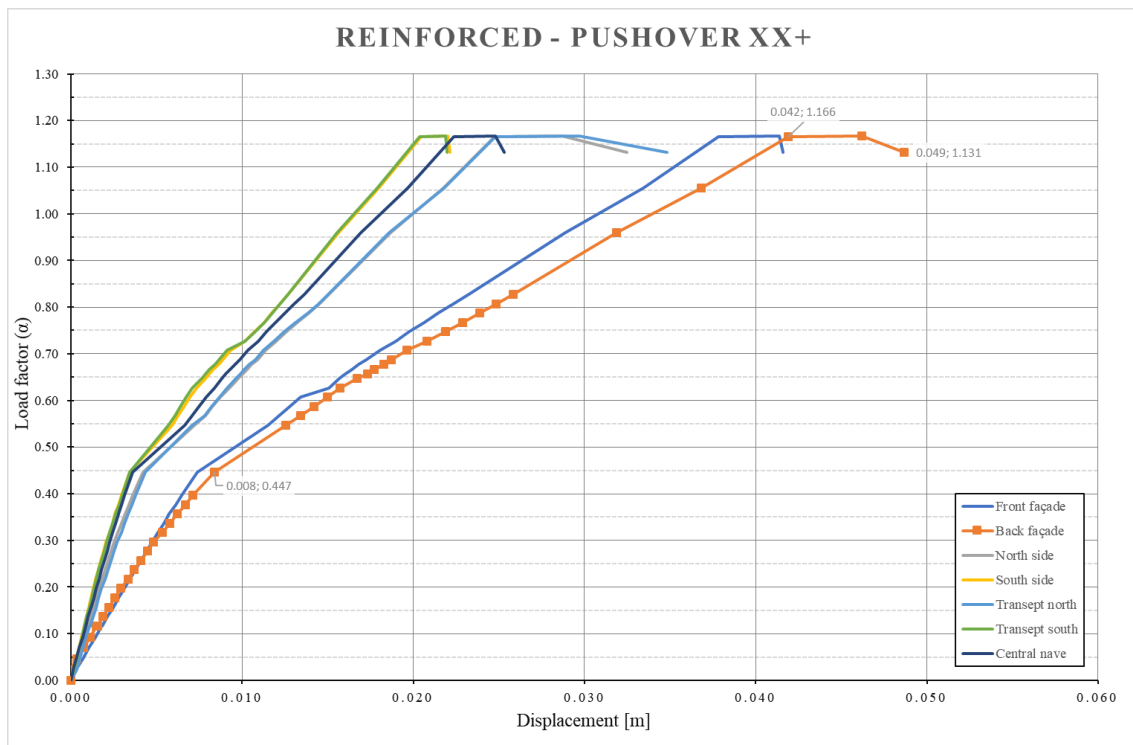
Figure 6.11 Pushover curves for the reinforced model in the longitudinal direction (XX+)

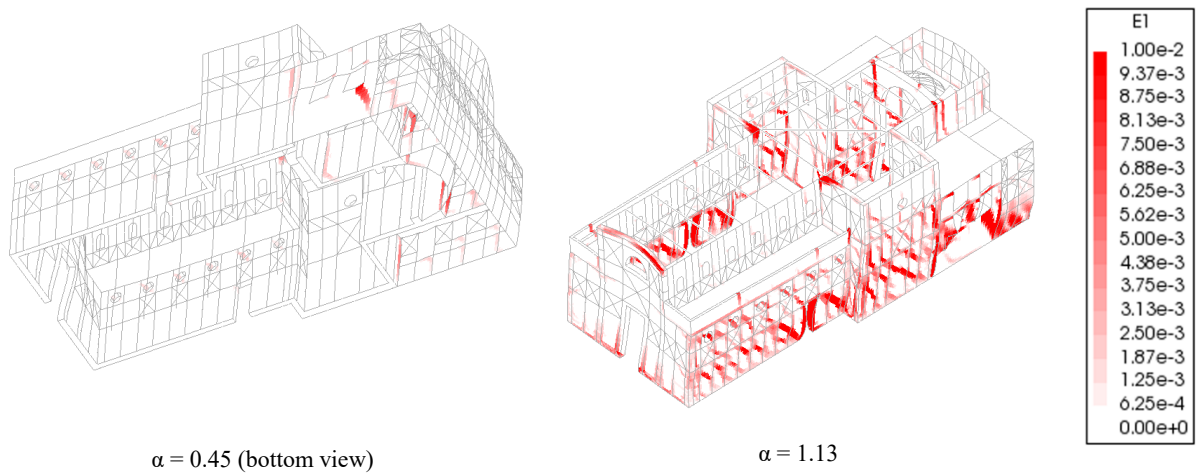
Figure 6.13 E1 plots showing the developing of damage indicators distributions

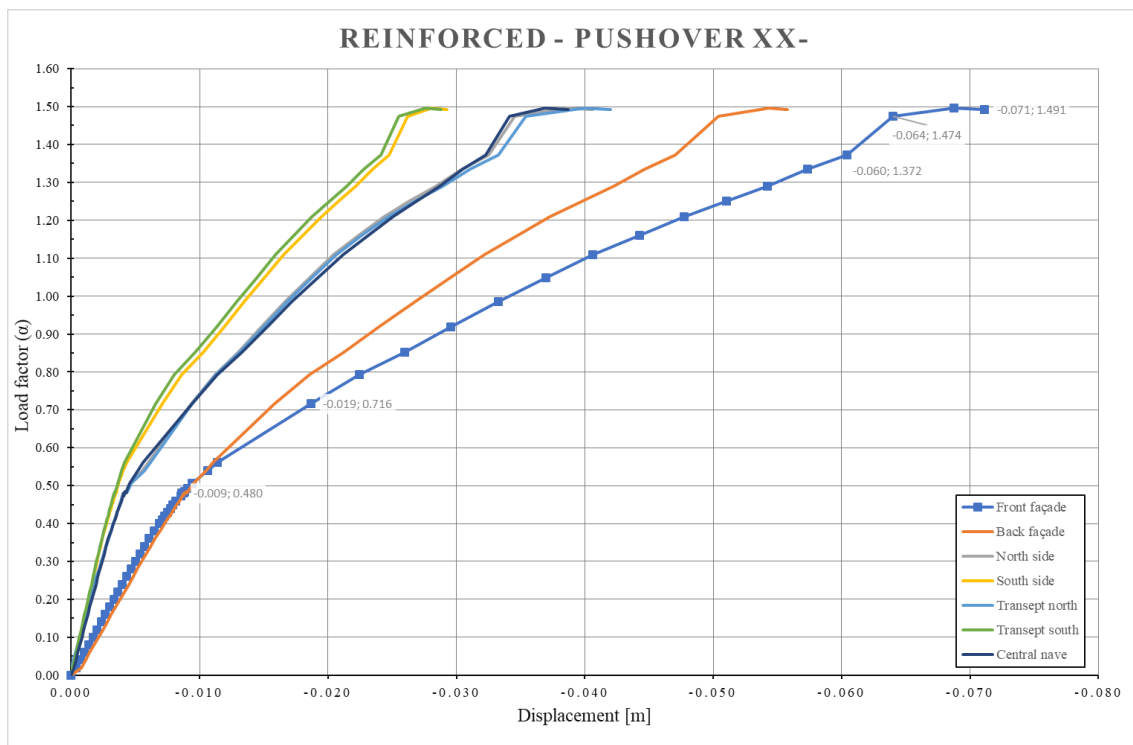
Figure 6.14 Pushover curves for the reinforced model in the longitudinal direction (XX-)

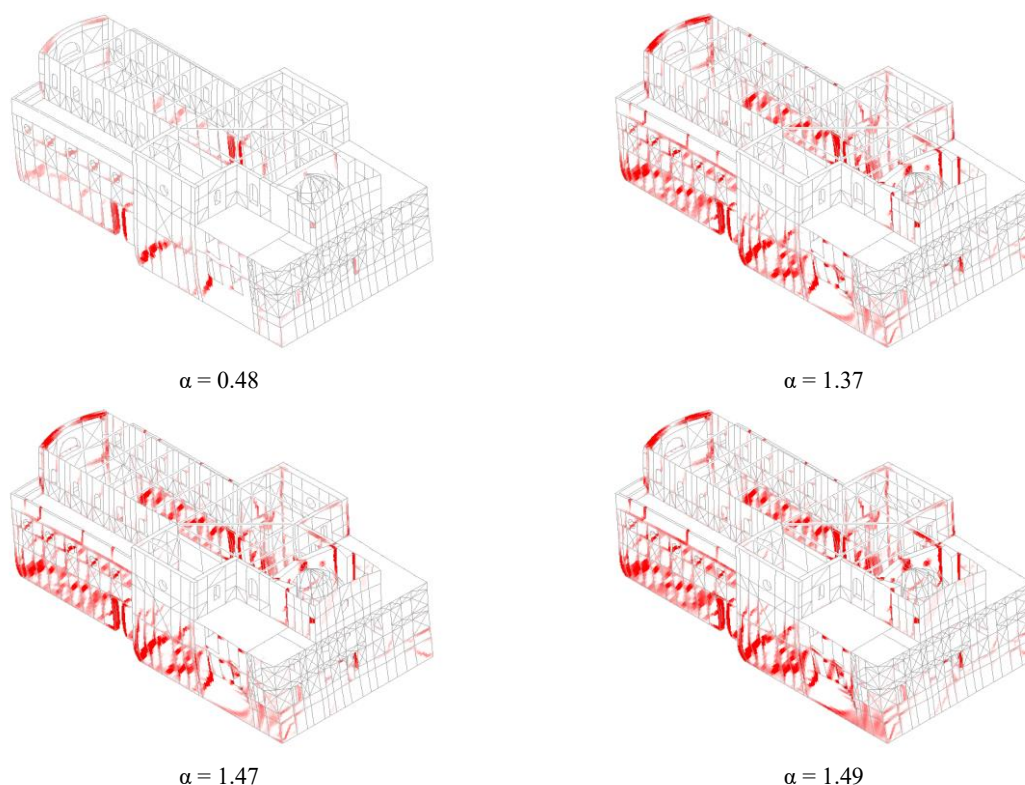
Figure 6.15 E1 distributions showing the expected damage development through the reinforced model (XX+)

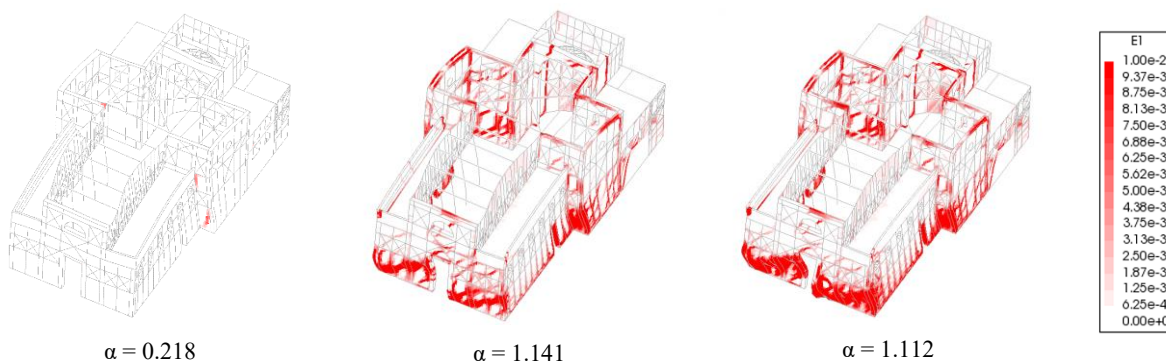
Figure 6.16 E1 plot of the highlighted steps of the pushover curve (R_YY+)

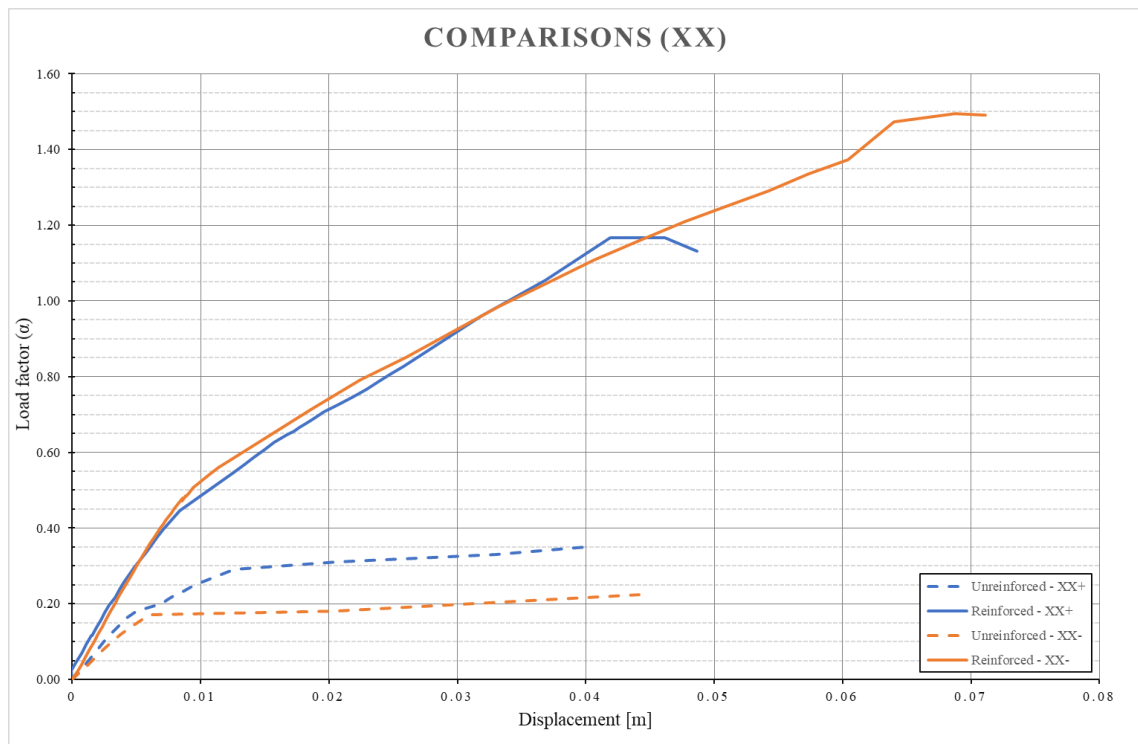
Figure 6.19 Comparison of the capacity curves in the XX direction
