## **IMPROVING BUILDINGS REFURBISHMENT THROUGH OPERATIVE CONDITIONS EVALUATION**

Sandra Monteiro da Silva<sup>1</sup>, Pedro Silva<sup>1</sup>, Manuela Almeida<sup>1</sup>, Luís Bragança<sup>1</sup>

<sup>1</sup>Department of Civil Engineering, University of Minho, Guimarães, Portugal

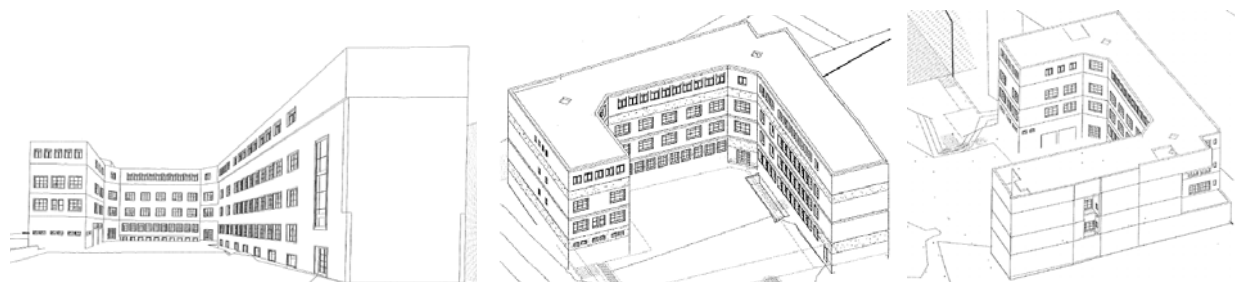
**Figure 1.** Views of the building (general perspective, SW and SE perspective)

The building under analysis is located in an urban area, the city centre of Oporto in the North-West of Portugal. The building, represented in Figure 1, has 5 floors. The ground floor is partially underground. The building was built in the 1970's and suffered some changes in the 1990's. This building was chosen as it is representative of most of the Portuguese office buildings and was built before the implementation of the first Portuguese Thermal Regulation.

The walls are concrete masonry units (CMU) with 27 cm thickness with plaster finishing and the roof is a concrete slab. All the windows are single glazed with metallic frame. The ground floor windows do not have any shading devices and the first floor windows have inside venetian blinds. The windows in the second and third floor have roller shutters and the windows in the fourth floor have curtains.

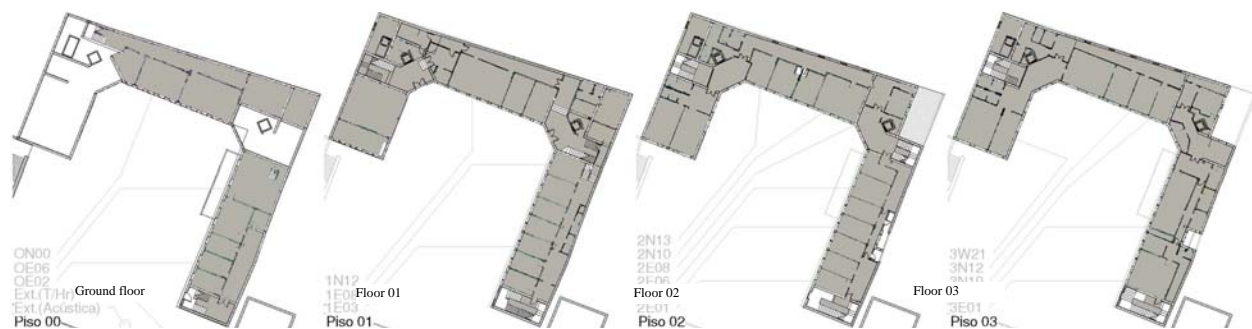
Figure 2. Measured rooms (first number represents the floor, the letter represents the orientation of the room, the last two numbers represent the room number)

The results obtained through the measurement campaigns performed on several offices are presented below according to the type of analysis done. In Figure 2 are shown the offices where the measurement campaign was performed, i.e., all the offices with permanent occupation. Some additional measurements were also performed outdoors (temperature, relative humidity, pollutants, L<sub>Aeq</sub>).

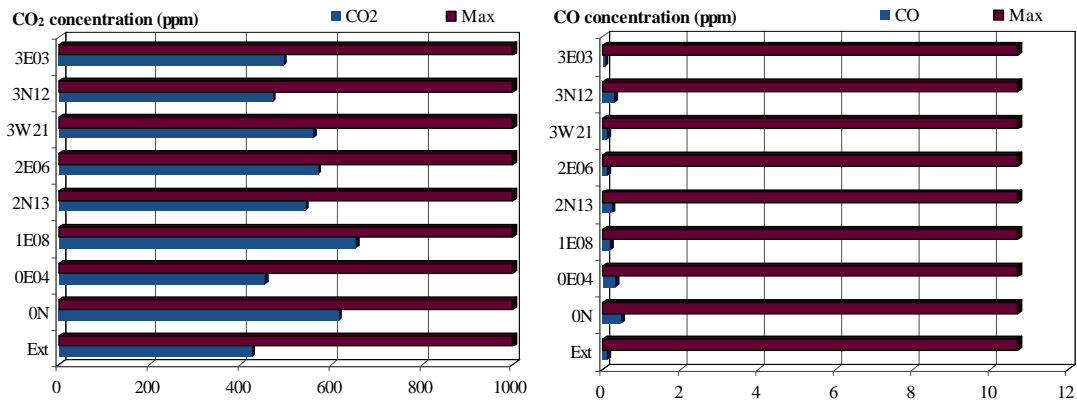
Figure 3. CO<sub>2</sub> and CO concentration and maximum reference values

Figure 3 shows the results of the carbon dioxide and monoxide (CO<sub>2</sub> and CO) measurements for the different office rooms of the building that were studied. The measurements shown considerably lower concentrations than the maximum limits since the occupants open the windows and the outdoor concentration is also low.

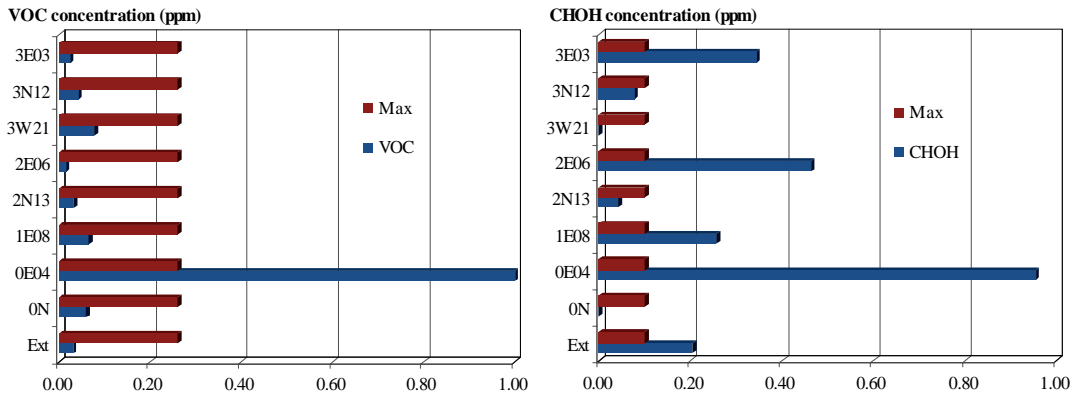
Figure 4. VOC and CHOH concentration and maximum reference values

Figure 4 shows the results of the volatile organic compounds (VOC) and formaldehyde (CHOH) measurements for the different office rooms of the building that were studied. The measurements showed a high concentration of volatile organic compounds in the room 0E04 – a laboratory – where several reagents are used. A high concentration of formaldehyde was also measured in the exterior and in rooms 0E04, 1E08, 2E06 and 3E03.

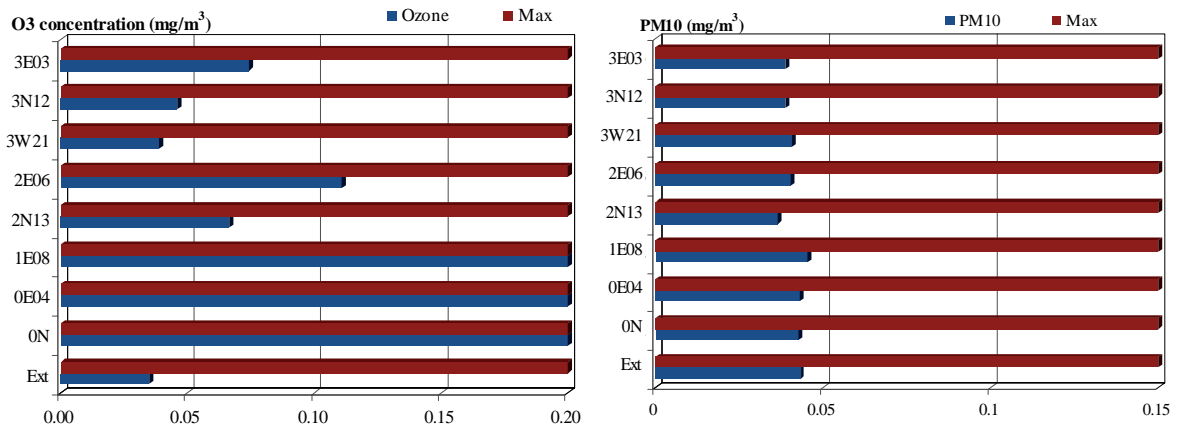
Figure 5. O<sub>3</sub> and PM<sub>10</sub> concentration and maximum reference values

Figure 5 shows the results of the ozone (O<sub>3</sub>) and suspended particles (PM<sub>10</sub>) measurements for the different office rooms of the building that were studied.

The high ozone concentrations are probably due to the outdoor concentration (intense traffic) and the presence of laser photocopiers in some of the rooms. Also, the air movement between spaces transfer the contaminant between rooms. The suspended particles concentration does not present a problem and are mainly due to the outdoor concentration, as the building is located near heavy traffic circulation road.

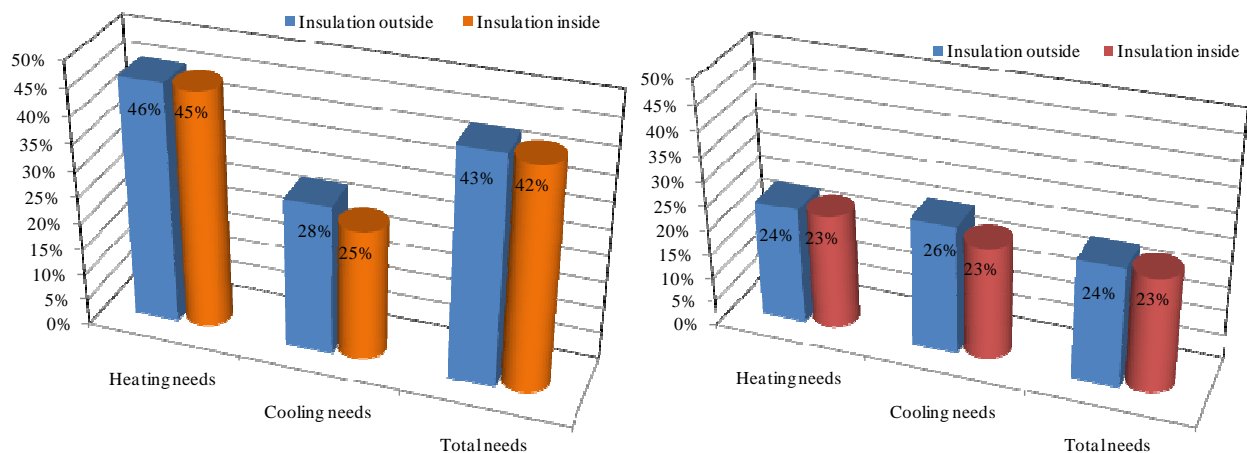
**Figure 6.** Percentage of reduction in the heating and cooling needs (left) and percentage of reduction in the heating and cooling power (right) due to building retrofit

Only with the refurbishment of the envelope, considering an ideal HVAC system with efficiency of 100%, the heating needs will be reduced in 45% and the cooling needs in more than 25% (Figure 6, left). The annual reduction is more than 40%. With the installation of a pellets boiler (efficiency of 60%) and the chiller (COP of 3) in addition to the improvement of the envelope the installed power needed is reduced in more than 20% (Figure 6, right).
