## Bond behaviour and durability of FRP composites applied externally to masonry structures

OLIVEIRA, DANIEL V.<sup>1</sup>; GHIASSI, BAHMAN<sup>2</sup>; LOURENÇO, PAULO B.<sup>3</sup>

**ABSTRACT:** The several advantages associated to the use of FRP composites for civil structural applications (mainly reinforced concrete and masonry) has led to a considerable increment in use during the last years. However, the performance of FRP composite strengthening systems when exposed to harsh environmental conditions is a matter of great concern, which justifies the recent research efforts towards the characterization of the deterioration effects. This paper discusses some of the most relevant environmental agents and their effect on the durability of FRP-strengthened concrete and masonry constructions. The results of a comprehensive series of accelerated ageing tests (water immersion and hygrothermal exposure) on external GFRP-strengthened masonry and respective constituent materials recently carried out at University of Minho are presented and discussed in detail.

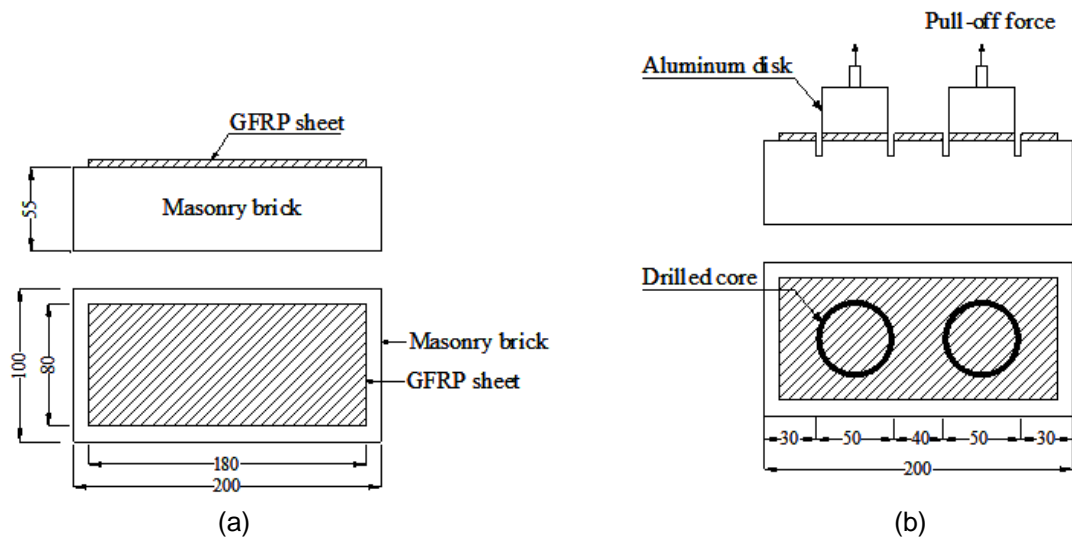
For the pull-off specimens GFRP sheets were applied over a 180x80 mm<sup>2</sup> area of the brick surface as illustrated in Figure 1. For the shear bond tests, GFRP sheets with 50 mm width were applied on the brick with a 150 mm bonded length and leaving a 40 mm unbounded part at the loaded end, see Figure 2.

The pull-off tests were performed in accordance to ASTM C1583 [8]. A 50 mm diameter partial core was drilled on the test zone with an approximate depth of 5 mm, see Figure 1(b). Then, aluminium disks were firmly glued on the GFRP surface and pulled at a rate of 20 kPa/s. The shear bond tests were carried out under displacement control at a rate of 5  $\mu$ m/sec, see Figure 2(b). Both the resulting force and the relative slip between the GFRP and the brick, measured with LVDTs placed at the free and loaded ends, were recorded.

**Figure 1.** Pull-off tests: (a) geometry of the specimens; (b) test setup (dimensions in mm).

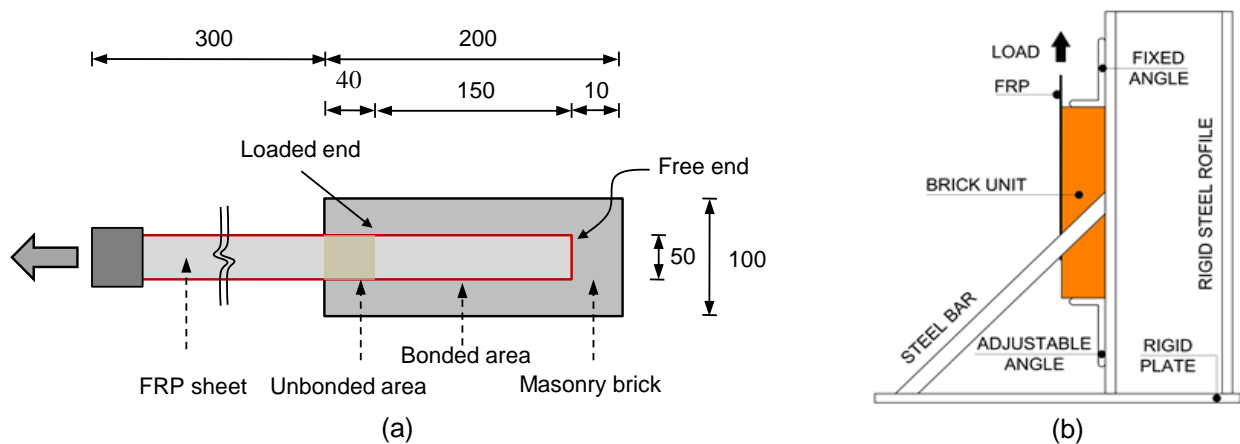
**Figure 2.** Shear bond tests (single-lap shear bond): (a) geometry of the specimens (dimensions in mm); (b) scheme of the test setup.

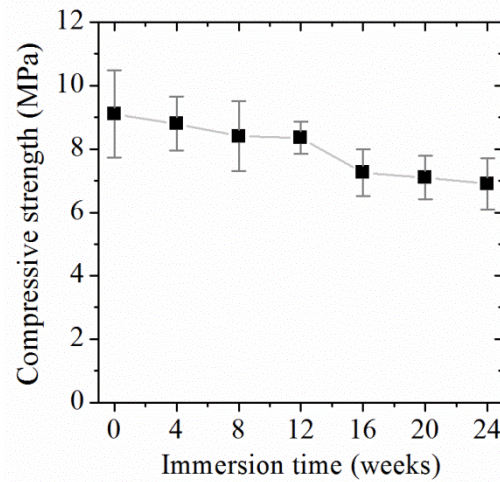
The effect of water immersion on the mechanical properties was investigated by performing compressive tests on brick samples and tensile tests on epoxy resin and GFRP coupon specimens. The variation of the brick compressive strength is illustrated in Figure 3. A reduction up to 25% of the compressive strength after 24 weeks of immersion was found, probably due to chemical reactions of water with brick constituents, promoted by the dissolving effect of water or by insufficient firing temperature [39]. Insufficient firing temperature in clay bricks can originate a low degree of vitrification and a high moisture expansion coefficient [40]. The water may react with the remaining clay inside the brick leading to micro-cracking, expansion and strength degradation.

**Figure 3.** Variation of the brick compressive strength.

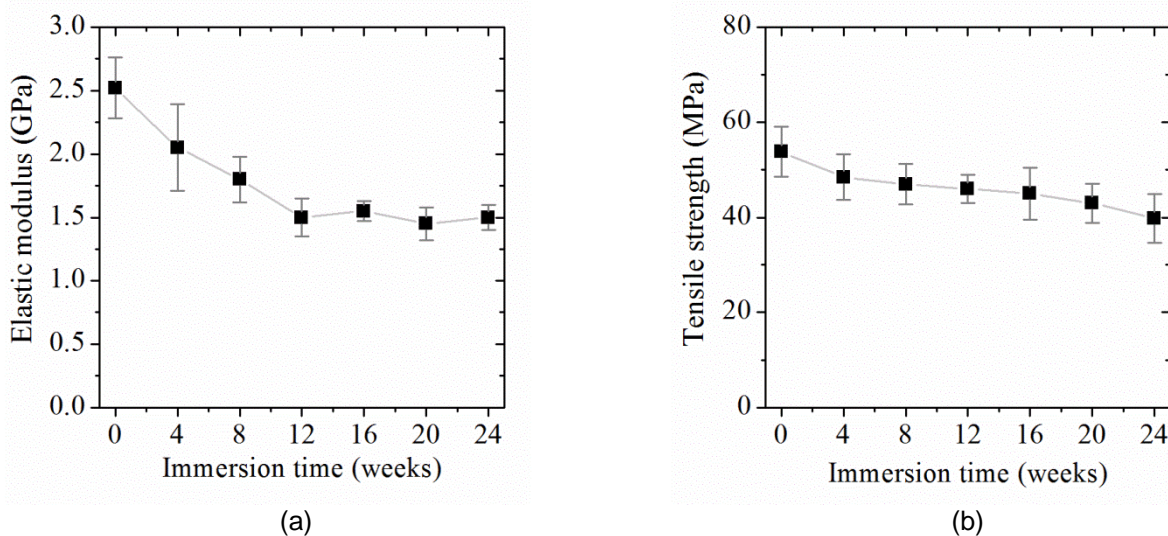
The variation of the Young’s modulus and tensile strength of epoxy resin specimens is presented in Figure 4. An important reduction of both parameters was observed. The Young’s modulus and tensile strength decreased by 40% and 25% after 24 weeks, respectively, corresponding to 1.2% of water absorption. Although the Young’s modulus degradation seems to stop after 12 weeks of immersion, the tensile strength decreases in a relatively continuous way during the entire period of exposure. Other studies have shown that the degradation of epoxy resins due to water absorption varies with the type of epoxy resin, e.g. see [37] [41]. While Sciolti et al. [37] reported a 45% reduction of Young’s modulus and 32% reduction of tensile strength for 4% water absorption, Tuakta and Büyüköztürk [41] reported a 7% reduction of Young’s modulus and 22% reduction of tensile strength in epoxy resin for 1.2% mass water absorption.

The reduction of the Young’s modulus and tensile strength is due to the plasticization and possibly hydrolysis of epoxy resin [42]. The water absorbed by the resin acts as a plasticizer, which usually reduces the  $T_g$  and mechanical properties. The decrease of  $T_g$  reflects the degree of plasticization and occurrence of water/resin interactions [43], nevertheless this decrease can be partially regained upon drying [44]. For long exposure periods, the possibility of resin degradation increases because hydrolytic reactions may also occur and these can affect the resin performance in a serious way [43].

**Figure 4.** Variation of the properties of epoxy resin: (a) Young’s modulus; (b) tensile strength.

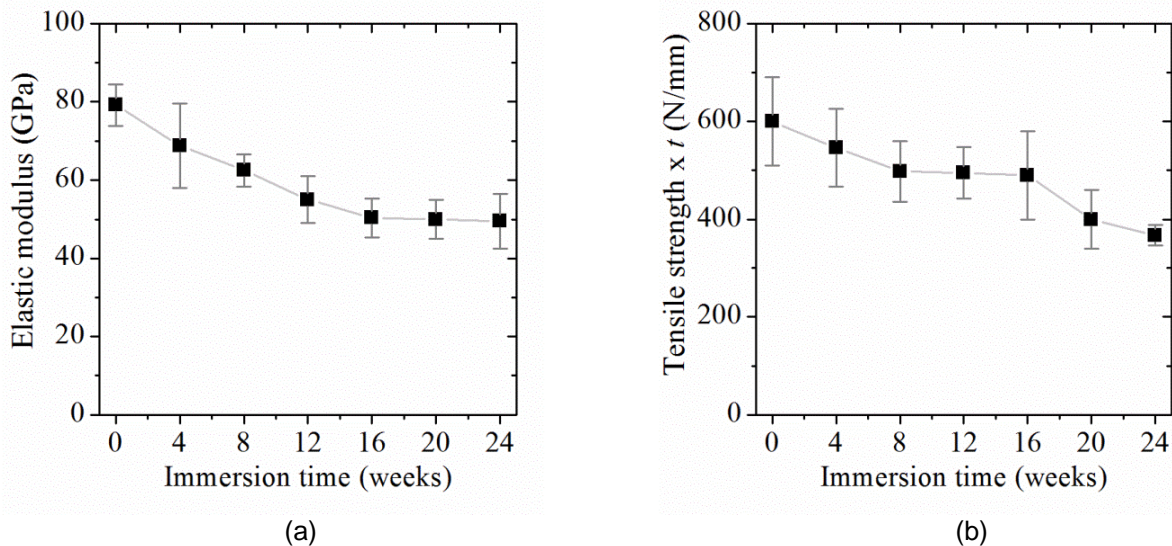
The variation of the Young's modulus and tensile strength of GFRP coupons is depicted in Figure 5. As in wet lay-up procedures the specimens' thickness may vary, the results were normalized to the specimens' thickness according to ASTM standards [45]. As for the epoxy resin, Young's modulus and tensile strength values decreased significantly. The Young's modulus reduction stabilized at 16 weeks of immersion with a 38% degradation. The tensile strength decreased about 40% after 24 weeks of exposure corresponding to 3.7% water uptake. A similar severe reduction of mechanical properties of GFRP (tensile strength degradation of 50%) has been reported in [46]. The formation of air bubbles and non-uniformities in the specimens prepared following the wet lay-up procedure increases the vulnerability of the composite material to moisture uptake [18]. Therefore, the degradation of mechanical properties of GFRP coupons reported in this paper can be attributed to the water effect on the epoxy and epoxy-fiber interface. Additionally, the water can cause attack fibers, which results in corrosion and bond degradation at the epoxy/fiber interface [47].

As GFRP coupons were cured for 2 months before water immersion, it is considered that polymerization of the resin has fully occurred and, therefore, the results present solely the strength degradation due to water immersion, without any beneficial effect due to post-curing.

**Figure 5.** Variation of the properties of GFRP coupons: (a) Young's modulus; (b) tensile strength.

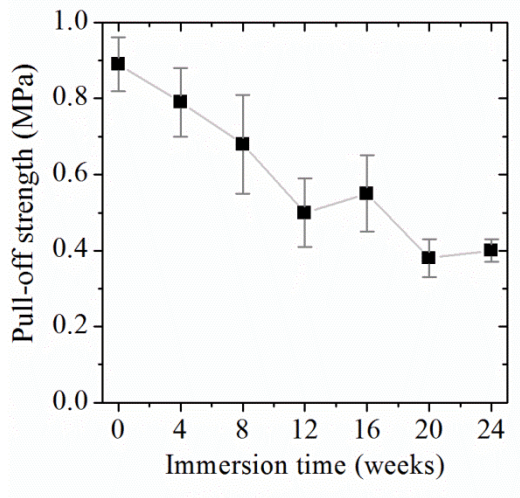
Figure 6 illustrates the variation of the average pull-off strength as a function of the immersion time. A huge and progressive reduction of the bond strength can be deduced from the tests, with a 56% reduction after 24 weeks of immersion. The scatter found in the results is somehow common for this type of test [48]. The failure mode remained cohesive in all immersion periods with a reduction of the thickness of the detached brick layer until reaching the primer impregnated layer of the brick.

**Figure 6.** Variation of the pull-off strength.

- The final pull-off strength decreased considerably, but these results showed a different degradation trend when compared to results from shear bond tests. A cohesive failure mode was found in all tests, but the fracture surface moved progressively from the brick to the brick-primer interface.

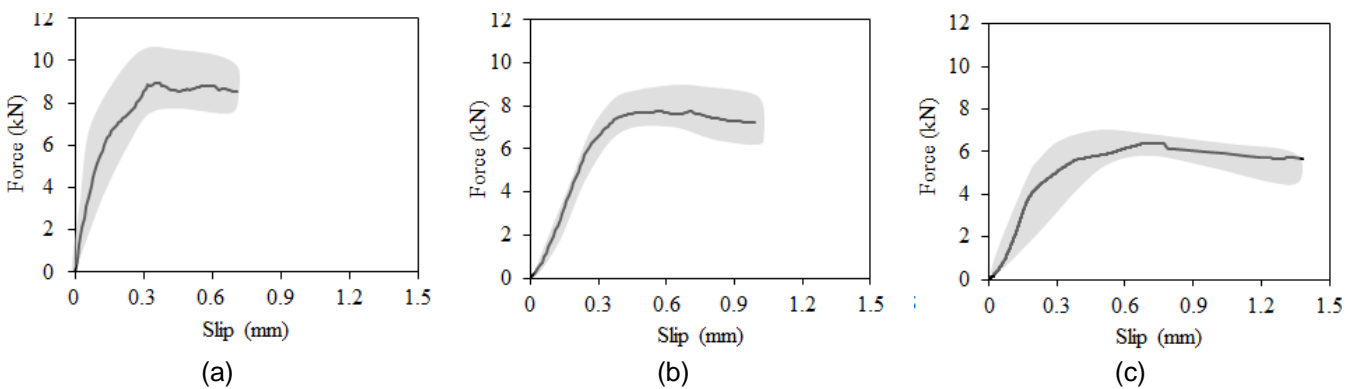
**Figure 7.** Envelope and average load-slip curves from single-lap shear tests: (a) prior to immersion; (b) 12 weeks of immersion; (c) 24 weeks of immersion.

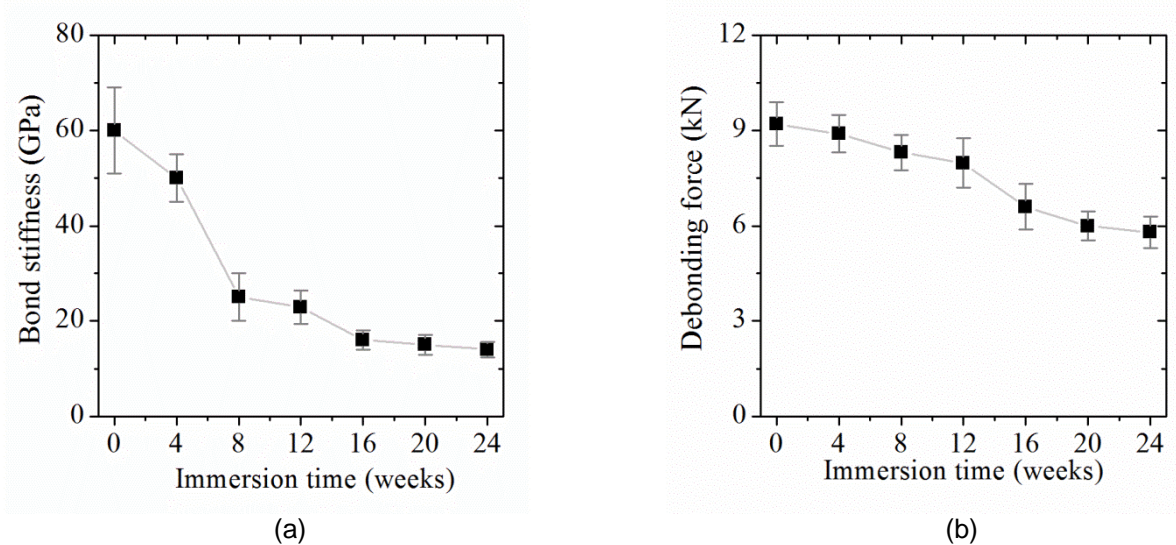
Figure 8 presents the variation of the average values of the bond stiffness and debonding force with the immersion time. The bond stiffness, defined as the initial slope of the load-slip curves, has decreased considerably in the first 8 weeks (around 60%). Afterwards, the rate of bond stiffness degradation is much lower, reaching 80% reduction at 24 weeks. This reduction in the bond stiffness can be attributed to the stiffness reduction in epoxy resin, GFRP, and FRP-brick bond. In comparison, it

**Figure 8.** Variation of bond parameters: (a) bond stiffness; (b) debonding force.

It is possible to observe that the bond strength decreased slightly in the first 12 weeks of immersion (about 16%). Then, the degradation rate increased reaching 35% reduction of bond strength after 20 weeks of exposure. Figure 8(b) suggests that the degradation is less dependent on time after 20 weeks of immersion and the bond strength might have reached its residual value. Nevertheless, a longer immersion time is necessary to investigate this apparent trend. A similar residual bond strength has been reported by Sciolti *et al.* [29] after 8 weeks of immersion for CFRP strengthened calcernite stones.

In general terms, it seems that the degradation rate diminishes with exposure for both bond stiffness and bond strength. This phenomenon is an evidence that most probably a thermodynamic balance has been attained, as reported also in [41] [49].

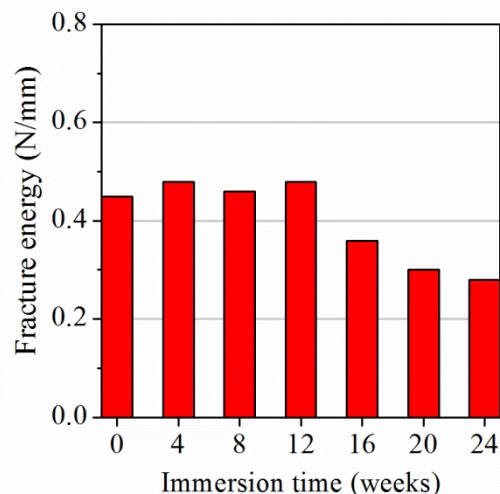
Considering debonding as a local failure involving crack propagation, a fracture mechanics approach seems more appropriate than a conventional strength-based approach [41]. Taking the fracture energy  $G_f$  as the preferred degradation parameter, its value for each immersion period can be computed according to CNR-DT 200 [10] as:

Figure 9 presents the average fracture energy associated to each immersion period. In the first 12 weeks of immersion there is no reduction of the interfacial fracture energy. However, a significant reduction degradation occurs between the 12<sup>th</sup> week and the 20<sup>th</sup> week. After 20 weeks of immersion, the fracture energy value apparently reached a residual value with 40% reduction when compared to its initial value. A similar degradation trend is also reported in [49]. The dominant failure mode observed was mainly a cohesive one, with a progressive reduction of the thickness of the detached brick layer with immersion time, up to a thin layer equal to the primer impregnated thickness.

**Figure 9.** Variation of the interfacial fracture energy.

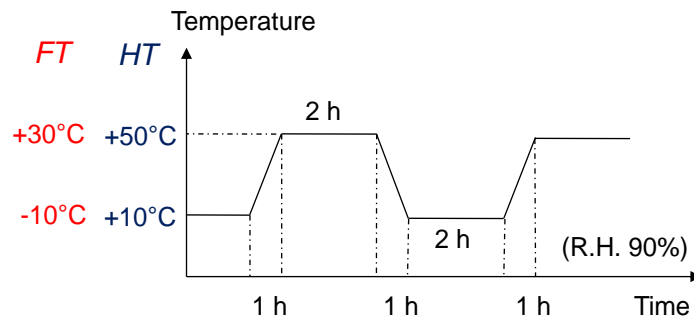
In the first exposure (HT), specimens were submitted to 6 hours temperature cycles from +10 °C to +50 °C. Within each cycle, the temperature was kept constant at +10 °C for 2 h, subsequently increased to +50 °C in 1 h, followed constant temperature of +50 °C during 2 h. Subsequently, the temperature was decreased back to +10 °C in 1 h resulting in a 6 h cycle of exposure. The +50 °C temperature is considered relatively high to accelerate the degradation phenomenon, but far enough from  $T_g$  (70 °C). Taking into account that environmental conditions can lead to a reduction of the glass transition temperature in epoxy resins, the maximum temperature set in the thermal cycles should prevent reaching  $T_g$  during the tests [12]. The specimens were subjected to 225 cycles during this exposure.

Within the second exposure (FT), temperature cycles ranged from -10 °C to +30 °C. Conversely, here the objective was to investigate the effect of freeze-thaw conditions on the bond behaviour while keeping unchanged all the other potential influencing parameters regarding exposure HT. Therefore, similar temperature rates were adopted leading to a 20 °C decrement of the maximum and minimum temperatures. Specimens were subjected to 300 cycles during this exposure.

Figure 10. Conditioned hygrothermal cycles adopted.

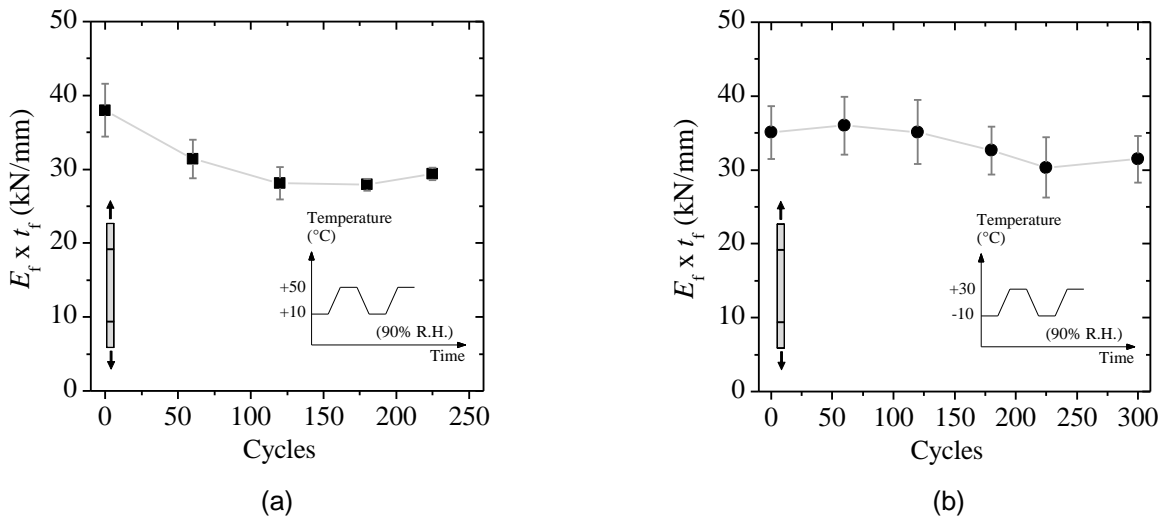
As for the GFRP coupons, both hygrothermal exposures caused some degradation, but a higher degradation was observed in specimens exposed to HT conditions. The results regarding the Young's modulus and the tensile strength are illustrated in Figure 12 and Figure 13, respectively. Also here, results were normalized to the specimens' thickness according to ASTM D7565 [45]. The Young's modulus of the GFRP coupons decreased 23% and 18% under the HT and FT exposures, respectively. In a similar way, the tensile strength of the GFRP coupons decreased 22% and 10% under the HT and FT exposures, respectively. The CoVs of the experimental results in both exposures were kept under 12%.

Figure 12. Variation of the Young's modulus of GFRP coupons: (a) HT exposure; (b) FT exposure.

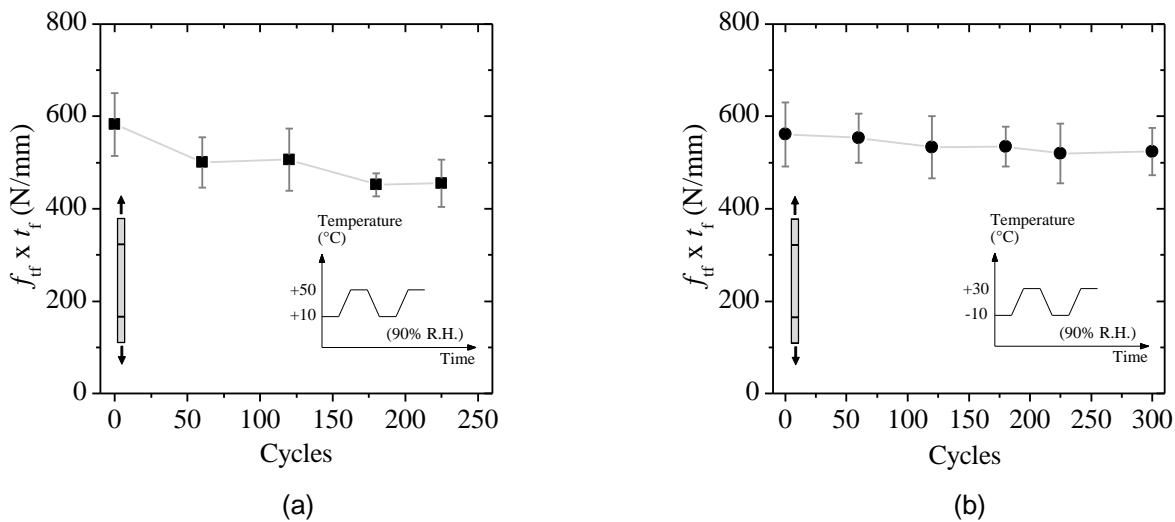
Figure 13. Variation of the tensile strength of GFRP coupons: (a) HT exposure; (b) FT exposure.

Also in this case, the degradation observed experimentally can be attributed to different degrading mechanisms. GFRP coupons absorb moisture when exposed to moisture conditions, which causes degradation in the epoxy resin properties, as discussed above. Additionally, the water attacks the glass fibers degrading their mechanical properties. Under this scenario, the fiber-epoxy interface may also be degraded due to the degradation of fibers and epoxy resin and also the produced osmotic pressure at the interface [12]. On the other hand, the cyclic temperature may causes micro-cracking due to differences between the thermal expansion coefficients of glass fibers and epoxy resin [50] [51]. Finally, the 50°C temperature in the HT exposure may lead to post-curing of the epoxy resin and increase the moisture absorption coefficient, as referred to above.

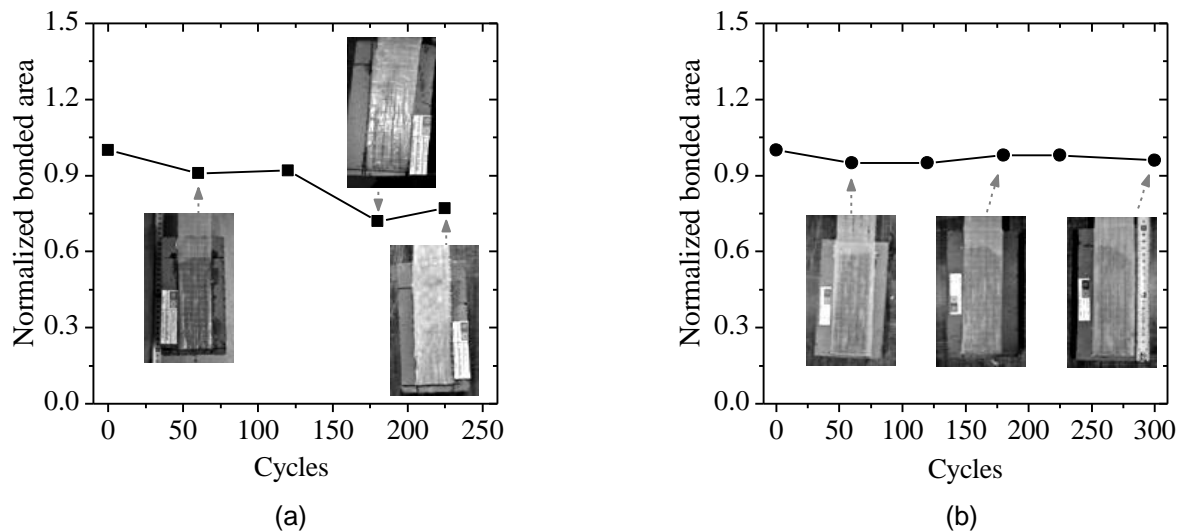
The bond degradation evaluation was investigated following both qualitative and quantitative approaches. Initially, specimens were inspected visually in order to detect the existence of any visible damage or delamination in the interfacial region. Progressive FRP delamination was observed in some specimens with the increasing number of exposure cycles. The reduction of the bonded area (normalized by the initial bonded area) with exposure time is illustrated in Figure 14. Each point represents the average value of five inspected specimens. Delamination was generally larger in specimens subjected to HT cycles.

Delamination observed in the FRP-strengthened specimens subjected to hygrothermal cycles is most probably due to the thermal incompatibility between the composite material and the brick. The thermal expansion coefficient of clay bricks is in the order of  $5 \times 10^{-6} / ^\circ\text{C}$  [52]. The thermal expansion coefficient of E-glass fibers is similar to the one from bricks, while for epoxy resin it is in the range of  $30\text{--}54 \times 10^{-6} / ^\circ\text{C}$  [10]. This large difference of thermal expansion coefficients between the epoxy resin and the glass fibers and bricks induces thermal strains at the brick-resin and fiber-resin interfaces. This effect is further amplified by cycling leading to thermal fatigue that may cause FRP delamination from the brick surface during exposures. On the other hand, it has been shown that the thermal expansion coefficient of epoxy resins is much lower at low (and negative) temperatures [53]. Therefore, it is expected that the interfacial strains produced by thermal incompatibility would be lower for the FT exposure. This fact explains the smaller delaminated areas observed in specimens exposed to the FT conditions.

**Figure 14.** Reduction of the bonded area induced by hygrothermal exposure: (a) HT exposure; (b) FT exposure.

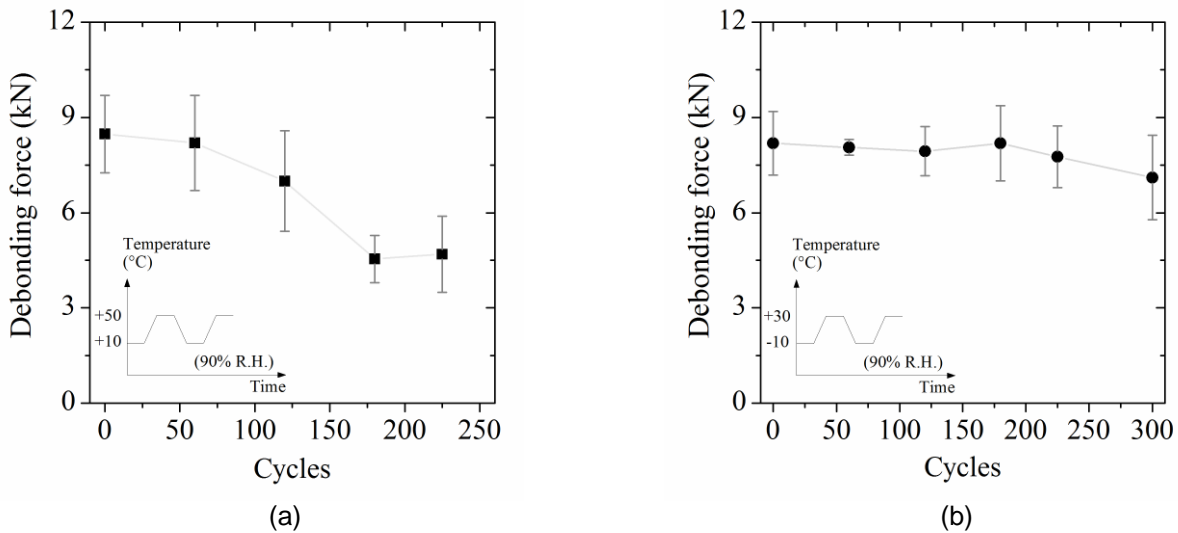
The effect of the two hygrothermal exposures on the debonding force is depicted in Figure 15. The debonding force progressively decreased with the number of exposure cycles, but at different rates. The debonding force decreased 17% and 45% after 120 and 225 cycles of HT exposure, respectively. As for the FT exposure, it decreased 4% and 14% after 120 and 300 cycles, respectively. A direct comparison between the results normalized with respect to the initial force clarifies that the HT exposure induces a higher degradation in the FRP-strengthened specimens tested in this study, see Figure 16.

**Figure 15.** Variation of the debonding force: (a) HT exposure; (b) FT exposure.

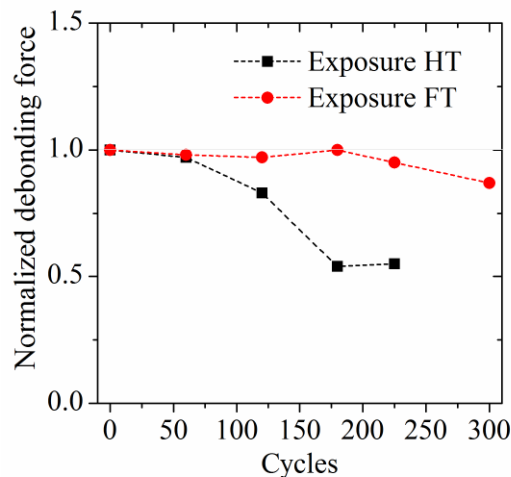
**Figure 16.** Comparison of the debonding force recorded for the HT and FT exposures.

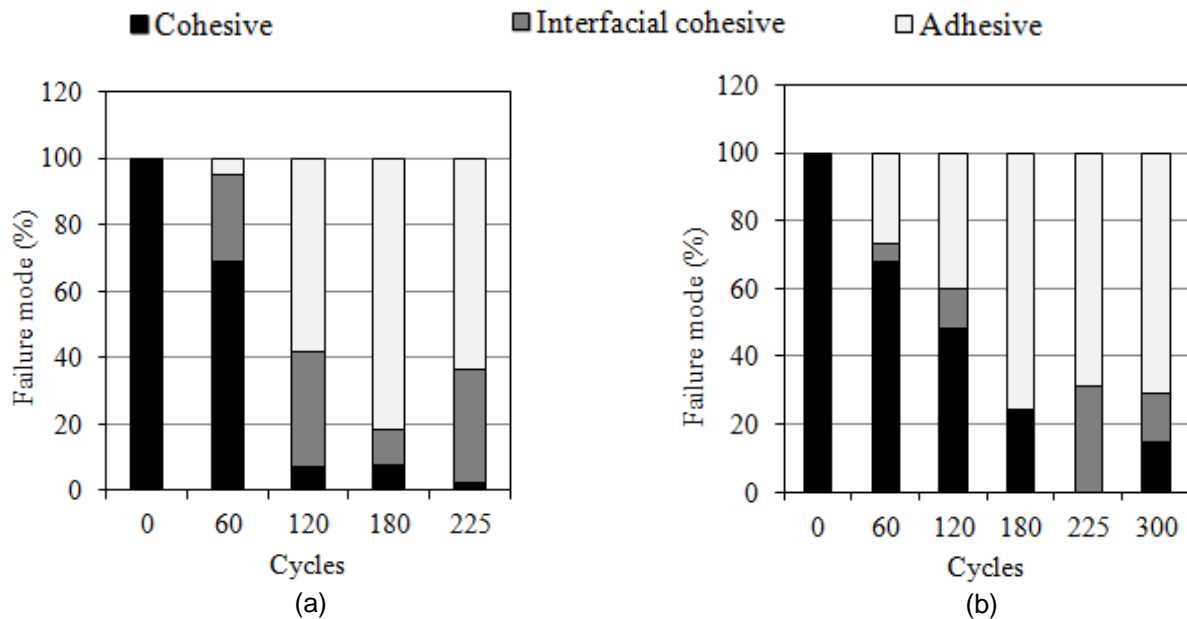
- cohesive: failure within a thick layer of brick
- interfacial cohesive: failure within a superficial layer of brick
- adhesive: failure at the FRP/brick interface

More precisely, the increase of the number of exposure cycles causes larger bond degradation and changes the dominant failure mode from cohesive to adhesive in both hygrothermal exposures. Similar results regarding changes in the debonding process have been also reported in literature for specimens exposed to freeze-thaw and wet-dry cycles, e.g. [55] [56].

The measurement of the area in correspondence to each failure mode in each specimen and for each exposure period, after the debonding tests, allows to estimate the relative contribution of each failure mode in the debonding behaviour. This result is illustrated in Figure 17. As realized during the tests, the contribution of the cohesive failure mode reduces as the exposure time increases, being progressively substituted by adhesive failure.

**Figure 17.** Contribution of each failure mode for the debonding behaviour: (a) HT exposure; (b) FT exposure.
