Evaluation of the bond performance in FRP-brick components re-bonded after initial delamination

ABSTRACT

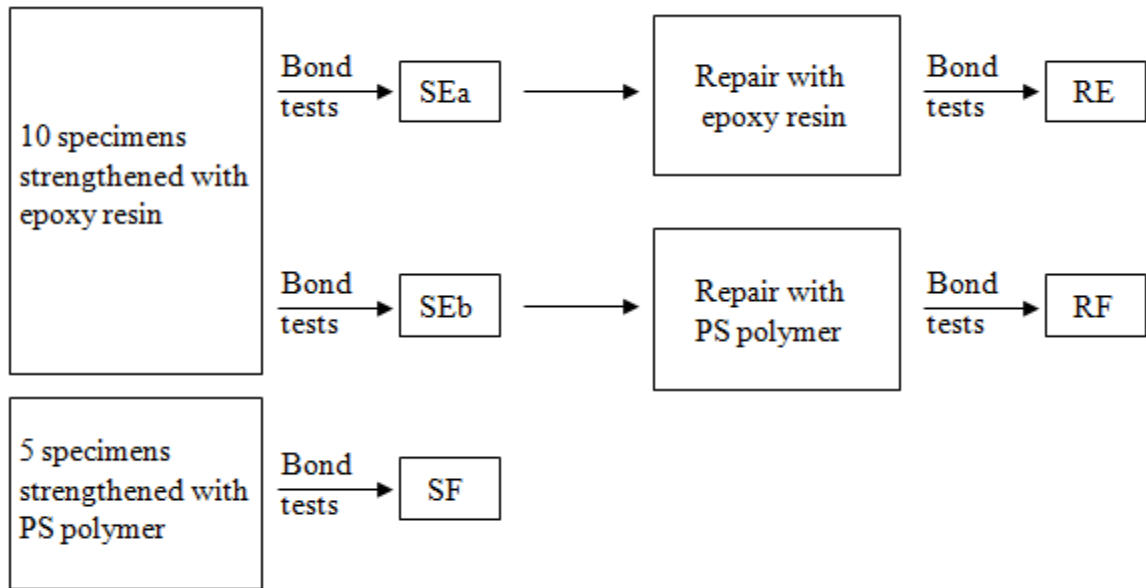
Fig.1. Specimens' preparation and testing program.

The prepared specimens can be categorized into four groups as illustrated in **Fig.1**, where **S** indicates a reference Strengthened specimen, **R** indicates a Repaired strengthened specimen, **E** indicates Epoxy and **F** indicates the Flexible polymer:

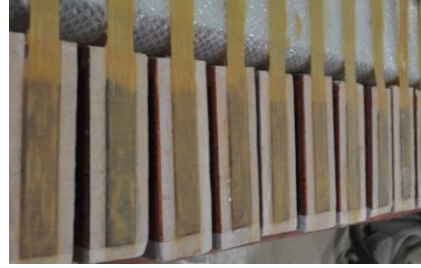
Fig.3. Strengthened specimens: (a) SE-specimens; (b) SF-specimens.

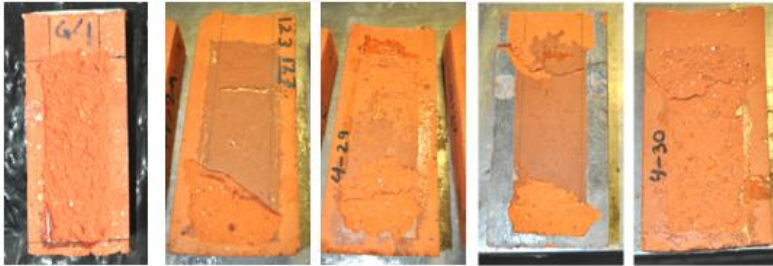
Bricks selected to be repaired with PS polymer

Bricks selected to be repaired with epoxy resin

Fig.5. Bricks surfaces after initial delamination tests (used for repair).

For preparation of the repaired RE- and RF-specimens, the ten SE-specimens are debonded under single-lap shear bond tests after curing in the laboratory conditions, see **Sec. 3** for the test setup and procedure. The failure mode of the SE-specimens was delamination of a thin layer of the brick (six specimens) or delamination of a brick bulb at the free end (four specimens) of the specimens as shown in **Fig.5**. As it can be observed in the figure, the specimens are divided into two groups (to be repaired with PS polymer and epoxy resin) containing specimens with similar fractured surface conditions. The bricks surfaces are carefully cleaned with air compressor followed by application of a primer layer on the bricks' surfaces. The delaminated GFRP sheets are then bonded again to the bricks' surfaces with the conventional epoxy resin (for the RE-specimens) and with the PS Polymer (for the RF-specimens).

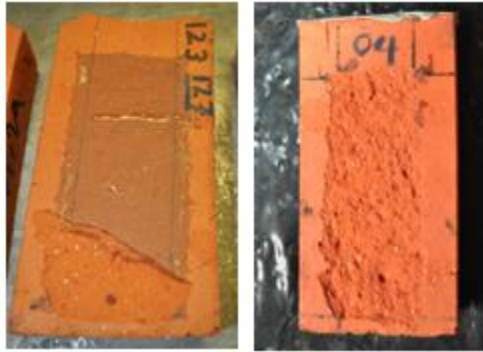
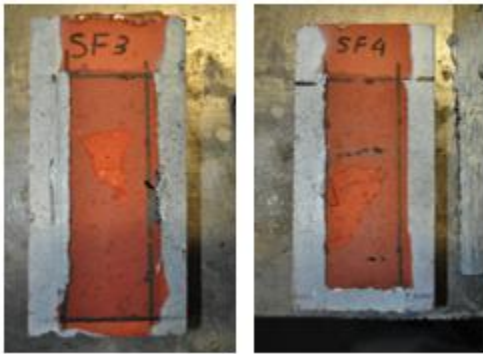
Fig.9. Typical failure modes of (a) SE- and (b) SF-specimens.

The failure mode in the SE-specimens was mostly cohesive with fracture inside a thin layer of the brick or adhesive with formation of a brick bulb at the free end, see **Fig.9(a)**. However, the governing failure mode in the SF-specimens was adhesive failure at the polymer-brick interface as shown in **Fig.9(b)**. This can be due to the low chemical and mechanical adhesion between the brick surface and the PS polymer in the strengthened specimens.

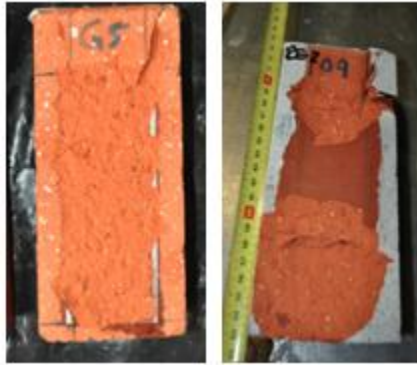
Fig.10. Typical failure modes of (a) RE- and (b) RF-specimens.

All the RE-specimens had a cohesive failure with the fracture occurring inside the brick, see **Fig.10(a)**. In some cases a brick bulb was also detached at the free end of the specimens. A similar failure mode was also observed in the corresponding strengthened specimens (SEa), see **Table 3**. However, the failure of the RF-specimens changed in comparison to their corresponding strengthened specimens (SEb). The failure mode in these specimens was either cohesive inside the brick or cohesive inside the PS polymer as shown in **Fig.10(b)**. This change of failure mode can be due to reduction of stress concentrations caused by many times lower Young's modulus than epoxy resin and strong mechanical interlocking between the PS polymer and the brick surface in the repaired specimens.

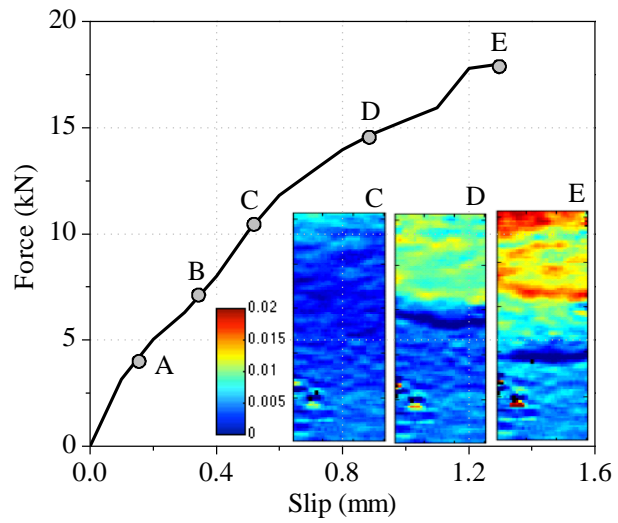
Fig.11. Strain distribution along the bonded area at different load levels in a typical (a) SE- and (b) RE-specimen.

Fig.11 and **Fig.12** present the typical evolution of longitudinal strains on the FRP surface during the debonding tests at different load levels. The full-field strain distributions, determined from the DIC measurements, clearly show the strain transfer zone along the bonded length. It can be observed that longer bonded lengths are contributing to the strain and stress transfer to the

substrate in the RE-specimens in comparison to the SE-specimens, see **Fig.11**. On the other hand, it seems that in SF- and RF-specimens the strains are developed along all the bonded length gradually diminishing near the free end.

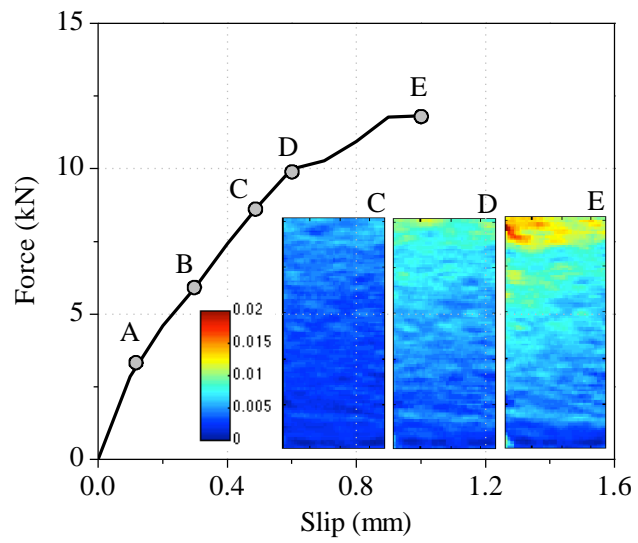
Fig.12. Strain distribution along the bonded area at different load levels in a typical (a) SF- and (b) RF-specimen.

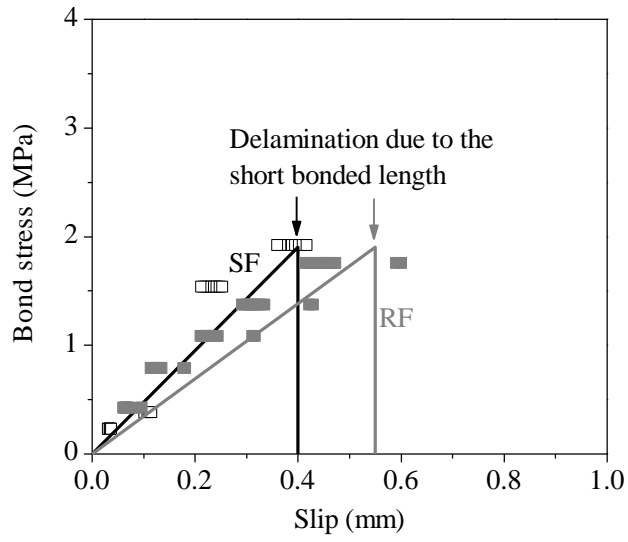
Fig.17. Bond-slip laws obtained for SF- and RF-specimens.

In case of SF- and RF-specimens, the maximum transferrable shear stresses cannot be developed in the composite system due to the short actual bonded length of the specimens, see **Fig.17**. The bond fracture energy in this case is 0.38 N/mm and 0.52 N/mm in SF- and RF-specimens, respectively for the tested specimens. However, for development of the maximum bond stress and fracture energy, preparation of specimens with longer bonded lengths is necessary. This brings in an obvious difficulty in this case, as the brick has a length of 200 mm only.
