Maria Pia Ciocci - Structural Analysis of the Timber Structure of Ica Cathedral, Peru

# Master's Thesis

Structural Analysis of the Timber Structure of Ica Cathedral, Peru

Portugal | 2015

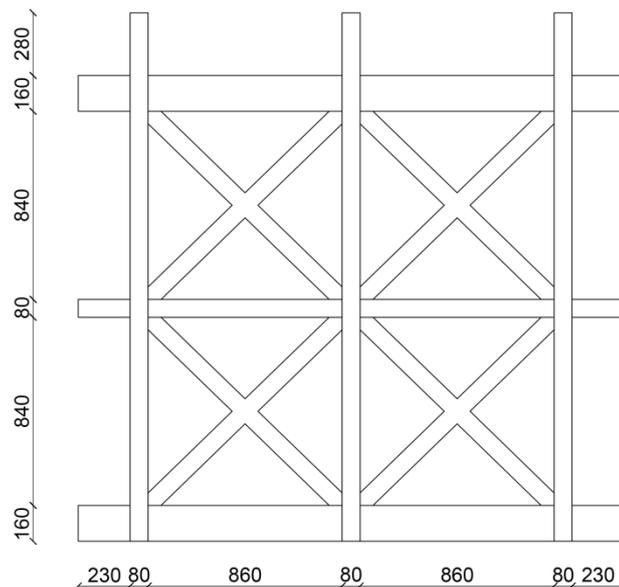
A real scale specimen of a timber frame wall was constructed taking into account the common dimensions of existing buildings. The timber frame wall – that has a total width of 2.42 m and a total height of 2.36 m – was composed by four braced cells with the dimensions of 840 x 860 mm<sup>2</sup>. The top and the bottom beams of the main frame had a cross section of 160 x 120 mm<sup>2</sup>, while all the other elements were of 80 x 120 mm<sup>2</sup>. The geometry of the test specimen is shown in **Figure 1**.

**Figure 1. Geometry of the timber frame wall specimen.**

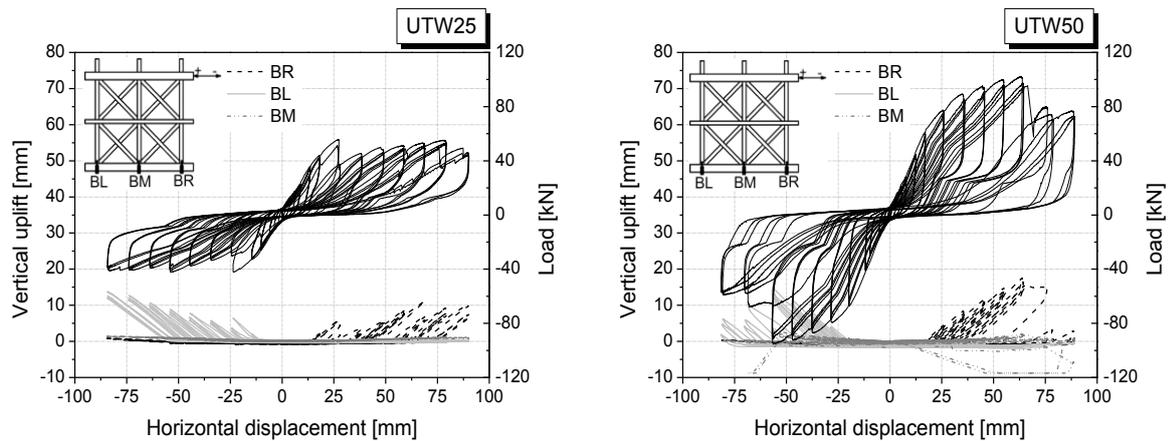
The timber frame – tested as a cantilever – showed a shear resisting mechanism as presented by the force-displacement hysteresis diagrams, see **Figure 2**. Besides, the flat trend of the hysteretic curves – that was not only at the origin where the load was inverted – is associated with a severe pinching effect for the timber frame wall. The evolution of the vertical displacements pointed out that there was an uplift of the posts which conditioned the shape of the hysteretic loops – 13.8 mm and 17.5 mm for the lower and higher values of the load. However, the unloading branch of the various loops was quite regular.

**Figure 2. Timber frame wall with lower (left) and higher (right) vertical load levels (Poletti, 2013).**

In general, the experimental tests showed that when a higher pre-compression vertical load was applied, the load capacity and the stiffness were higher: an increase in the lateral resistance of 105% with a loss of ultimate displacement of only 3% was noticeable. In particular, in the wall with the lower pre-compression vertical load the failure occurred at an applied displacement of 30.4 mm, while for the higher pre-compression vertical load failure occurred at an applied displacement of 70.8 mm.

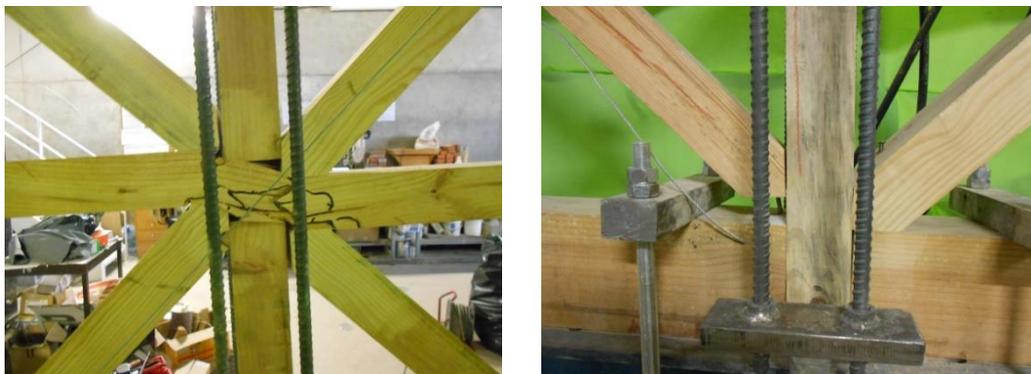
The damage pattern of the timber frame wall was characterized by the significant bending experienced by the posts and the trend of pulling-out of the nails from the connections, see **Figure 3**. Regarding the half-lap connections, as previously mentioned, the damage was concentrated in the central connection that crushed due to the lateral compression applied by the diagonals. The redistribution of stresses that was observed after the failure of the central connection in the case of the lower pre-compression vertical load level led to the failure of the right connection after that of

Figure 3. Typical damage of the connections.

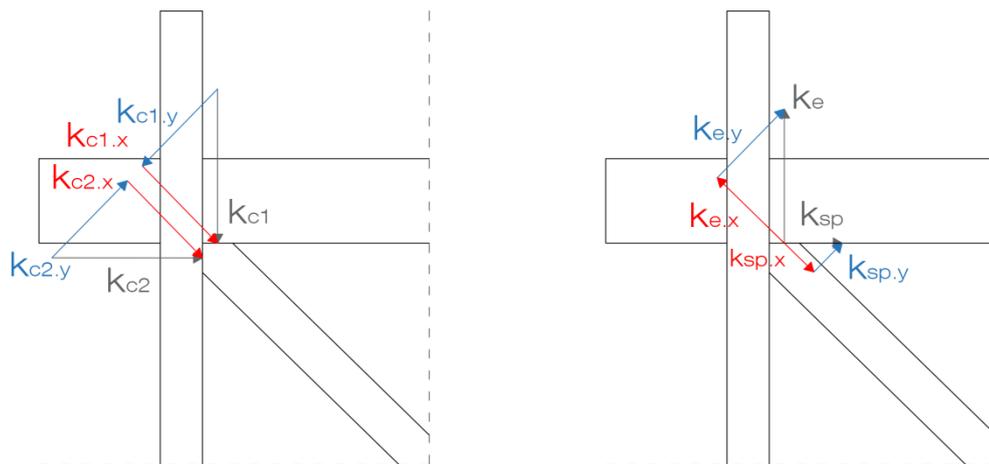
**Figure 4. Axial and shear stiffness for the connection between the diagonals and the main frame.**

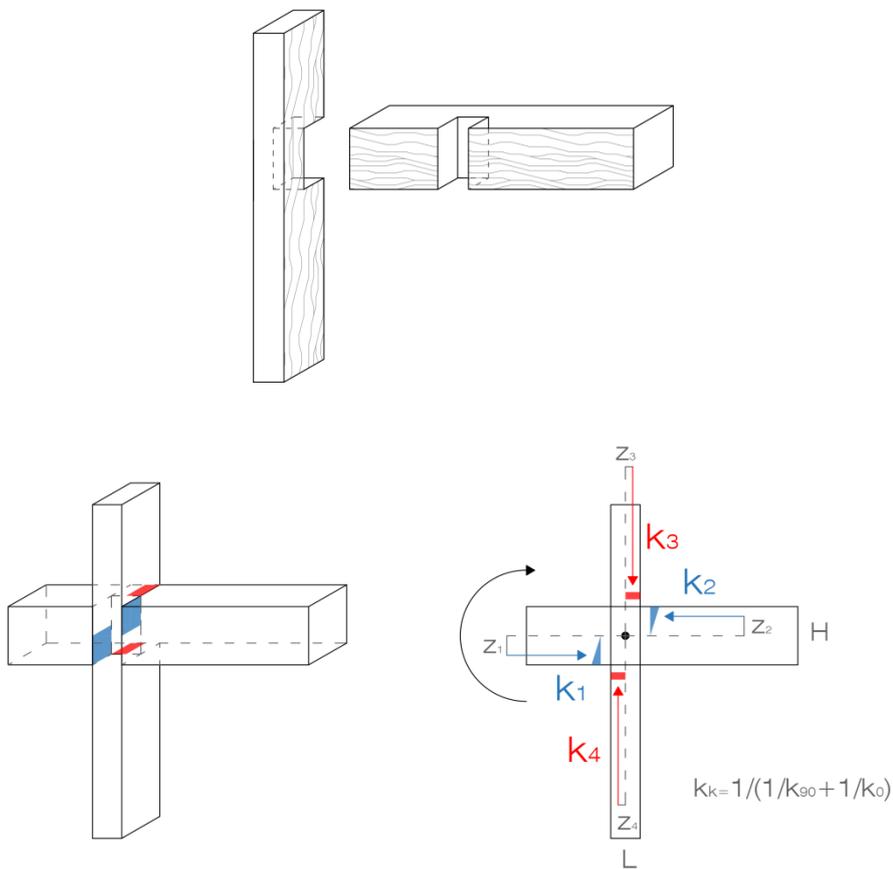
**Figure 6. Rotational stiffness for the half-lap connection.**

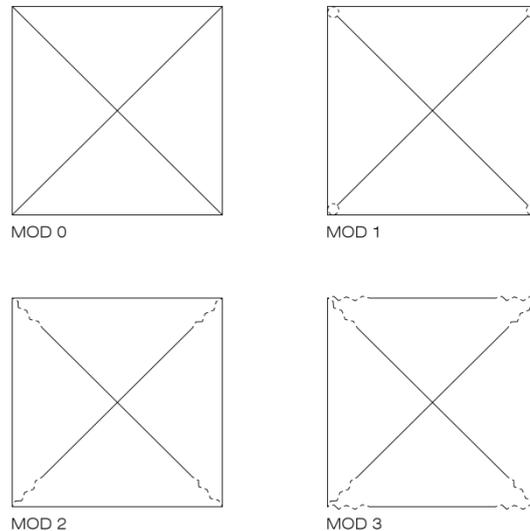
**Figure 8. Typical cell for each numerical model.**

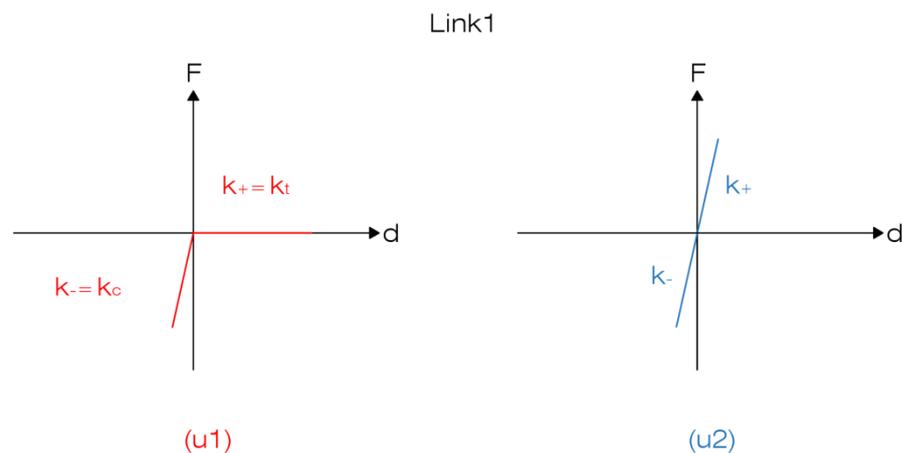
**Figure 9. Linear elastic force–deformation for *Link 1* in MOD 2.**

In this study, two link elements are considered: *Link 1* and *Link 2*. *Link 1* is located at each connection between the main frame and the diagonal elements in MOD 2 and MOD 3. In MOD 3, *Link 2* is located at each beam–post connection. Because of the planar nature of the problem, only the axial  $u_1$ , shear  $u_2$  and pure bending  $r_3$  stiffness are considered for the element deformational DOFs. While the axial and the shear stiffness are specified for *Link 1*, the rotational one is defined for *Link 2*. Linear elastic force–deformation relationships are used for *Link 1* in MOD 2 (**Figure 9**); linear and nonlinear elastic force–deformation ones are introduced for *Link 1* and *Link 2* in MOD 3 (**Figure 10**).

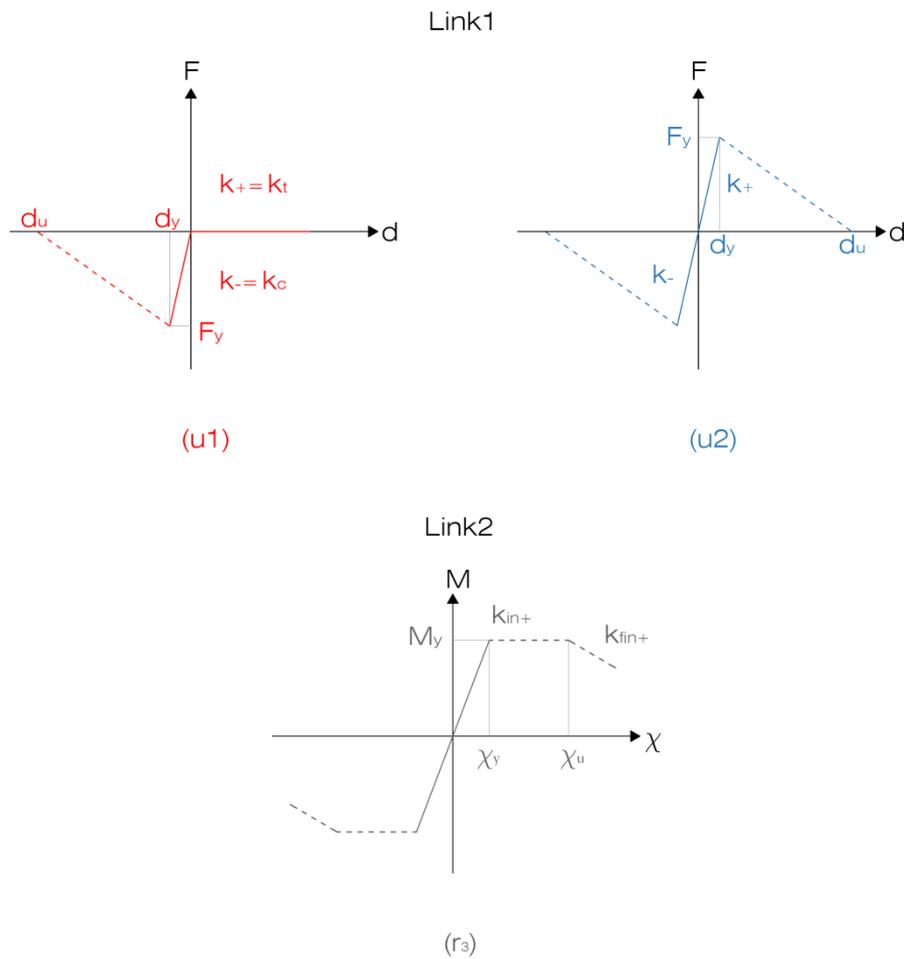
Figure 10. Linear and nonlinear elastic force–deformation for *Link 1* and *Link 2* in MOD 3.

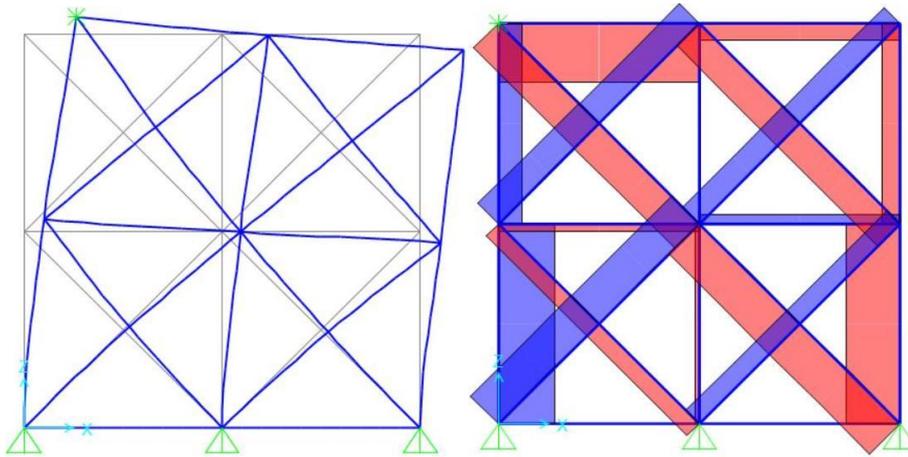
Firstly, MOD 0 is considered with rigid connections for all joints. By observing the deformed shape in **Figure 11**, it is noted that the deformation is mostly due to the application of the horizontal displacements. Moreover, all the nodes behave rigidly as expected. As observed in the axial forces diagram, the diagonal elements that are inclined along (against) the applied displacement are in tension (compression). The value of the stiffness of the timber frame wall is  $39.94 \cdot 10^3$  kN/m, which is much higher than the experimental value.

Figure 11. Deformed shape (left) and axial force diagram (right) of MOD 0.

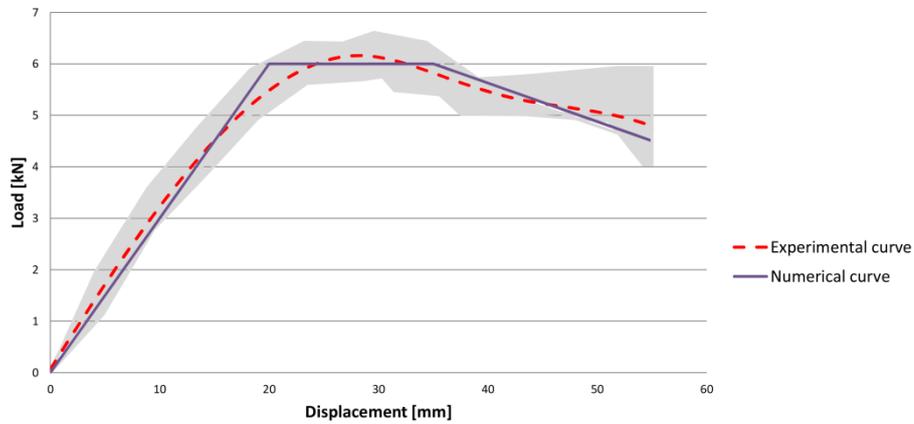
**Figure 12. Force–displacement for the half–lap connection.**

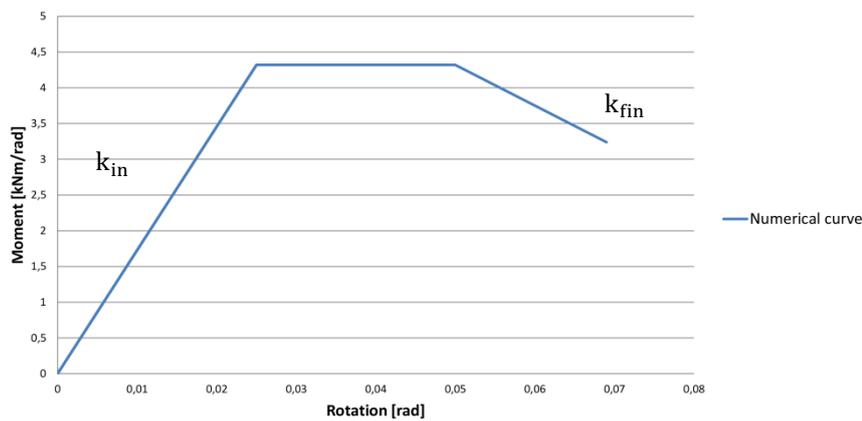
**Figure 13. Moment–rotation for the half–lap connection.**

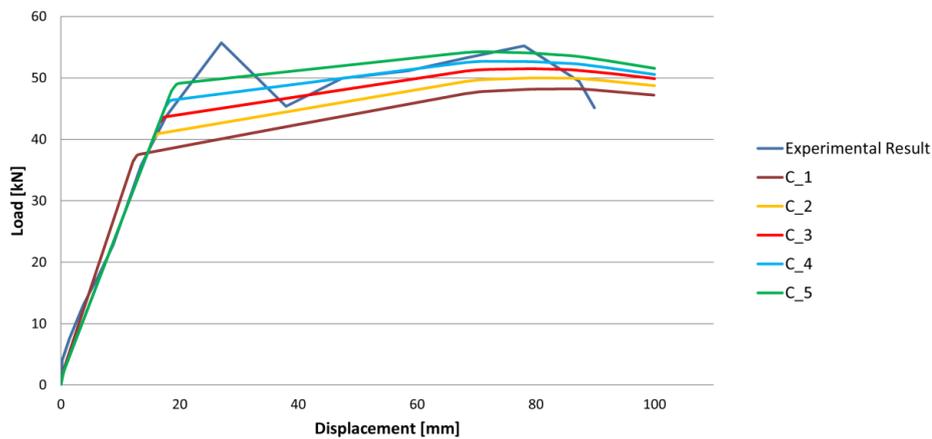
**Figure 14. Parametric analysis on the capacity of the connection between the diagonals and the main frame.**

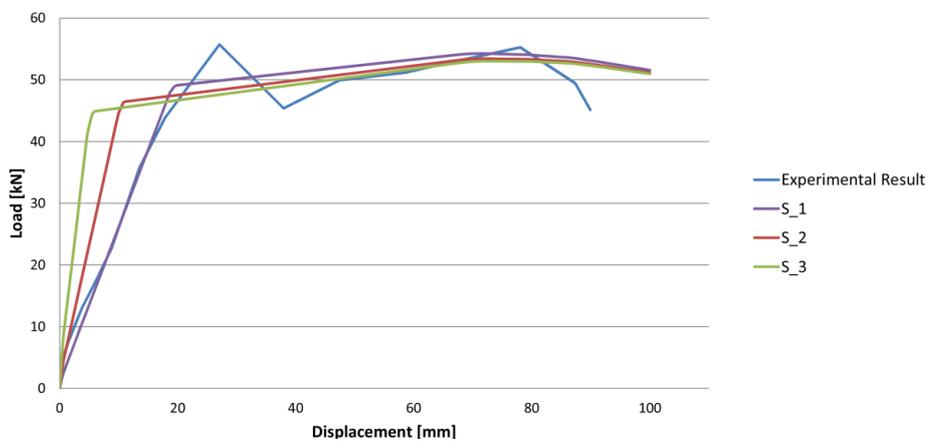
**Figure 15. Parametric analysis on the stiffness of the connection between the diagonals and the main frame.**

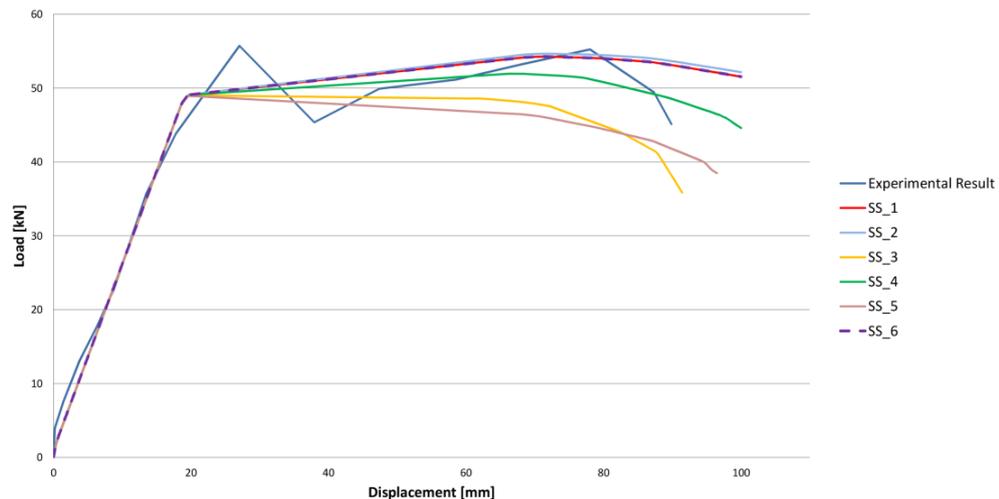
**Figure 16. Influence of shear stiffness in nonlinear analysis.**

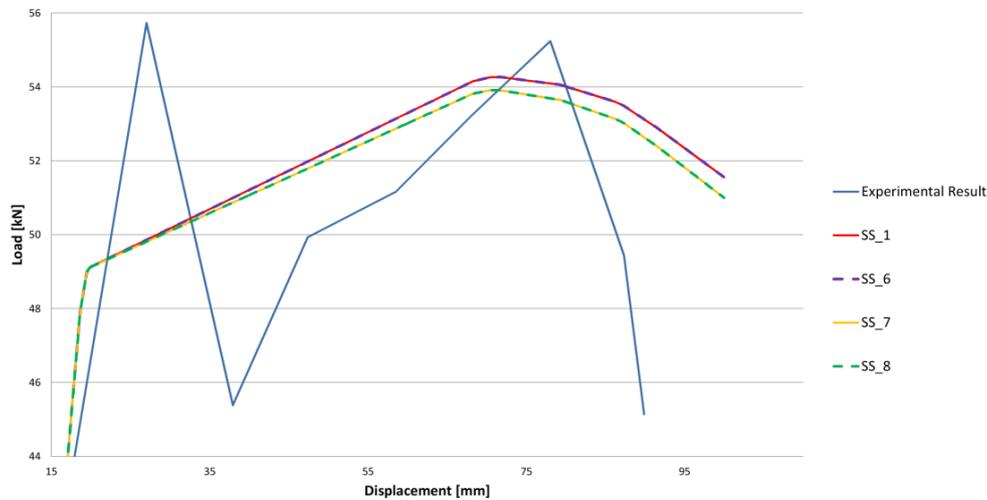
Figure 17. Influence of the shear stiffness.

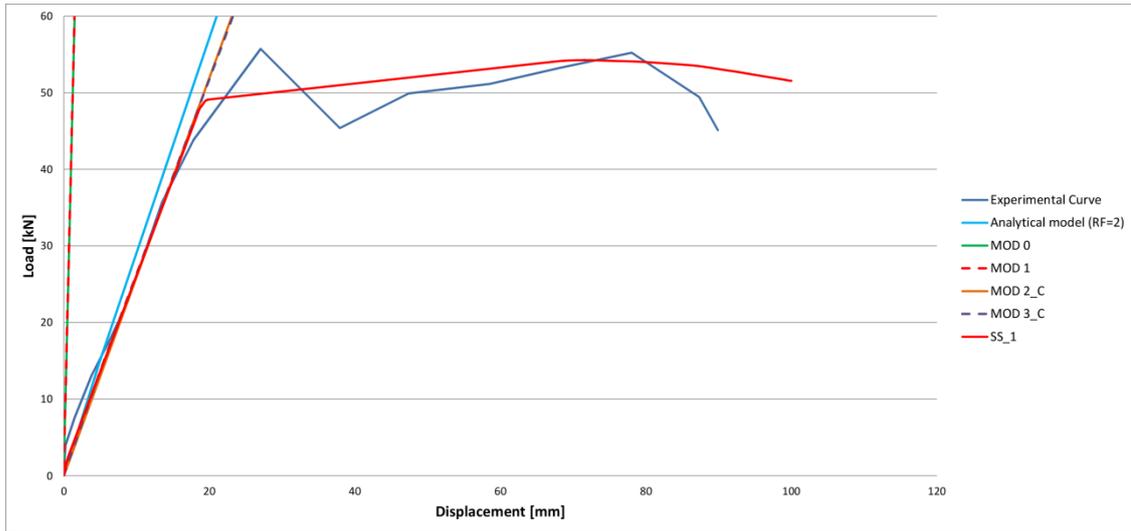
In conclusion, it should be underlined that these results were carried out considering a pre-compression load of 25 kN. When the pre-compression load is higher, the stiffness of the timber frame wall is higher as the gaps close and the contact increases. A summary of the capacity curves obtained for the timber frame wall is presented in **Figure 18**.

**Figure 18. Summary of the capacity curves obtained from the modelling of the timber frame wall.**

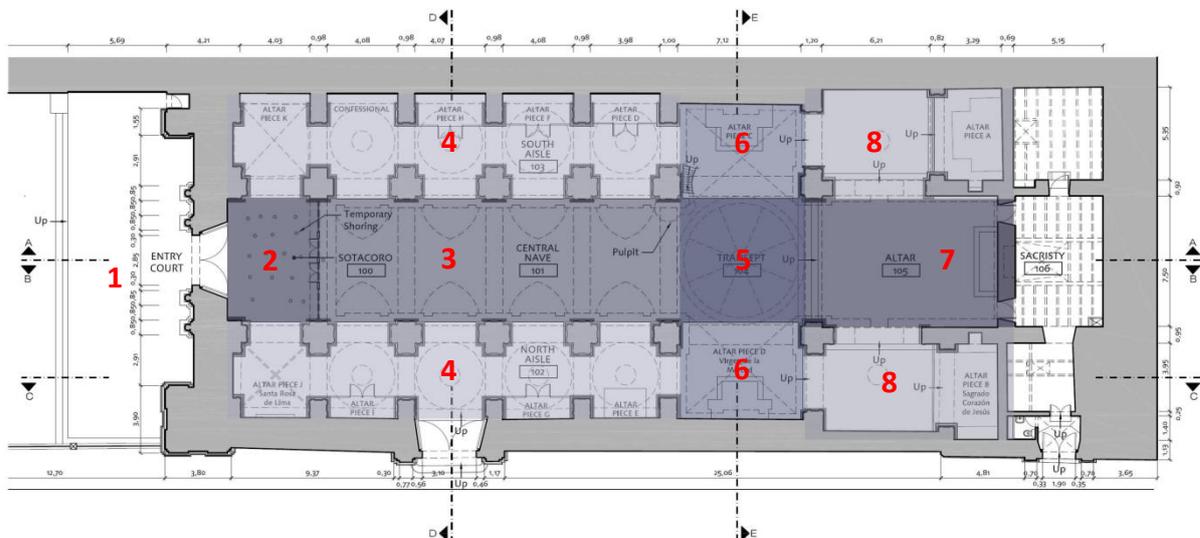
**Figure 22. Schematic of the plan of Ica Cathedral: atrium (1), main entrance (2), main nave (3), side aisles (4), crossing of the transept (5), arms of the transept altar (6), altar (7) and chapels (8).**

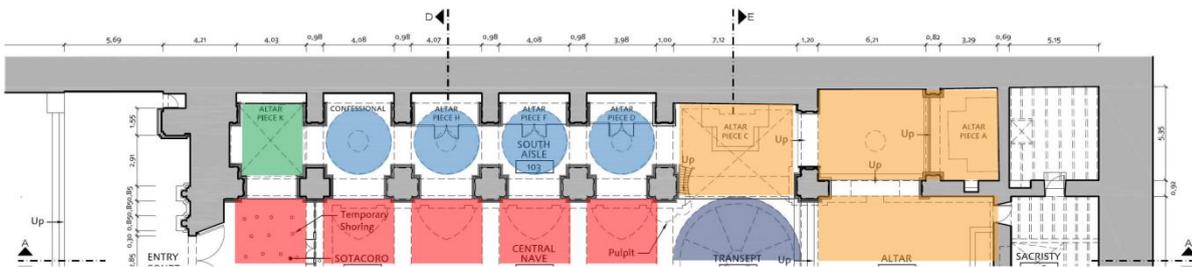
**Figure 23. Vaulted roof framing system of the Ica Cathedral: barrel vaults with lunettes (red), barrel vault (orange), main dome (dark blue), aisles' domes (light blue), cross ribs vaults (green) and flat ceiling (white).**

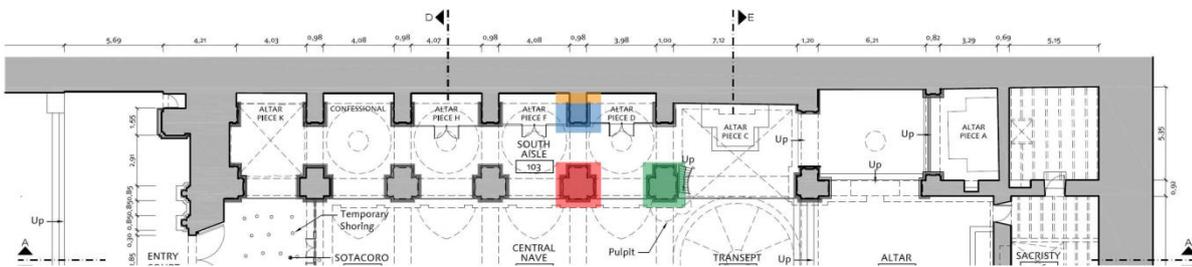
The pillars have a fired brick foundation that extends from 0.50 m below the floor level to 0.80 m above creating a pillar base (Garcia Bryce & Soto Medina, 2014). The foundation of the pilasters is similar to those at the lateral masonry walls. However, it is important to notice that the bricks at the pilasters' base do not interlock with the brick course along the lateral walls (Cancino, et al., 2012).

Figure 24. Pillars of Ica Cathedral: pillar of the crossing (green), nave pillar (red), pilaster (blue) and pier (orange) (Cancino, et al., 2012).

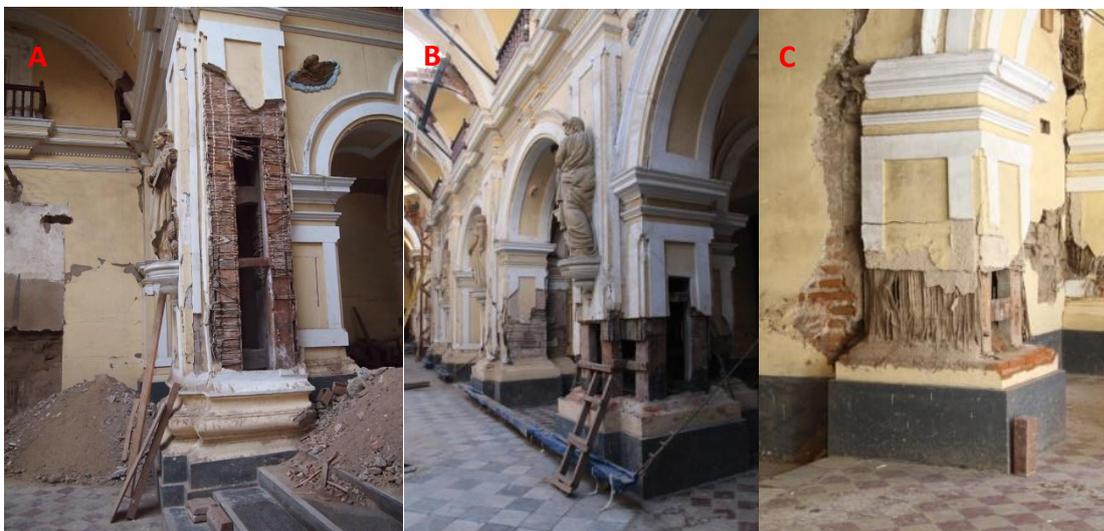
Figure 25. (A) Pillar of the crossing (Image: Emilio Roldán Zamarrón for GCI), (B) Nave pillar, (C) Pilaster with the pier behind.

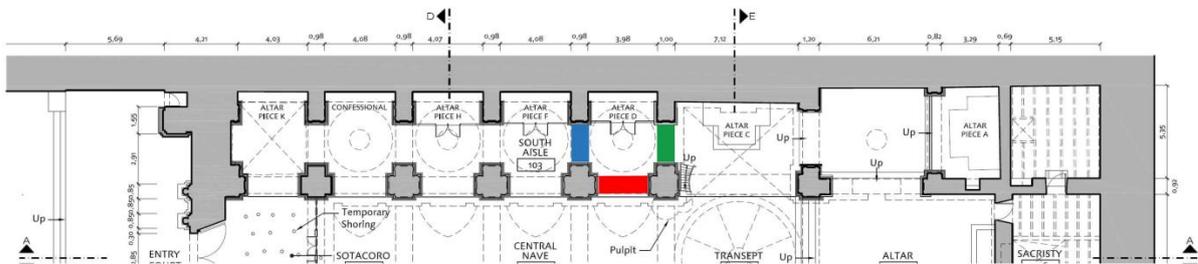
**Figure 26. Couples of wooden frameworks between nave pillars (red), nave pillar and pilaster (blue) and pillar of the transept and pilaster (green).**

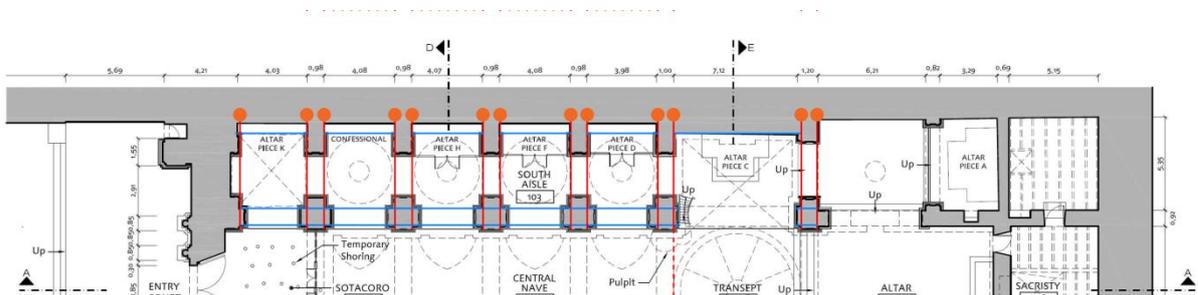
**Figure 27. Schematic of the horizontal elements of Ica Cathedral: longitudinal beam (blue), transversal beam (red) and connection between timber and masonry structures (orange).**

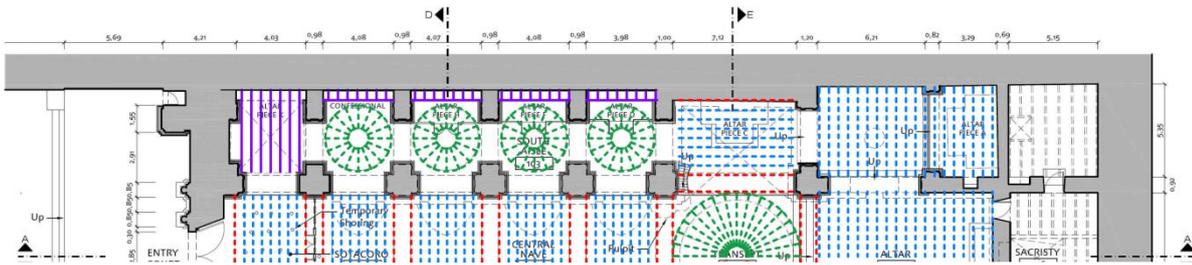
**Figure 28. Schematic of the vaulted roof framing system of Ica Cathedral: principal arch (red), secondary arch (blue), vertical and horizontal ribs of the main dome and ribs of the aisle's dome (green) and flat ceiling (purple).**

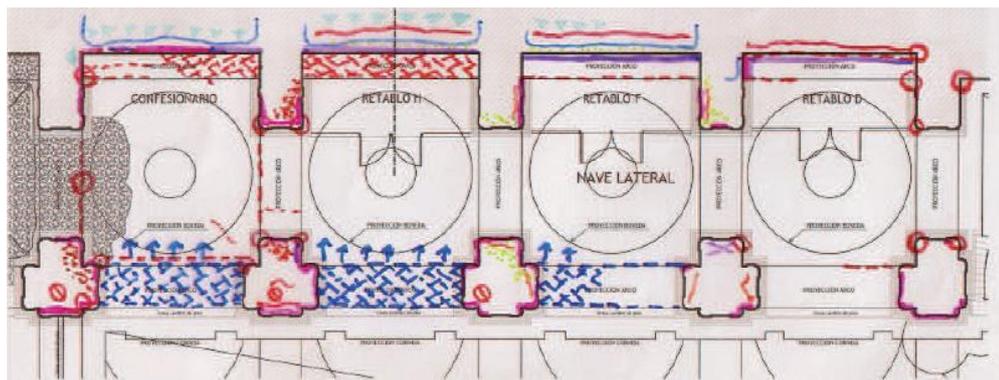
**Figure 29. Graphic condition survey of the south side aisle: humidity (light blue arrows), vertical cracks (red circles), horizontal crack (red line), partial collapse (red hatch pattern), out-of plane displacement (dark blue hatch pattern and dark blue arrows) (Cancino, et al., 2012).**

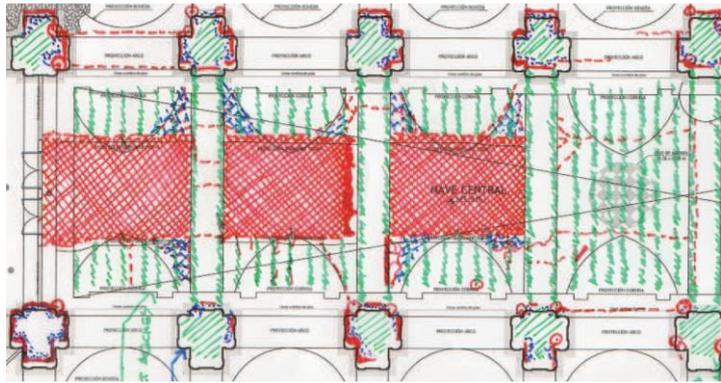
**Figure 30. Graphic condition survey of the main nave: termite damage (green line), partial collapse (red hatch pattern), cracking (red line) (Cancino, et al., 2012).**

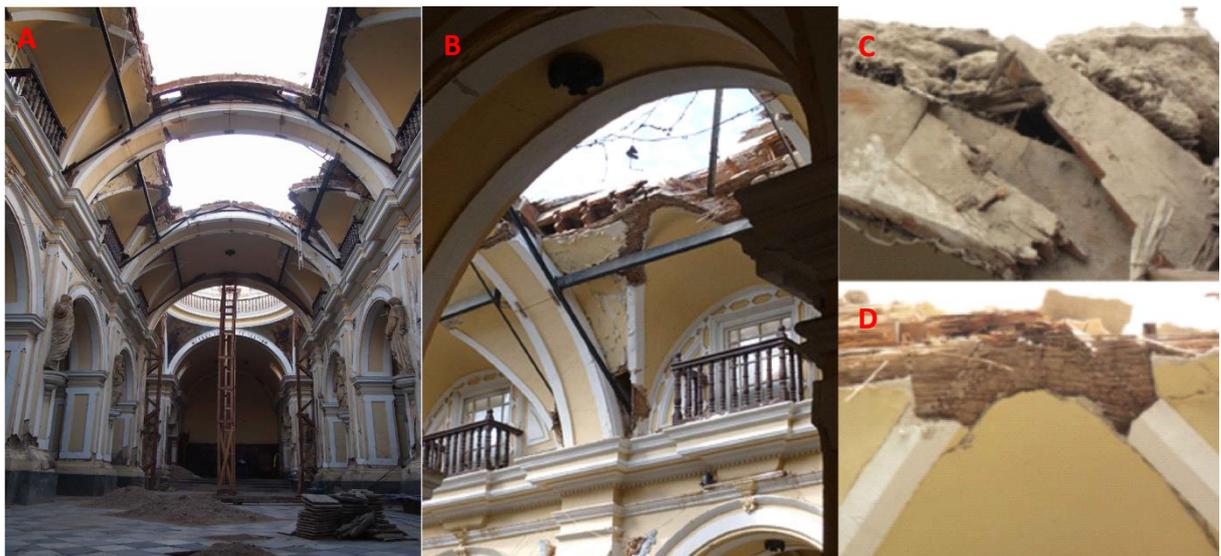
Figure 31. (A) Partial collapse of the barrel vaults (Image: Emilio Roldán Zamarrón for GCI), (B) Mortise and tenon connections at the top of the lunette (Image: Emilio Roldán Zamarrón for GCI) (C) Corrosion of the nailed connection of the arches of the barrel vaults (Cancino, et al., 2012) (D) Detail of the lunette's beam (Cancino, et al., 2012).

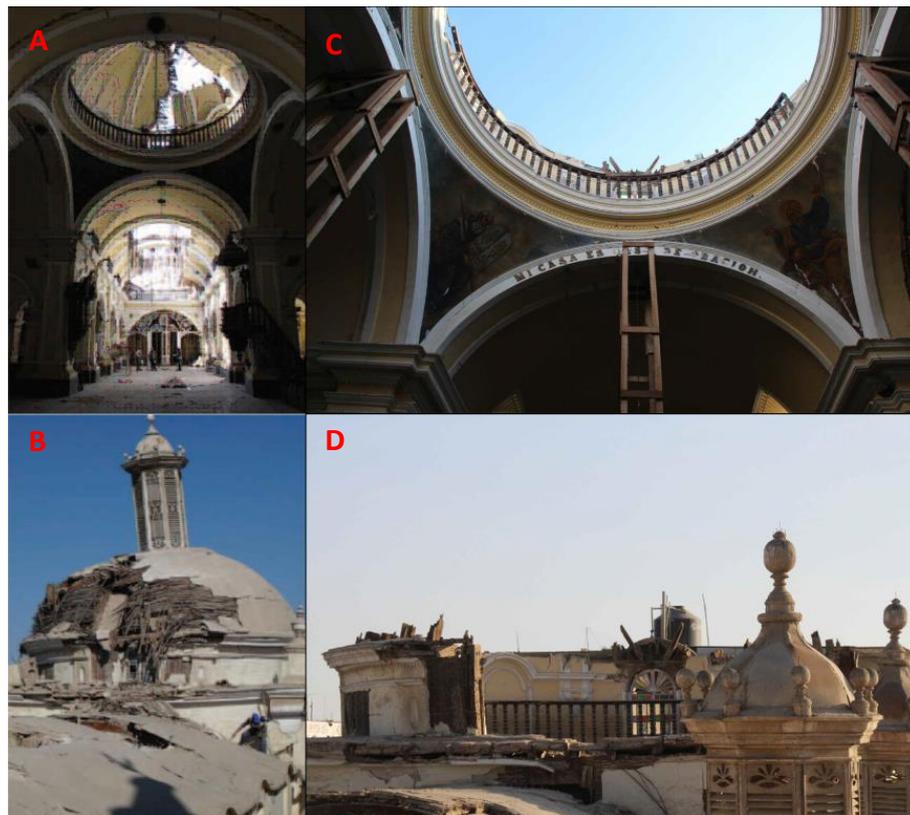
Figure 32. (A) and (B) Partial collapse of the main dome after the 2007 Pisco earthquake (Cancino, et al., 2012), (C) and (D) Total collapse of the main dome actually.

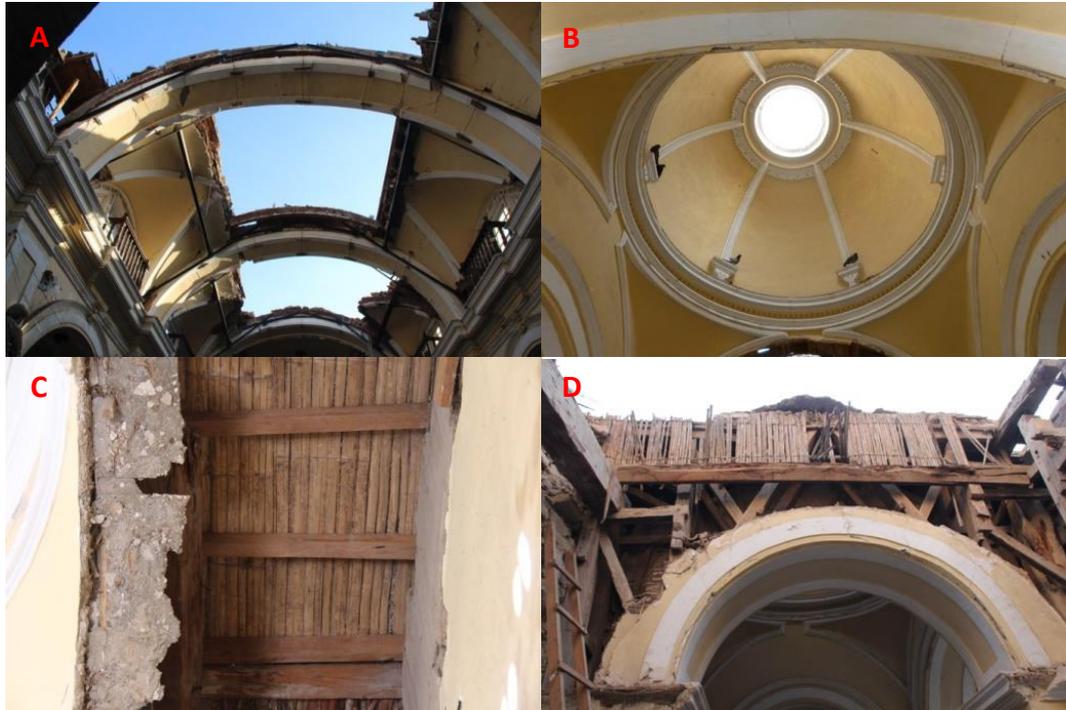
**Figure 33. The main parts of the representative bay: (A) Barrel vault with lunettes, (B) Aisles' domes, (C) Aisles' joists and (D) Timber framework.**

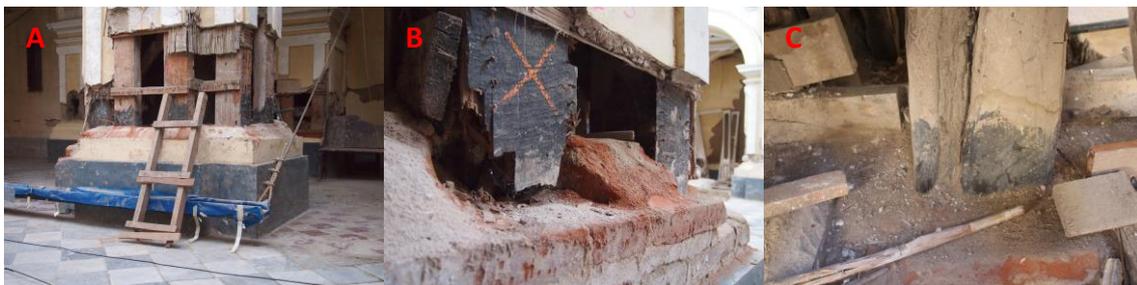
**Figure 34. Survey of the nave pillar: (A) View of the nave pillar, (B) Connection between the posts and the fire brick base and (C) Detail of the huarango trunk tree.**

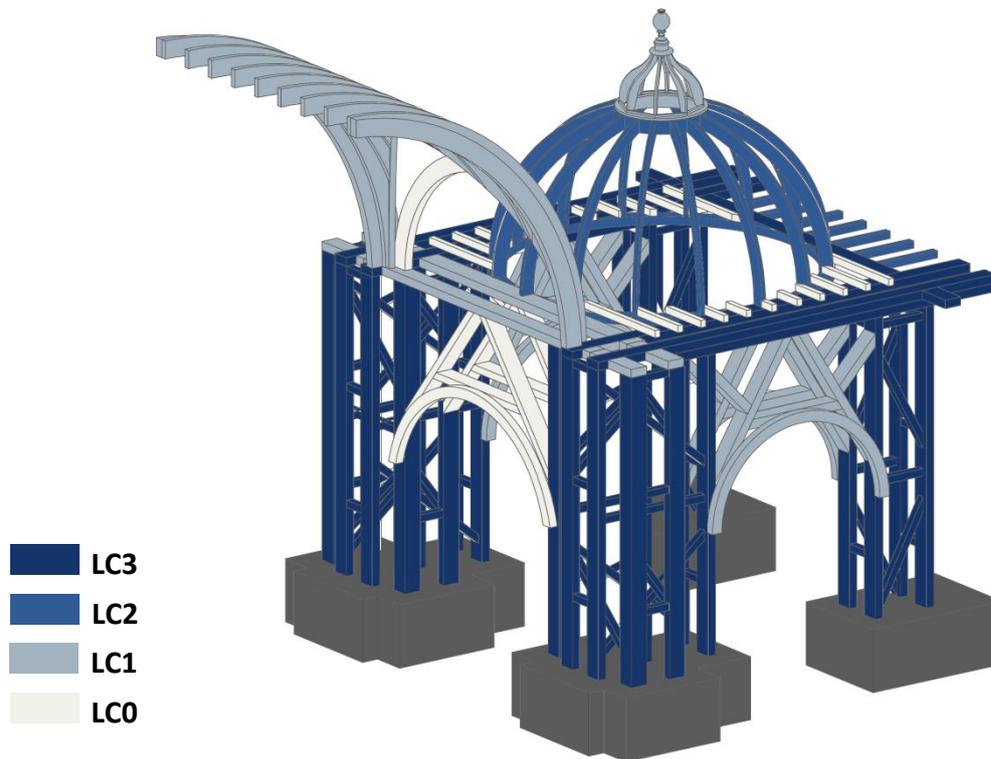
**Figure 35. Mapping of the levels of confidence for the representative bay.**

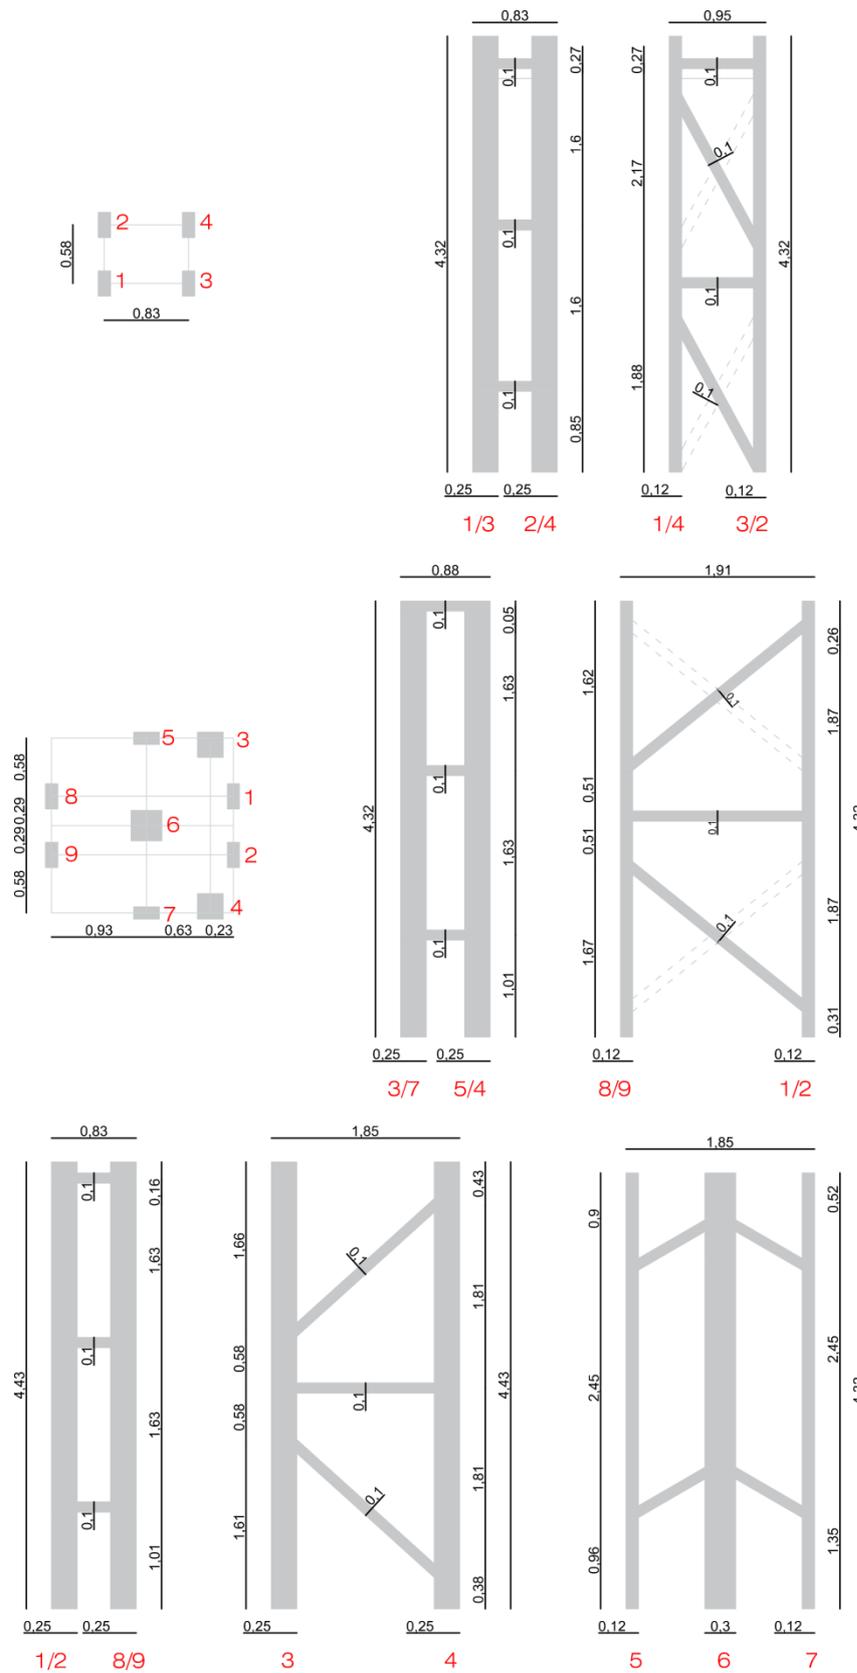
Figure 36. Characterization of the pilaster (top) and the nave pillar (bottom).

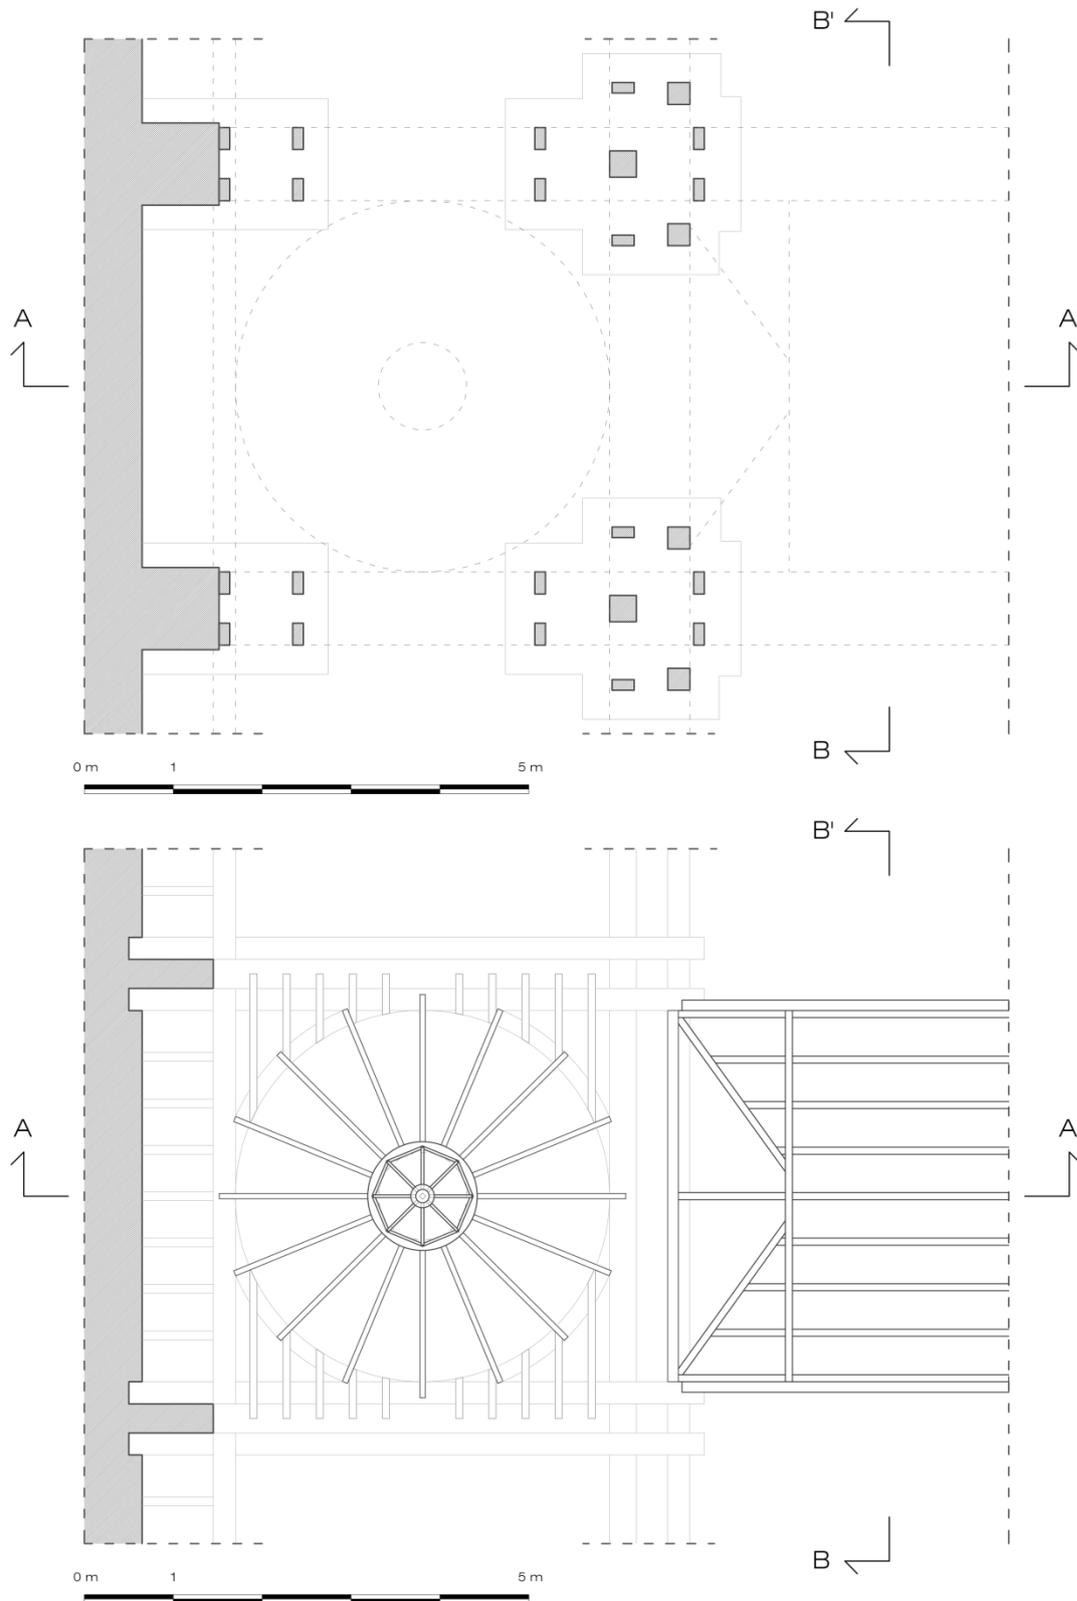
Figure 37. Ground plan (top) and roof plan (bottom) of the representative bay of the Ica Cathedral.

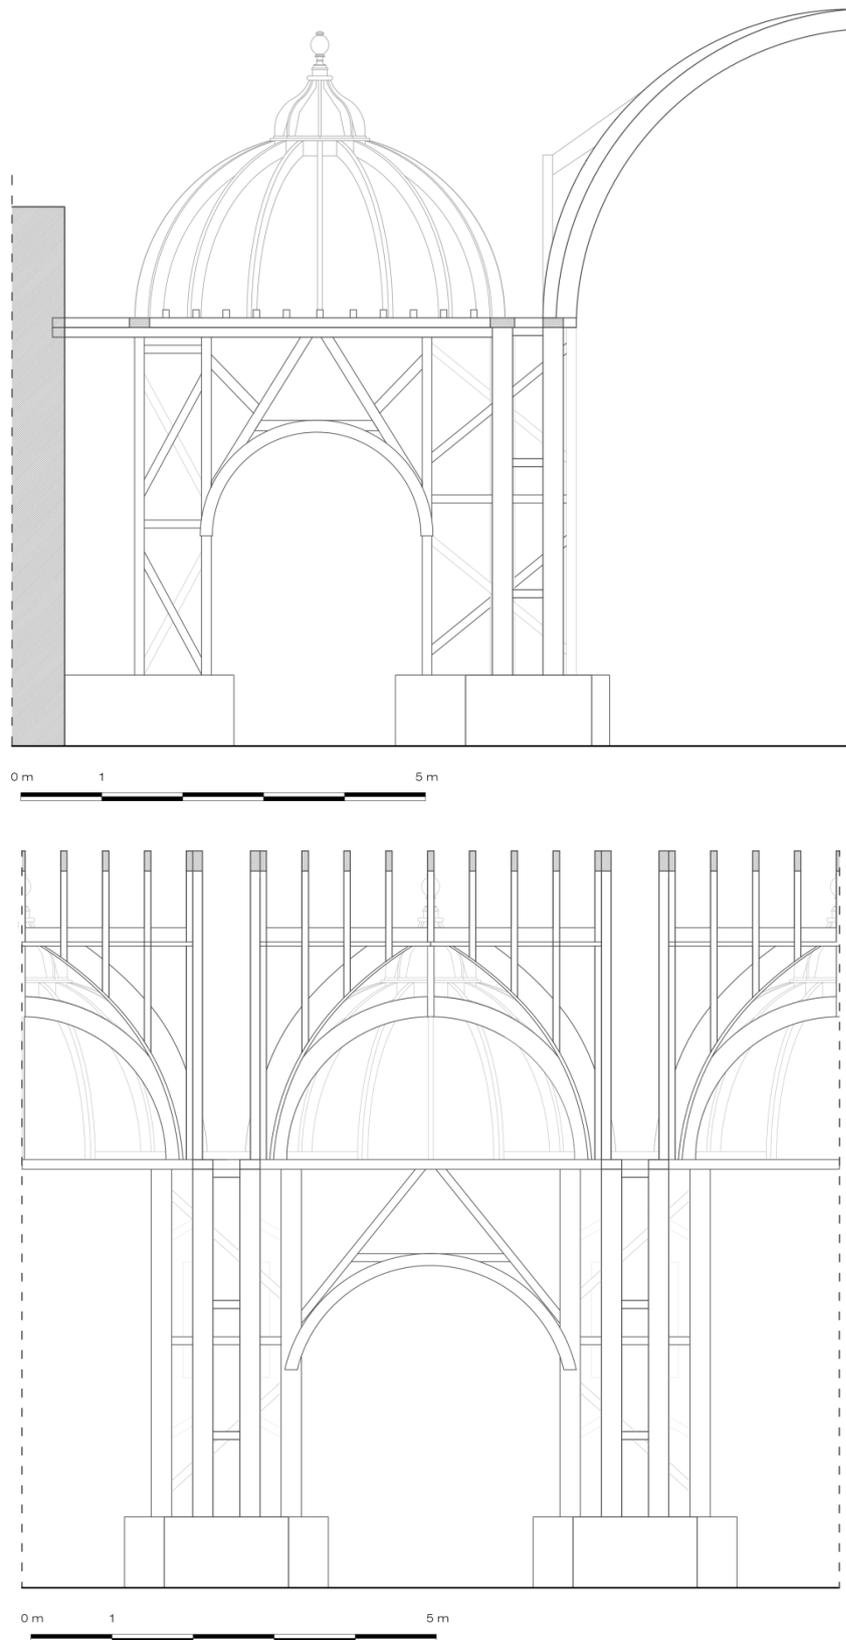
**Figure 38. Section A–A' (top) and section B–B' (bottom) of the representative bay of the Ica Cathedral.**

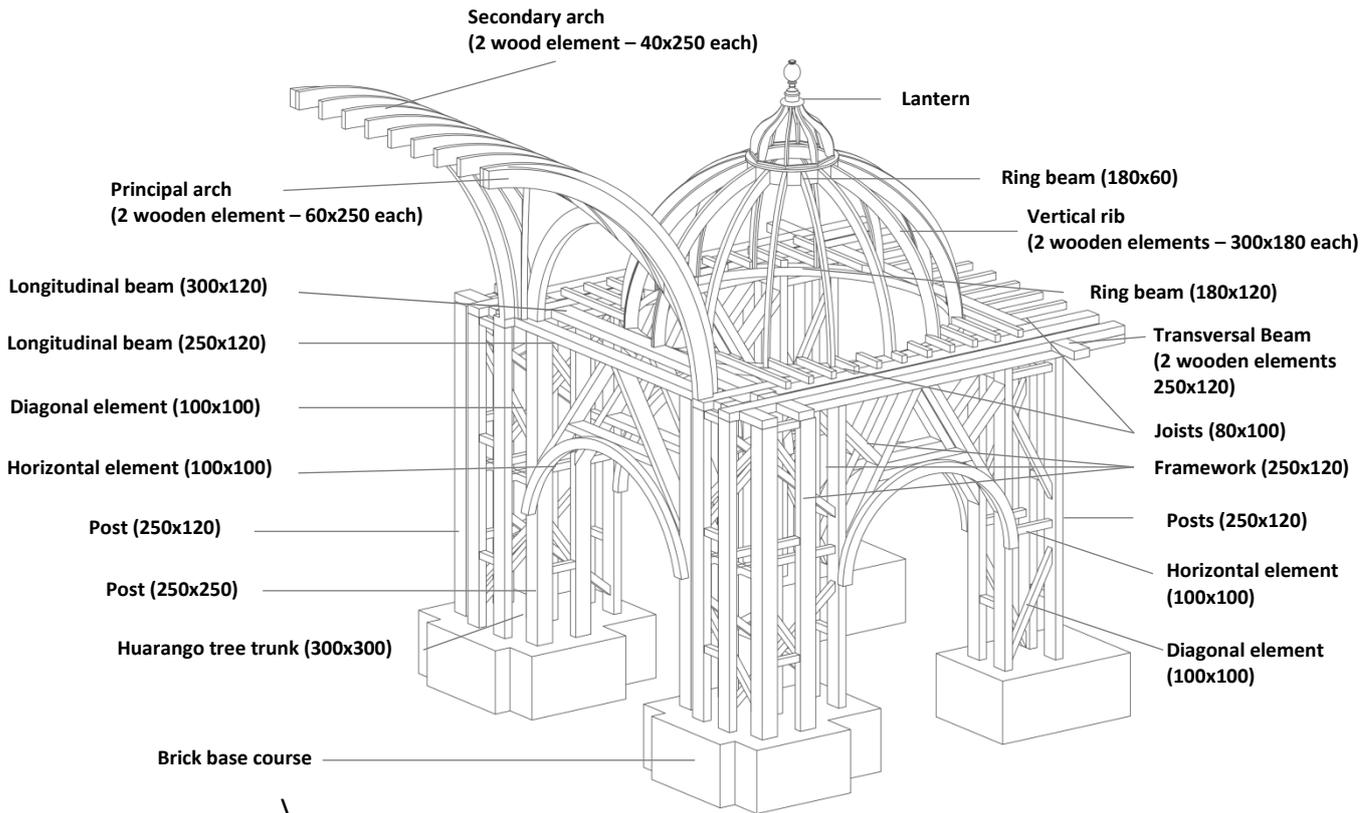
Figure 39. Main elements of the representative bay of the Ica Cathedral.  
Note that the dimensions are in mm.
