Maria Pia Ciocci - Structural Analysis of the Timber Structure of Ica Cathedral, Peru

# Master's Thesis

Structural Analysis of the Timber Structure of Ica Cathedral, Peru

Portugal | 2015

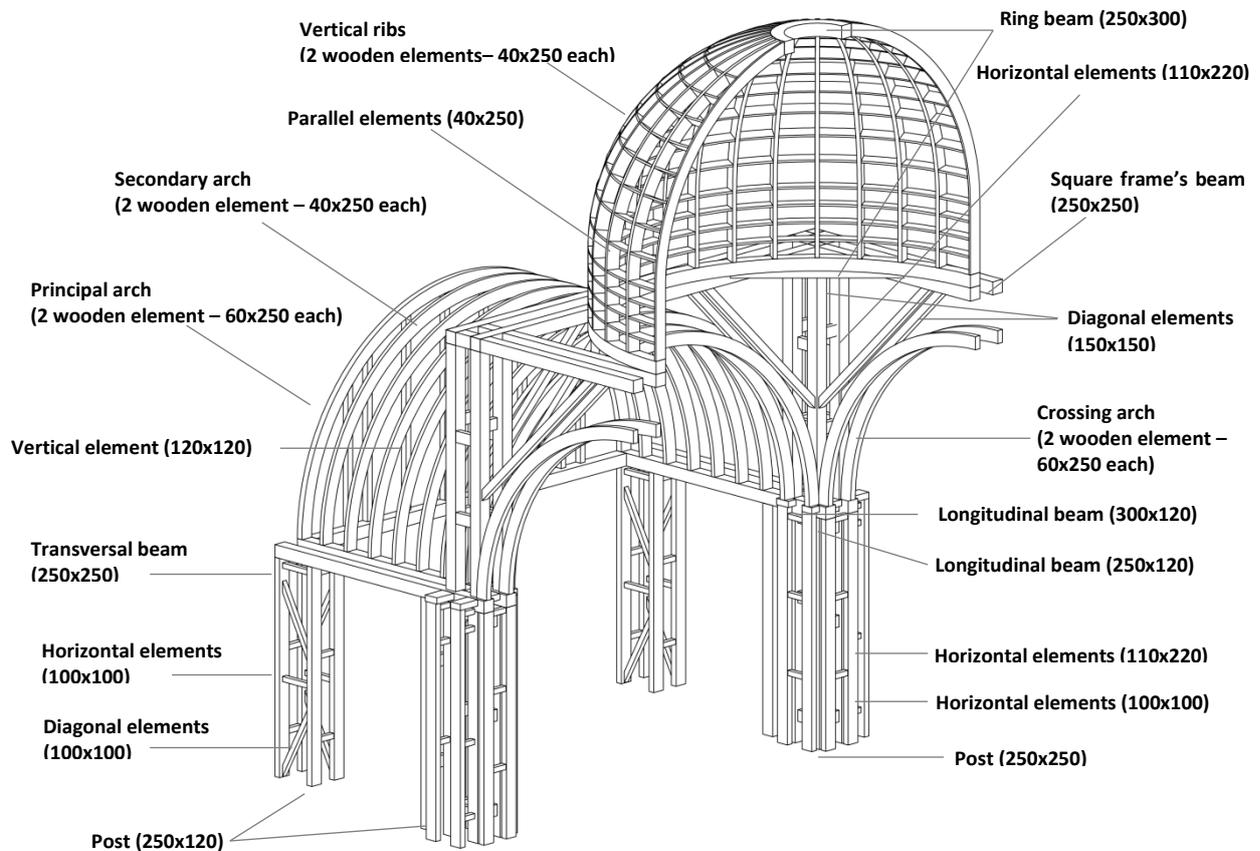
**Figure 41. Main elements of the representative bay of the Ica Cathedral.**

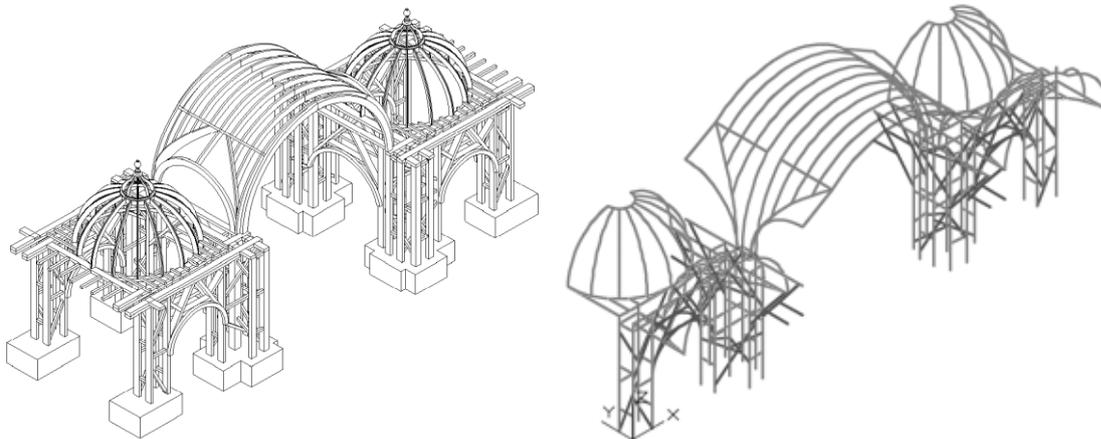
**Figure 42.** 3D architectural AutoCAD mode (left) and the discretized model in AutoCAD (right).

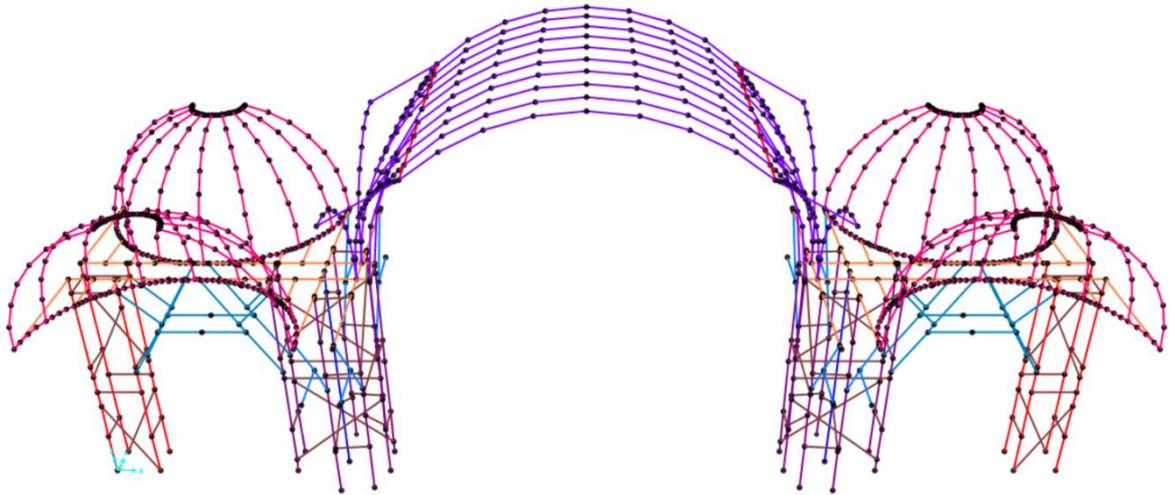
Figure 43. FE mesh in SAP 2000.

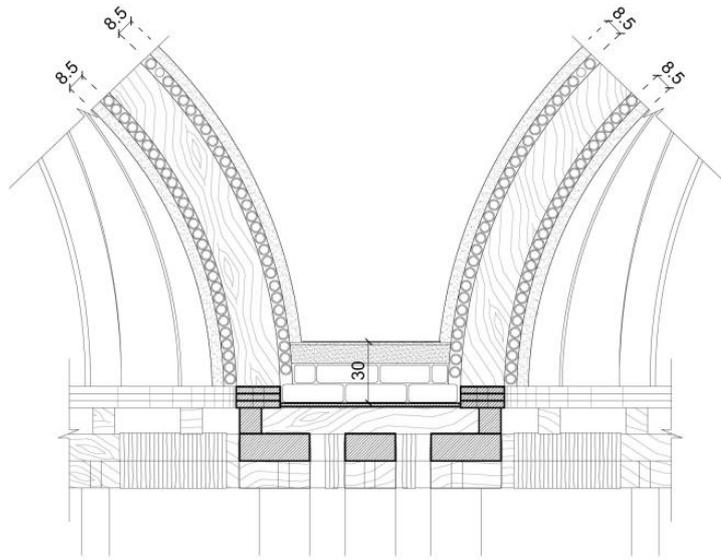
Figure 44. Assumptions on the covering layers on the timber structure (Garcia Bryce &amp; Soto Medina, 2014).

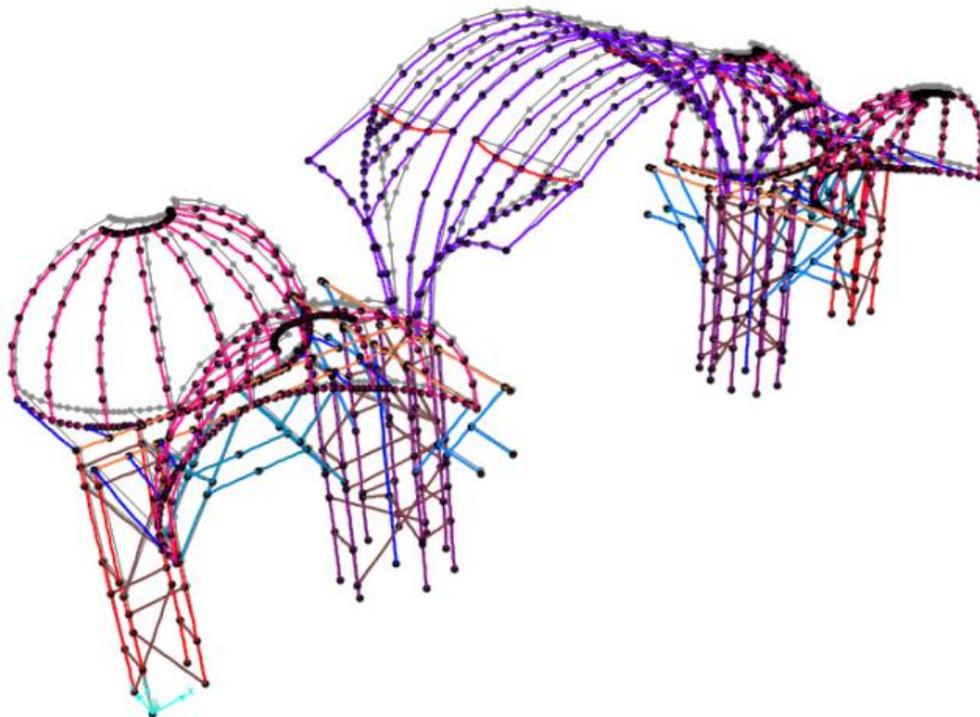
**Figure 45. Deformed shape of the structure under the load combination for ULS.**

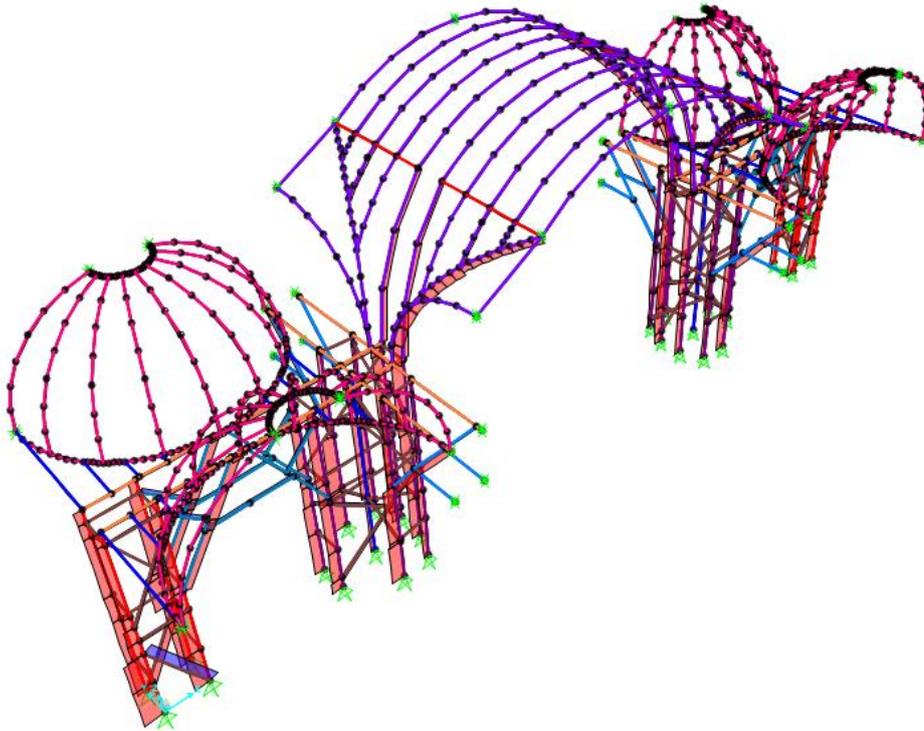
**Figure 46. Distribution of axial forces in the structure under the load combination for ULS.**

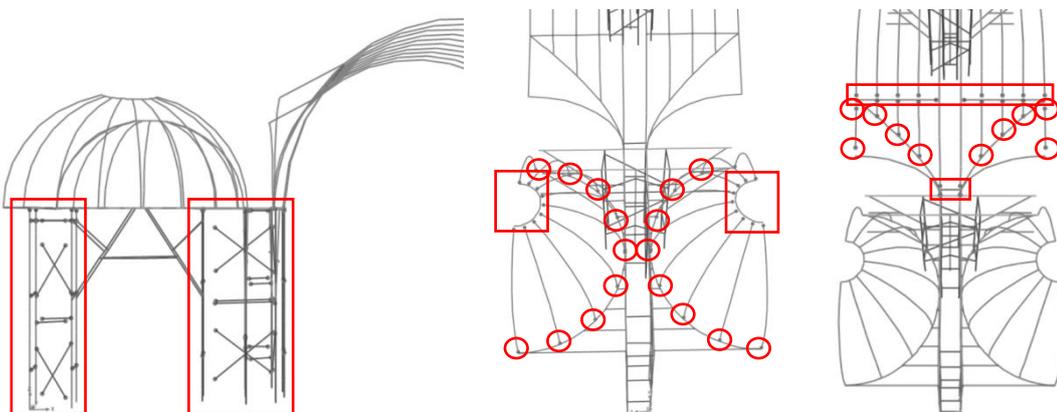
**Figure 47. Sets of timber connections for parametric analyses performed on SB 1, SB 2 and SB 3.**

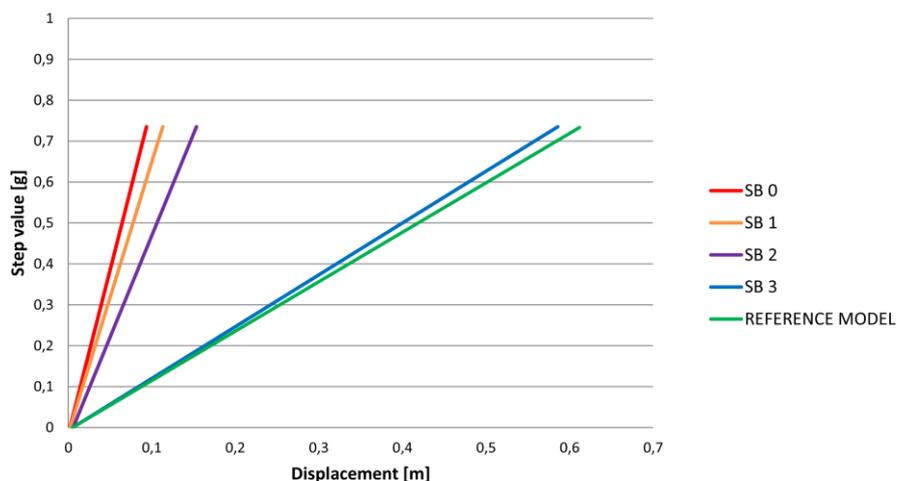
**Figure 48. Capacity curves obtained from parametric analysis on the connections of the representative bay.**

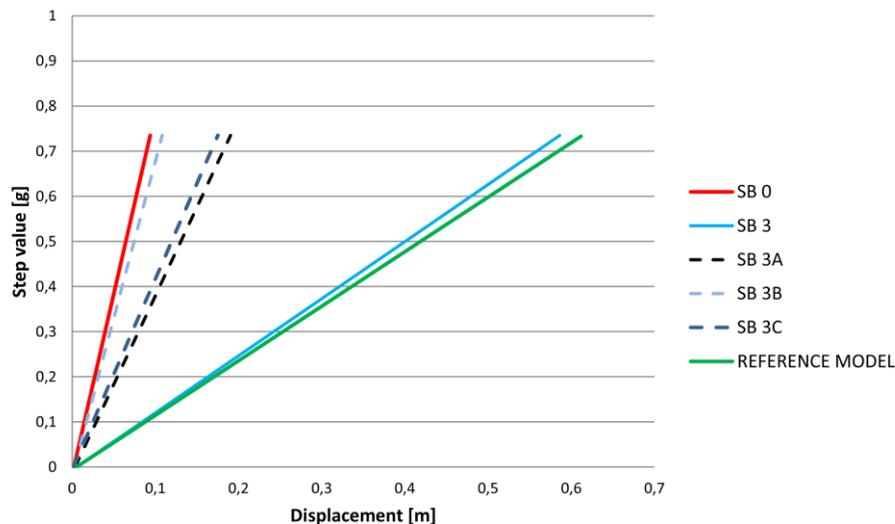
**Figure 49.** Capacity curves obtained from parametric analysis on the connections of the barrel vault.

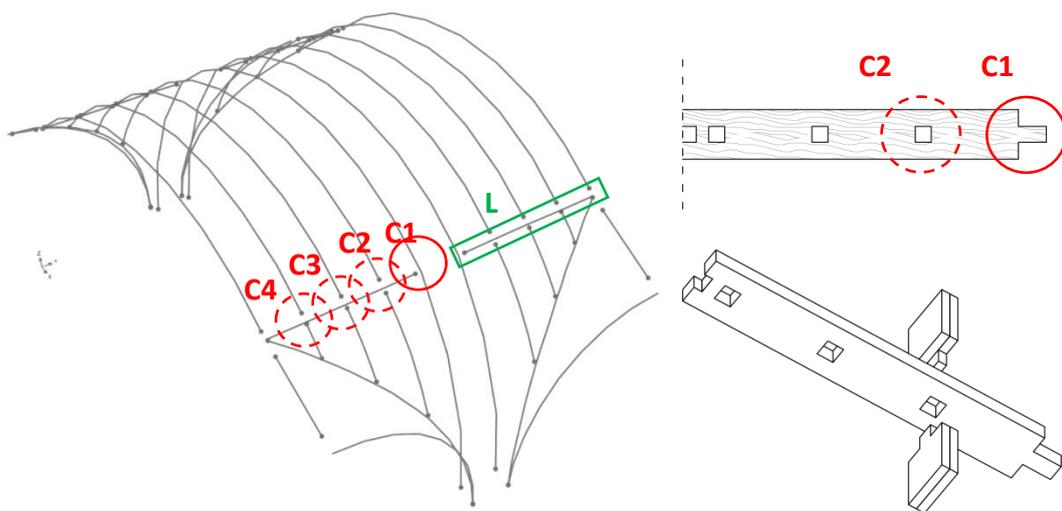
**Figure 51. Beam at the top of the lunettes and its mortise and tenon connections.**

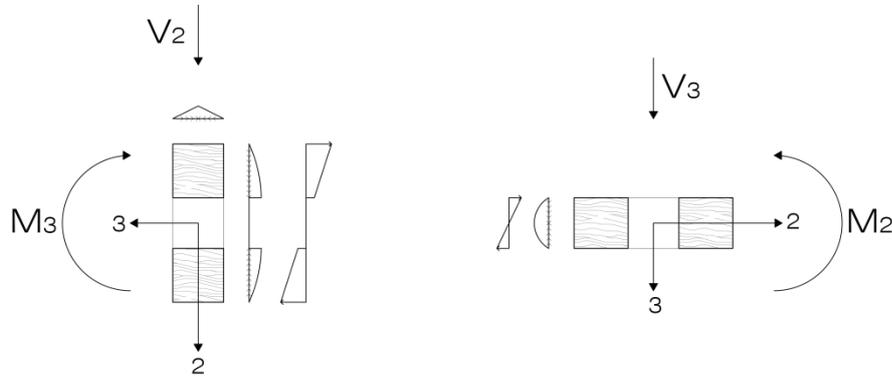
**Figure 52. Distribution of the stresses in the beam at the top of the lunettes.**

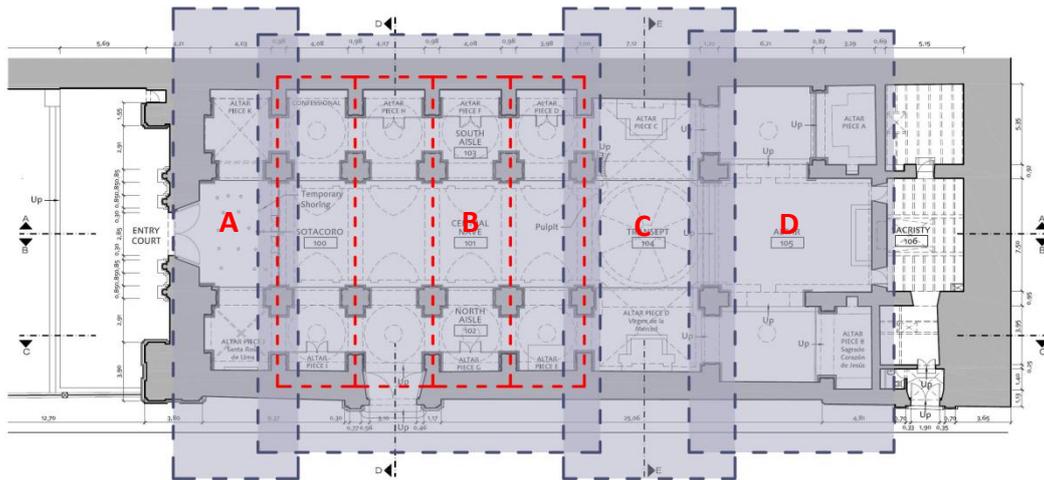
Figure 53. Configuration of sectors used of the numerical model.

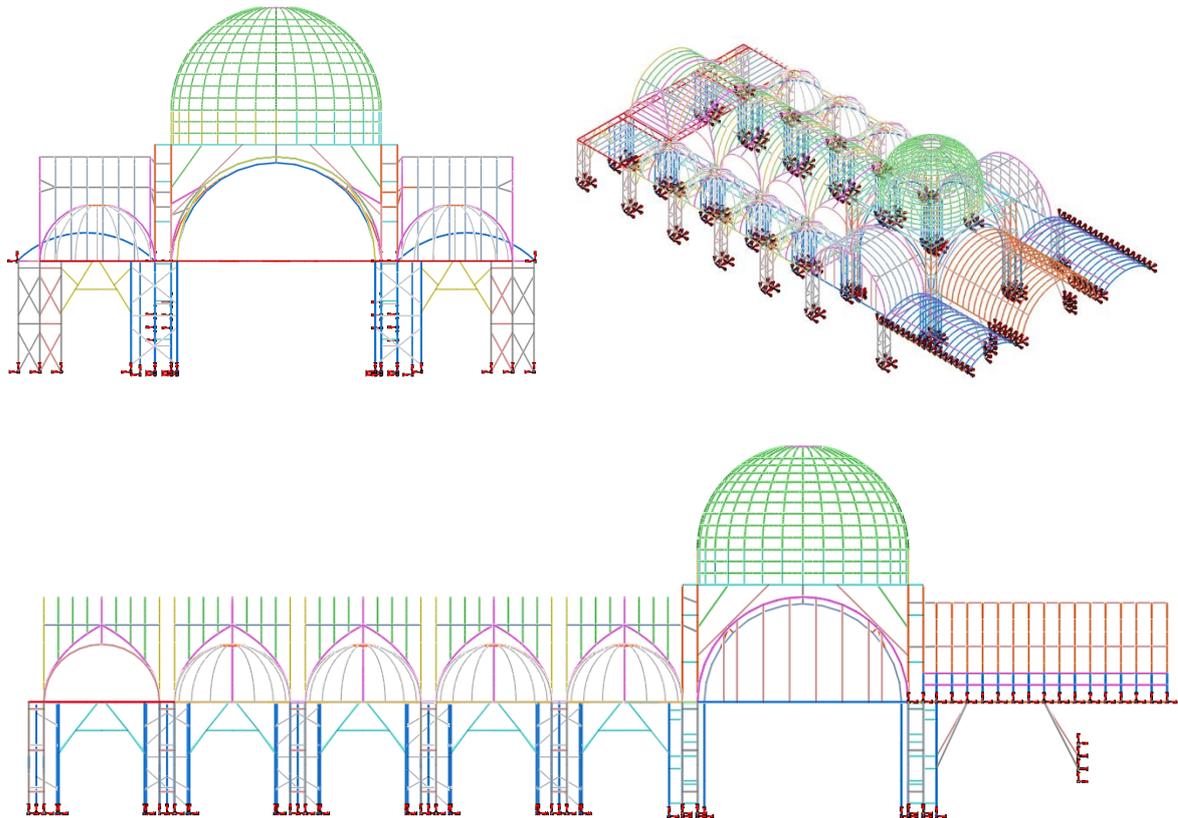
Figure 54. Numerical model of the complete timber structure of Ica Cathedral.

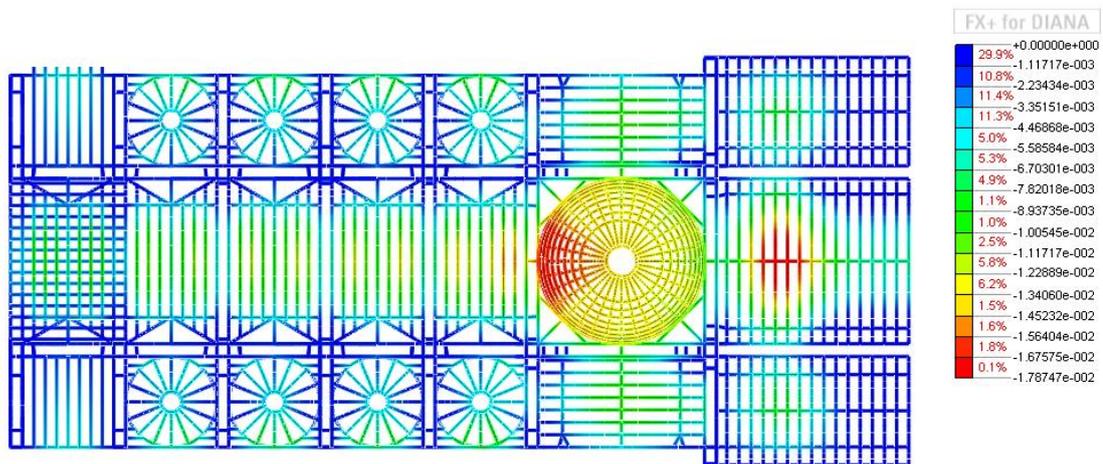
**Figure 55. Vertical displacements of the timber structure of Ica Cathedral under self-weight.**

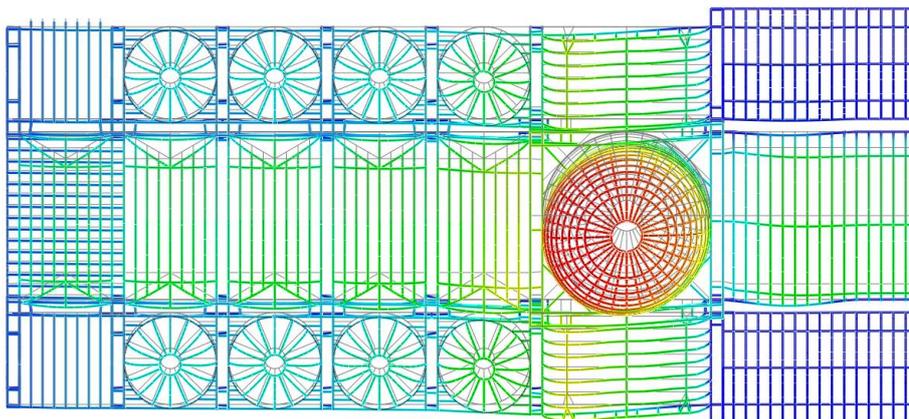
**Figure 58. Deformation under lateral loading  $\pm YY$  direction**

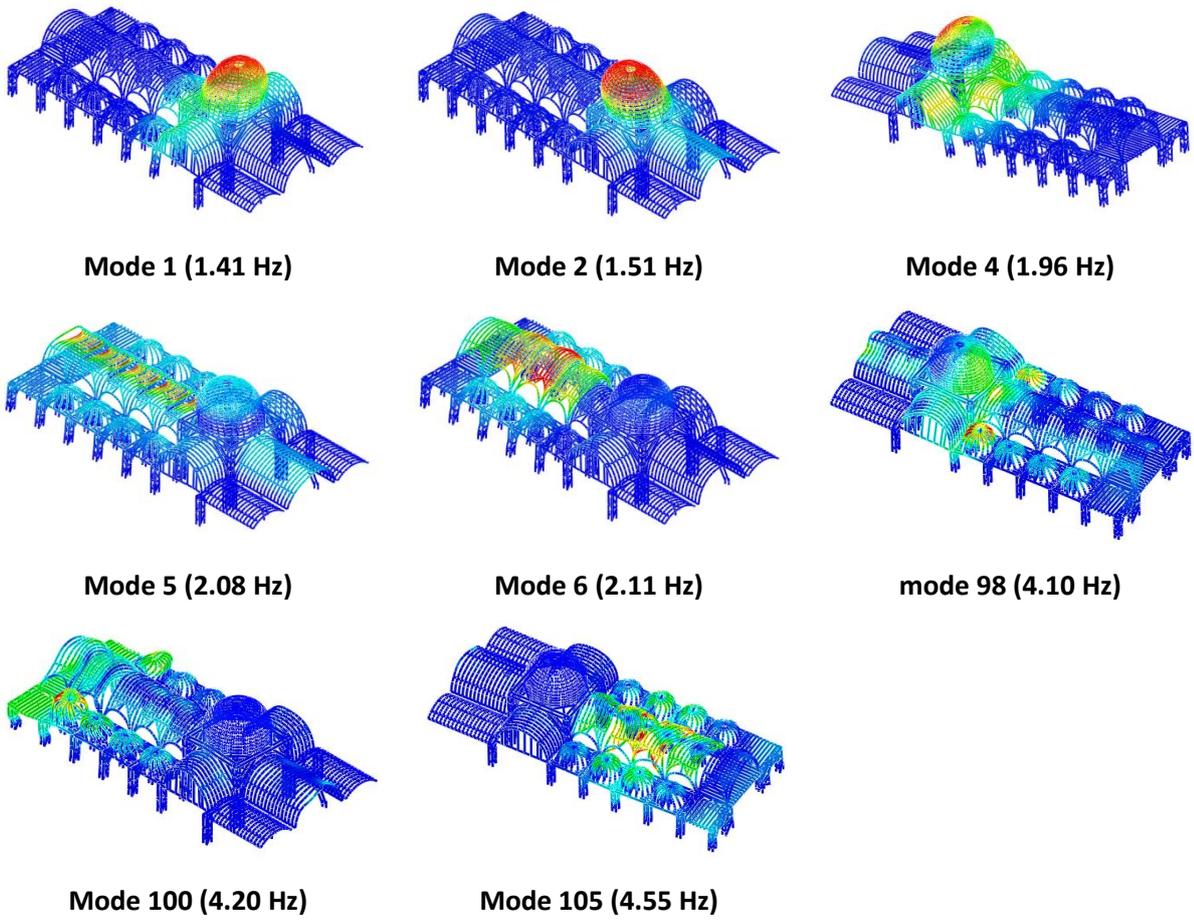
Figure 59. Selected mode shapes of the timber structure of Ica Cathedral.

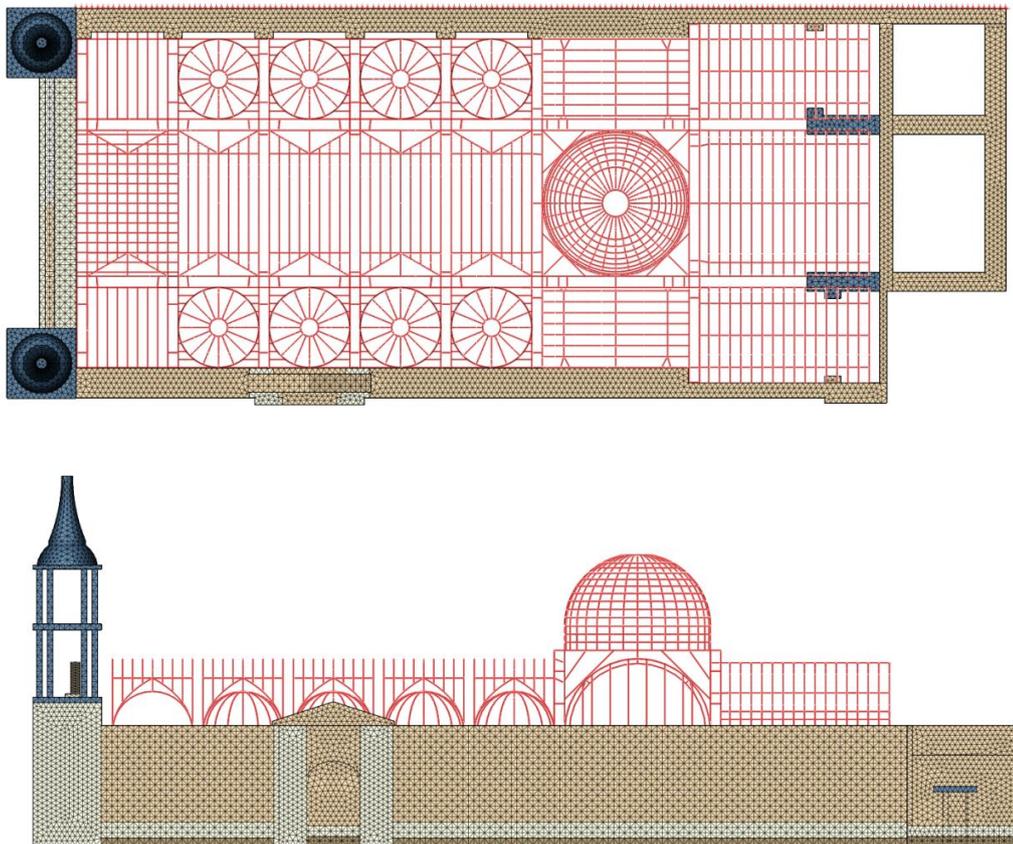
**Figure 1. Numerical model of the combined model with both timber and masonry structures.**

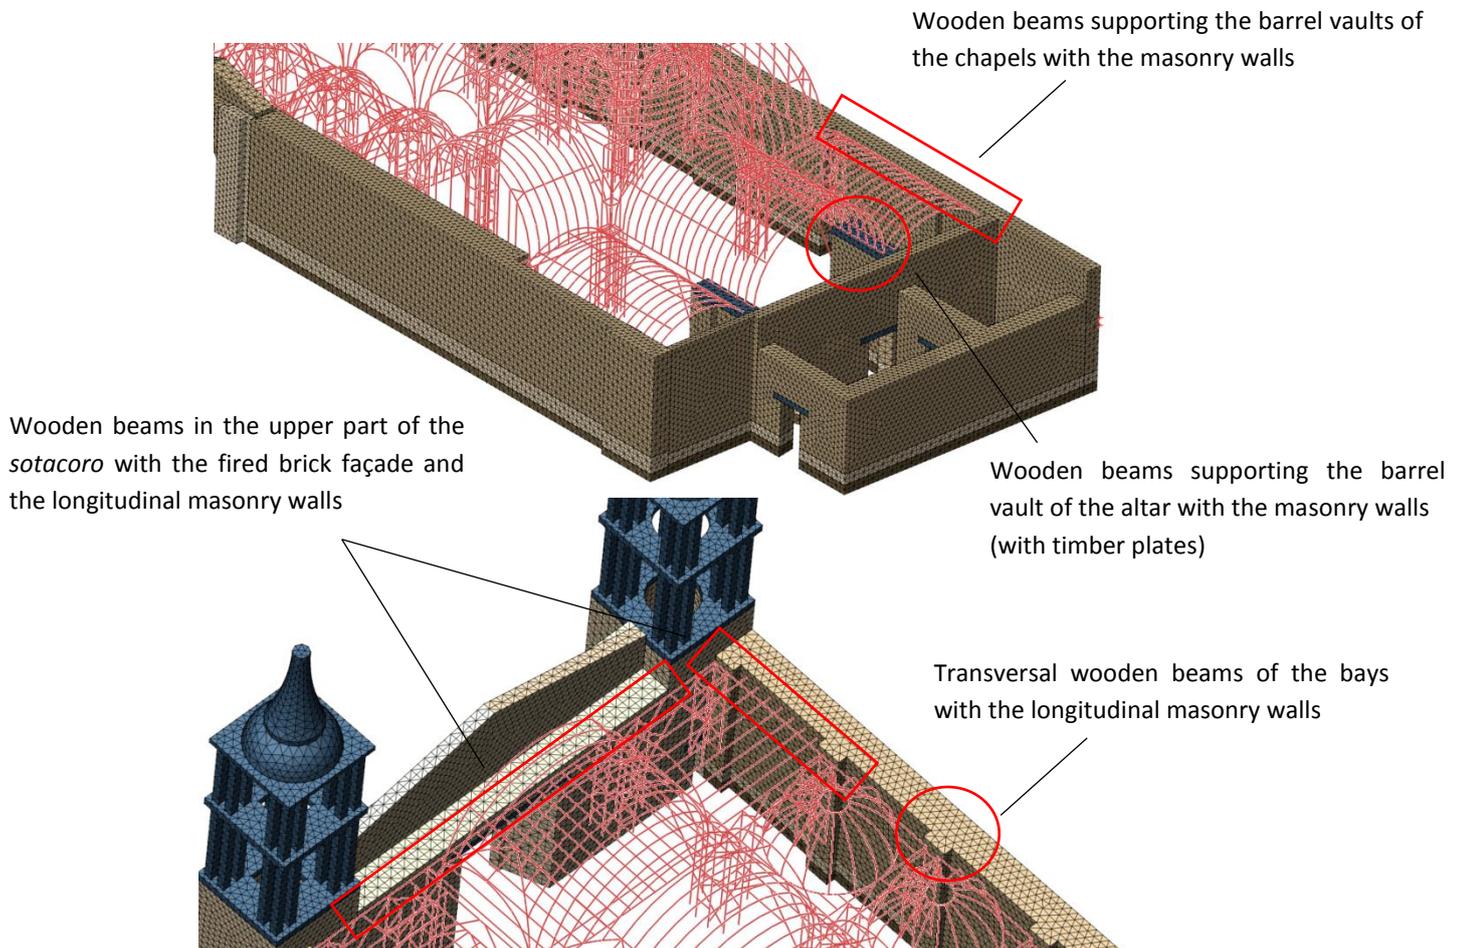
**Figure 2. Details of the connections in the numerical model of the combined structures.**

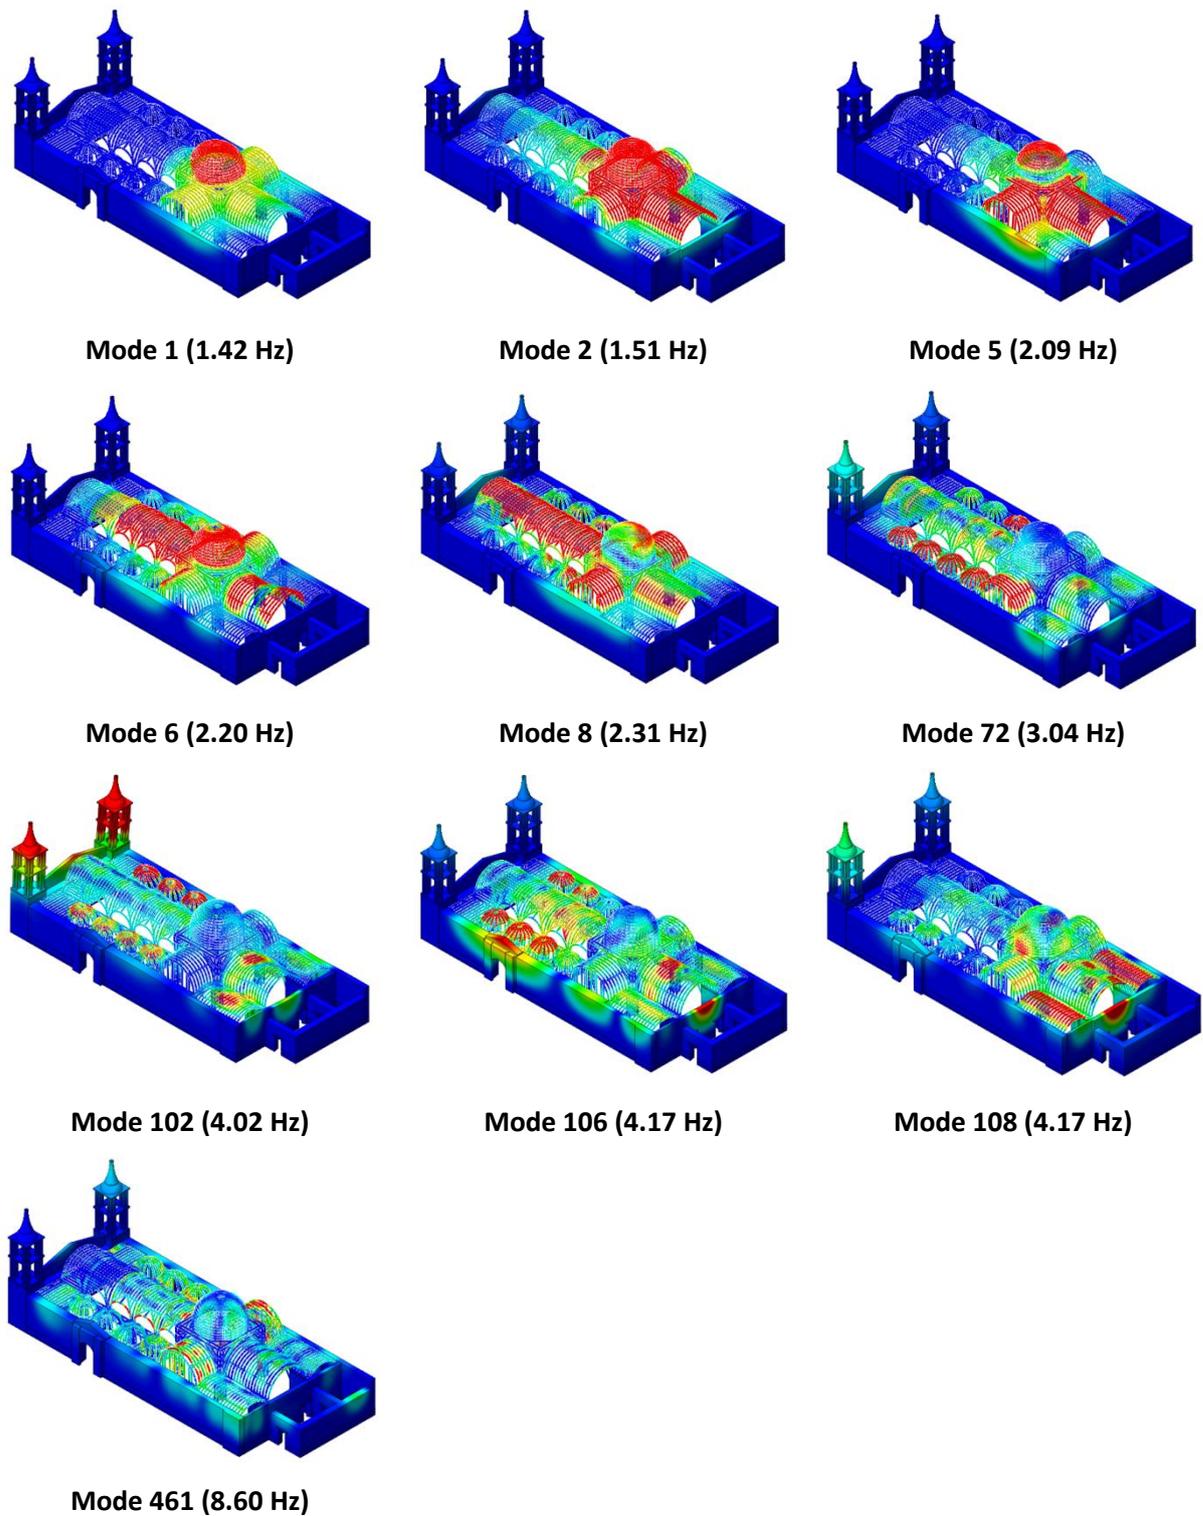
Figure 3. Selected mode shapes of the combined structures of Ica Cathedral.

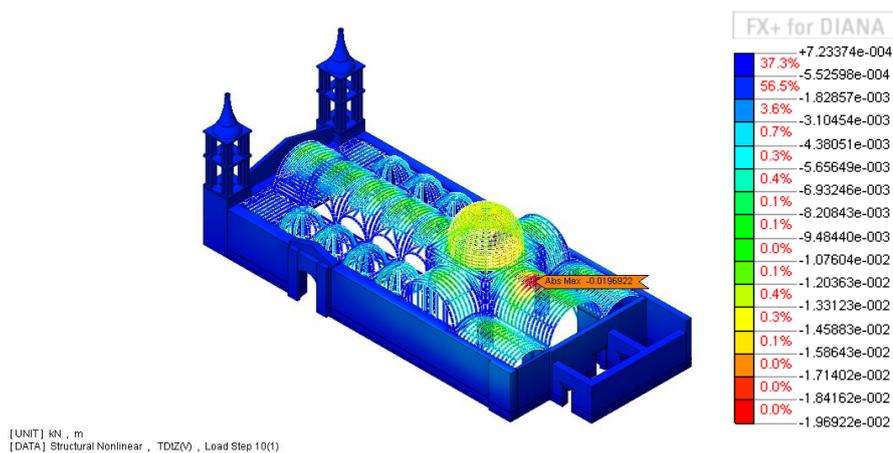
**Figure 4. Distribution of vertical displacements and the location of maximum vertical displacement.**

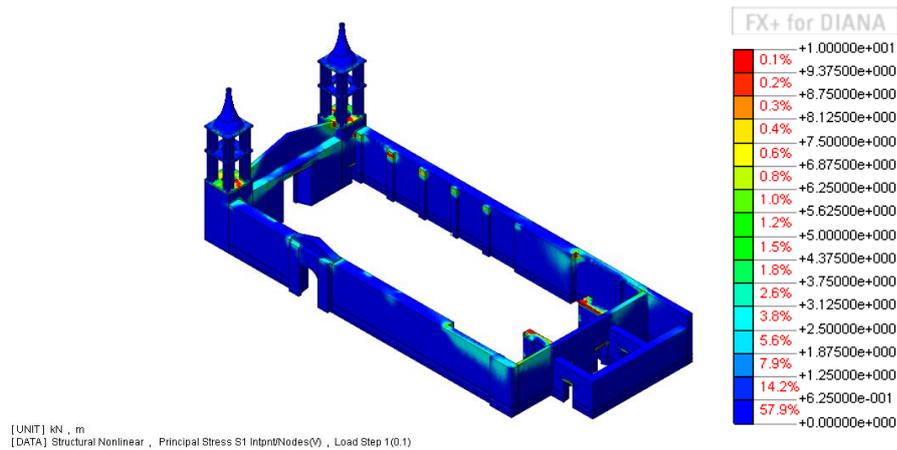
Figure 5. Distribution of the maximum principal stresses in the combined model.

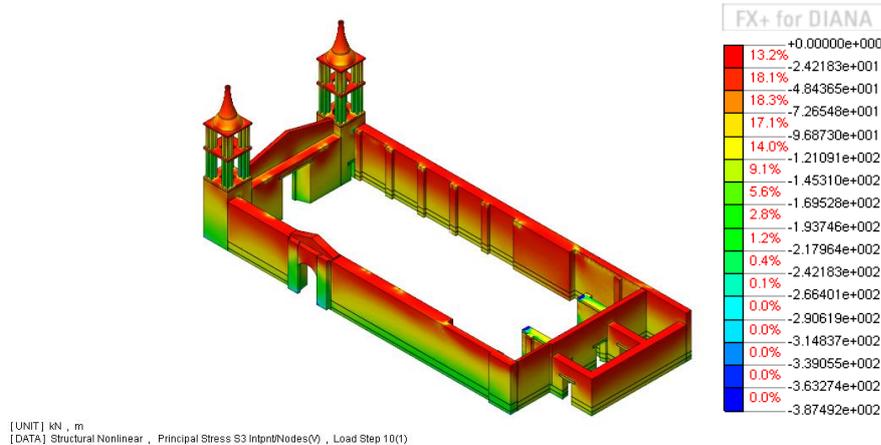
Figure 6. Distribution of minimum principal stresses in the combined model

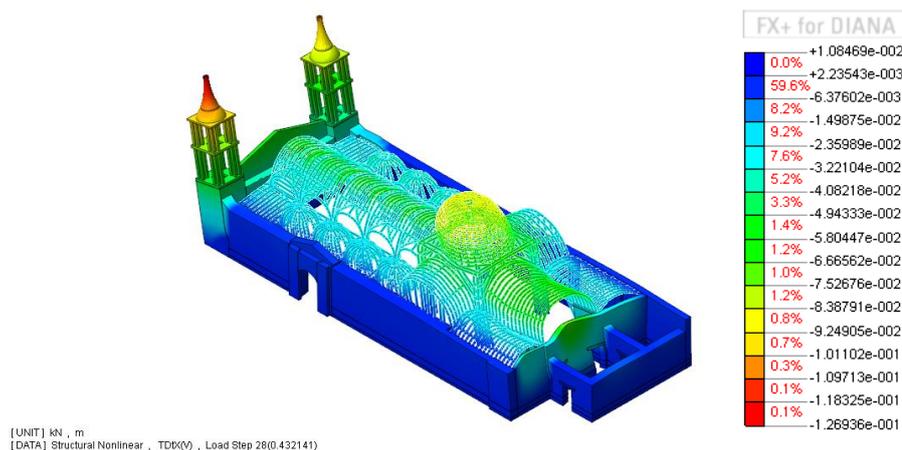
**Figure 7. Deformed mesh of the numerical model under applied loading in XX- direction.**

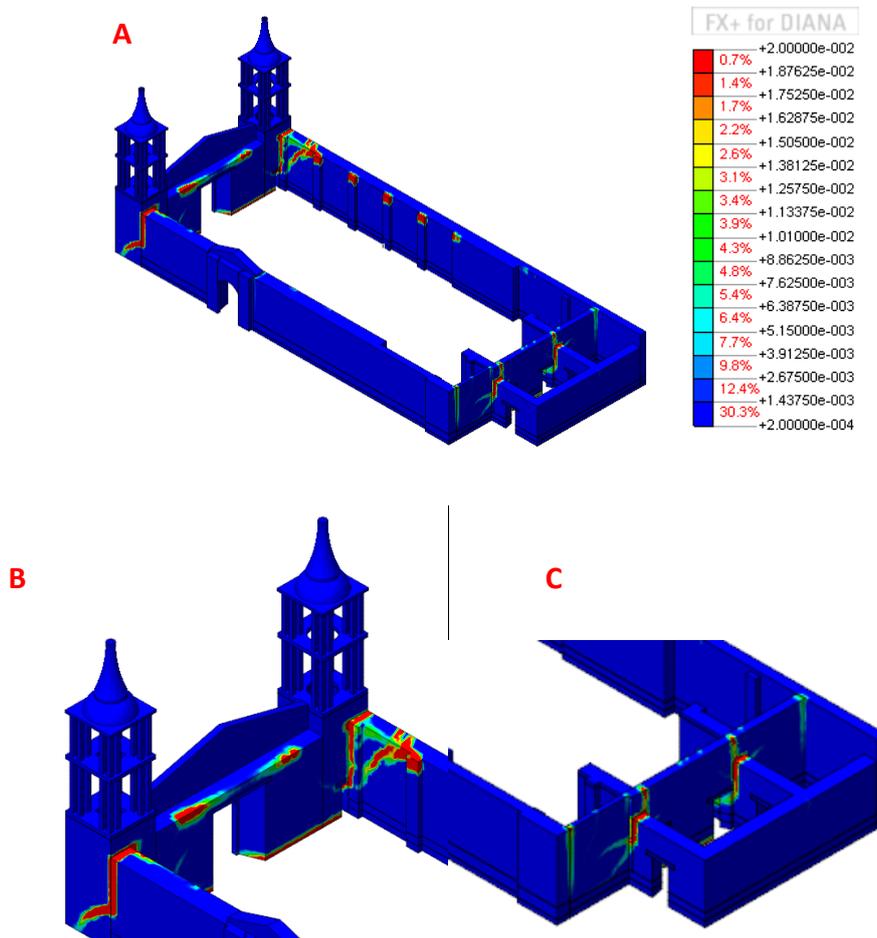
**Figure 8. Crack pattern depicting the failure mechanism: A) global crack pattern and the close up view of the tensile strains in B) the connection between the bell towers and facade and C) in the proximity of the altar (XX– direction).**

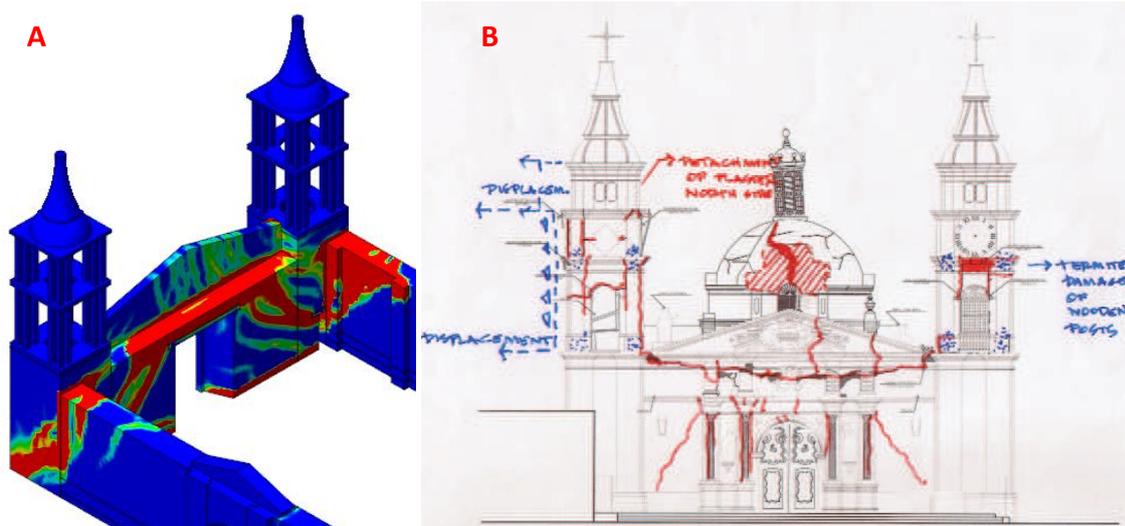
**Figure 9. Cracking occurring in correspondence to the connection between the pediment and the facade observed in A) the numerical model and B) in-situ (Cancino, et al., 2012).**

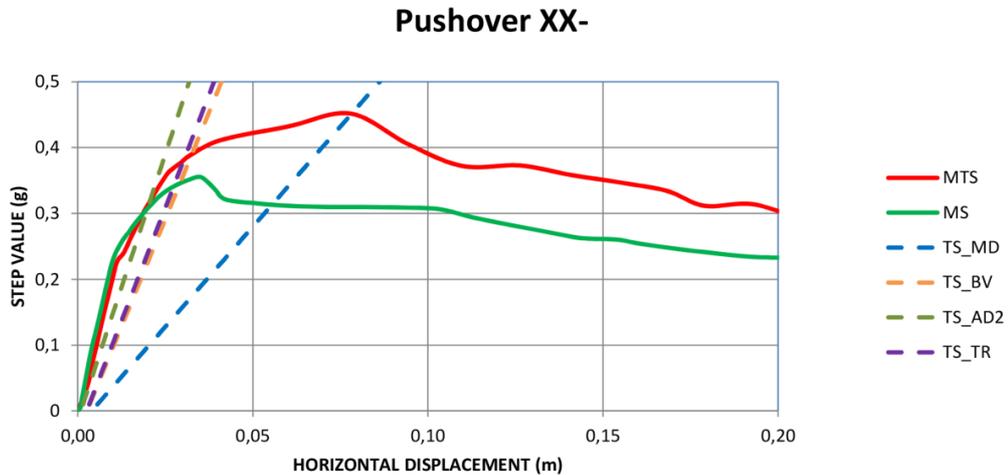
Figure 10. Comparison of the load displacement diagrams of the numerical models of the combined masonry and timber structures, the masonry envelope and various parts of the complete timber structure (XX-direction).

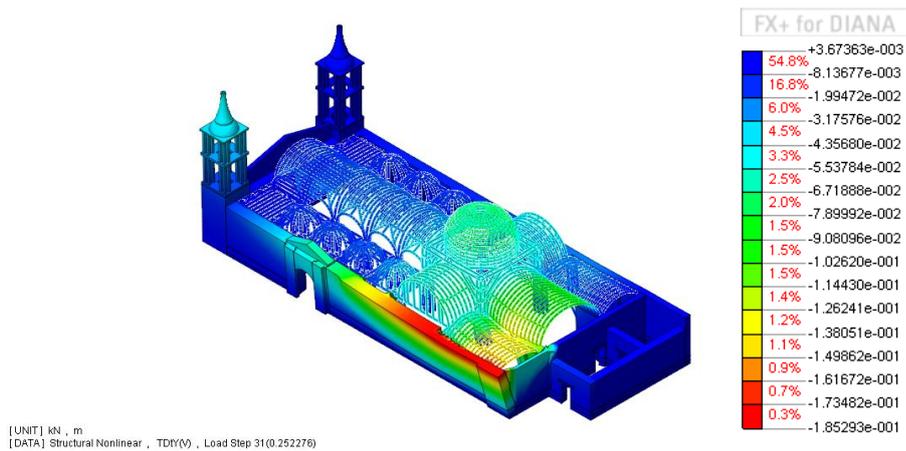
Figure 11. Deformed mesh of the numerical model under applied loading in YY-direction.

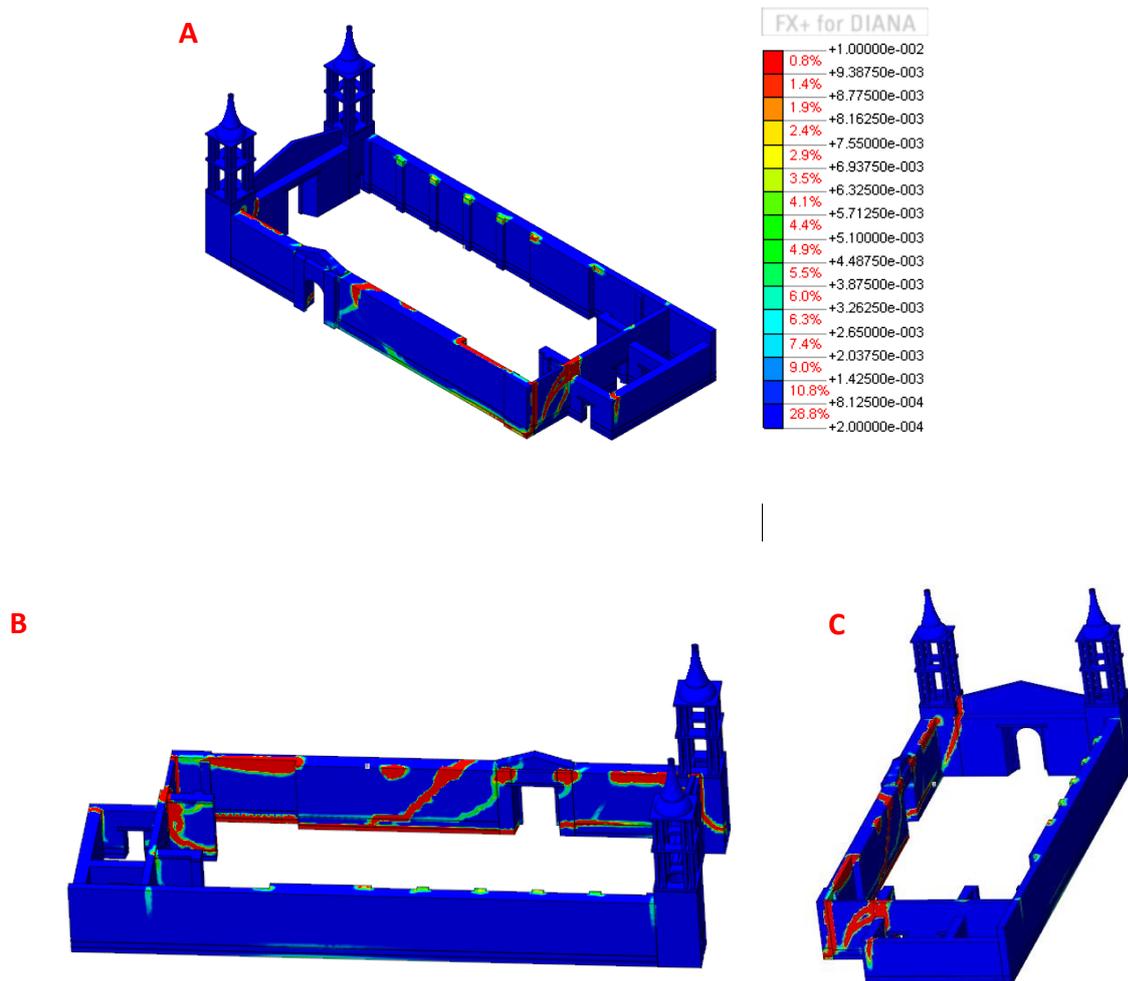
**Figure 12. Crack pattern depicting the failure mechanism: A) global crack pattern and close up view of the tensile strains in B) inner face of longitudinal wall and C) in the proximity of the northern bell tower.**

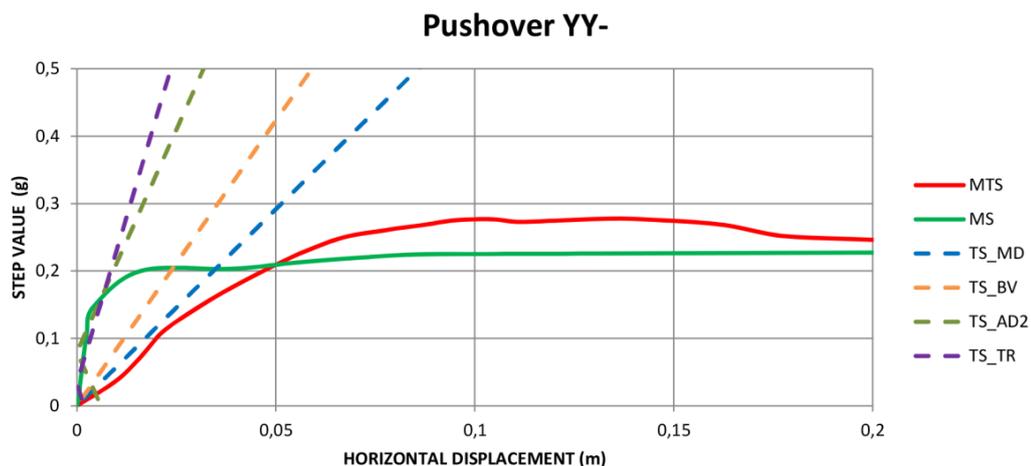
**Figure 13.** Comparison of the load displacement diagrams of the numerical models of the combined masonry and timber structures, the masonry envelope and various parts of the complete timber structure (YY-direction).

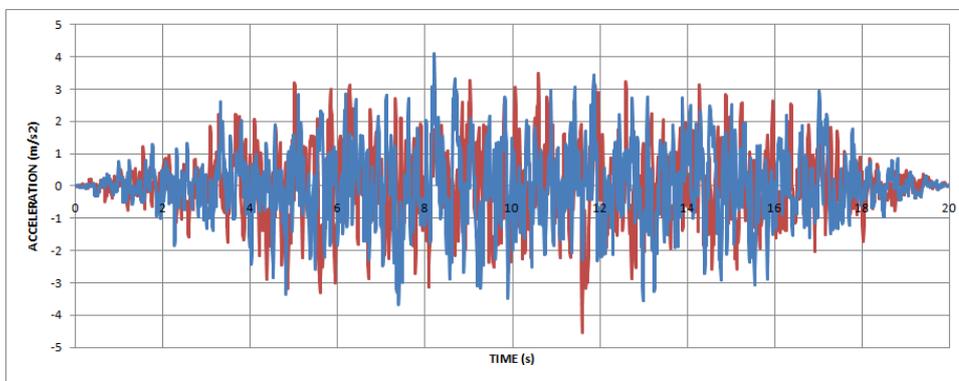
**Figure 14. Acceleration – Time Histories applied on the numerical model of the combined structures.**

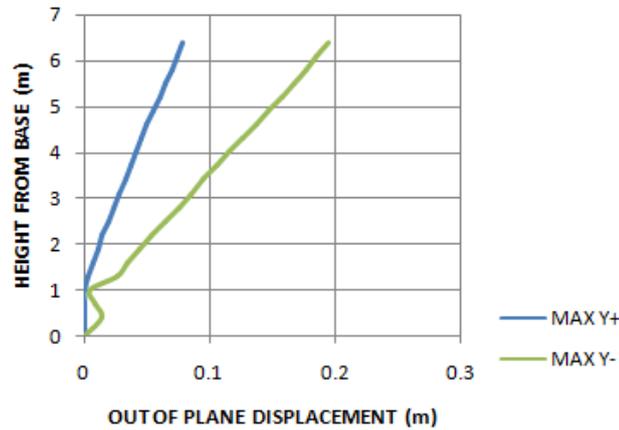
**Figure 15. Relative out of plane displacements in elevation for a selected region of the structure.**

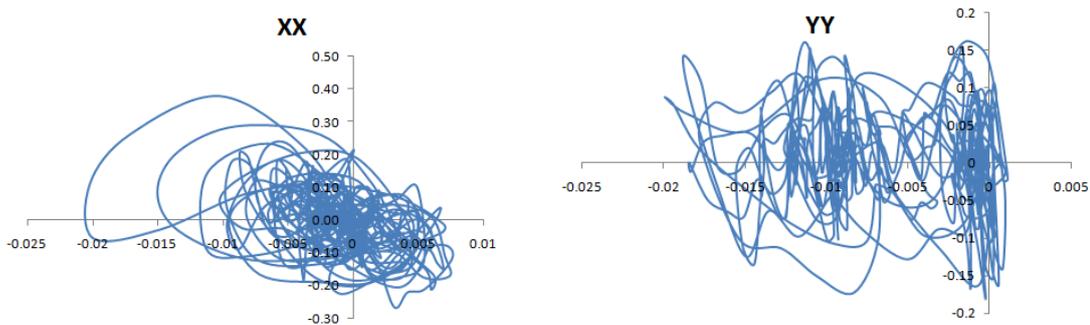
**Figure 16. Load Factor – Horizontal displacement (m).**

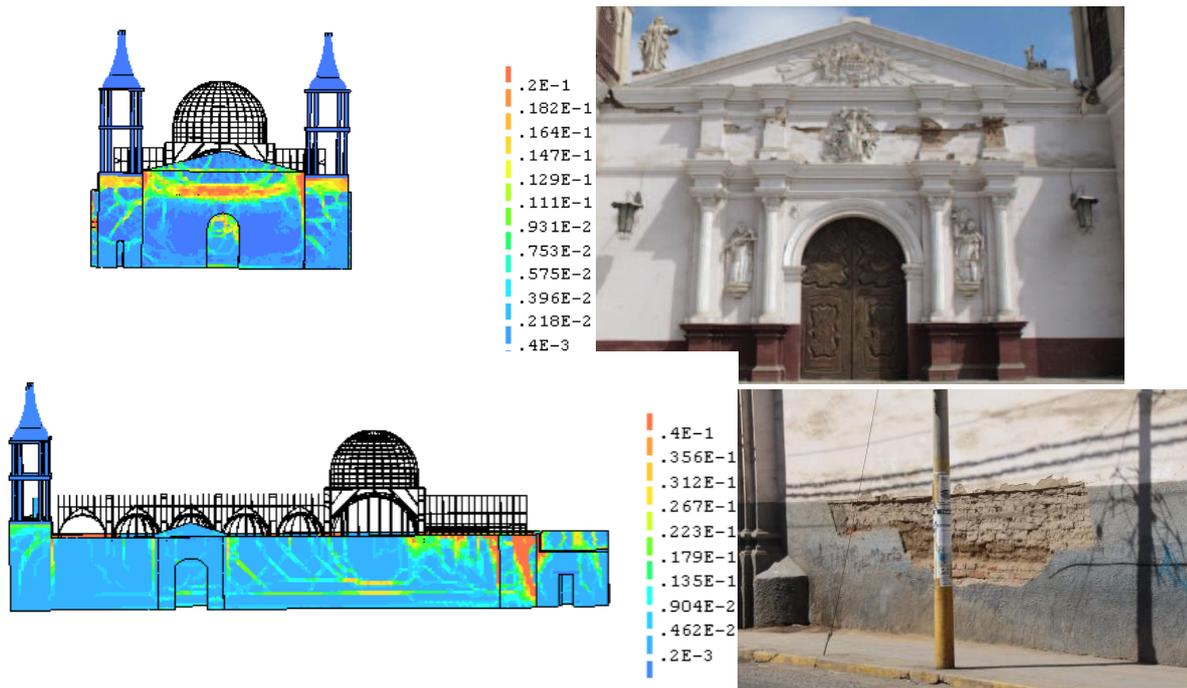
Figure 17. Crack correlation from time–history analysis.
