Shaking Table Testing for Masonry Infill walls: Unreinforced vs. Reinforced solutions

**Paulo B. Lourenço¹, João M. Leite¹, Manuel F. Paulo-Pereira¹,
A. Campos-Costa², P. X. Candeias², Nuno Mendes¹**

¹ISISE, Department of Civil Engineering, University of Minho, Guimarães, Portugal

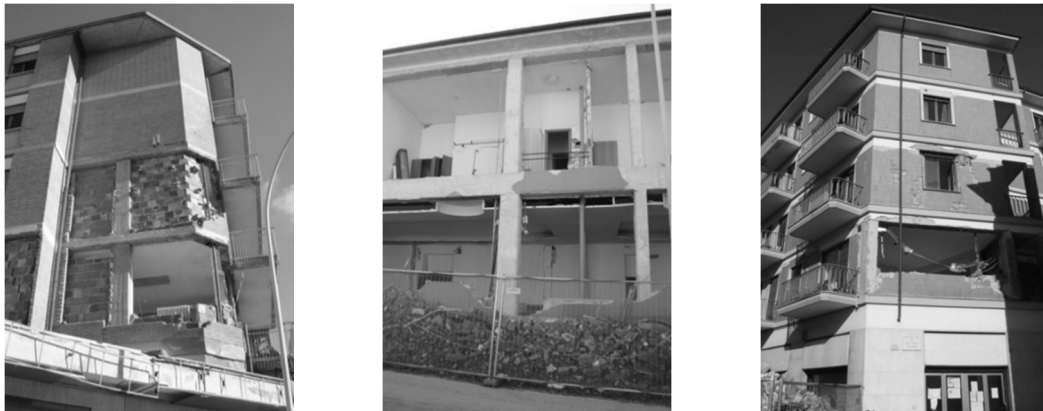
Figure 1: Partial and complete out-of-plane collapses of infill walls during the L'Aquila earthquake (2009), Italy, which is a recurring phenomenon.

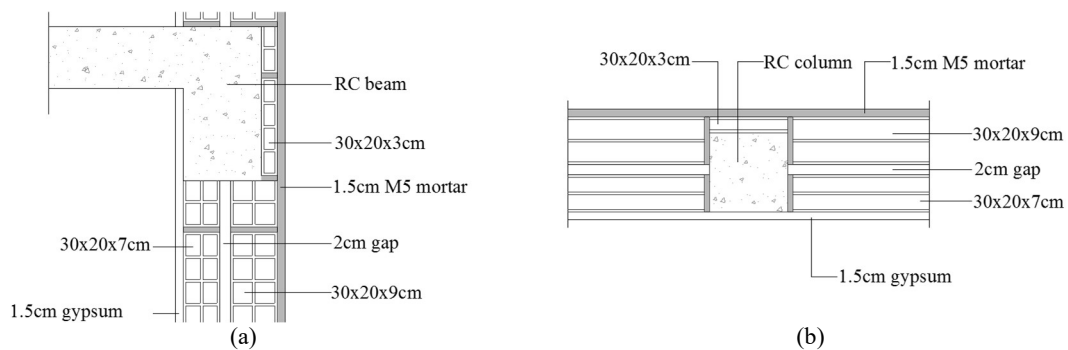
Figure 3: Double leaf clay brick unreinforced infill walls of Model 1, scaled. Details at: (a) RC beam (elevation section); (b) RC column (plan section).

The infills of model 1 were an unreinforced double leaf clay brick wall with a cavity, see Figure 3. Horizontally perforated units were used and the outer leaf partially hanging from the RC frame. The outer surface of the RC frame was covered with a thin clay brick unit to avoid thermal bridges. The inner leaf had a gypsum plaster, while the outer leaf had a mortar rendering.

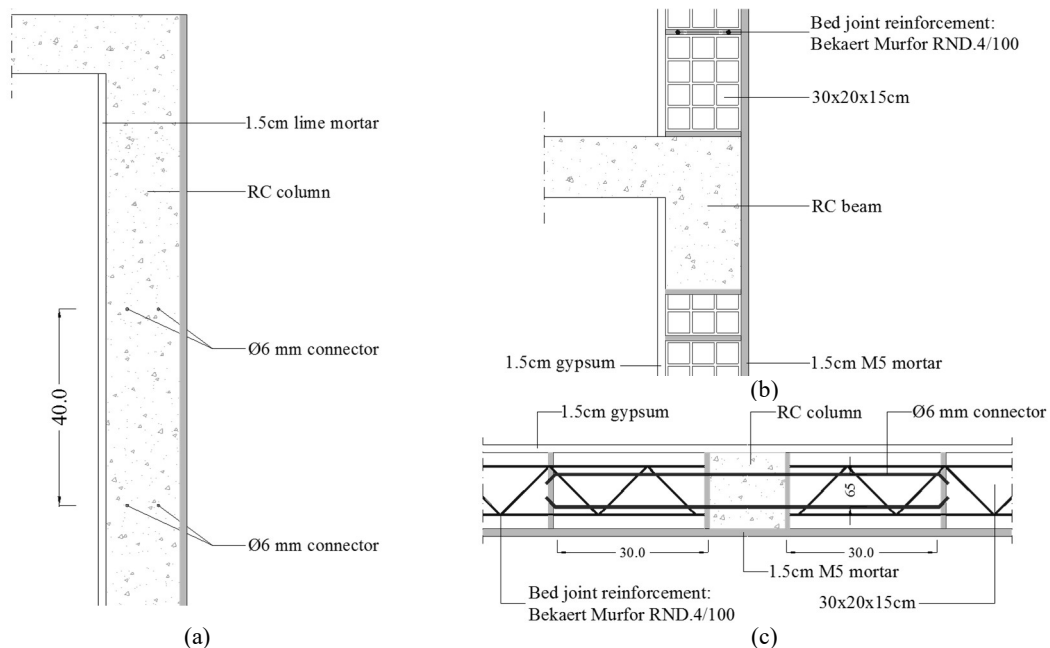
Figure 4: Single leaf clay brick infill walls with bed joint reinforcement from Model 2, scaled: (a) wall section; (b) detail at the RC beam (elevation section); (c) detail at the RC column (plan section).

The infills of model 2 were a single leaf clay brick wall with bed joint reinforcement every two bed joints, see Figure 4. The leaf was completely within the RC frame plane (as an external thermal insulation system will be required) with an internal gypsum plaster and an external mortar rendering. Again, horizontally perforated units were used. The bed joint reinforcement was a truss Bekaert Murfor RND.4/100, with longitudinal bars 100 mm apart and 4 mm diameter. The bed joint reinforcement was connected to the RC frame through steel bars at both ends, see Figure 4 (c). These bars are 30 cm long bars with 6 mm diameter and inserted in the RC columns during the formwork construction. The adopted amount of bed joint reinforcement is the minimum requested EC2 [6] to help control cracking, to provide ductility or to enhance resistance to lateral loads (0.03%), whereas the reinforced concrete bars have been designed to withstand the maximum force in the bed joint reinforcement.

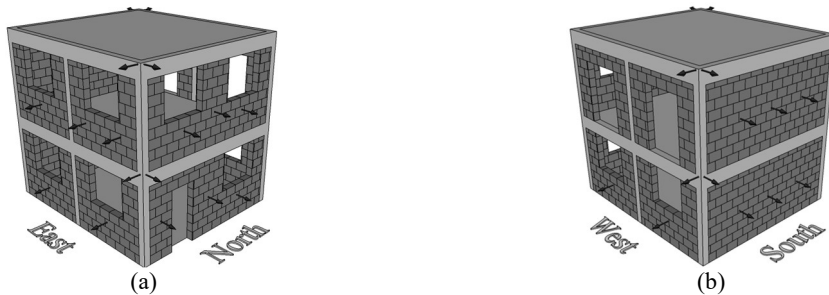
Figure 6: Accelerometers setup (Model 1): (a) North and East facades; (b) South and West facades.

Several accelerometers (ACC) were attached to the structure: (i) out-of-plane behaviour of the infill walls; (ii) global behaviour of the RC concrete structure. The out-of-plane behaviour of the infill walls was captured by a set of ACC distributed in the surface of the wall, see Figure 6. In model 1, due to the existence of two leaves, ACC had to be placed in the inner and outer leaves at the same position. This scheme can be seen in the outer leaf and repeats itself in the inner leaf at the exact same position, totalling thirty-eight ACC. Models 2 and 3 follow a similar scheme, which does not repeat itself in the inside since these models have single leaf infill walls. The ACC not used inside the model were applied in the outside increasing the number of measurement points considerably. The global behaviour of the RC structure was captured using two ACC orthogonally placed in the Northeast and Southwest corners of the RC slabs.

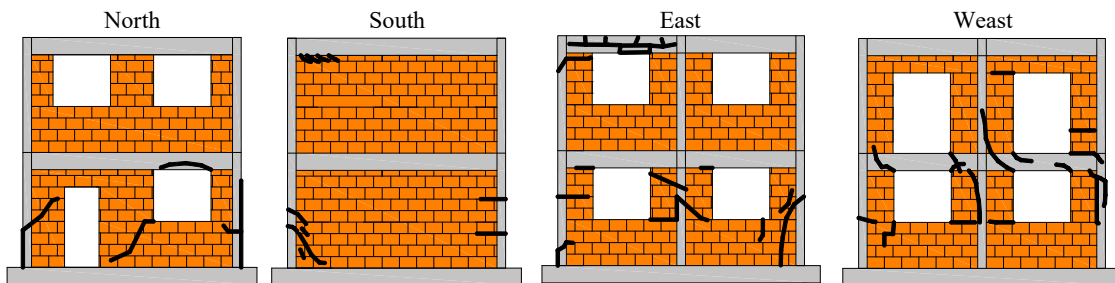
Figure 7: Crack patterns of the exterior leaf of model 1 after stage 3 (2475 YRP) (Note: the lines drawn on the RC frame represent damage on the clay bricks applied to the RC frame to avoid thermal bridges).

After the first two stages (225 and 475 YRP), model 1 did not present any visible damage, even if the dynamic data shows a small decrease in the frequencies. This loss of stiffness can be due to micro-separation of the infill walls from the RC frame or distributed micro-cracks in the RC frame or walls that remain undetected. After the third stage (2475 YRP), the model presented clear cracks on both leaves of the infill walls, see Figure 7 and Figure 8, mainly at the ground storey of the North, East and West facades. The cracks appeared mainly at the connection between the infill wall and the RC frame, and at the corners of the openings, moving towards the RC frame. In the infill walls at the ground floor in the East and West facade, and on both leaves, the crack pattern around

several opening jambs is clear, separating them from the RC frame and the section of the infill wall below the openings. Associated with this damage, the frequencies of the first three mode shapes decreased 13.6%, 28.4% and 20.2%, respectively, in comparison to the undamaged state.

After the third stage, the average frequency decrease of all modes was 30.3% and the average MAC of the last three modes was 0.390. The first two modes merged into a single mode with a diagonal translation following the Southeast – Northwest direction. This severe loss of stiffness is possibly due to the separation between RC structure and infills, as the damage observed at this level is only moderate, see Figure 7 and Figure 8.

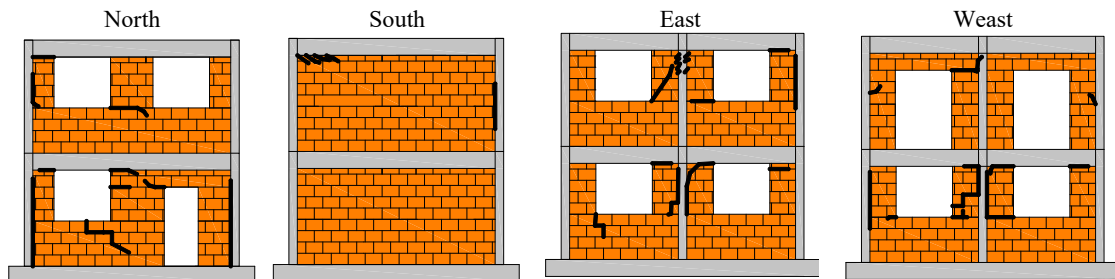
Figure 8: Crack patterns of the interior leaf of model 1 after stage 3 (2475 YRP) (Note: the lines drawn on the RC frame represent damage on the clay bricks applied to the RC frame to avoid thermal bridges).

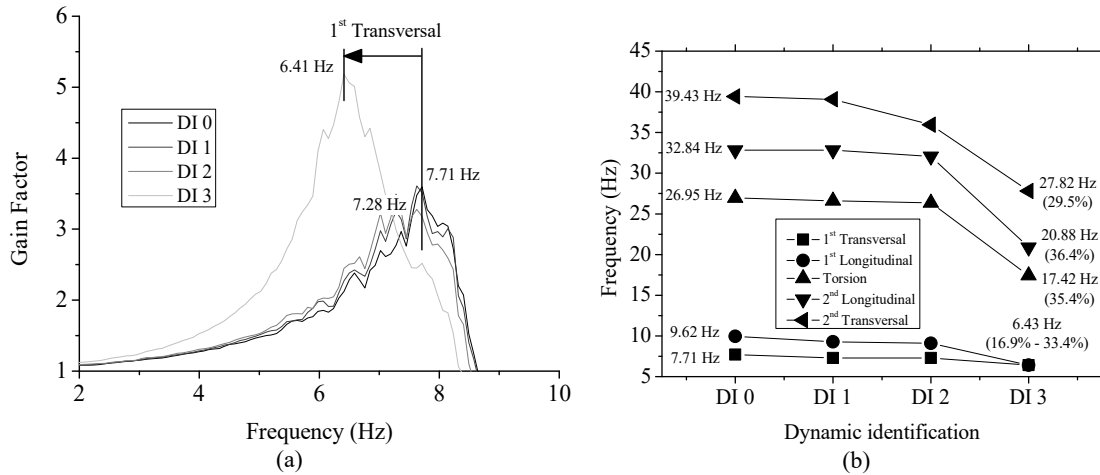
Figure 11: Frequency change along loading stages: (a) variation of the FRF's along the test of model 1 at the longitudinal accelerometer of the NE corner (1st floor); (b) evolution of the frequencies along the test of model 1 and their final variation in respect to DI 0.

The repetition of the dynamic identification tests after each test stage, DI 1 to DI 3, allowed detecting the decrease of the frequency of all peaks in the FRF that represent the above mentioned mode shapes (Figure 11a). Damage affects the frequency and the shape of the mode. In order to track the evolution of the mode, ensuring a correct comparison along the loading stages, the Modal Assurance Criterion (MAC) [14] was used:

Figure 11 (b) presents the frequency variation of the identified mode shapes along the dynamic identifications. All five mode shapes were identified from DI 0 to DI 2, while on DI 3 the first two modes, 1st transversal and 1st longitudinal, merged into a single mode due to damage in the RC structure. After the first two stages of the shaking table test, all the identified mode shapes had an average frequency decrease of 3% and the first three modes had an average MAC of 0.934. This means that the structure was barely damaged after the 275 YRP and 475 YRP seismic actions, stages 1 and 2 respectively, and that the first three mode shapes remained unaltered. This is in agreement with the observations.

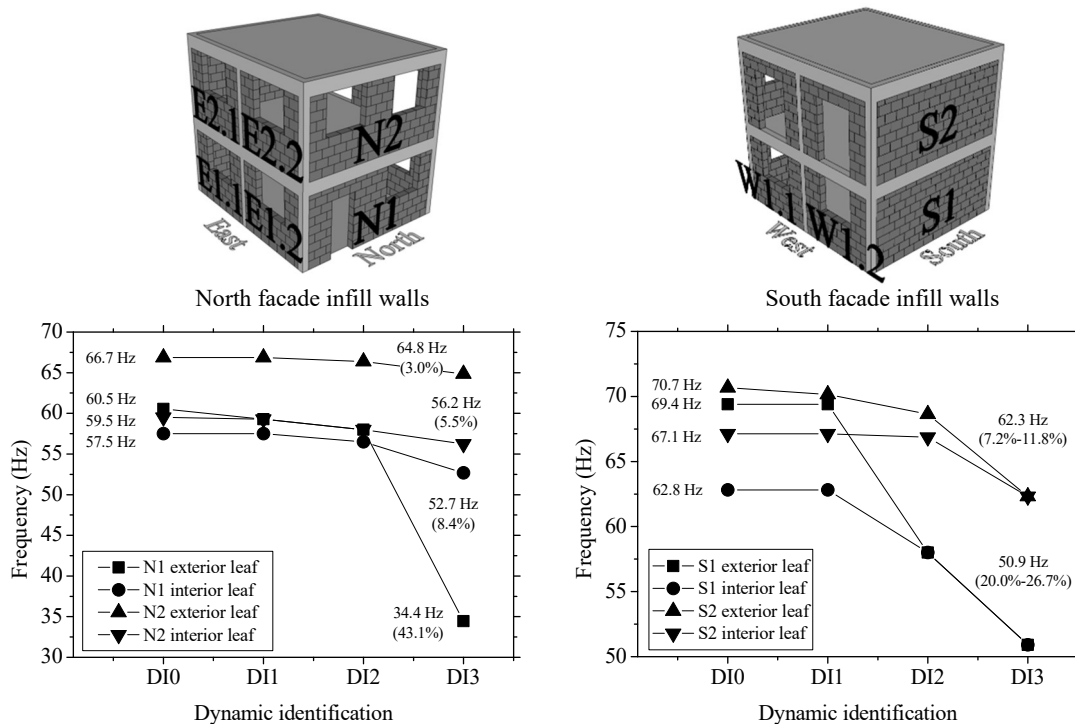
Figure 13: Evolution of the frequencies of the infill walls in the North and South facades along the test of model 1 and their final variation in respect to DI 0.

The frequencies of the infill walls were also monitored, see Figure 13. Only the first mode shape of the North and South walls were identified. The results showed that the exterior leaves have a slightly higher frequency when compared to interior ones, which is expected because the stiffness increases to the third power of the thickness while the mass only increases linearly. The reason for the small increase is likely to be the boundary conditions, as the exterior leaves are partly overhanging the slab, thus with lower restriction to rotation. The infills of the South facade have a higher frequency than the infills at the North facade, in the same position, due to the lack of openings.

After the first test stage, DI 1, the infill walls did not present any considerable frequency decrease. After the second stage, in which no damaged was observed and no considerable frequency decrease was registered in the global structure, the infill walls of the ground floor of the south facade and the exterior leaf of the ground floor of the North facade presented a frequency decrease of 16.4%, 7.7% and 4.2%, respectively. This frequency loss, since the walls did not present any visible damage, is likely to be due to the small loss of connection between the infill and RC frame.

After stage 3, the infill walls of the South facade had an average frequency loss of 16.4% while the walls on the North facade had an average frequency loss of 15.0%. In the South facade, the exterior and interior leaves, both in the ground and first floors, converged to the same frequency after in DI 3, which indicates larger damage in the exterior walls. The same situation was not registered in the North facade, where stiffness reduction was proportional, with the exception of the P1 external leaf. The infill walls of the ground floor presented a higher frequency loss when compared to the ones on the first floor, which is in agreement with the observed damage. The exterior leaf of the infill wall of the ground floor at the North facade presented a frequency loss of 43.1%, which is in agreement with the observed damaged since this infill was more damaged than any other in the transversal direction, and it was one of the first walls to completely collapse out-of-plane.

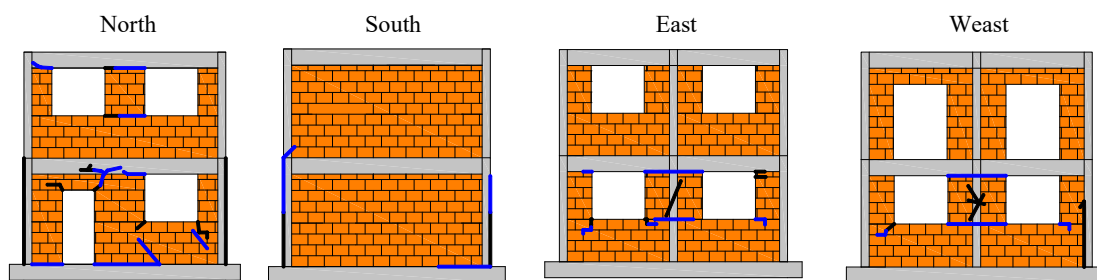
Figure 18: Crack patterns of model 3 after stage 3 (2475 YRP) (Notes: the drawn lines on the RC frame represent damage on the rendering applied to the RC frame. The blue lines developed after stage 3).

After stage 2 (475 YRP), model 3 (with reinforced plaster) presented cracks in the mortar rendering in all four corners, starting at the base of the RC column, and between the jambs on the intermediate columns of the East and West facades, see Figure 18. Small cracks starting at the corners of some of the openings and moving towards the RC frame were also visible at the ground floor, while the first floor presented no visual damage. After stage 3 (2475 YRP), the cracks in the mortar at the corners of the models extended and small pieces of mortar rendering fell. The cracks in the jambs of the East and West facade also were further extended. New cracks surrounding the ground floor infills of the North and South facades appeared, along with some cracks in the infill wall at the first storey of the North facade, mainly between the openings. Overall, the model presented light damage, and the cracks seemed to affect only the mortar.

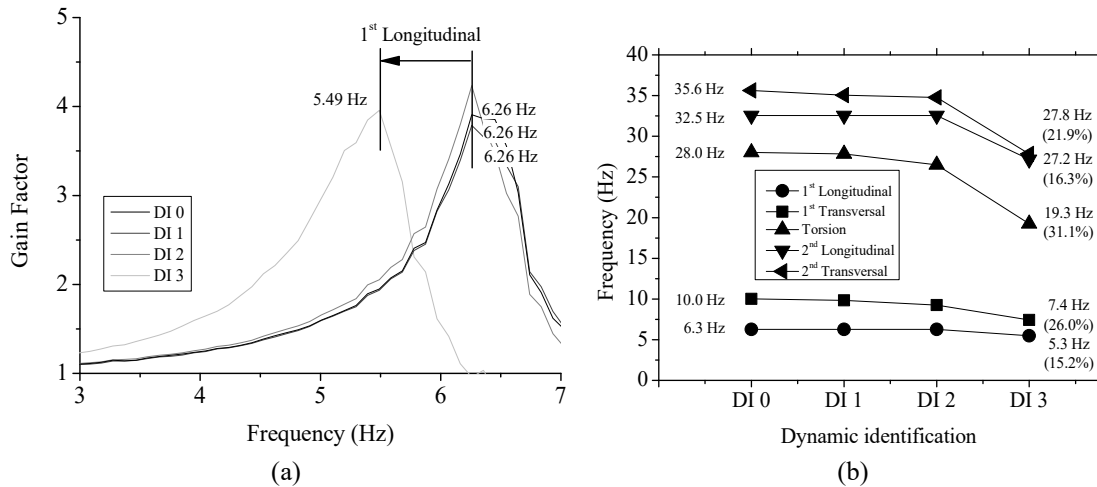
Figure 19: Frequency change along loading stages: (a) variation of the FRF's along the test of model 3 at longitudinal accelerometer of the NE corner (1st floor); (b) evolution of the frequencies along the test of model 3 and their final variation in respect to DI 0.

The dynamic identifications provided the five mode shapes as in the previous models, although the first transversal and first longitudinal changed positions, which is most likely associated to the interaction between the model and the shaking table and /or the interaction between masonry infill and frame, which depends on workmanship and the actual execution of each infill. Until the second stage, the longitudinal direction presented no frequency decrease, the transversal direction presented an average 5.1% frequency decrease and the torsional mode presented a 5.5% frequency decrease, see Figure 19.

After stage 3 (2475 YRP), the average decrease in the longitudinal direction was 15.6% and the average frequency loss in the transversal direction was 24.0%. The torsional mode presented a 31.1% decrease.

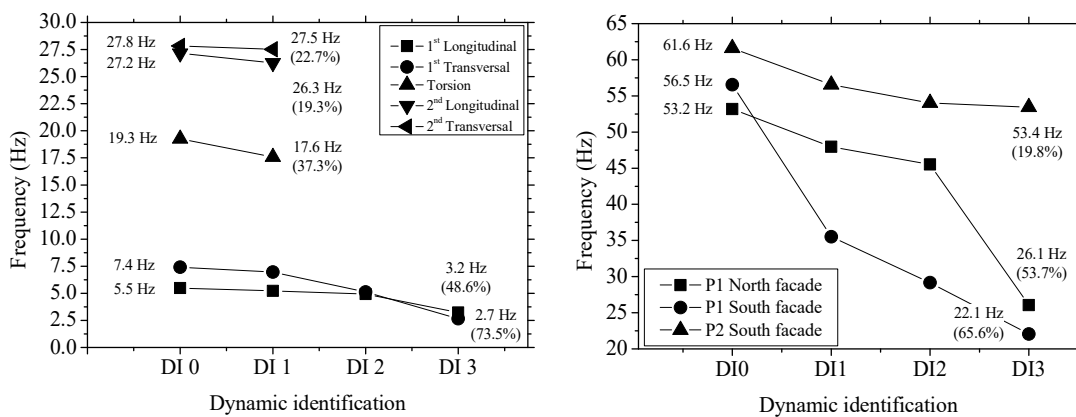
Figure 20: Evolution of the frequencies along the test of model 3 with additional stages, and their final variation in respect to DI 0, at the RC structure and infill walls in South facade and ground level of the North facade.

Figure 20 presents the frequency decrease of the RC structure and of three infill walls in the model along the three additional test stages. The initial dynamic identification, DI 0, corresponds to end of the first test stage. In the RC structure, the identification of the (first) torsional and second longitudinal and transversal modes was not possible after stage 3 (2475 YRP). The first transversal mode presented a higher stiffness loss when compared to the longitudinal mode. After stage 2 (475 YRP) the modes presented 0.2 Hz of difference between them and after stage 3 the transversal direction presented a higher

stiffness loss. At the end of the test, the transversal direction presented a 73.5% frequency loss, while the longitudinal direction presented a 48.6% decrease, when compared to the undamaged state. This difference can be associated to the infill walls at the ground floor, which on the transversal direction presented a clear disconnection to the RC frame at the jambs.

The infill wall at the upper level of the South facade presented an extra 12.2% of frequency decrease during the three stages, which add to the previous damage totalizing 19.8%, when compared to the undamaged state. This infill wall did not present any visible damage, and the loss of stiffness is associated to the loss of connection between the infill wall and the RC frame. The infill walls at the ground floor presented a similar and considerably higher frequency loss at the end of stage 3, when compared to the upper level one, although the South infill wall presented the highest loss at the first stage (225 YRP) and the North one presented the highest loss in the last stage.

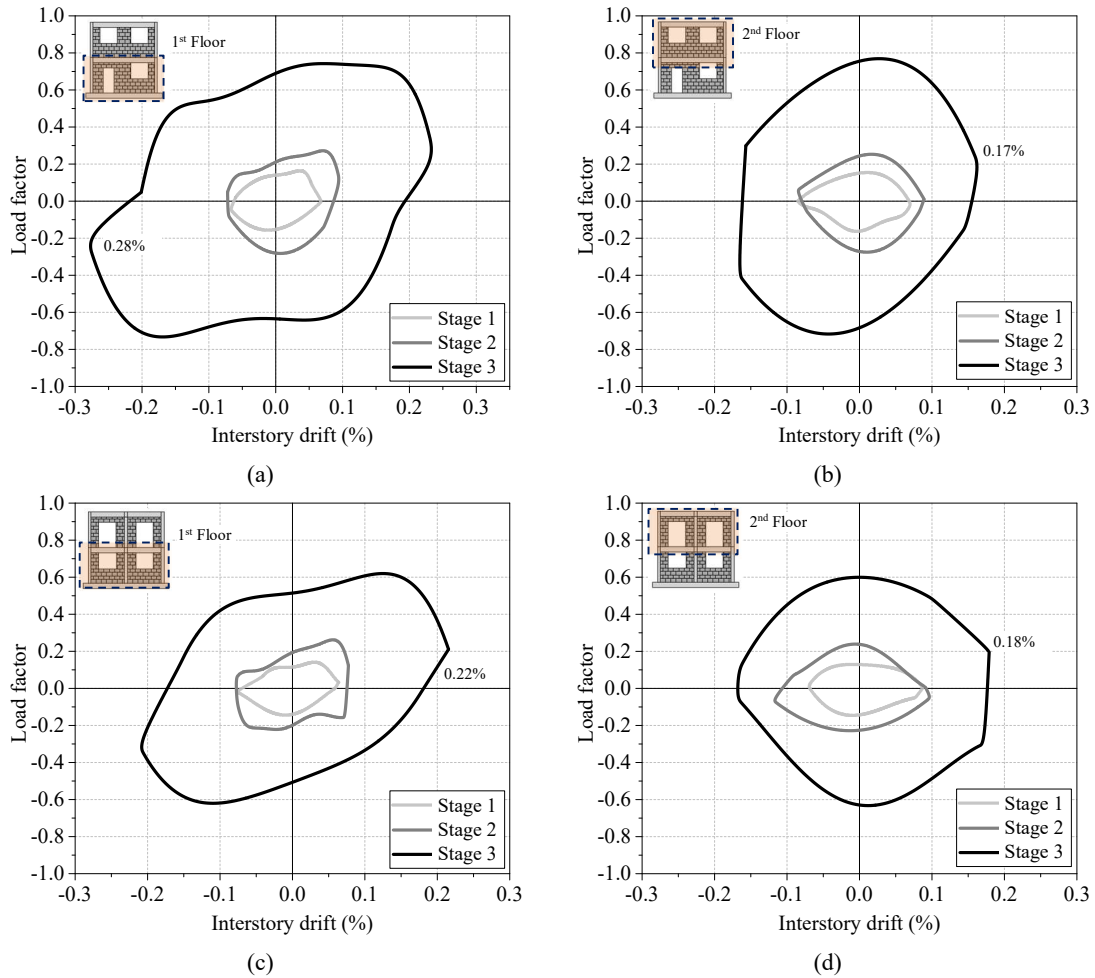
Figure 21: Envelopes of the hysteric behaviour for model 1 (39.5 ton): (a) load factor in the longitudinal direction vs. interstory drift of 1st floor; (b) load factor in the longitudinal direction vs. interstory drift of 2nd floor; (c) load factor in the transversal direction vs. interstory drift of 1st floor; (d) load factor in the transversal direction vs. interstory drift of 2nd floor.

Figure 21 presents the envelopes of the hysteretic behaviour of the model 1 (unreinforced model) for each floor in the longitudinal and transversal direction. The maximum load factor in the longitudinal direction is equal to 0.16, 0.28 and 0.76 for stage 1, stage 2 and stage 3, respectively. In transversal direction the maximum load factor is equal to 0.15, 0.25 and 0.63 for stage 1, stage 2 and stage 3, respectively.

The maximum interstory drift of the model 1 occurs at the first floor and is equal to 0.28% and 0.22% in the longitudinal and transversal direction (stage 3), respectively, which is according to the concentration of damage at the first floor observed in the shaking table tests. The interstory drift at the first floor presents a significant variation between the stage 2 and the stage 3 (about 65%), showing that in stage 3 model 1 presented significant damage. This aspect is in agreement with the variation of frequencies, in which a decrease of about 30.3% for all modes was observed after stage 3. It is noted that model 1 collapsed during stage 4.

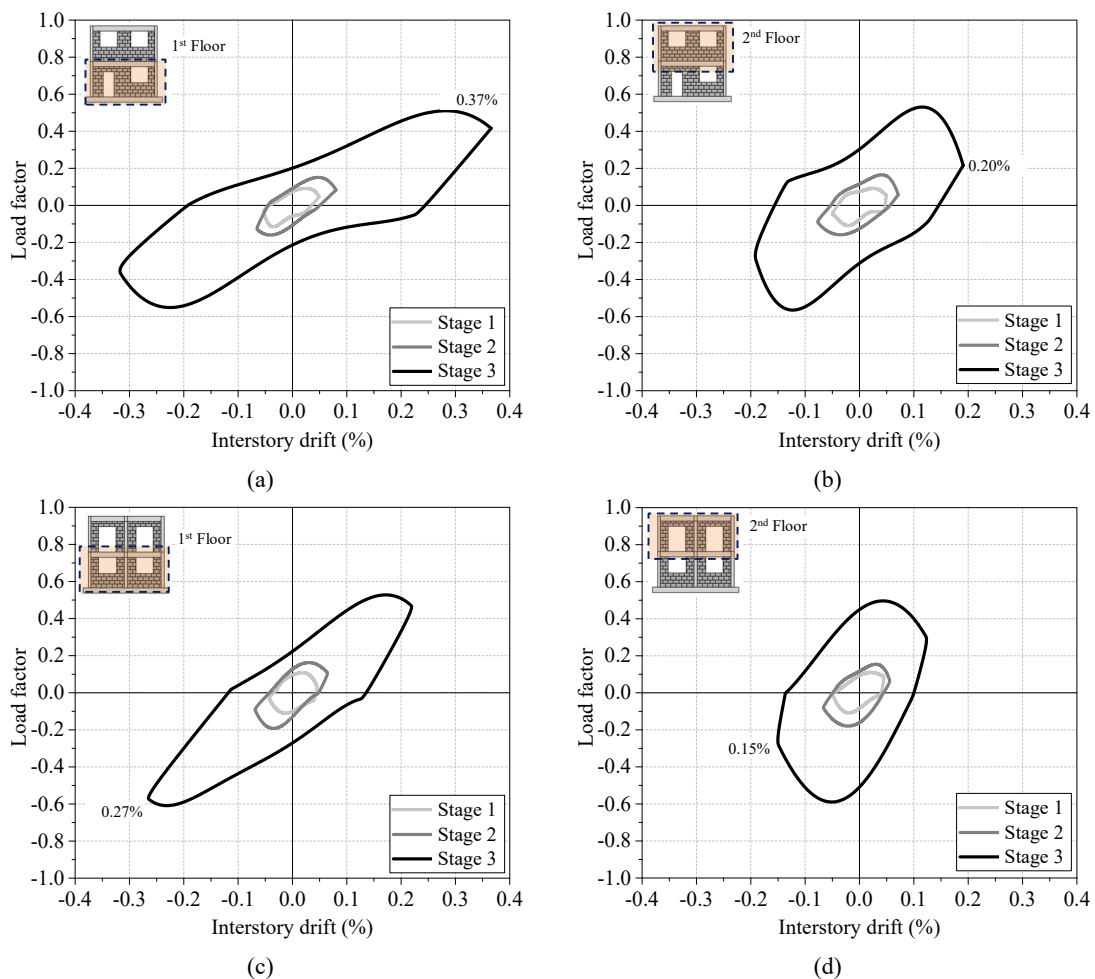
Figure 22: Envelopes of the hysteric behaviour for model 2 (37.7 ton): (a) load factor in the longitudinal direction vs. interstory drift of 1st floor; (b) load factor in the longitudinal direction vs. interstory drift of 2nd floor; (c) load factor in the transversal direction vs. interstory drift of 1st floor; (d) load factor in the transversal direction vs. interstory drift of 2nd floor.

Model 2 (with bed joint reinforcement) presents similar maximum load factors for both directions (Figure 22). However, this model presents a maximum load factor (0.62) lower than the maximum load factor of model 1 (0.76) for stage 3 (-20%). The maximum interstory drifts occurs at the first floor, namely 0.37% in the longitudinal direction and 0.27% in the transversal direction, showing that the damage concentrates at the first floor. Model 2 presents a more flexible dynamic response when compared to the response of model 1, which is in agreement with the stiffness and frequencies of the models. In stage 3, model 2 presents an interstory drift for the first floor higher than model 1 with a damage with lower severity. These aspects lead to the conclusion that the model 2 presents higher ductility than model 1, allowing more dissipation of energy and improving the dynamic behaviour of the structure, which is in agreement with the fact that the RC structure of
