ADVANCED MASTERS IN STRUCTURAL ANALYSIS OF MONUMENTS AND HISTORICAL CONSTRUCTIONS

# Master's Thesis

## Earthquake-Induced Damage Assessment in an Historical Bell-tower Based on Long-term Dynamic Monitoring Data

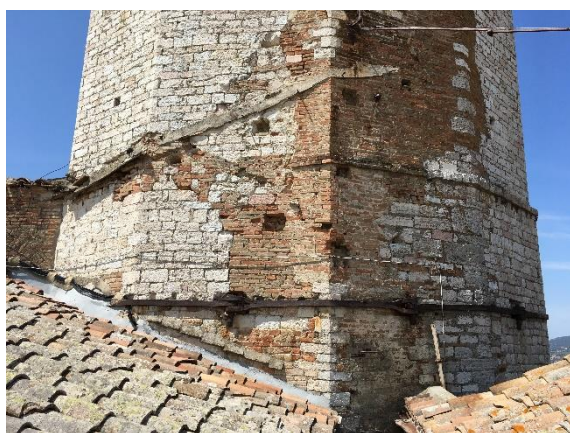
Figure 3-3 Repair brickwork

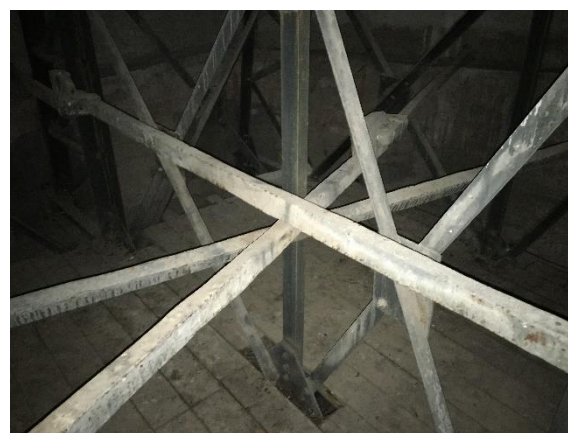
Figure 3-4 Tie rods in the shaft

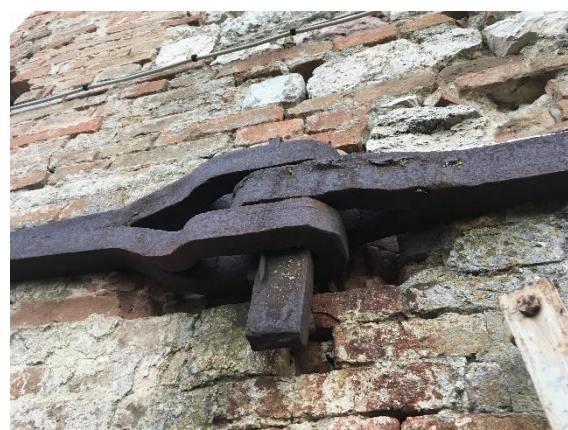
Figure 3-6 Detail of metal confinement

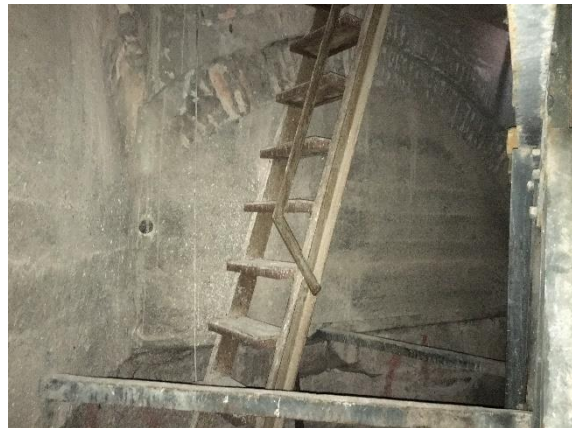
Figure 3-8 Concrete elements supporting the lateral arches of the demolished vault

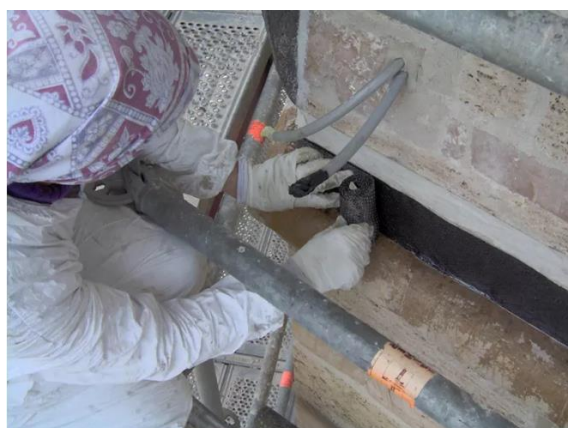
Figure 3-9 Application of FRP materials during the last restauration works [30]

Due to the 1997 Marche-Umbria earthquake, the monument underwent various damages that were repaired in 2002. The direction of the works was entrusted to architect Francesco Ventura and to engineer Riccardo Vetturini. The intervention was made with modern techniques and materials according to the observation of the crack pattern, and on the identification of damages and failure mechanisms. Carbon and glass fibers impregnated with epoxy resin and FRP bars were massively used to strengthen the cusp and the belfry. Regarding the cusp, the carbon fibers were applied in two perpendicular directions: longitudinally, to prevent rotation of the element, and radially, to prevent its opening. The horizontal confining fibers were fixed both on the exterior and on the interior surface. The two layer were connected by means of aramid bars. A framework of horizontal and vertical carbon fibers impregnated with epoxy resin was also applied in the belfry, see Figure 3-9.

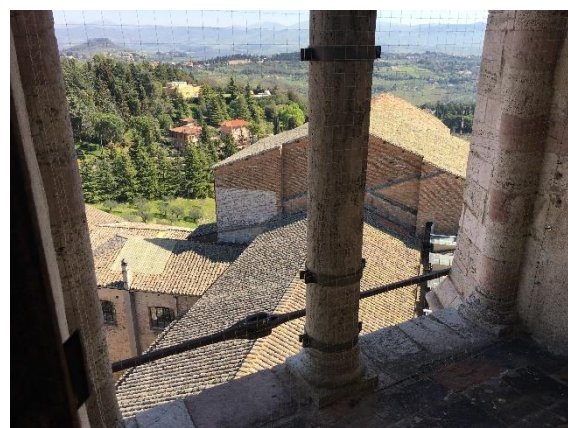
Figure 3-10 Confining elements in double-arched windows

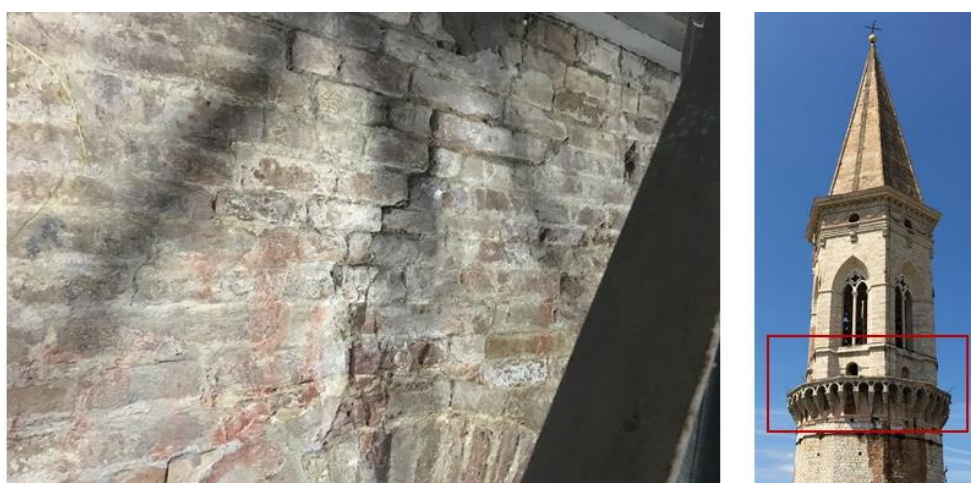
Figure 4-1 Crack in the lower part of the belfry

The visual survey allowed verifying the information about the monument and constituted the first step of the in-situ investigation. All the compartments of the bell tower were inspected, namely base, shaft, belfry and cusp. The visual inspection of the masonry of shaft allowed computing the MQI of its walls. Special attention was given to the metal structure, as no existing surveys were available. The following paragraphs of the chapter deal with these aspects. Furthermore, eventual damages caused by the last earthquake were examined.

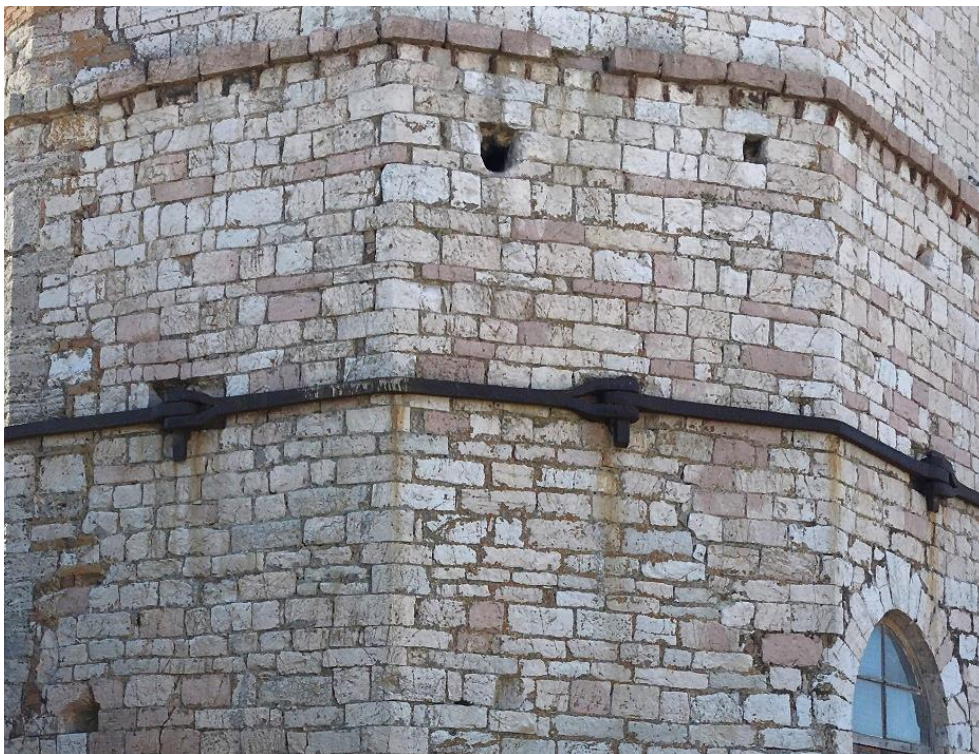
Figure 4-2 Exterior masonry of the shaft

The masonry of the shaft is analyzed (Figure 4-2) with the MQI method. The brick masonry insertions are not taken into account. The seven parameters considered in MQI are analysed consistently with the indication provided in literature [23]. The criteria for masonry assessment are shown in Table 4-1. The MQI evaluation is shown in Table 4-2.

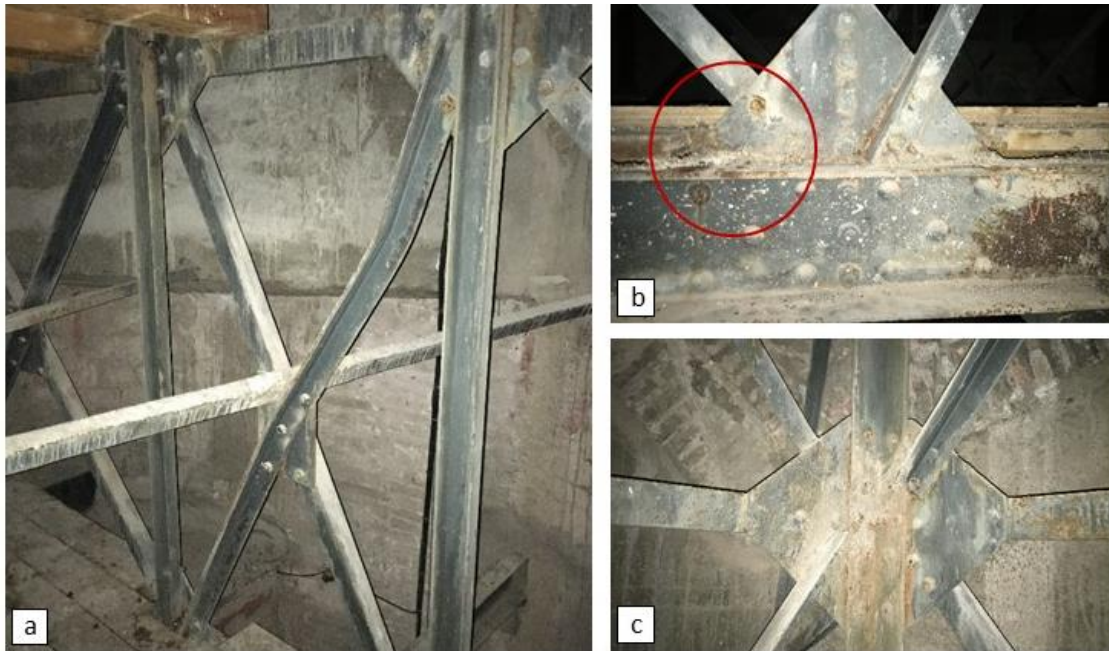
Figure 4-10 Metal structure decay: a) deformations, b) corrosion of connectors, c) corrosion of profiles

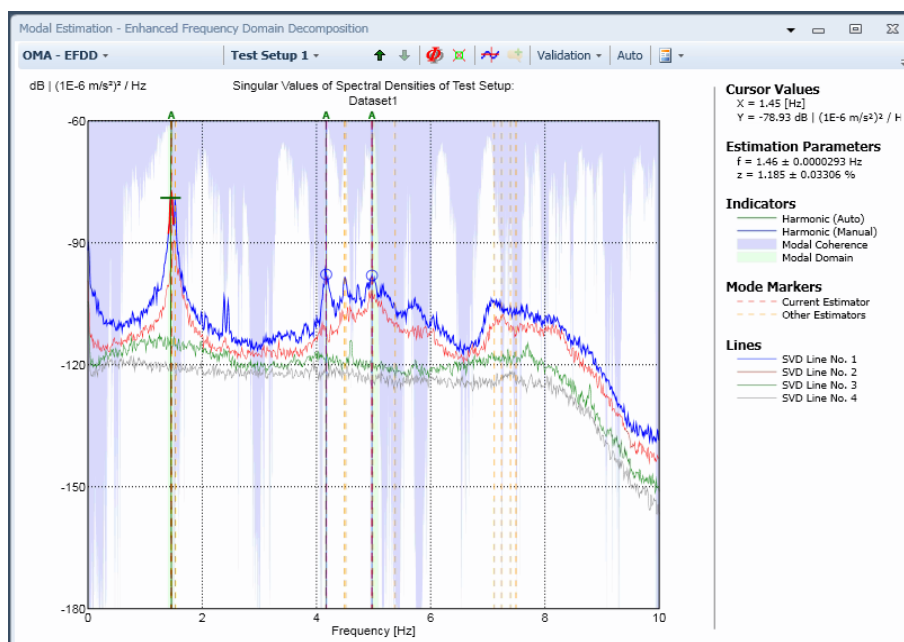
Figure 4-11 Typical results from EFDD

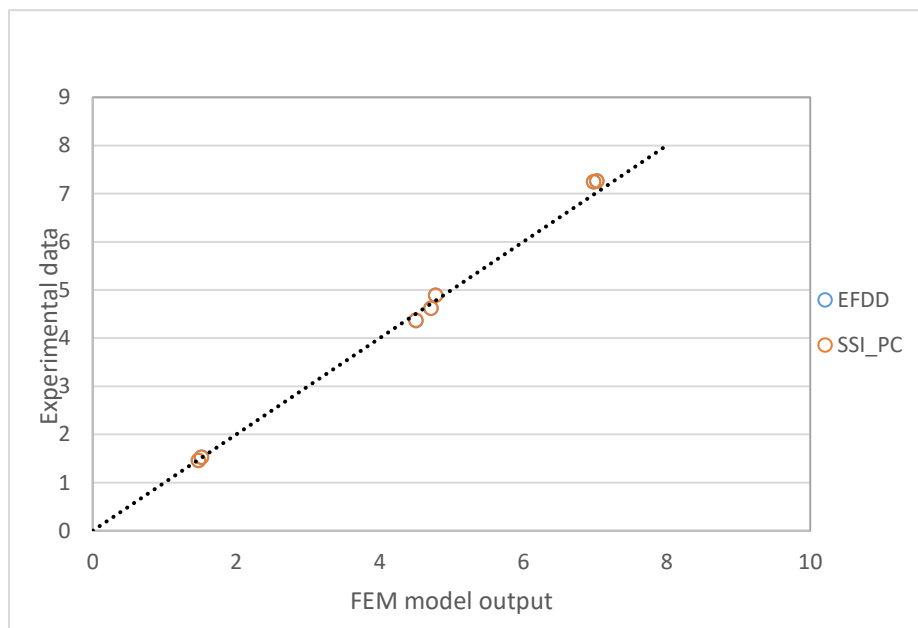
Graph 5-2 Pre-earthquakes condition: numerical frequencies VS experimental data: the data almost lie on the bisect of the first quadrant
