ADVANCED MASTERS IN STRUCTURAL ANALYSIS OF MONUMENTS AND HISTORICAL CONSTRUCTIONS

Master's Thesis

Numerical Modelling of the seismic performance of Romanian traditional timber-framed buildings

University of Minho

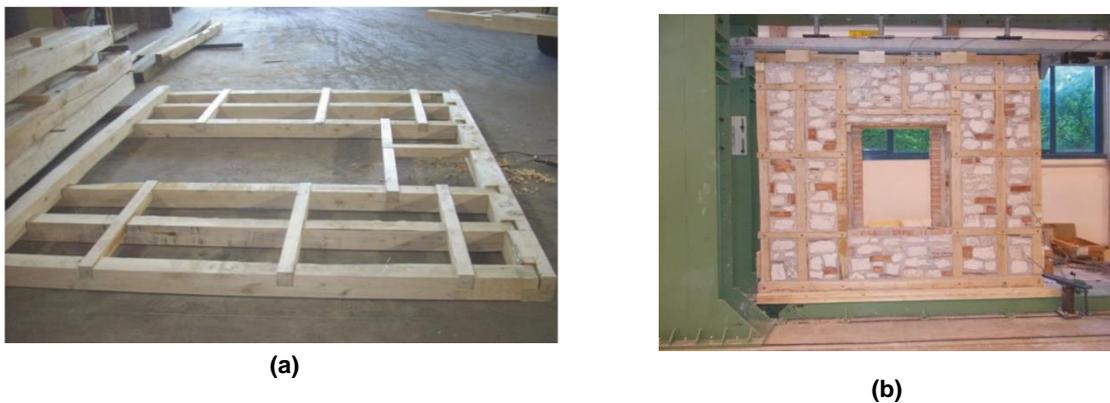
Figure 2.18 Timber frame (a) and tested wall (b) (Ruggieri 2015).

Regarding the *Baraccato* construction system, a full-scale specimen of Mileto masonry reinforced with timber elements was tested under quasi-static cyclic loading. A second specimen without the infill was also built and analyzed to better understand the contribution of masonry infill. In this case, it plays an important role due to the lack of diagonal bracings, thus the in-plane stiffness depends mostly on masonry characteristics. Wood species was Calabrian chestnut and all the connections are half-lap type nailed by pyramidal pins. Figure 2.18a and b show the frame geometry and wall configuration that presents also a centered opening. A uniformly distributed vertical load of 18.7 kN/m was considered as representative of the self-weight of upper structure of Mileto building. Moreover, the standard protocol provided by UNI EN 12512:2003 was adopted as cyclic loading procedure (Ruggieri 2015). Figure 2.19 shows the load-displacement curve (grey) and envelope (blue with yellow dots) of the tested wall.

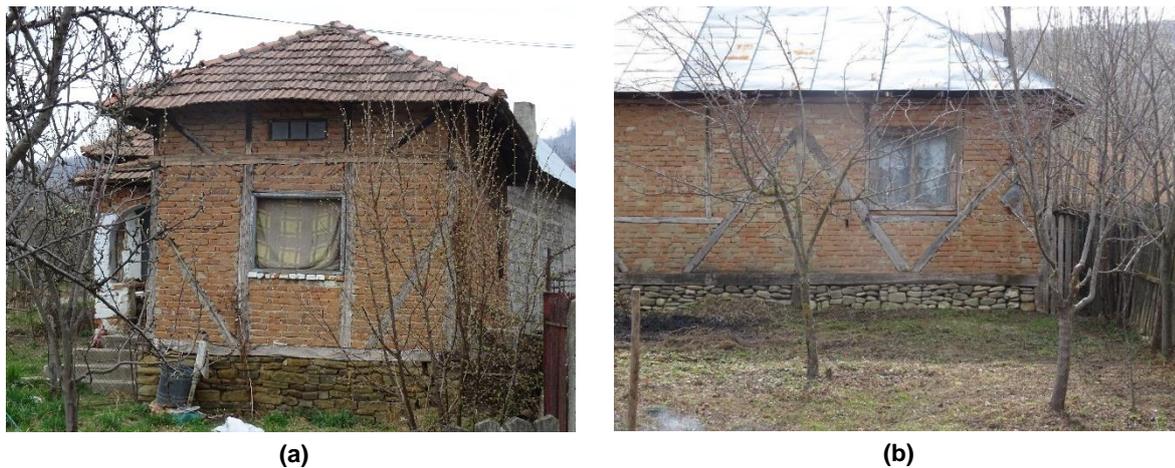
Figure 2.33 Timber frame geometry of building in Ocnești (a) and Vrancea (b), Romania (Dima and Dutu 2016).

The timber frame consists of posts and beams with a cross-section between 15x15 cm to 20x20 cm and 12x12 cm to 20x20 cm, respectively (Dima and Dutu 2016). The bracings range from 10x10 cm to 15x15 cm and their position does not match exactly the diagonal of the frame but they are connected to the post, not at the frame corner, Figure 2.33a. This may be due to construction: one hypothesis is that they may be just temporary supports of the post (Dutu et al. 2018a). Sometimes it was observed that the bracings are just connected to the lower beam because there is no column, Figure 2.33b. However, it is worth to stress that they are effective only in compression since they detach from the frame in tension due to the type of connections.

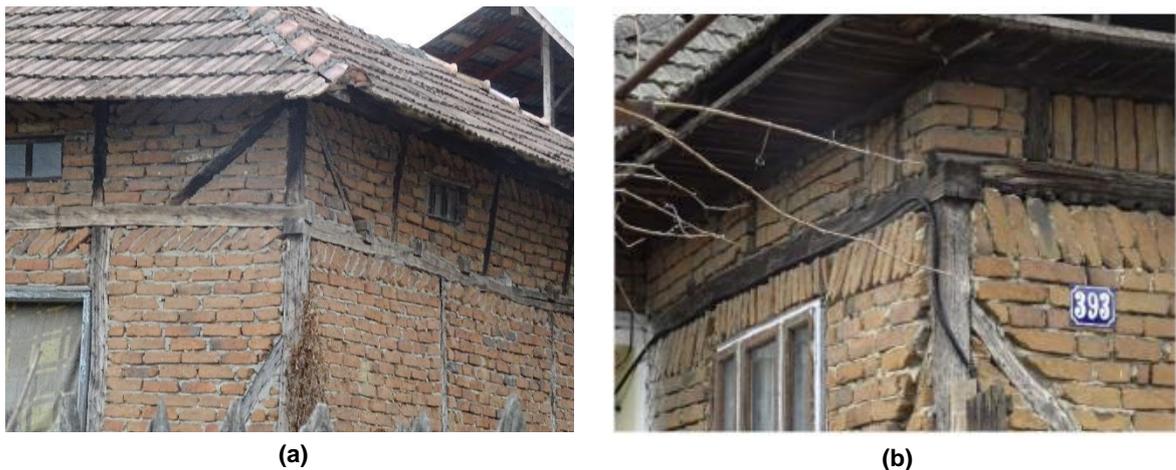
Figure 2.34 Diagonal bricks below the upper beam in Ocnesti (a) and mixed perimeter beam (b) (Dutu et al. 2018b)~.

The masonry infill is made of mud brick masonry stacked with mud mortar. It is obtained by mixing raw earth with sand and water even though the mix design varies from area to area depending on the type of soil and construction techniques. If the mortar includes a significant amount of clay, it will be more cohesive and harder, but it is likely to crack during the setting process, thus sand is required anyway. It should be noticed that the interaction between infill and timber frame is characterized by the lack of adherence, therefore out-of-plane mechanisms are not prevented (Dutu et al. 2018b). Moreover, the masonry infill bond varies along the height of the panel, Figure 2.34a and b. Units are placed horizontally up to the connection between post and bracing and then they are inclined to increase the friction in the upper part of the wall as well as the stiffness (Dutu et al. 2018b). Figure 2.34b shows a mixed perimeter beam above the upper stringer.

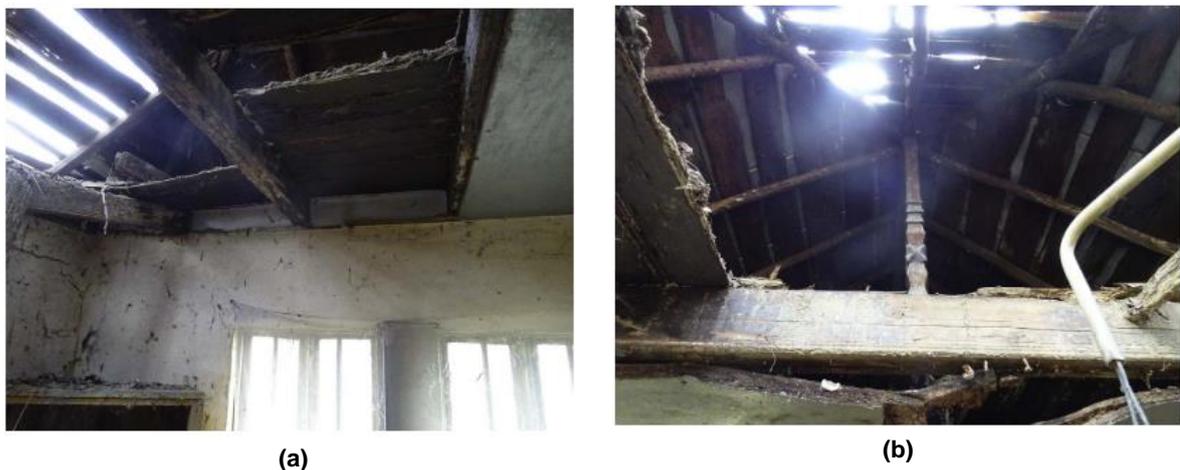
Figure 2.35 Detail of timber floor (a) and roofing system (b) (Dutu et al. 2018b).

The roofing system is made of timber as well. In some cases, it is connected to the walls through a perimeter beam that ensure a proper bond since it is a mixed timber-masonry beam. The most common types are hip or gable roof with king post trusses with no struts, Figure 2.35b. The traditional roof covering consists of shingles or ceramic tiles. Since the wooden shingles are prone to biological attacks, most of them have been replaced by steel sheets (Dutu et al. 2018b).

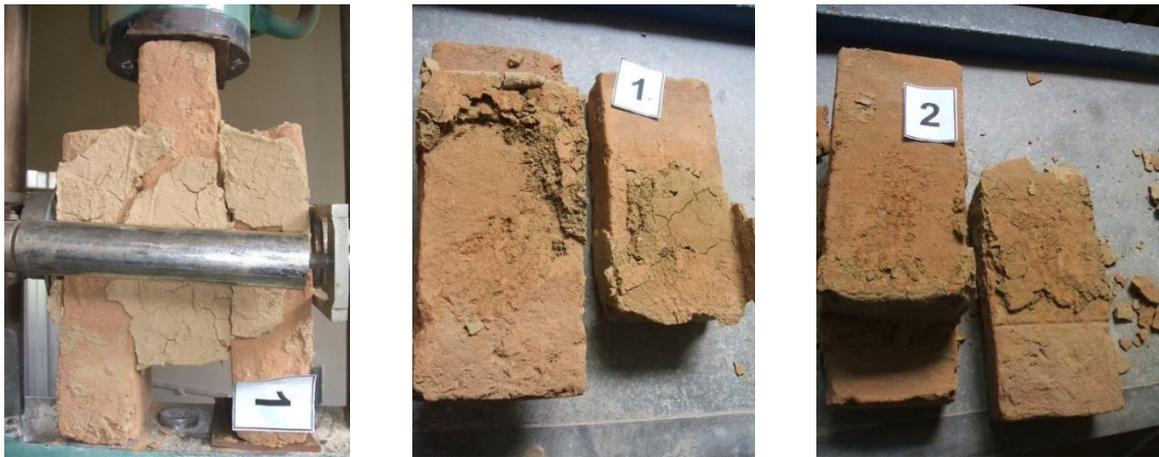
Figure 3.6 Shear test on masonry specimen (Dutu 2017).

Moreover, three specimens were tested to estimate the shear strength of masonry under low compression (0.1 MPa) according to SR EN 1052-3 (2003), Figure 3.6. The mortar was left to set under normal environmental conditions (temperature and humidity). Table 3.2Table 2.1 shows the dimensions of the specimens and the measured maximum forces. The average shear strength was 0.069 MPa, around 1/30 of the mean compressive strength, 1.86 MPa (Dutu 2017).

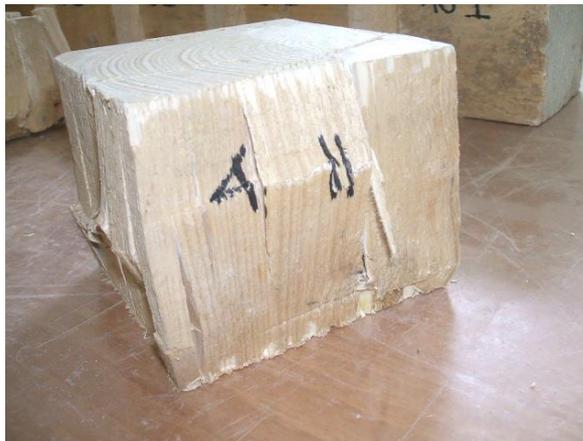
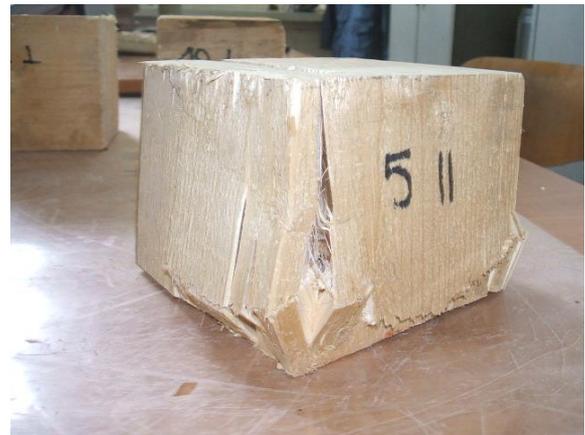
Figure 3.8 Damages on timber specimens after compression test parallel to fiber direction (Dutu 2017).
Table 3.6 Size and compressive strength perpendicular to grain direction of tested specimens in INCERC, Bucharest (Dutu 2017).

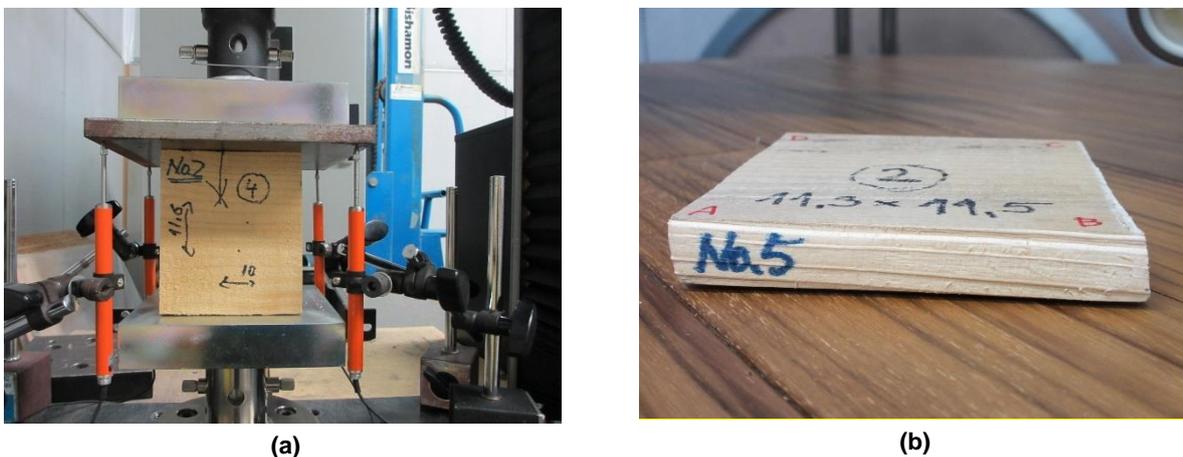
Figure 3.10 Compressive tests on timber specimens: cubic (a) and rectangular (b) (Dutu 2017).

The previous outputs are compared with those resulting from tests performed on the same timber species (Romanian fir) in Japan (Dutu 2017). They are presented to better characterize timber mechanical properties such as compression perpendicular to the grain. In this case, both cubic and rectangular specimens were tested in BL-Institute, Figure 3.10. The average ultimate strength of cubic specimens was 4.38 MPa, Table 3.7 and a similar value (5.02 MPa) was obtained for rectangular ones, Table 3.8. Both values are comparable with the compressive strength perpendicular to the grain measured in the previous experimental tests (5.06 MPa). In addition, the mean yielding strain of cubic specimens (2.8%) is almost half of the one for rectangular specimens (5%), Table 3.7 and Table 3.8. In terms of average initial stiffness, cubic specimen showed more stiffness, 175.24 MPa, than the rectangular ones, 102.67 MPa.

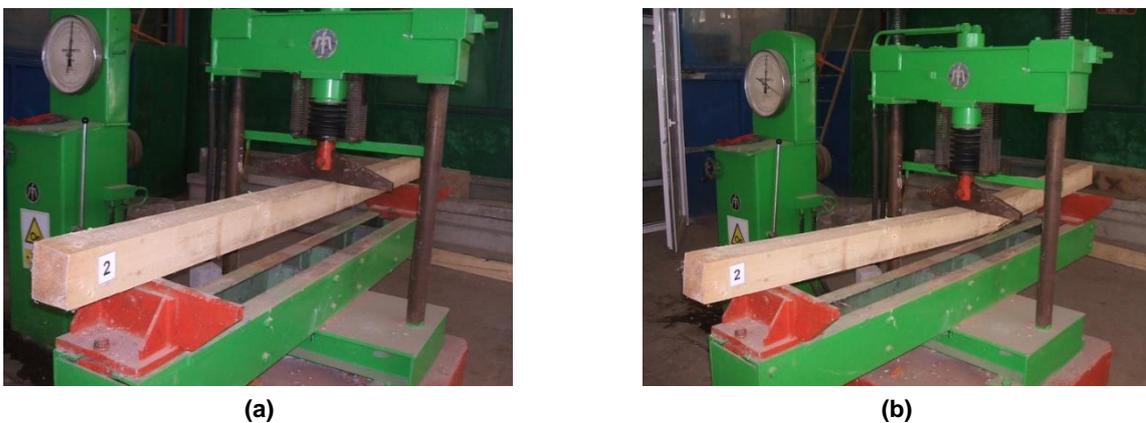
Figure 3.11 Bending tests on timber specimens: first (a) and ultimate (b) step (Dutu 2017).

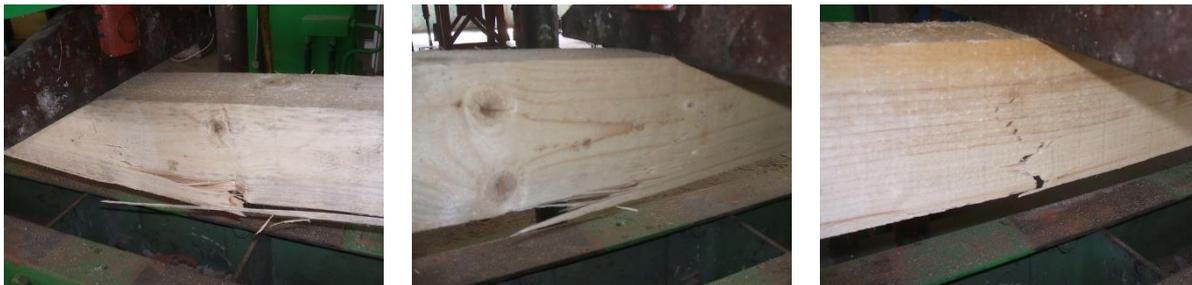
Figure 3.12 Types of failure mechanisms of 3-point bending test (Dutu 2017).

where F_{max} is the maximum force, l the distance between the supports (2000 mm), b and h the dimensions of the cross-section. Table 3.9 shows the average bending strength per specimen and the mean value of 3.59 MPa, while the types of failure mechanisms are shown in Figure 3.12.

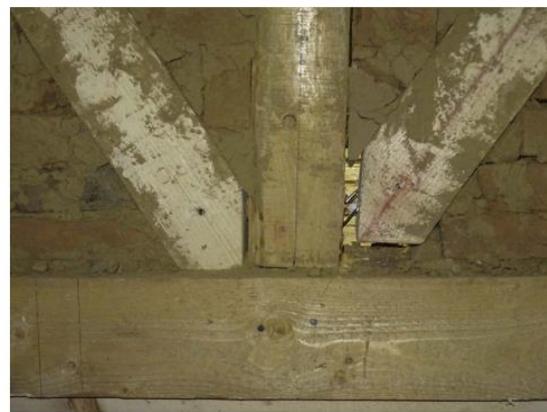
Figure 3.17 S1 damages: compression parallel to the grain (a) and diagonal detachment (b) (Dutu et al. 2018b).

Although S2 is more damaged than S1, both specimens show a similar pattern at their last step such as local compression perpendicular to the grain in the upper cross-halved joint and pull-out of the diagonal bracing subjected to tension which goes back to the initial position during the reverse cycle, Figure 3.16a and b. Specimen S1 does not show significant uplifts in the timber joints (around 1 mm in the bottom connection as long as the transducers worked properly), while S2 reveals larger uplifts in the lower (up to 25 mm) and upper connections, Figure 3.17a and b. This is due to the arrangement of the bracings that push against the upper beam in S2. It is important to note that brick masonry infill is prone to out-of-plane collapse in case of earthquakes since the infill-to-frame adhesion is very low. The infill does not increase significantly the wall stiffness because it was already cracked due to shrinkage almost from the beginning and it detached from the timber frame after the first cycle. However, masonry infill can prevent buckling of the diagonals due to its confinement effect and can increase the seismic energy dissipation through shear sliding. Moreover, the crack pattern and resulting amount of dissipated energy depends also on the strength of the mortar: if a weak one is applied, the dissipation will occur along the joints through cracking and sliding, while with a strong mortar and weak units the cracks will develop at the interface between mortar and units and through the elements.

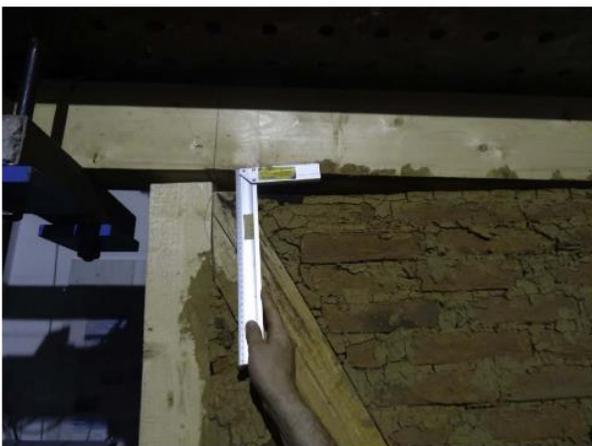
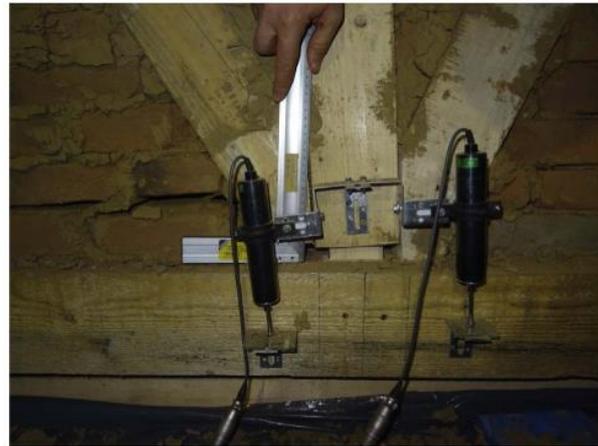
Figure 3.18 S2 damages: uplift of upper beam (a) and central post (b) (Dutu et al. 2018b).

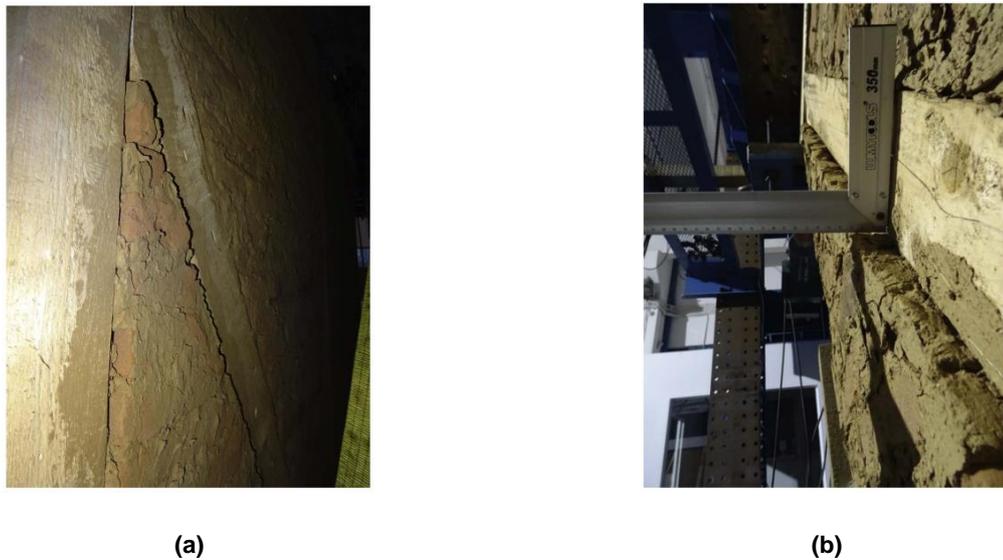
Figure 3.19 Out-of-plane of masonry infill S1 (a), S2 (b) (Dutu et al. 2018b).

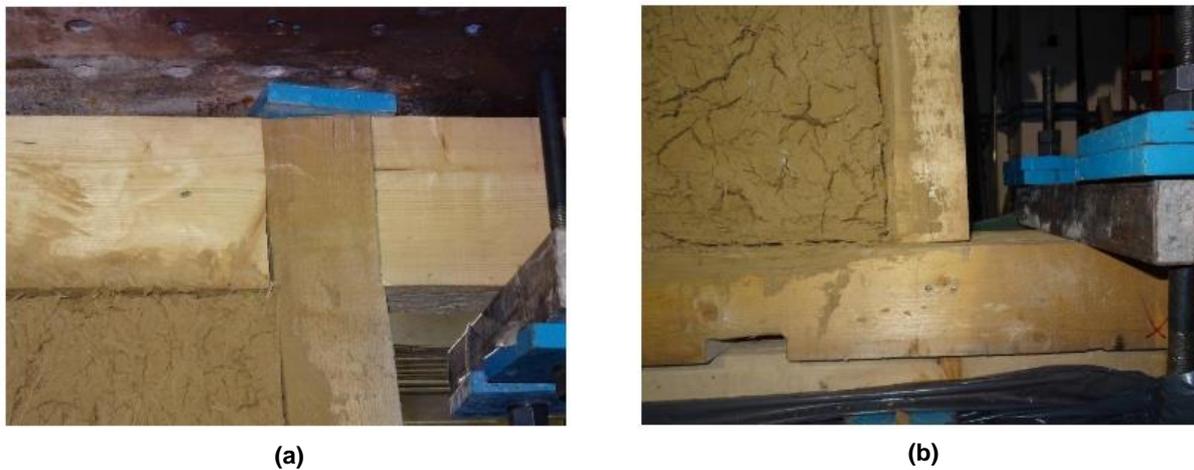
Figure 3.22 S3 damages: compression perpendicular to grain (a), small uplift external connection (b) (Dutu et al. 2018a).

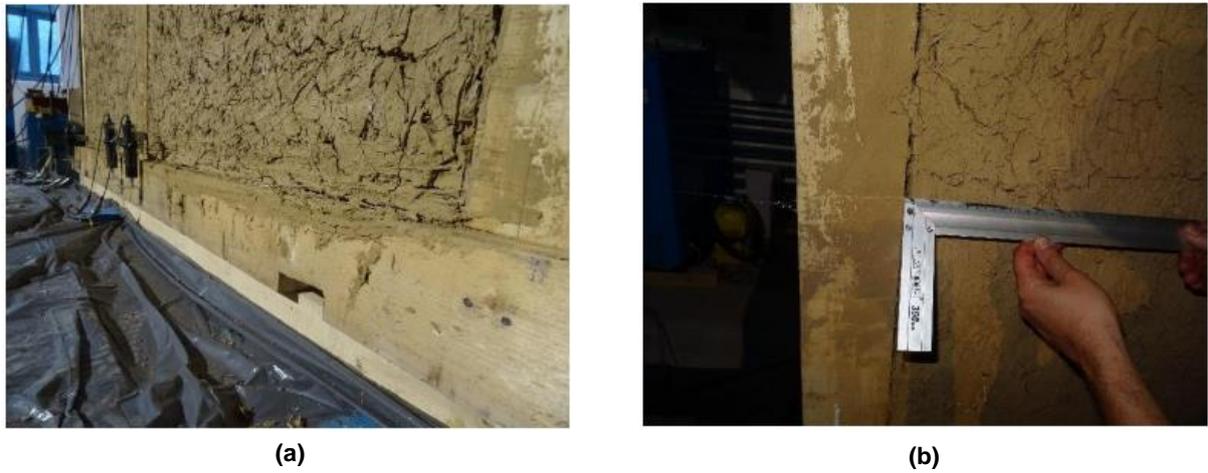
Figure 3.23 S3 damages: no out-of-plane mechanism (a), detachment of infill (b) (Dutu et al. 2018a).

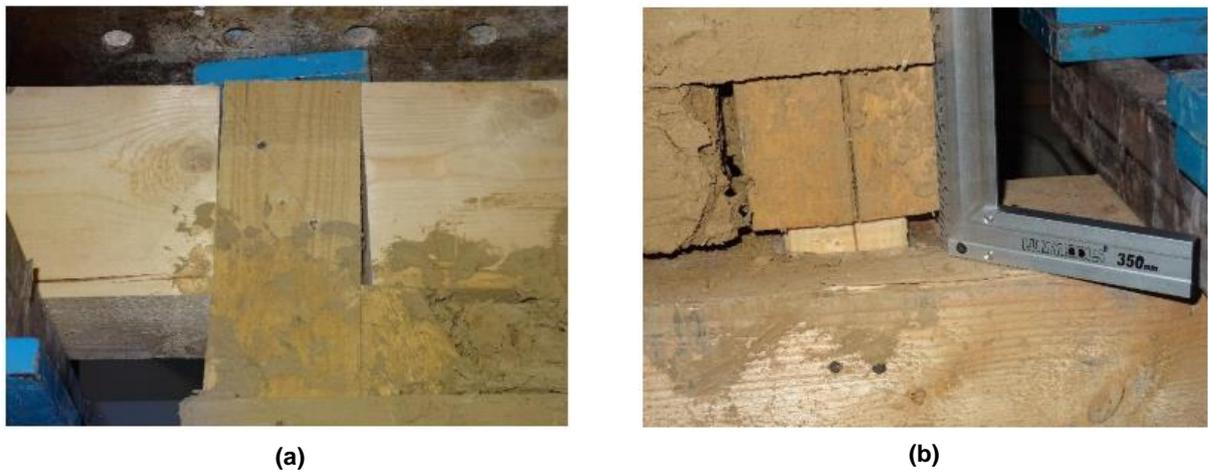
Figure 3.24 S4 damages: compression perpendicular to grain (a), uplift of external connection (b) (Dutu et al. 2018a).

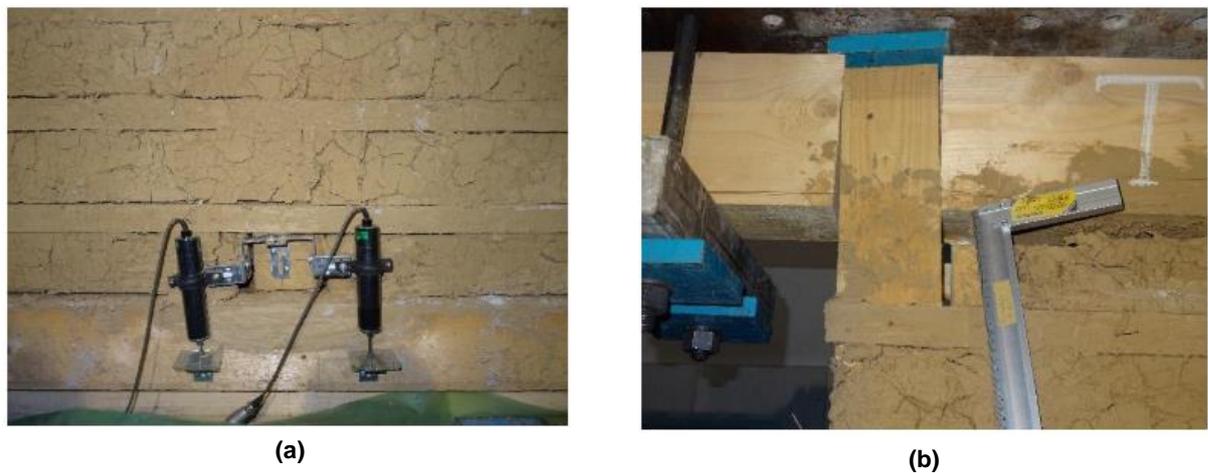
Figure 3.25 S4 damages: central connection with detachment of bracing (a), detachment upper beam (b) (Dutu et al. 2018a).

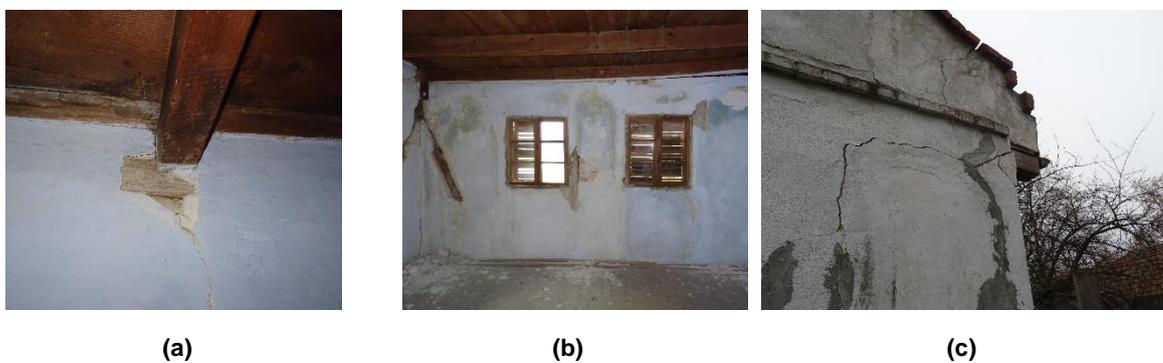
Figure 6.18 Minor cracks (a), detachment of plaster (b) and crack of masonry infill (c).

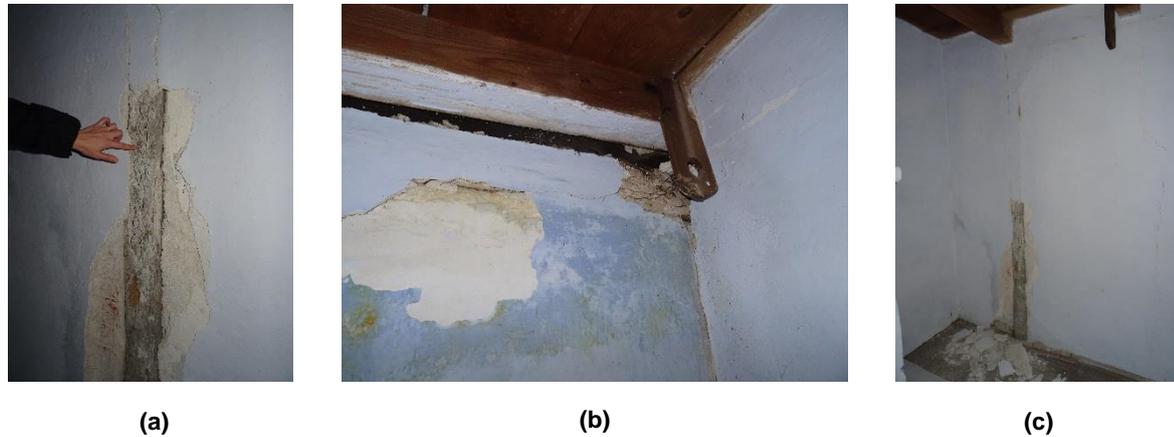
Figure 6.19 Reinforced render along post (a) and beam (b), and its detachment (c).

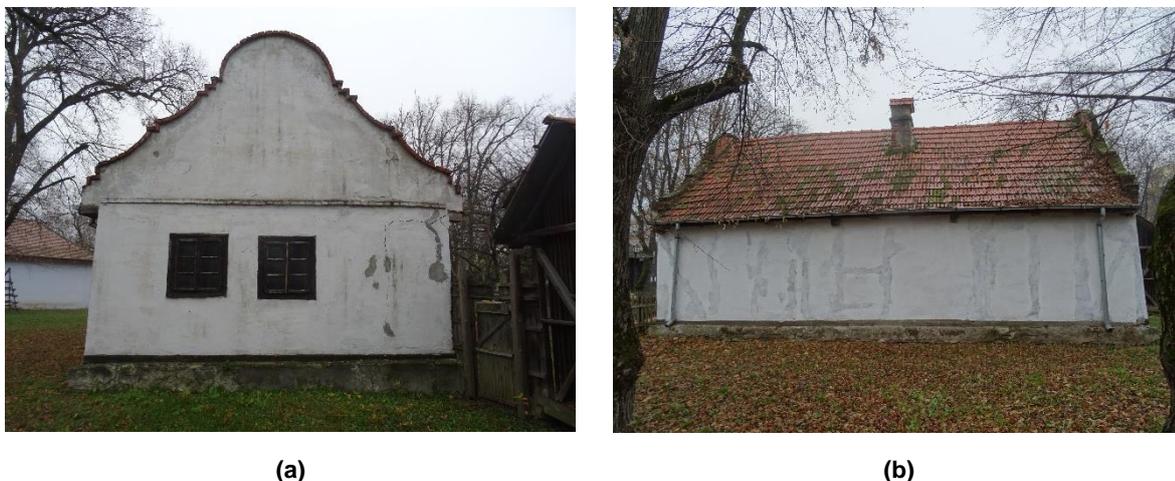
Figure 6.20 Moisture-related problems in TW4 (a) and LW1 (b) walls.
