**1<sup>st</sup> International Conference  
on Restoration of Heritage  
Masonry Structures  
Cairo, Egypt  
April 24-27, 2006**

## **Structural Restoration of Monuments: Recommendations and Advances in Research and Practice**

Paulo B. Lourenço<sup>1</sup>

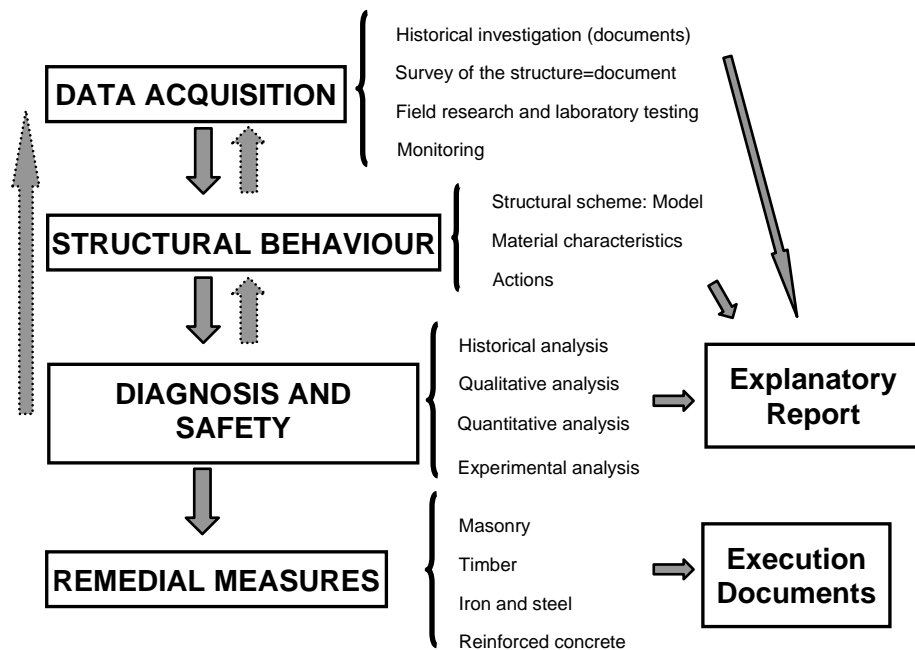
Figure 1 - Flowchart with the methodology for structural interventions<sup>2</sup>

The recommended methodology for completing a project is shown in Figure 1, where an iterative process is clearly required, between the tasks of data acquisition, structural behavior, and diagnosis and safety. In particular, diagnosis and safety evaluation of the structure are two consecutive and related stages on the basis of which the effective need for and extent of treatment measures are determined. If these stages are performed incorrectly, the resulting decisions will be arbitrary: poor judgment may result in either conservative and therefore heavy-handed conservation measures or inadequate safety levels. Evaluation of the safety of the building should be based on both qualitative (as documentation, observation, etc.) and quantitative (as experimental, mathematical, etc.) methods that take into account the effect of the phenomena on structural behavior. Any assessment of safety is seriously affected by the uncertainty attached to data (actions, resistance, deformations, etc.), laws, models, assumptions, etc. used in the research, and by the difficulty of representing real phenomena in a precise way.

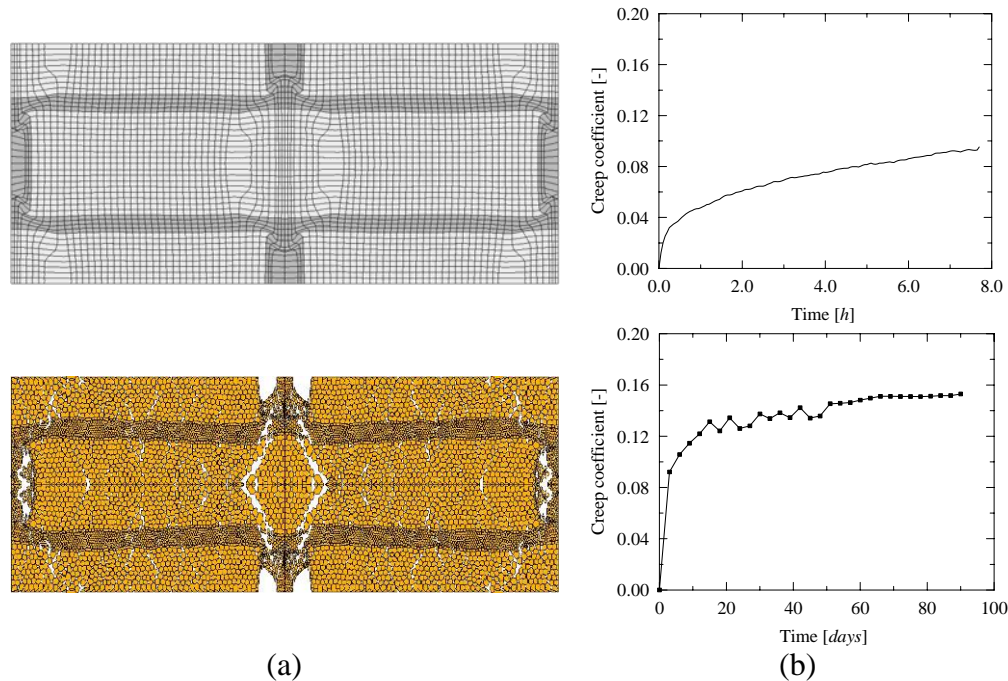
**Figure 2 - Masonry under compressive behavior<sup>9</sup>, (a) short-term and (b) long-term loading**

loading<sup>9</sup>, see also Figure 2. Figure 2a shows the simulation of a masonry representative volume under compression, with a continuum and particulate model. The differences found in terms of simulated compressive strength are up to 30%. Figure 2b shows a striking difference between strain rate values in short-term and long-term creep tests, meaning that the minimum duration of loading when conducting creep tests at high stress levels must be carefully selected.

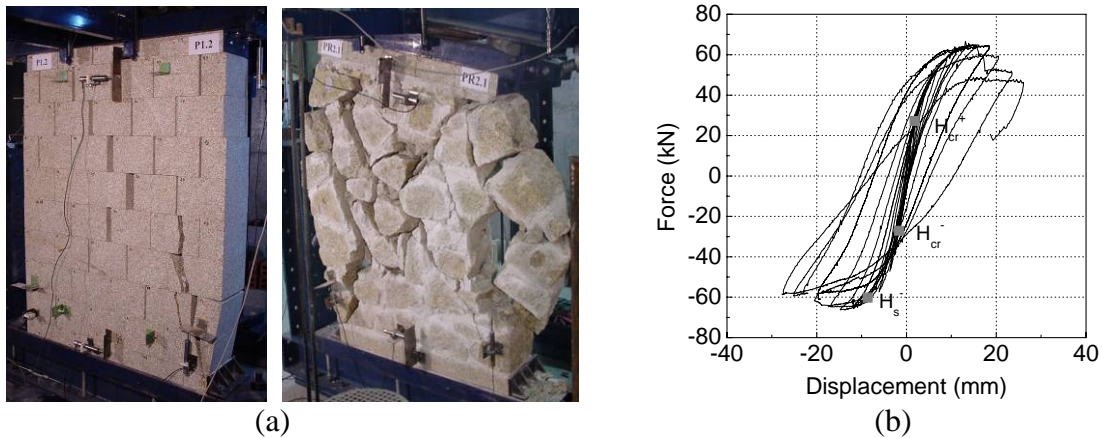
**Figure 3 - Behavior of stone masonry walls with different bond<sup>6</sup>: (a) failure modes and (b) selected force-displacement diagram.**

Scarce experimental information is available for stone masonry walls and a comprehensive testing program was started at University of Minho, aiming at increasing the insight about the behavior of typical ancient masonry walls under cyclic loading<sup>6</sup>. Besides the strength and stiffness characterization, information about nonlinear deformation capacity was obtained in terms of ductility factors and lateral drifts, which represents a step forward for the new concepts of performance based design. Regular and irregular stones have been adopted, see Figure 3. Although no significant differences were found in terms of strength and lateral stiffness among the distinct types of walls, low mortared strength masonry walls exhibit markedly higher level of energy dissipation when compared with dry stacked masonry.

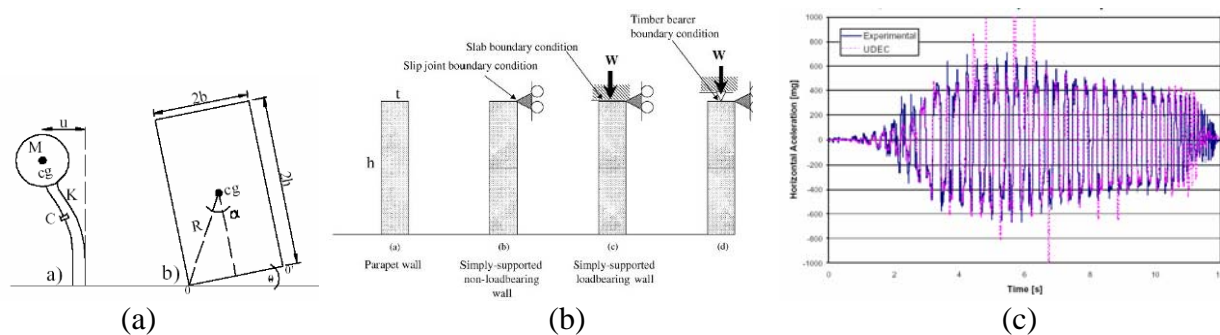
**Figure 4 - Dynamic behavior of blocky stone structures: (a) simplified models for analysis, (b) possible out-of-plane conditions for masonry walls, and (c) typical experimental / numerical results for hanning sinusoidal forced vibration**

The behavior of masonry can often be associated with dry blocky structures, which feature zero tensile strength in the joints but horizontal homogenized tensile strength and shear strength due to frictional effects. Limit analysis simulations are often used in practice for safety assessment and strengthening design. In order to extend limit analysis formulation to include dynamics and in order to study out of plane seismic behavior of masonry walls, another comprehensive testing program was set-up at University of Minho and National Laboratory of Civil Engineering (LNEC, Portugal). Figure 4 illustrates the details of the testing program, including simplified

analysis models, structures under analysis and results. Tests of single blocks, two blocks and a dolmen structure have been carried out<sup>10,11</sup>.

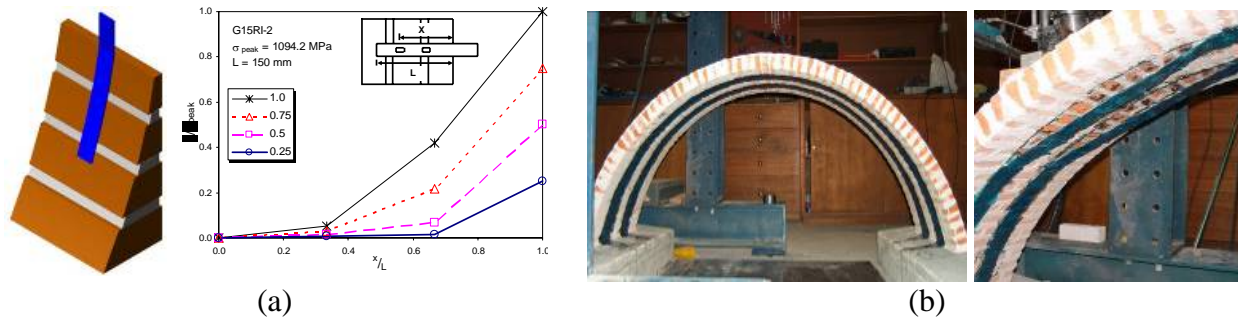
**Figure 5 – Traditional masonry strengthened with FRP: (a) bond tests with different masonry curvatures; (b) arch tests under point load**

Among the materials used to repair or upgrade civil engineering structures, there has been an increasing interest devoted to the use of FRP (fiber-reinforced polymer) composites in the form of bonded surface reinforcements. A set of eight arches, built with traditional low strength materials, have been tested under a monotonic vertical load applied at the quarter span, with different positions for the strengthening. In addition, also the bond between masonry and FRP have been characterized in a testing program being finalized, see Figure 5.

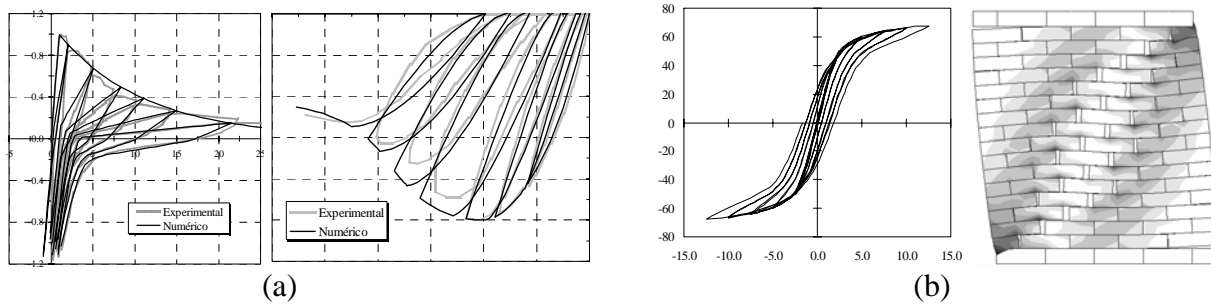
**Figure 6 – Behavior for an interface model extended to cyclic formulation: (a) tension-compression, (b) compression and (c) shear walls.**

A complete micro-model must include all the failure mechanisms of masonry, namely, cracking of joints, sliding over one head or bed joint, cracking of the units and crushing of masonry<sup>12</sup>. By adopting appropriate evolution rules in a finite element environment<sup>13</sup>, it is possible to reproduce non-linear behavior during unloading. Figure 6 shows the results of modeling a shear wall with an initial vertical pre-compression pressure. Figure 7 illustrates results using advanced solution procedures for non-linear optimization problems, with a limit analysis constitutive model that incorporates non-associated flow at the joints and a novel formulation for torsion<sup>14</sup>.

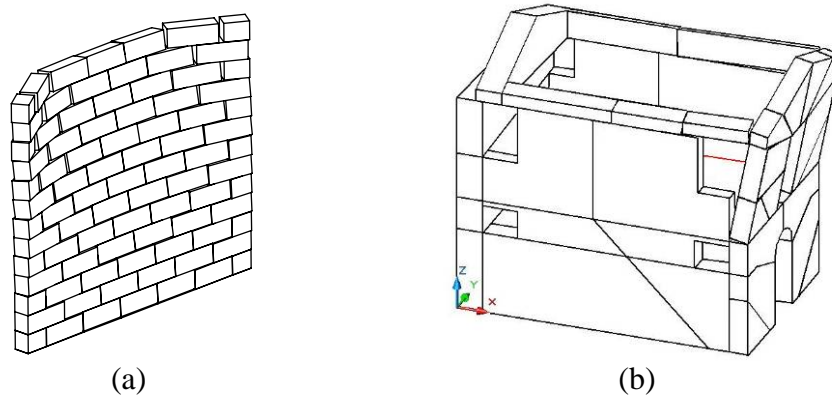
**Figure 7 – Results for rigid block limit analysis: (a) panel subjected to out-of-plane failure and (b) simplified analysis of a complete building with macro-blocks.**

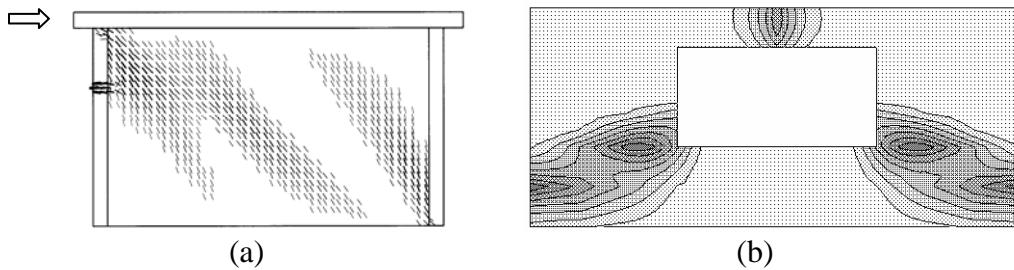
**Figure 8 – Results for macro-modeling analysis: (a) shear wall and (b) panel subjected to out-of-plane failure**

behavior, which includes different hardening/softening behavior along each material axis. Figure 8 shows the results of modeling a shear wall with an initial vertical pre-compression pressure and a wall panel subjected to out of plane failure.

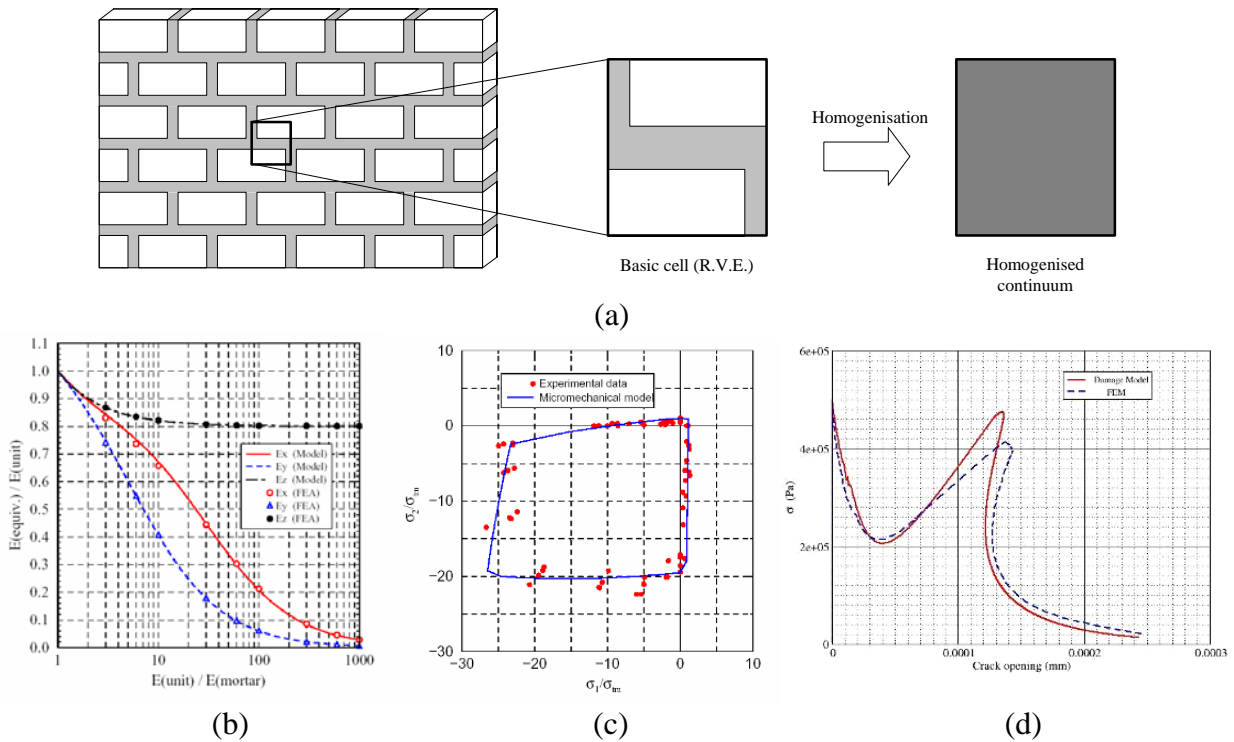
**Figure 9 – Results for homogenization (macro) analysis: (a) basic cell and process; (b) elastic homogenization; (c) failure surface; (d) constitutive behavior in tension.**

Another approach that is receiving much attention from researchers is the homogenization theory, in which the macro constitutive behavior of masonry is obtained from a mathematical process involving the geometry and the constitutive behavior of the masonry components. Figure 9 illustrates typical results obtained for homogenized failure surfaces and homogenized constitutive behavior<sup>16-18</sup>.

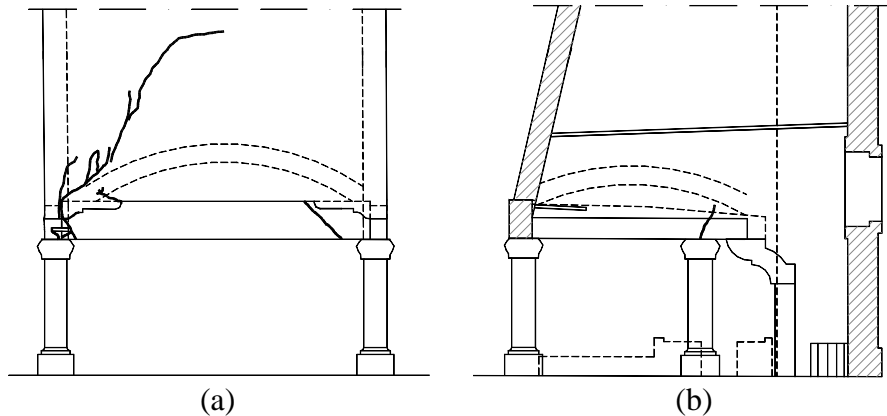
**Figure 10 – Observed cracking patterns: (a) main wall and (b) left side wall.**

The main damage exhibited by the chimney consists of a diagonal crack, which appeared suddenly in the main lintel, close to the right support, and resulted in temporary propping of the structure, see Figure 10. This crack intercepts the anchoring zone of a  $45^\circ$  iron tie (corroded) that connects the main lintel and the right lintel, which is a singular and weaker part of the lintel. The main lintel exhibits also several cracks close to the left support and in the vicinity of the iron

cramp, which is severely corroded. In the masonry wall above the main lintel, a set of diagonal cracks is present. The inspection openings in the plaster indicate that the cracks do not intercept the hidden masonry arch, but they run through the arch extrados. An ancient crack is also present in the left side lintel and wall, probably due to the reduction of height of the stone lintel in the corbel region, as discussed above. As a result of this crack, two stone columns under each side of the lintel were added to the structure in an unknown date.

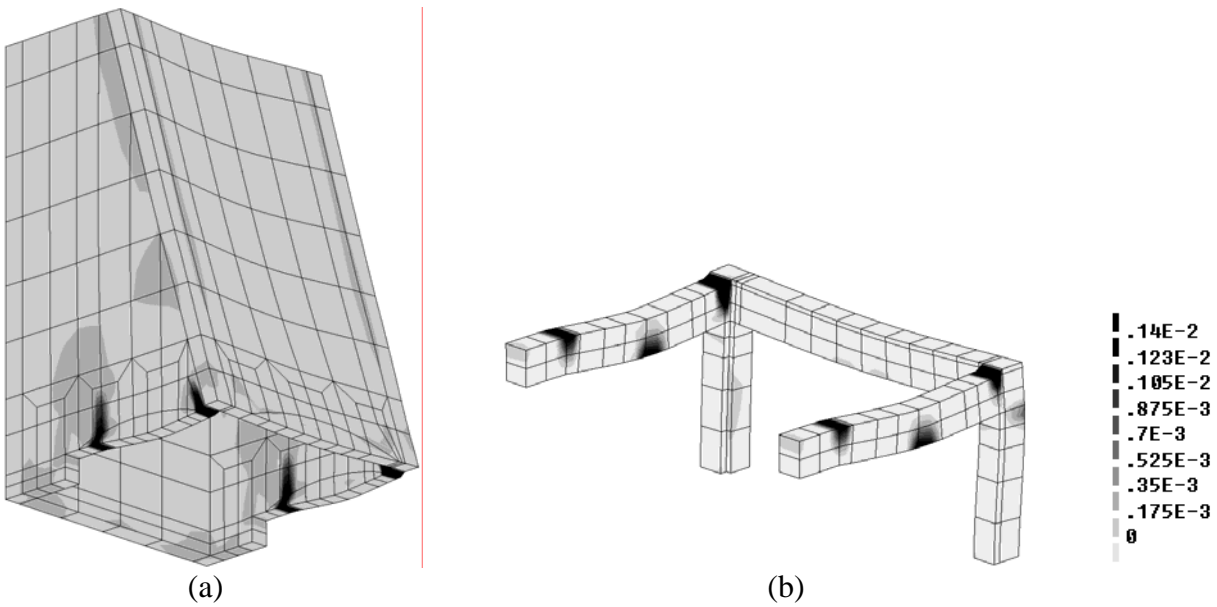
**Figure 11 – Maximum principal strains (cracks), plotted in the deformed mesh at collapse:  
(a) brick masonry part; stone columns and lintels. Results are dimensionless.**

Structural collapse was found for a load factor of 2.0, where the load factor represents the ratio between the applied loads and the original reference loads. For the ultimate load factor, the most damaged zones in the masonry walls occur close to the supports of the side lintels and in the lintels-columns set, which clearly defines the collapse mechanism, see Figure 11. Three plastic hinges appeared in the side lintels, one hinge at mid-span with cracking at the lower face of the lintels (positive bending moments), and two hinges at the supports with cracking at the upper face of the lintels (negative bending moments).

The results of the structural analysis clearly indicate that the sudden collapse of the main lintel was not due to structural reasons, being probably triggered by corrosion of the tie that connects the main lintel and the right side lintel (here, it is noted that the environment is aggressive due to rising damp, salt and organic materials from the old kitchen activity). Certainly the local discontinuity associated with the hole for anchoring the iron tie also contributes to weaken the main lintel. The structural analysis results justify the ancient damage in the left side lintel. In fact, the numerical simulation does not take into account the cross section reduction in the left side lintel (the height varies linearly from 0.46 m to 0.30 m), which would reduce the safety factor significantly. This justifies the remedial measures adopted in the past by adding new stone columns close to the back supports of the side lintels.

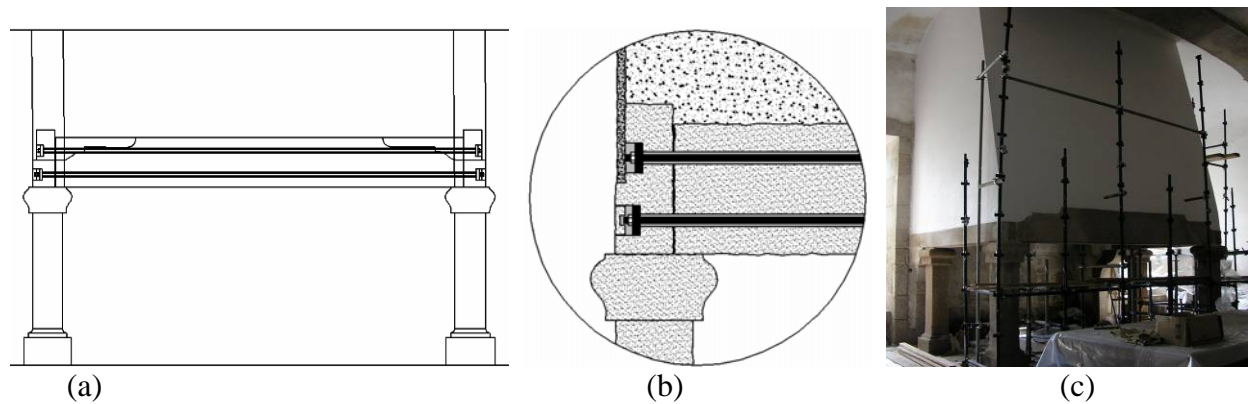
**Figure 12 – Strengthening: (a) front view; (b) detail of anchoring zone; (c) final aspect.**

The final solution consists of strengthening and repairing the main lintel including: (a) reconstitution of the original stone integrity by injection of epoxy resins; (b) hole drilling of the stone along its full length (4.70 m); (c) insertion of bars and injection of the hole. Figure 12 illustrates various details of the solution, which includes two stainless steel rods with a diameter of 25 mm as internal ties / reinforcement of the granite lintel. The ties were designed after the integration of the tensile stresses of the linear elastic results for the numerical model without arching action, which is conservative. These rods are inserted in drilled holes of 50 mm and are provided with anchoring plates of 120 mm. After adjustment of the bolts, the drilled holes are injected with fluid lime mortar. Stone stoppers at both ends of the bottom tie are also included so that the anchoring plates are not visible. The stoppers are glued with epoxy resin and are made from the actual core removed from the lintel. It is noted that the usage of stone stoppers in both ends of the ties requires the drilling to be executed from both sides, which requires precision and qualified workers.

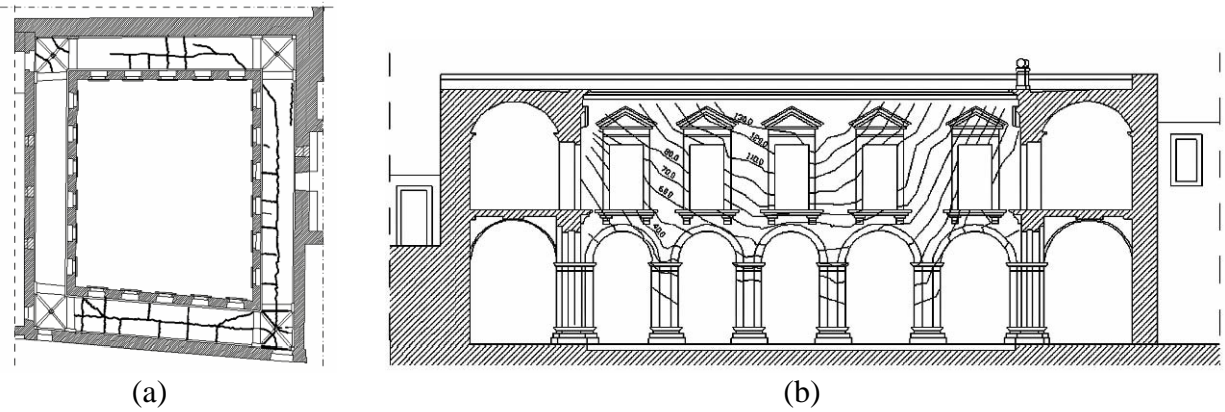
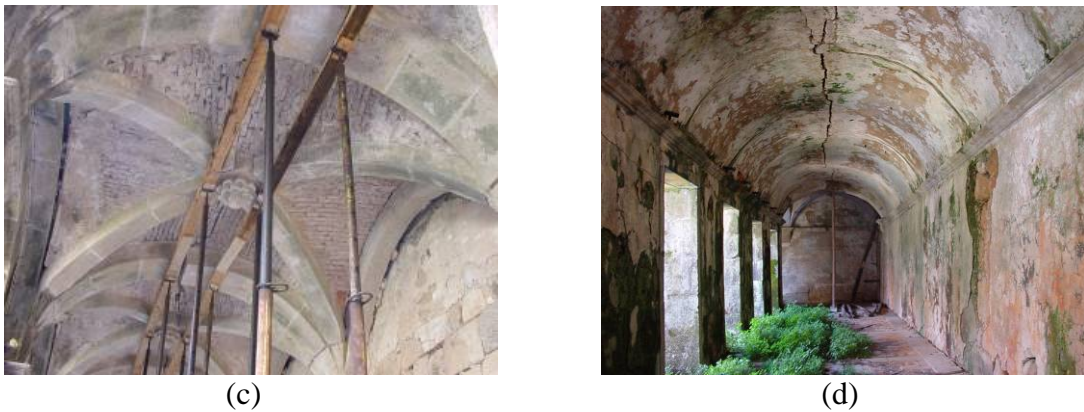
**Figure 13 – Damage in the Salzedas’ cloister: (a) mapping of cracks (2<sup>nd</sup> level); (b) out-of-plane displacements; (c) aspect of vault (1<sup>st</sup> level); (d) aspect of vault (2<sup>nd</sup> level).**

The condition of this cloister is quite poor, including biological colonization sometimes associated with moisture stains, deterioration of the bricks in the vaults, cracks with variable thickness, crushing of stones and excessive movements in walls and vaults<sup>20</sup>. The largest and widest set of cracks occurs in the barrel vaults of the 2<sup>nd</sup> level, as well as in two corners. The cracks occur mostly in the longitudinal direction, even if some transversal cracks also occur, up to a crack opening of 40 mm. The vaults of the first level also exhibit cracks, up to a crack opening of 15 mm. One wing is supported on temporary wooden poles. The walls exhibit widespread cracking at the 2<sup>nd</sup> level and almost no cracking at the 1<sup>st</sup> level. Vertical displacements up to 35 mm were measured at the key of the crossed vaults of the 1<sup>st</sup> level. But all the walls of the cloisters exhibit large horizontal movements that lead to the separation between the vaults and the walls, in a clear lack of verticality. The out-of-plumb displacement of the internal walls reaches values of up to 0.18 m. Several brackets supporting the crossed vaults of the first level show signs of compressive crushing. Also, a significant number of bricks show deterioration, particularly around the cracked areas. Figure 13 and Figure 14 detail typical observed damage.

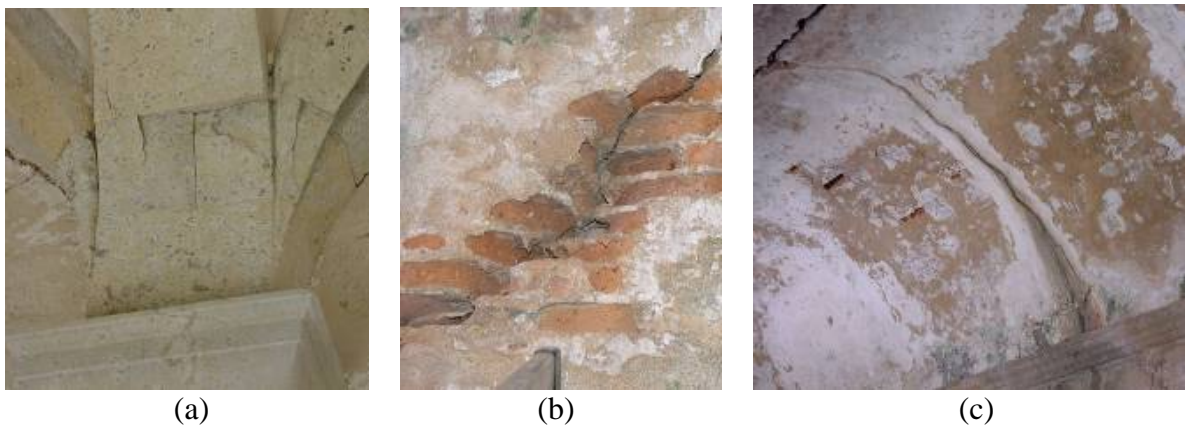
**Figure 14 – Damage in the Salzedas’ cloister: (a) crushing of brackets; (b) deterioration of brick; (c) moisture stains and biological colonization.**

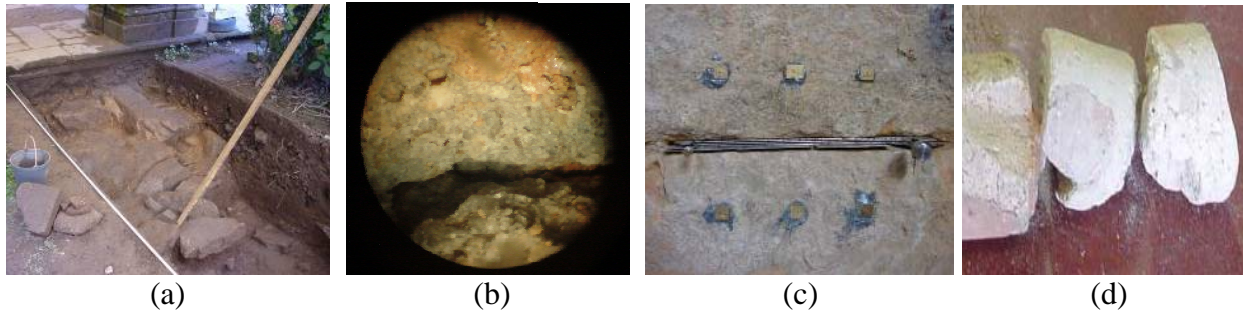
**Figure 15 – Inspection and diagnosis: (a) foundation pits; (b) boroscopic observations; (c) flat-jack testing; (d) coring.**

In order to characterize the cloister, to justify the observed damage and to define corrective measures, an experimental in-situ and laboratory testing program was carried out. This included a soil and foundation survey, visual inspection with the aid of an endoscope, flat-jack testing, coring, and chemical, physical and mechanical characterization of materials, see Figure 15. A numerical analysis of the structure allowed to discuss its safety and to better understand the causes of damage. The conclusions of the study were that: (a) the non-symmetry between the internal and external walls of the cloister resulted in movements in the direction of the court, as observed in the construction; (b) a linear elastic analysis of the construction results in very limited displacements (in the order of the millimeter) and moderate stress values (maximum tensile stress of  $+0.25 \text{ N/mm}^2$  and maximum compressive stress of  $-0.6 \text{ N/mm}^2$ ). The large displacements observed in the construction require a geometrical and physical non-linear analysis; (c) in order to obtain horizontal displacements in the order of the observed in the structure, it is necessary to consider the soil-structure interaction. It seems therefore that the foundations play a key-role in the observed damage; (d) the high movements recorded in the construction and the deterioration of the brick vaults indicate that the safety level of the structure is not compatible with any use and remedial measures are necessary, see Figure 16.

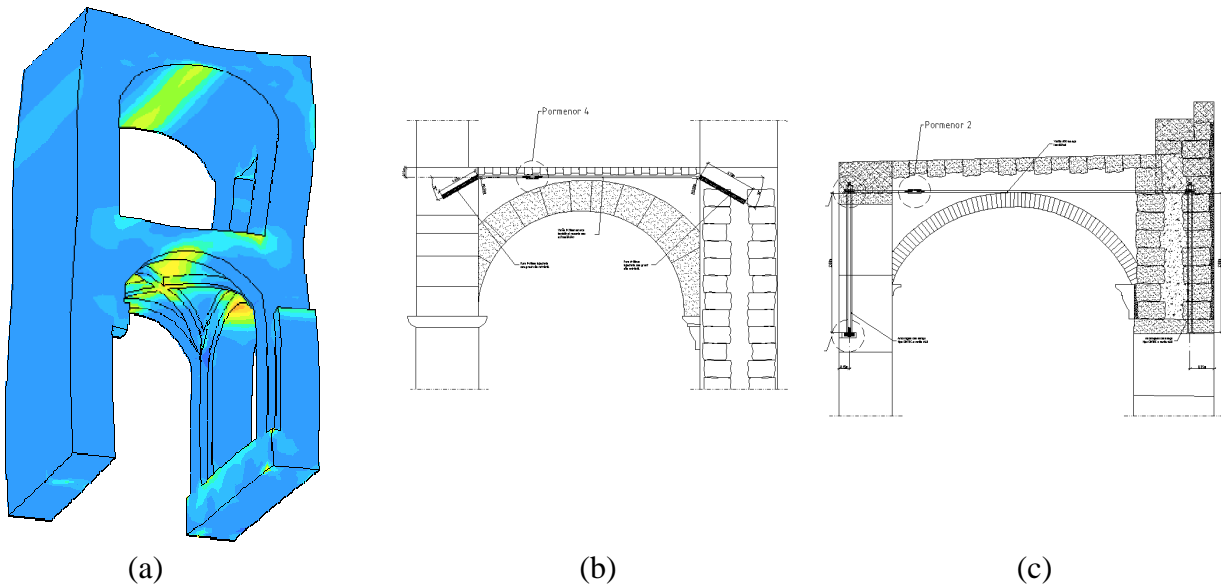
**Figure 16 – Remedial measures: (a) safety assessment; (b) 1<sup>st</sup> level tying; (c) 2<sup>nd</sup> level tying and stitching.**
