1 **Seismic vulnerability and loss assessment of Vila Real de Santo António, Portugal: application of**
2 **a novel method**

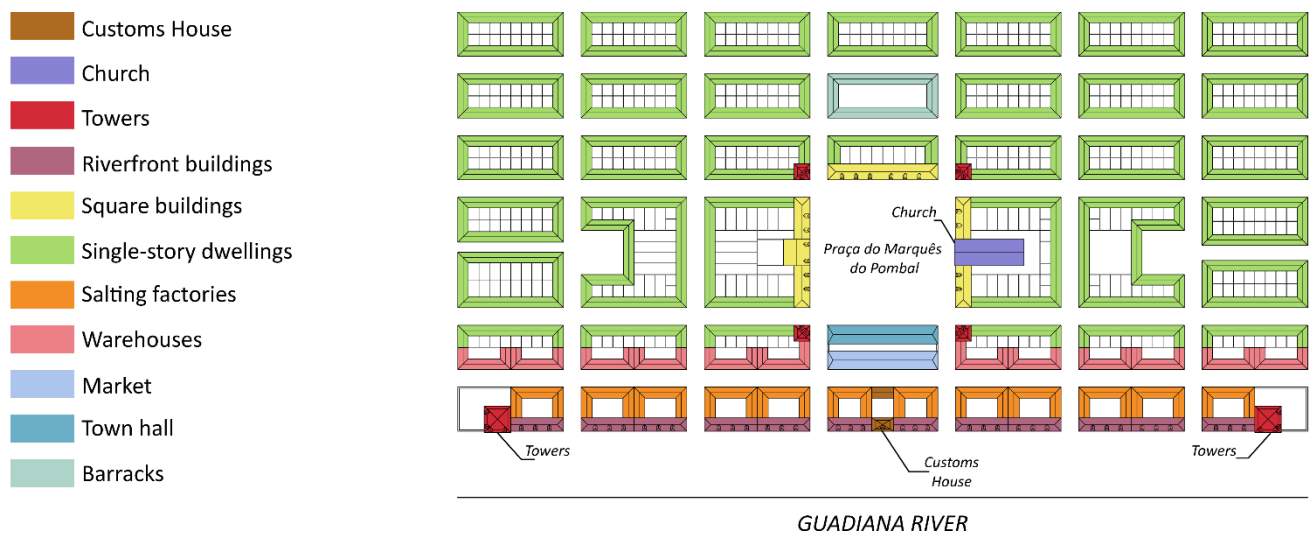
60
 61 Figure 1. Original plan of VRSA city center and main building types (adapted from Rossa 2009)

42 square buildings from Figure 1), was the inclusion of timber frame partition *frontal* walls connecting the timber
43 roof and the timber floor structures, analogous to the system developed for the reconstruction of Lisbon and known
44 as *gaiola Pombalina*. In addition, some ground floor rooms had vaulted ceilings supporting the first floor as a fire
45 prevention measure, as occurred in Lisbon (Mascarenhas 1996). The seismic concern that emerged after the
46 earthquake can also be perceived in the generalized good quality and strength of the original buildings of VRSA
47 (Oliveira 2009).

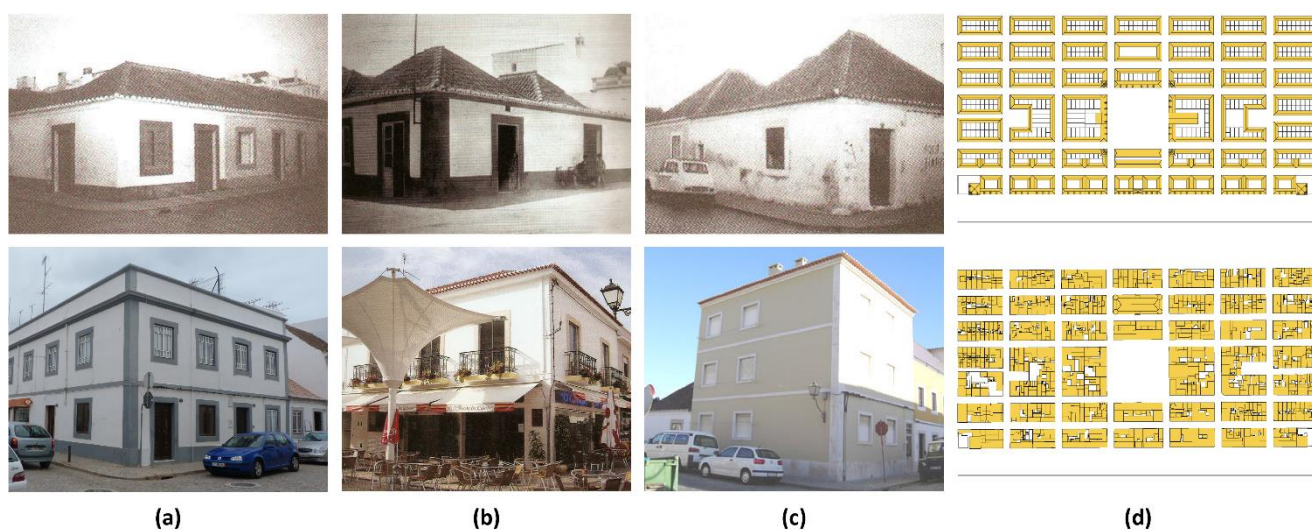
153 Figure 4. (a-c) Typical alterations occurred throughout the 20th century: original versus current condition (adapted
154 from Gonçalves 2009); and (d) comparison between the original and current plan of VRSA city center

149 alterations done in the historical city center and the degradation of the ideal originally designed plan. Figure 4
150 shows examples of the deep alterations on the built-up environment that took place in the last century in VRSA
151 and a comparison between the original and the current urban plan.

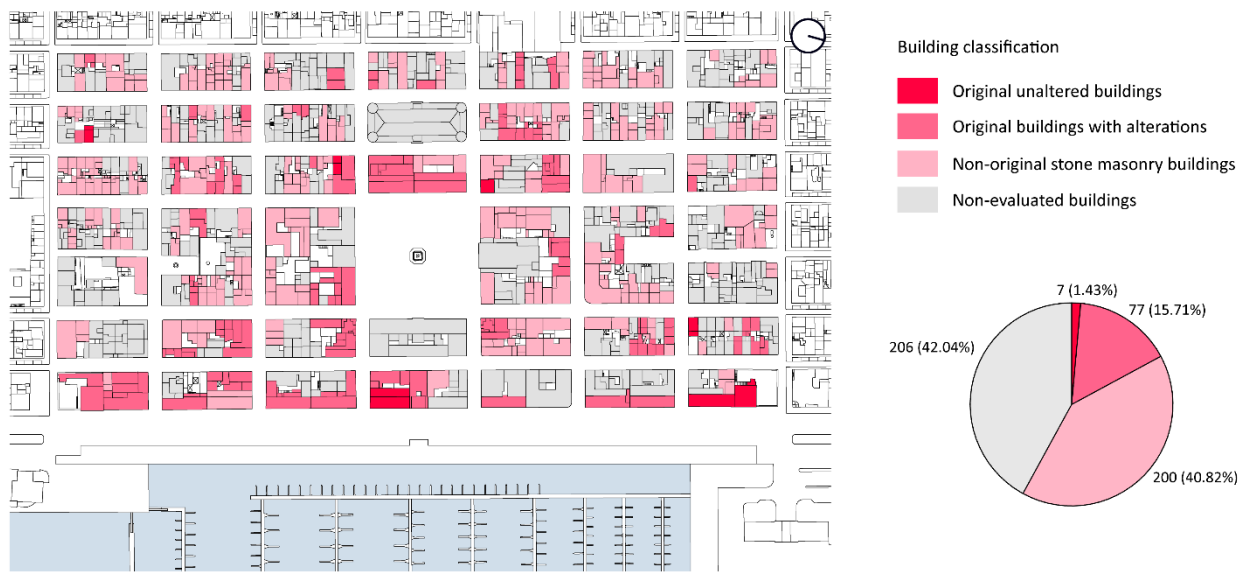
180 Figure 6. Evaluated buildings in VRSA city center classified according to their date of construction and altered
 181 condition

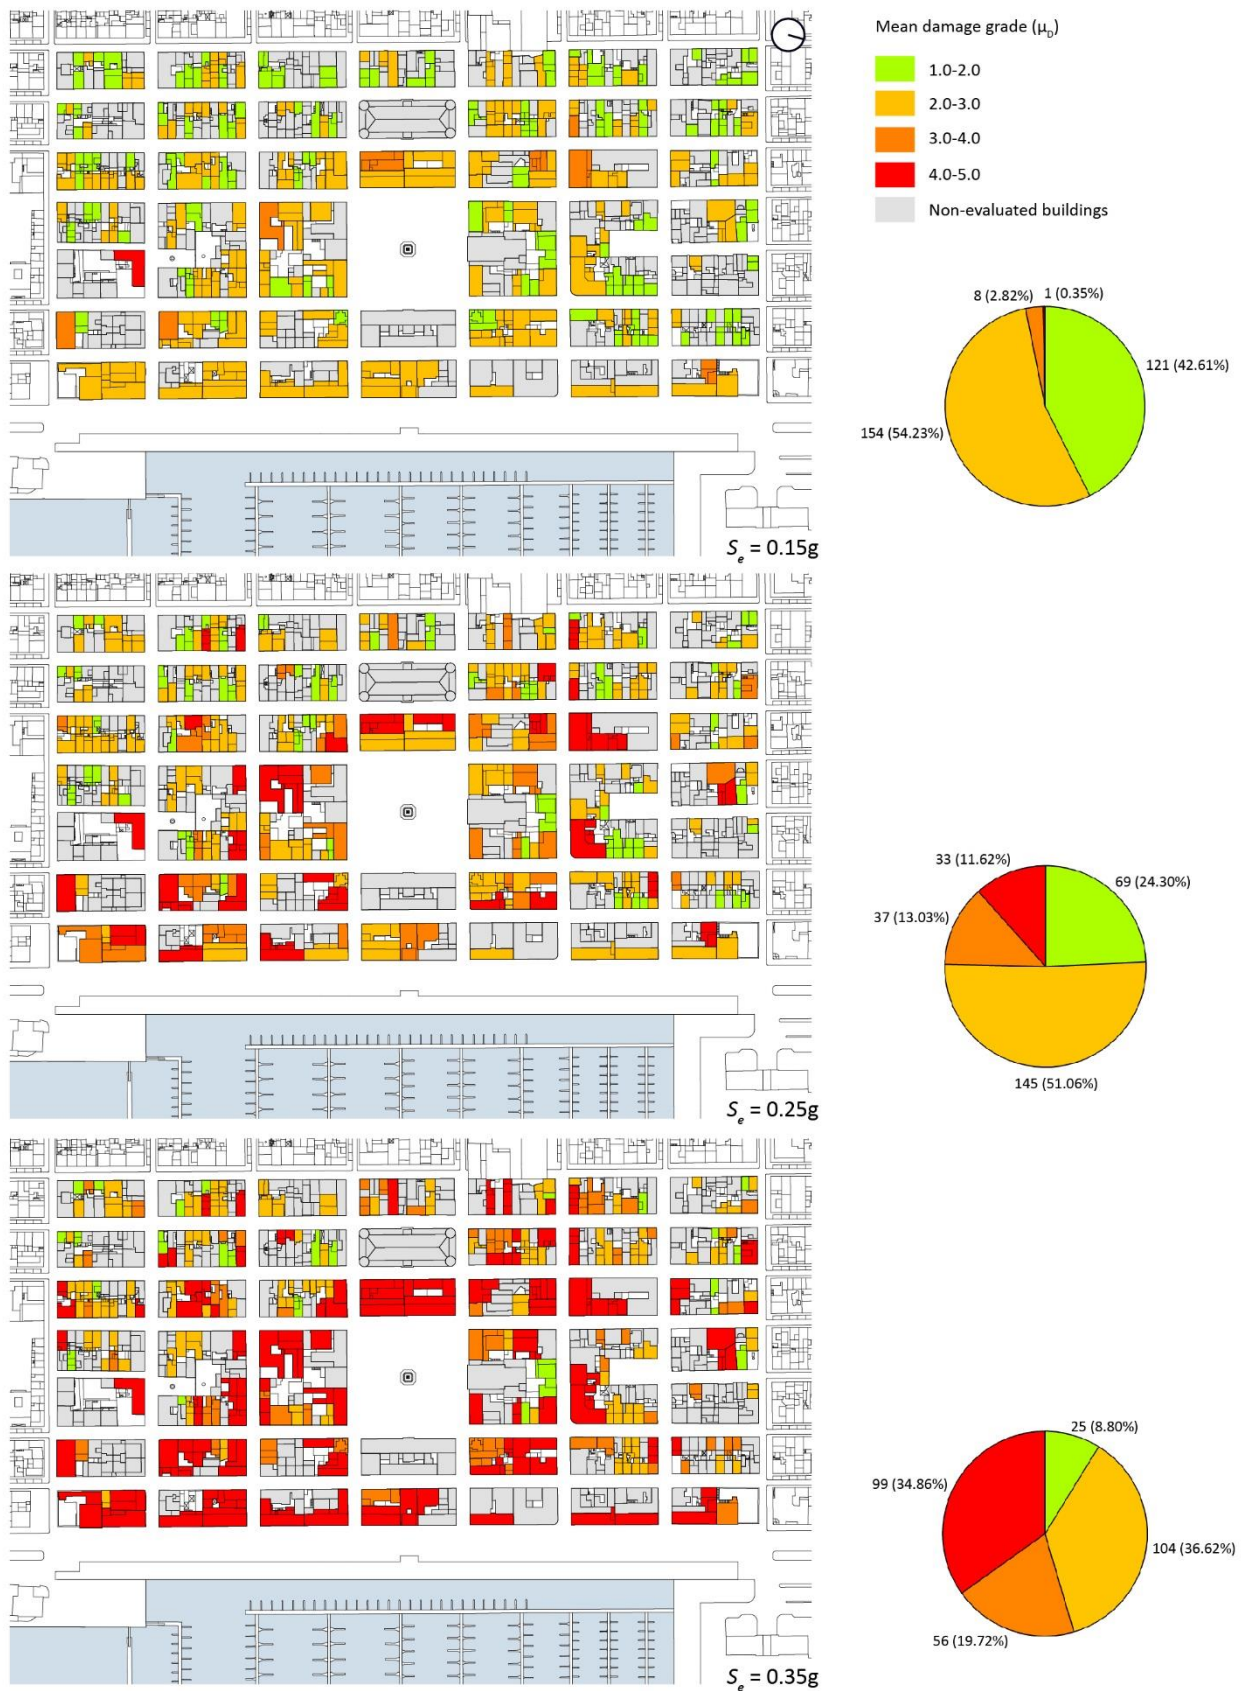
312 Figure 9. Damage scenarios for different seismic input in terms of **seismic demand (S_e)**: (a) 0.15g; (b) 0.25g; and
 313 (c) 0.35g

301 The GIS tool is also used to present the damage scenarios. Figure 9 shows the results for three different earthquake
 302 inputs: (a) $S_e = 0.15g$ ($PGA = 0.11g$); (b) $S_e = 0.25g$ ($PGA = 0.18g$); and (c) $S_e = 0.35g$ ($PGA = 0.25g$).
 303 The maps show that few damage is expected for an earthquake with $S_e = 0.15g$, for which only a reduced number
 304 of buildings would reach a state of severe damage ($\mu_D > 3$) and only one shows values of damage close to
 305 potential collapse ($\mu_D > 4$). This is in agreement with the high values of LS3 obtained. As it could be expected,
 306 the risk highly increases for an earthquake scenario with $S_e = 0.35g$, for which the majority of the buildings are
 307 expected to either show a state of severe damage or be close to potential collapse. Nonetheless, there is a high
 308 variability and the SAVVAS method is able to individualize well the seismic behavior of each building and the

309 maps show that there are several buildings presenting no structural damage even for an earthquake with $S_e =$
 310 $0.35g$.

323 application of the method, see Figure 9. Curve D2 thus represents the percentage of buildings in VRSA that would
 324 probably exceed damage grade 2, which, for example, is 78%, for an earthquake with $S_e = 0.15g$. This is higher
 325 than the 57% predicted by the individual assessment shown in Figure 9a. However, the amount of buildings
 326 expected to exceed damage grade 3 according to the fragility function is 2%, which is more in agreement with the
 327 results shown in Figure 9c. Despite the differences obtained, it should be highlighted that, given the uncertainties
 328 associated with this type of simplified assessments (also related to the evaluation of the parameters), a statistical
 329 interpretation of the results is typically preferred (Ferreira et al. 2017).

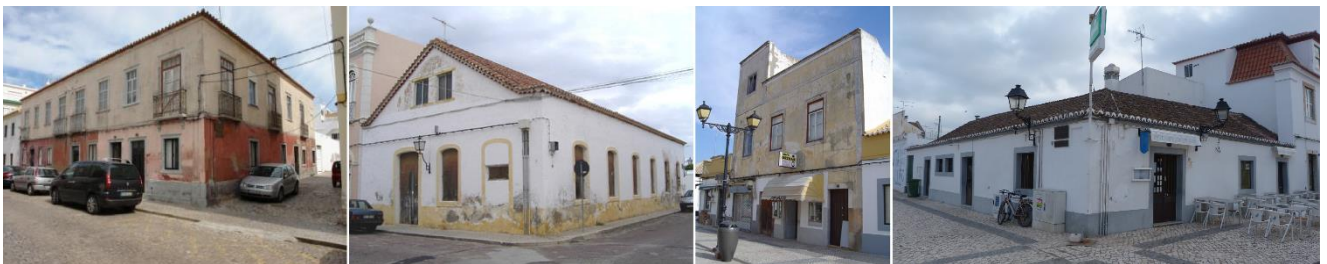
438
439 Figure 13. Examples of the 33 buildings in VRSA selected for the application of retrofitting solutions

429 A total of 33 buildings were selected based on the values of load factor associated to LS3 below 0.25g, which is
430 close to the seismic demand computed with Eq. 1 from the PGA established by the code of 0.17g (NP EN1998-1
431 2010). A common characteristic of the 33 buildings that show higher vulnerability is that they have greater
432 dimensions than the typical buildings from VRSA city center. Most of them have two or more floors and/or have
433 long facades walls presumably spanning large distances (high values for P2). It should be noted that, prior to the
434 definition of a retrofitting strategy, a more detailed assessment is always recommended, in order to confirm the
435 real condition of the building. For instance, regarding P2, the interior configuration should be evaluated in detail
436 to confirm that there are not intermediate supports well connected to the façade wall that can be considered as

437 shear walls. Figure 13 shows examples of some of the buildings showing higher vulnerability.

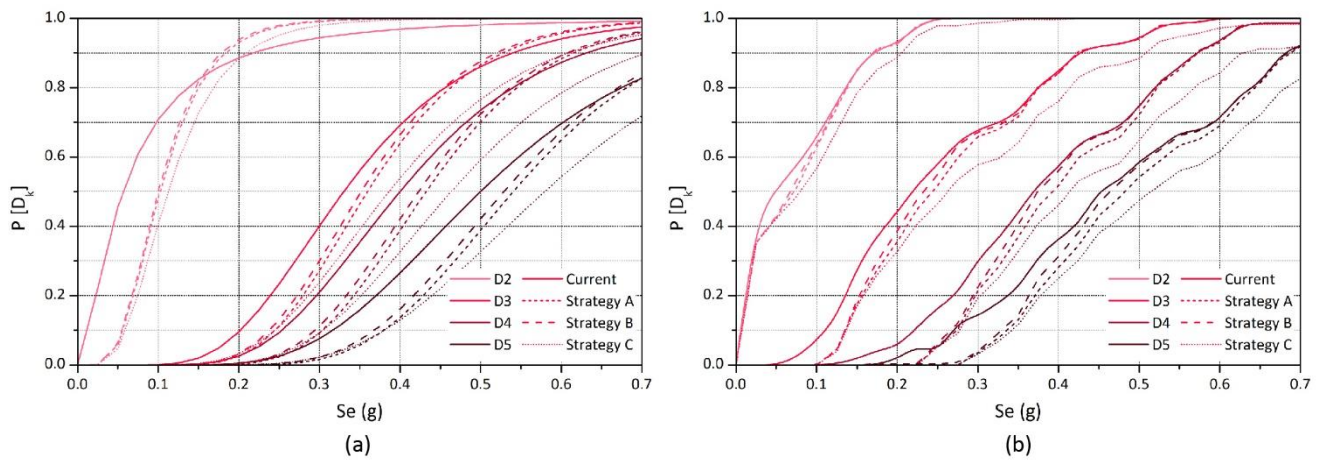
490 Figure 14. Comparison between the four different scenarios considered in terms of fragility curves: (a) analytical
 491 fragility curves; (b) empirical fragility curves

474 The differences are also visible in terms of fragility curves (Figure 14). Note that both the analytical and the
475 empirical sets of fragility curves were prepared and shown in Figure 14a and b, respectively. The trend observed

476 in both sets is similar. There is a notable reduction of the number of buildings ($P[D_k]$) that are expected to exceed
477 each damage grade, particularly for values of $S_e < 0.25g$. The three retrofitting strategies are efficient in delaying
478 the occurrence of severe damage with potential risk of collapse ($\mu_D > 4$). Strategy C is the most effective but also
479 the costliest because requires a greater intervention. Strategy A, on the contrary, only intervenes at the diaphragm
480 level, and proves to effectively reduce the seismic risk. For instance, for the earthquake used as reference from
481 the code of $S_e = 0.24g$ ($PGA = 0.17g$), this primary safety assessment shows that less than 5% of the buildings
482 is expected to show severe damage and risk of collapse ($\mu_D > 4$). It should be highlighted the results of first level
483 simplified assessments should be taken as a first estimation and interpreted in comparative terms. The process

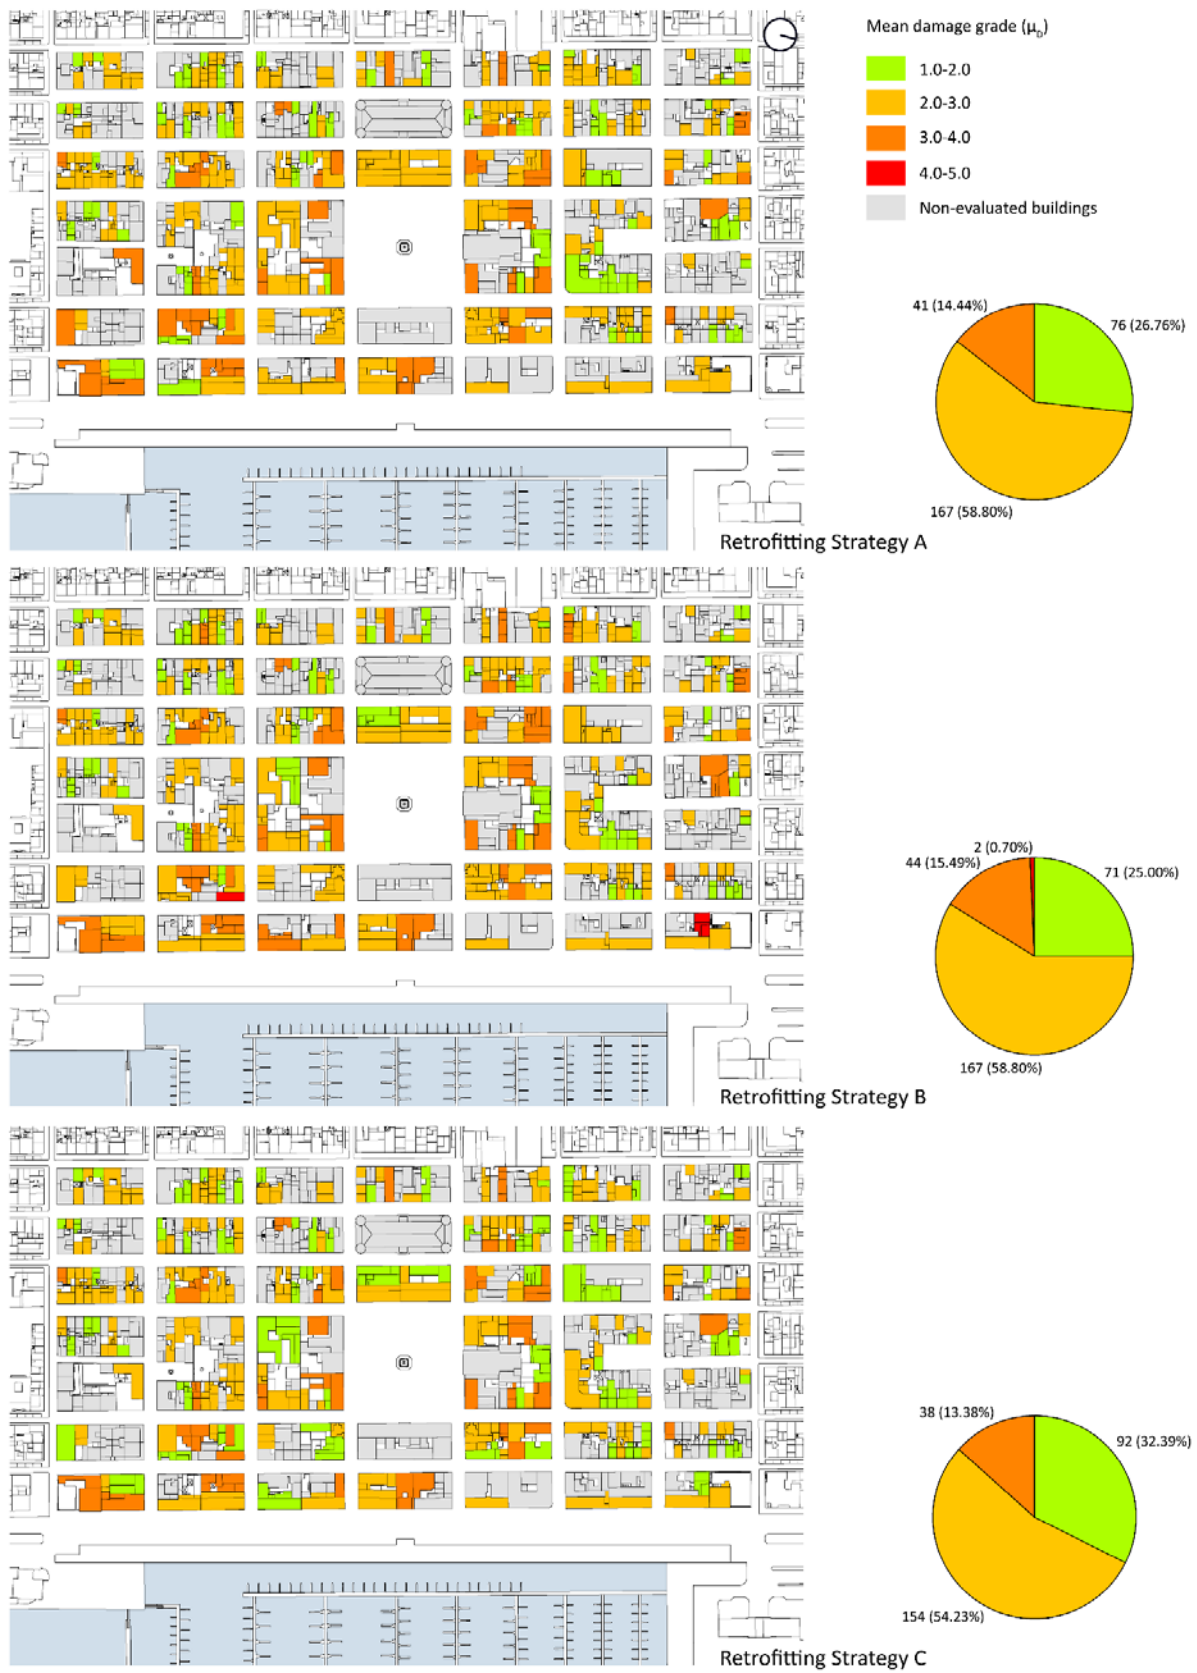
498 Figure 15. Damage scenarios for an earthquake with $S_e = 0.25g$ ($PGA = 0.18g$) considering the three
 499 retrofitting strategies

492 The results obtained can also be presented using the GIS tool, showing the damage scenarios for an earthquake
 493 with $S_e = 0.25g$ ($PGA = 0.18g$) considering the three different retrofitting strategies, see Figure 15. They can
 494 be compared with the same scenario for the current condition shown in Figure 9 in order to see how the collapse
 495 of several buildings is avoided. For example, no buildings are expected to suffer collapse considering the
 496 retrofitting strategies A and C.

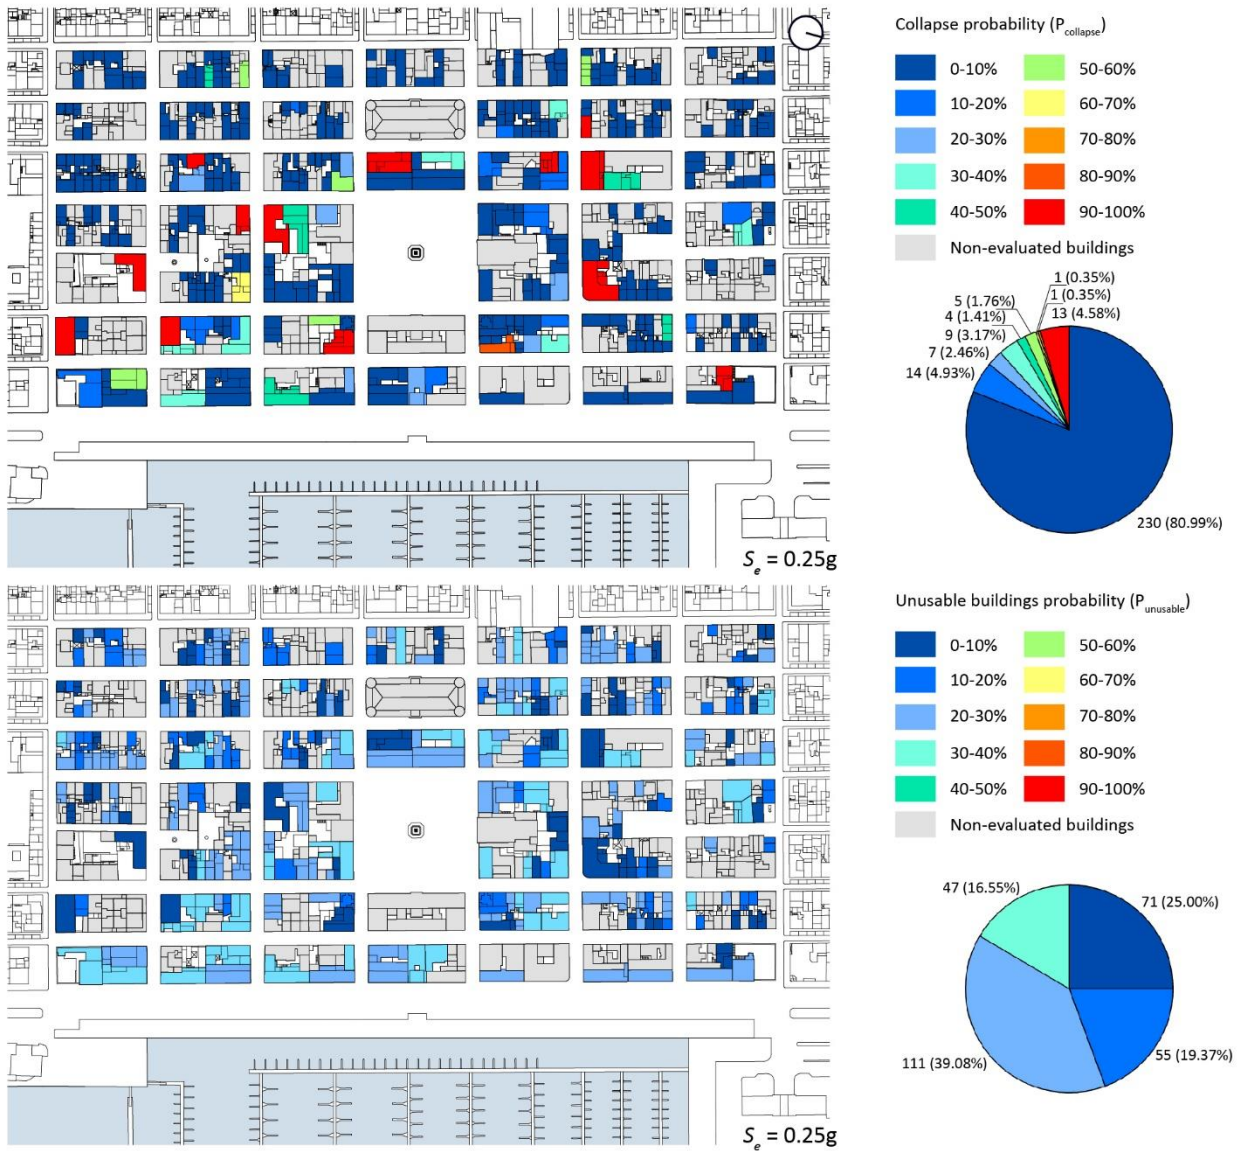
523 Figure 16. Collapsed and unusable buildings loss scenarios in the current condition: $S_e = 0.25g$ ($PGA = 0.25g$)

514 The factors 0.4 and 0.6 are adopted from Vicente et al. (2011). Figure 16 shows the results for the current condition
515 of VRSA, mapped using the GIS tool and considering a seismic event with $S_e = 0.25g$ ($PGA = 0.18g$). Overall
516 results for different seismic events with increasing S_e and for the three different scenarios are summarized in Table
517 5, where it is worth highlighting the low vulnerability of the historical condition, particularly in comparison with
518 the current configuration. Finally, Figure 17a depicts the probability of collapsed and unusable buildings based
519 on the percentage of buildings that are expected to exceed each damage grade shown in Figure 10b, i.e. according
520 to the empirical fragility curves. Figure 17b shows the comparison between the current, historic and retrofitted
521 scenario (considering the application of strategy A).

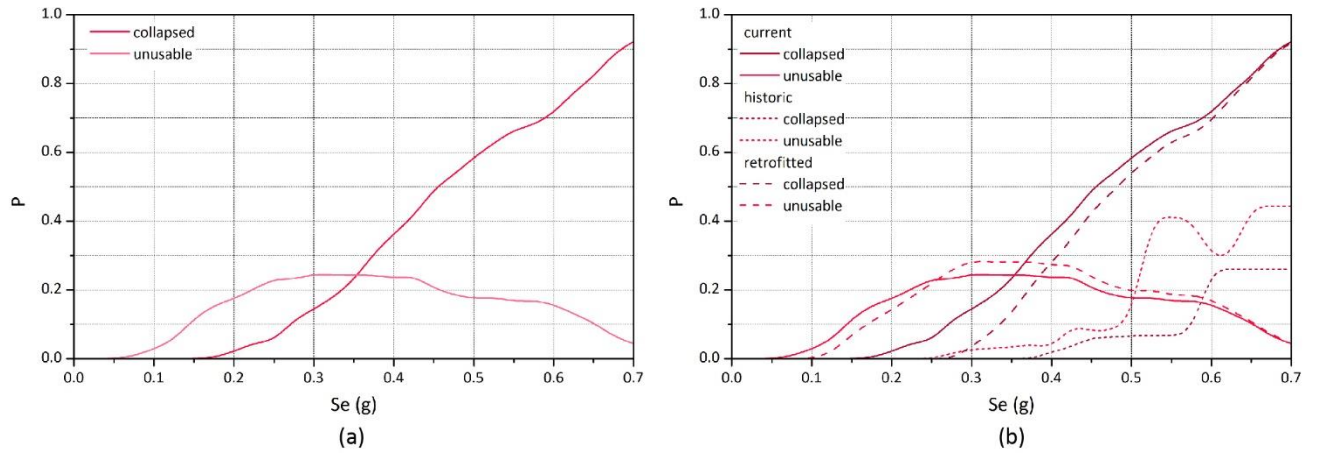
526 Figure 17. (a) Probability of collapsed and unusable buildings in the current condition; and (b) comparison with
 527 the historic and retrofitted condition (strategy A)

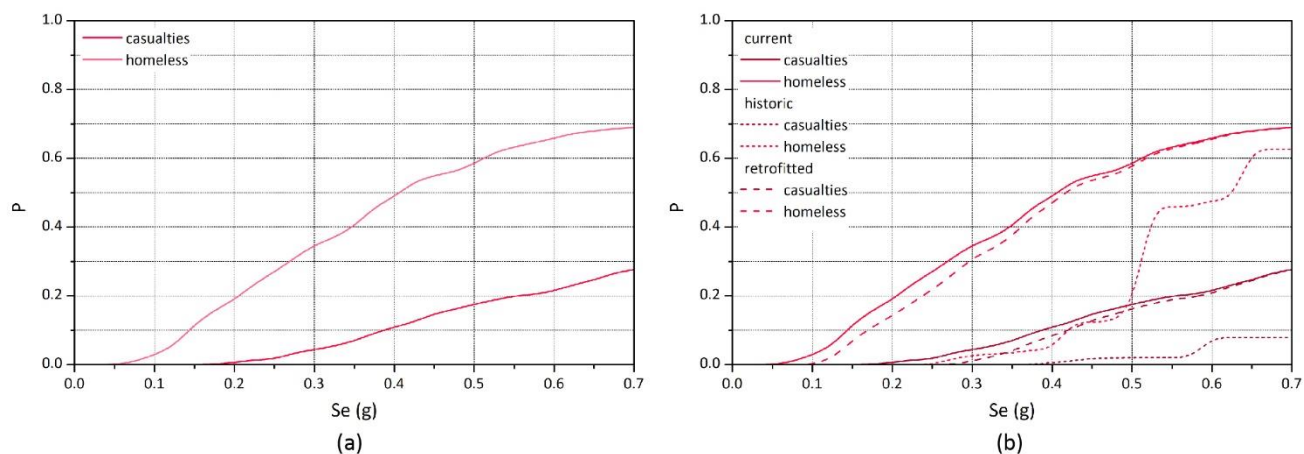
546 Figure 19. (a) Probability of casualties and homeless in the current condition; and (b) comparison with the historic
 547 and retrofitted condition (strategy A)
