# EXPERIMENTAL STUDY OF THE IN-PLANE BEHAVIOUR OF RAMMED EARTH WALLS STRENGTHENED WITH TRM

Michiel Van Gorp, Els Verstrynge, KU Leuven  
Daniel Oliveira, Rui Silva, Antonio Romanazzi, UMinho

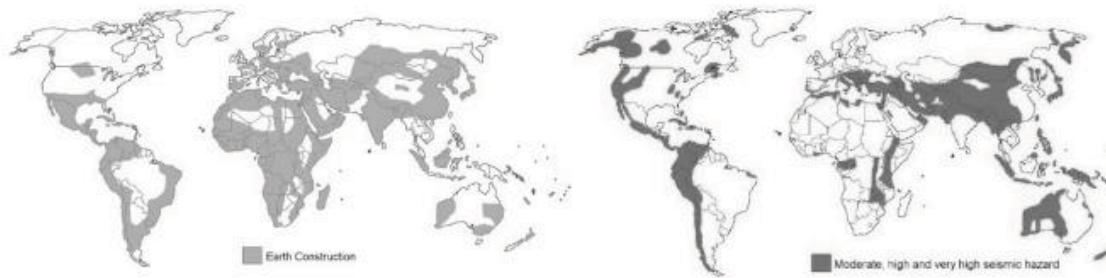
**Figure 1:** Remark the significant overlap between the regions, where rammed earth buildings are common (left), and the territories with a moderate to very high seismic hazard (right) (source: CRATerre)

Raw earth as building material is used in large parts of the world. A study by Houben and Guillaud (1989) projects that 30% to 40% of the earth's population lives in houses made of earth (fig. 1).

Rammed earth, like cob and adobe, is a construction technique that makes use of raw earth. Indeed, the product is readily available, low-cost and very sustainable. But as with masonry, historical earthen constructions can be vulnerable to certain types of forces. For example, cyclic and vibration type forces, normally visible during earthquakes. This effect certainly has its role for rammed earth, as this material is mostly used in regions which are very earthquake sensitive. (fig. 1)

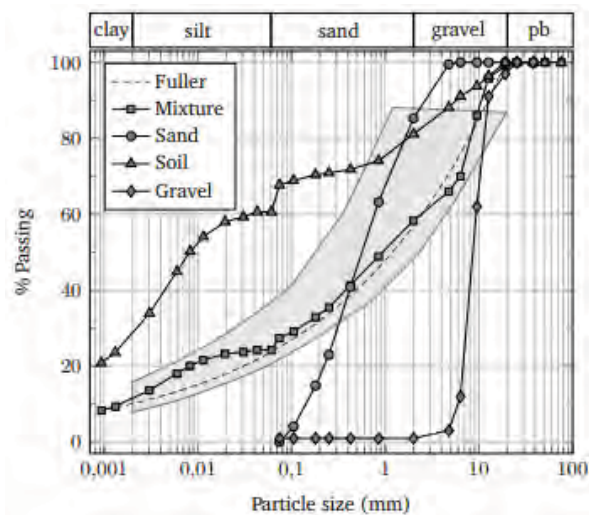
**Figur 2:** Particle size distribution of the original soil and the corrected mixture

To meet the requirements found in literature, the base soil is subsequently engineered by volume mixing 40% of the base soil with 35% sand and 25% gravel (Mixture in fig. 2).

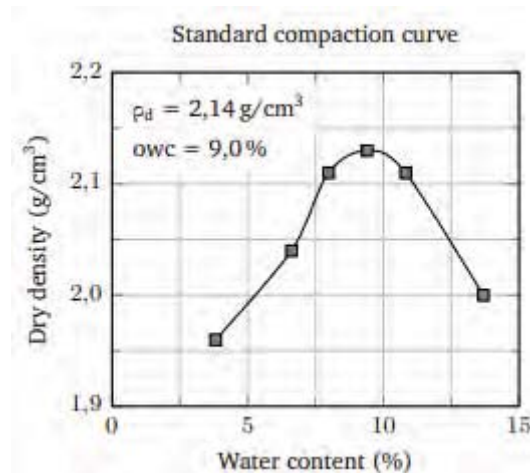
**Figuur 3:** Standard Proctor test according to LNEC E197 standard

Six specimens were compacted with different water content and their dry density was assessed. The compaction curve of the measurements is shown in fig. 3. A range of dry density between 2,10 g/cm<sup>3</sup> and 2,20 g/cm<sup>3</sup> guarantees suitable compressive strength of rammed earth elements. The dry density of the soil mixture is 2,14 g/cm<sup>3</sup> for an optimal water content (OWC) of around 9%.

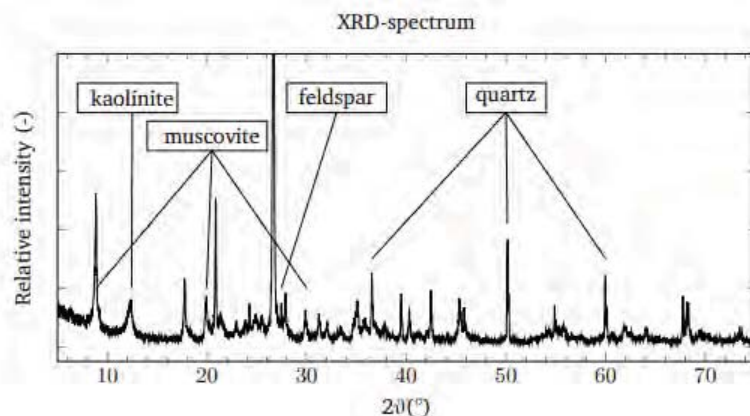
**Figuur 4:** XRD-spectrum of the fine grain fraction of the soil mixture

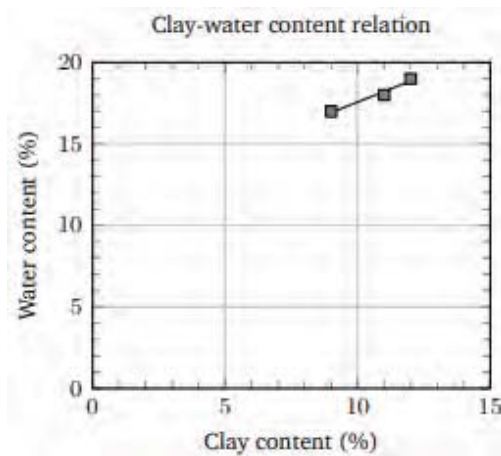
**Figuur 5:** Clay content vs water content for three mortars for optimal workability

According to Gomes (2013), workability is controlled by adding water to the sand-soil mixture. It is prioritized over other parameters, as it is an indispensable quality of any mortar. The results can be found in fig. 5.

Mortars with a higher soil/sand ratio require a higher water content to reach optimal workability. Mortars with lower water content are preferred as they are less vulnerable to cracking as a result of shrinkage.

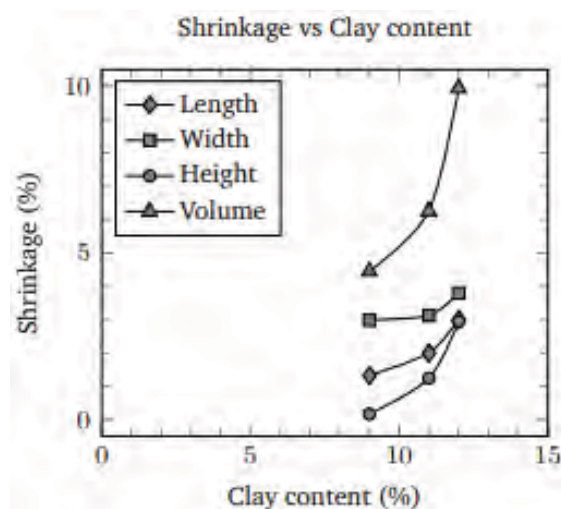
**Figuur 6:** Linear and volumetric shrinkage for several mortars

The Alcock test was conducted to evaluate the linear shrinkage of mortar beams and results are depicted in fig. 6. Aside from the length, the volumetric shrinkage and shrinkage of the height and width are also measured. However, the results show immediately that the shrinkage of the length is not representative for the other dimensions. The mortar with the highest clay content was not considered for further testing, as its linear shrinkage levels do not meet the maximum linear shrinkage value of 2%, as suggested in literature by Gomes (2013).

The shrinkage values show a dependency on the clay content. As expected, shrinkage is larger for mortars with a larger clay content. The effect is especially noticeable in the volumetric shrinkage. A change in clay content of 2% results in a doubling of the volumetric shrinkage.

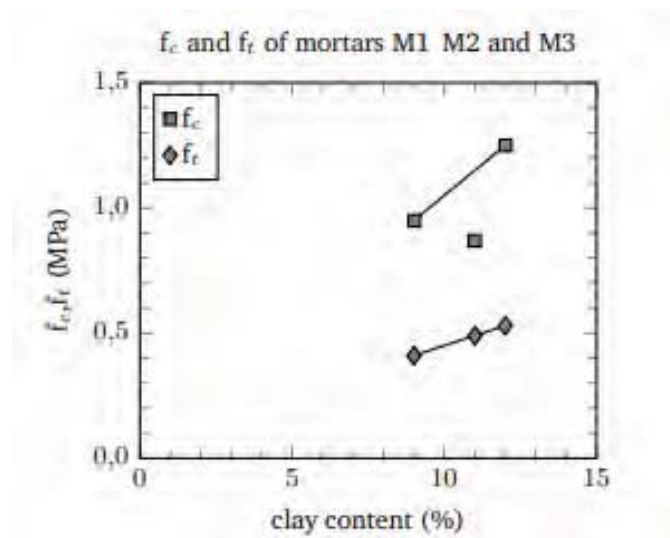
**Figur 7:** Compressive strength ( $f_c$ ) and tensile strength ( $f_t$ ) values of mortars against clay content

Finally, the compressive ( $f_c$ ) and flexural strength ( $f_t$ ) of the mortar specimens were assessed according to the EN 1015-11 standard using a LLOYD instruments automatic press LR 50K Plus. Test results are reported in fig. 7. Both strengths increase with the clay content of the mortar. The mortar with the highest clay content presented the highest compressive strength, as expected. Similar results are found in Barroso (2017), where a direct correlation between compressive strength and clay content was observed. The flexural strength is about half of the compressive strength, which is in line with expectations.

In order to avoid premature cracking in the TRM, the mortar for strengthening was selected fixing a threshold of linear shrinkage of 2%, making mixture M1 the most sensible choice, while also presenting the most suitable mechanical strength.

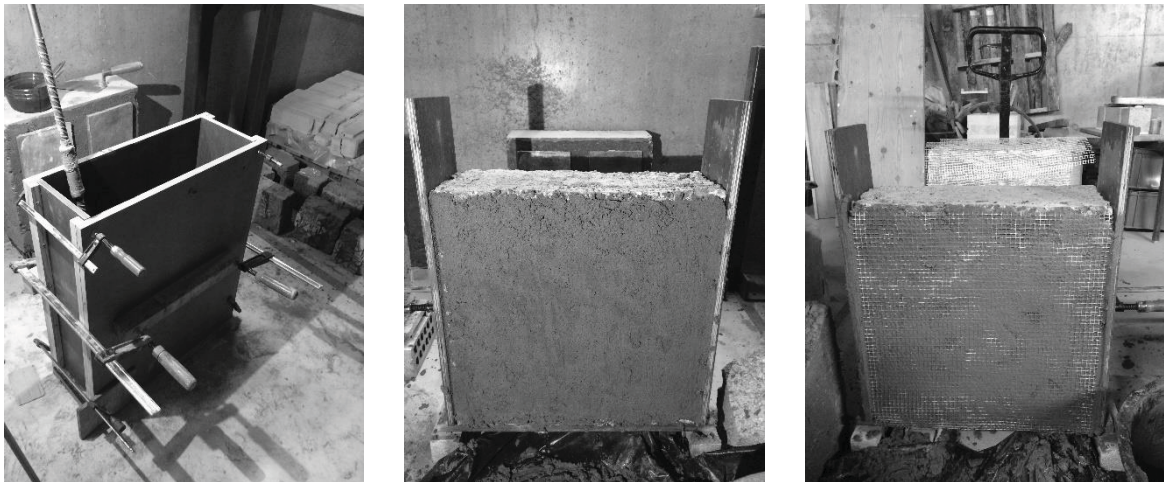
**Figure 8:** (a) Casting of RE wallet; (b) First layer of earth-based mortar; (c) Embedding of the mesh

The mixture was prepared considering the geotechnical analysis discussed in the previous section. The mixture was manually rammed into a wooden formwork (fig. 8a). The wallet consisted of nine layers, having thickness of about 61 mm each after compaction.

After a drying period of 28 days, the TRM was applied on both the surfaces of the rammed earth walls. A first layer was applied roughly to the wall (fig. 8b). Subsequently, the textile mesh was impregnated in the mortar setting the principal direction of the mesh perpendicular to the direction of the layers (fig. 8c). Finally, a second layer of mortar was applied (fig. 8c). After the application of the TRM, the specimens were stored to cure for a period of 28 days in laboratory conditions.

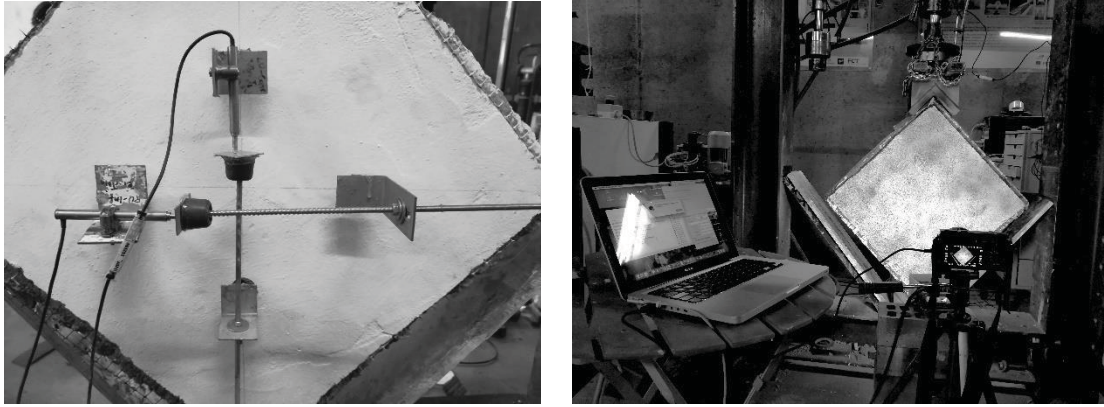
**Figure 9:** (a) Set-up of the diagonal compression test; (b) DIC equipment

The specimen was set diagonally on a steel support. Special care was taken to ensure a uniform contact and perfect alignment of the specimen with the displacement of the actuator. The displacements were recorded by two LVTDs set along the horizontal and vertical diagonal of one surface of the wallet (fig. 9a). Further digital image correlation (DIC) was implemented on the free surface. The stochastic pattern was created with black spots on white background and the frames were taken each 10 seconds (fig. 9b).

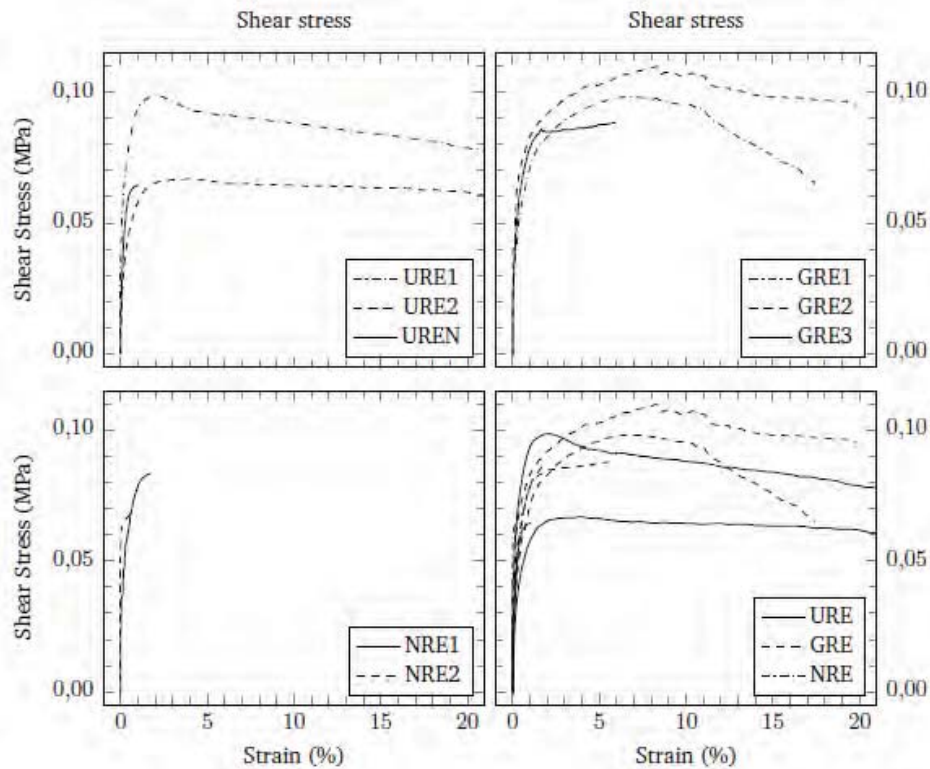
**Figure 10:** Shear stress - shear strain curves for a) unstrengthened walls (URE); b) strengthened walls with glass fibre based TRM (GRE) and c) walls strengthened with nylon based TRM (NRE).

Figure 10 shows the shear stress-strain curves of the walls. Due to non-coherent measurements of the LVDTs, some of the curves are cut reporting the reliable data.

In case of URE walls, after an elastic response characterized by the cohesion of the clay fraction, the peak stress is achieved as result from interlocking and friction of the larger particles. Sometimes a second peak is registered. This is attributed to a more severe interlocking of the larger particles. After the peak load, a large plateau is visible.

In case of strengthened rammed earth, the shear modulus is lower and the shear strength is reached for a much larger strain. Thus, the TRM improves the deformation capacity of the rammed earth. A bigger displacement is now allowed before failure. Not only does this influence the pre-peak behaviour of rammed earth, it also has an effect on what happens after the peak stress load. After peak load, the wall does not only have to rely on the internal contribution, but also on the stress-tensing of the TRM. The different reactions of the nylon and glass fibre are discussed in the next section.

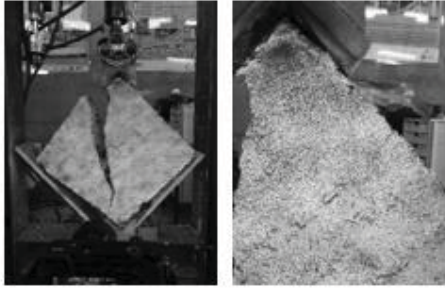
131	Main failure crack across all layers in direction of applied load. Cracks visible along main diagonal, side corners do not participate. Friction forces cause destruction of specimen. Shear cracks between layers visible after peak load.
GRE1

Table 2 depicts the failure surfaces and failure modes of three samples of the tested walls that are representative for each of the wall types. Further comments are provided on visual inspections of the cracks. Similar cracks propagate throughout the wall irrespective of the reinforcement. A diagonal crack, through the different layers, occurs along the same direction of the applied load. When the load on the wall becomes too large, internal forces are not able to contain the failure of the element. The wall is broken into two pieces. This crack and failure mode is visible in all walls and is to be expected, as the test is designed to assess the shear behaviour with diagonal shear cracking as result. Sliding failure between the layers was feared. However, the bond between the layers proved to be sufficiently strong and not a dominant factor in the failure modes.

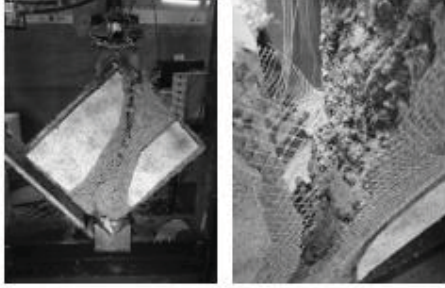
99	Main failure crack across all layers in direction of applied load. Crack pattern scattered. Friction forces cause destruction of specimen. Shear cracks between layers visible after peak load. TRM holds two halves together, also after completion of crack. Mortar detached.
NRE2

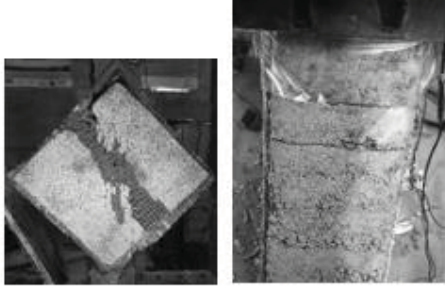
-	Main failure crack across all layers in direction of applied load. Crack pattern very scattered. Better distribution. Friction forces cause destruction of specimen. Multiple bigger shear cracks between layers visible after peak load. TRM holds two halves together, also after crack completion. Mortar detached parallel to main crack.

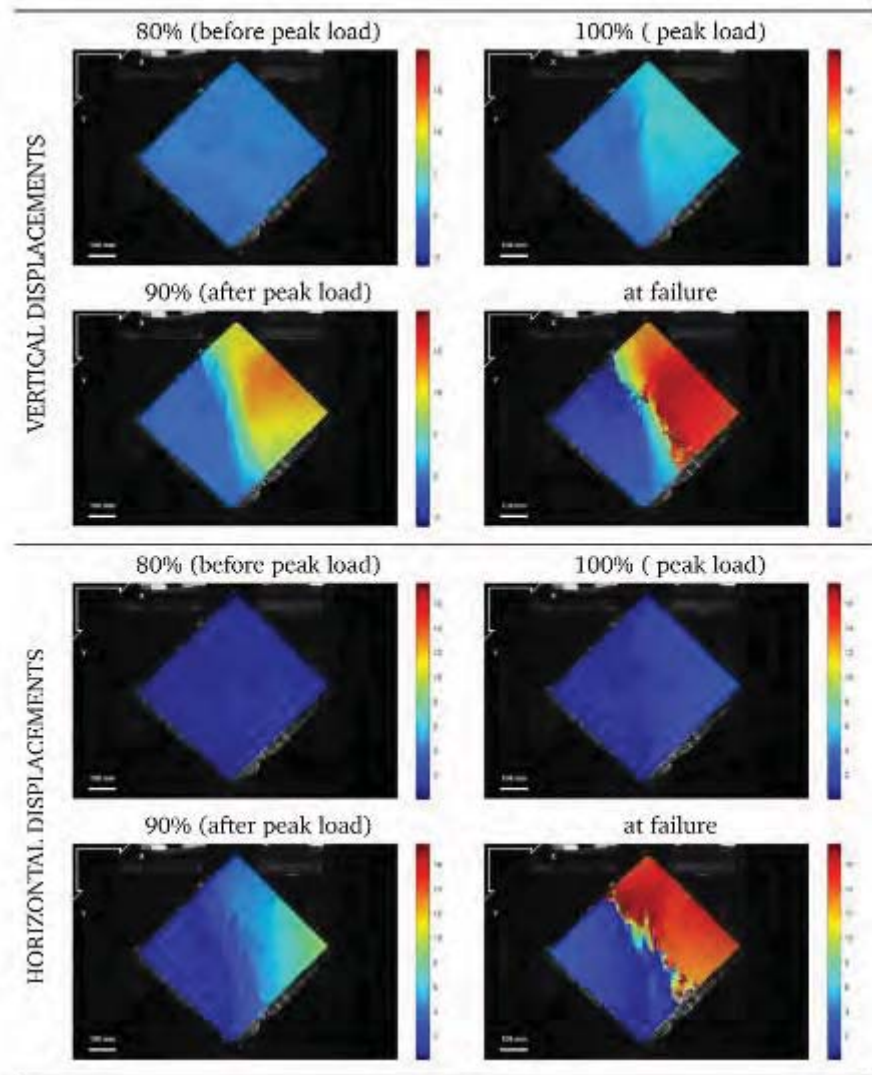
**Table 5:** DIC visualisation results for wall NRE2

A different situation is observed for the cracks and failure modes of the reinforced walls. While the NRE walls have a more spread-out crack pattern, the cracks at the GRE walls are more concentrated in the centre area of the wall. Not only does the pattern itself changes, also the width and length of the cracks are different. While the cracks appear to be smaller, but higher in number for the NRE, they are bigger and fewer for the GRE. This phenomenon shows that there indeed is a difference in the distribution of the forces. It suggests that the nylon mesh helps to better distribute the forces to the sides of the wall, resulting in a more active behaviour of the entire wall. The opposite could be in effect for the glass fibre meshes. As the cracks in the centre part of the wall grow, the development of the distribution of the forces is stopped.
