An experimental and numerical contribution for understanding the in-situ shear behaviour of unreinforced masonry

Abstract: The assessment and modelling of unreinforced masonry structures require an adequate understanding of masonry behaviour under shear loading. In particular, the behaviour of the interfaces connecting brick and mortar, are of key importance during seismic actions. This is because the unit-joint interface may act as the main plane of weakness in the masonry composite. It has been observed that the inelastic behaviour of masonry structural elements subjected to shear loading depends largely on this interface behaviour. Hence, different experimental techniques available to observe in-situ or in a laboratory the behaviour of masonry under shear loading are reviewed and a suitable experimental campaign, also employing DIC as optical monitoring system is undertaken and shear tests are performed. After visualisation and discussion of novel displacement and shear strain maps and graphs, the experimental masonry behaviour is replicated via different numerical models based on the finite element approach. Models are used for better characterising the behaviour of the interf

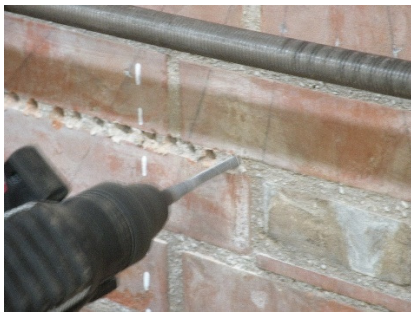
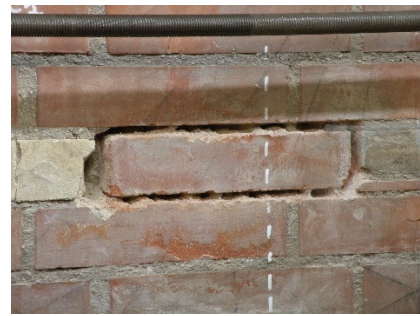
Fig. 4 - Demolition of mortar joints by drilling around the bricks would precede the removal of the brick to the sides of the test unit before placing the jack and applying the shear force.

Following the ASTM standard C1531, the test unit was first isolated at the left and right sides from the adjacent bricks in its brick course. Not to cause unwanted damage in the test area, the removal of adjacent mortar layers and bricks was first achieved by careful driller perforations gradually demolishing the mortar joints around the edges of the bricks to be removed (see Fig. 4), in order to separate as much as possible these bricks from surrounding masonry, lastly finishing off by chisel and hammer leverage action. Any remaining bits of unwanted mortar along the voids would also be gently removed by chisel. The test unit remained connected via mortar joints to the back leaf of the wall and also to the upper and lower courses in the front leaf of the wall.

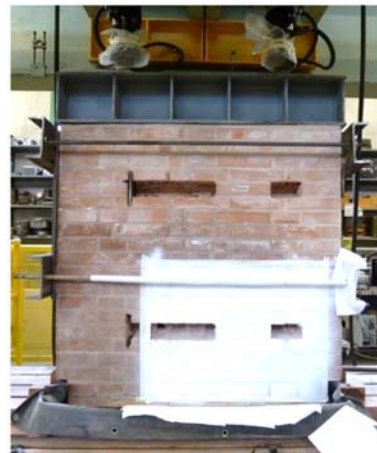
Fig. 5 - Experimental setup of the masonry wall: a) schematics of the originally planned and prepared test locations. Setup at course six was later modified; b) masonry specimen with top and bottom stiff beams for distribution of vertical load.

The shear test experimental setup can be observed in Fig. 5. Two shear tests have taken place in sequence, in the same wall. First, a brick test unit was selected at the 16th course counting from the wall's bottom (Fig. 5a). Subsequently, a second test took place at course 6.

The wall was set up to sustain a distributed constant vertical loading along its full length in order to replicate the boundary conditions that would be typically found in a large masonry structure. Accordingly, a steel beam was placed on the top of the specimen wall (Fig. 5b) to distribute the vertical force of two vertical hydraulic jacks. Different values for vertical load were envisaged to allow defining the cohesion and friction angle of the masonry.

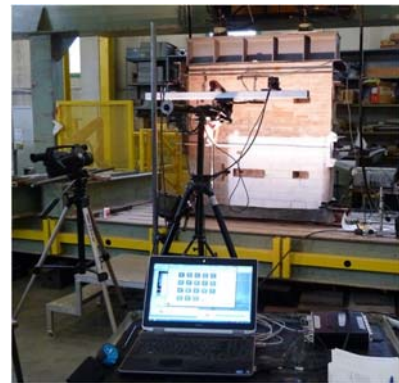
Fig. 6 - Test setup with DIC system: a) lateral view; b) plan view; c) full test setup

The 3D DIC monitoring system used in the experiments described herein, consisted of a tripod set with two photcameras connected to a laptop with dedicated acquisition card and software. The cameras placed not perpendicular to the wall surface allow to obtain a stereo vision configuration producing 3D information about the observed material surface (Fig. 6a and b). The first couple of photos is recorded at zero loading and will serve as a reference. Subsequent couples of photos, shot with user-defined frequency during monitoring, will be compared with the initial images by specific software employing point-tracking algorithms. In fact, according to the technique's prescriptions, the monitored area (in these shear tests, the area around the tested brick) is prepared by coating the surface in white and overlaying a random pattern of black dots. These dots will be exploited by the data post-processing software in order to reconstruct the fine geometry of the monitored surface as well as for visualising displacement and strain maps. An innovative DIC procedure that overcomes the need for surface

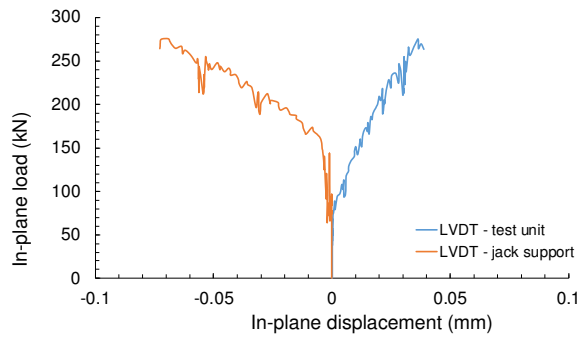
Fig. 7 - Horizontal load-displacement graph for the tested brick unit of the shear test at course 16 of the wall. Small displacements are measured (approx. 0.075 mm and 0.04 mm for each of the 2 LVDTs) for a considerable peak load (279 kN) before sudden failure.

From a preliminary test to check the efficacy of the setup, performed close to the top of the masonry wall (16th layer) with a horizontal compressive load reaching over 270 kN, an explosive failure mode was observed (Fig. 7). This, although the shear load was very gradually applied. The visible cracking and out of plane movement of some of the bricks show the extent of damage observed in this test (Fig. 8). In addition to the complete removal of the test unit, the applied lateral load has also caused sliding of adjacent brick units. A considerable amount of sliding was also observed near the reaction point at the rear of the horizontal jack where initial measured displacement was about double than the one measured at the test unit (Fig. 7).

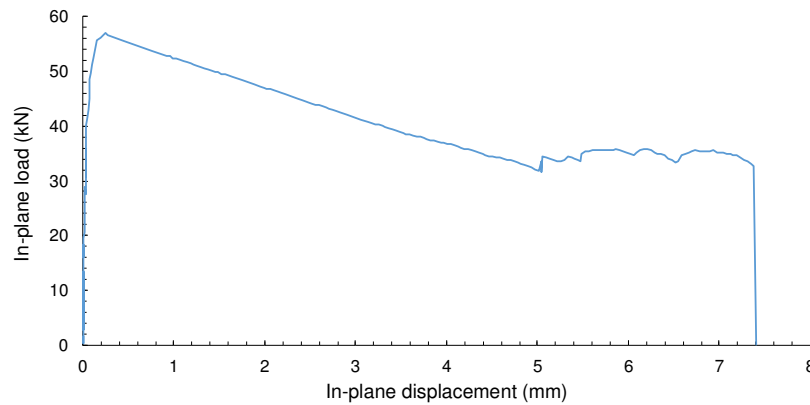
Fig. 12 - Load-displacement graph of the tested brick unit at course 6 of the wall. The shown displacement values are recorded via the applied front LVDT. A displacement of 0.27 mm is recorded at a peak load of 57 kN, whilst total sliding is 7.4 mm.

The obtained test unit resisted a maximum horizontal loading of 57 kN before its failure. It failed along the interfaces and slid along the bed joints. At the end of data acquisition, a final displacement of 7.4 mm was recorded for the test unit (Fig. 11a). The series of yellow arrows indicate the direction of the load and the area on which the load was applied on the brick head. Unlike the previous shear test at course 16, this test at course 6 did not show a sudden brittle behaviour, as it can be observed in the

first part of the in-plane load-displacement diagram presented in Fig. 12. This difference could easily be explained by both the introduced modifications in setup and by the lower position of course 6 in the wall. Compared to course 16 (only affected by rainwater absorption and its evaporation, with limited salt crystallisation causing mortar decay), course 6 underwent many more additional cycles of water evaporation and crystallisation, while moisture capillary rise did not reach course 16. In Fig. 12, the curve is obtained from LVDT data. It can be seen that at the peak load of 57 kN (the end of test according to masonry shear strength determination by sliding, as described in ASTM C1531), the measured displacement is between 0.2 mm and 0.3 mm. Such considerably larger displacement measured at this course 6 for a much smaller maximum load (57 kN) compared to values recorded for the case of testing at course 16 can be equally related to motivations provided just above in text.

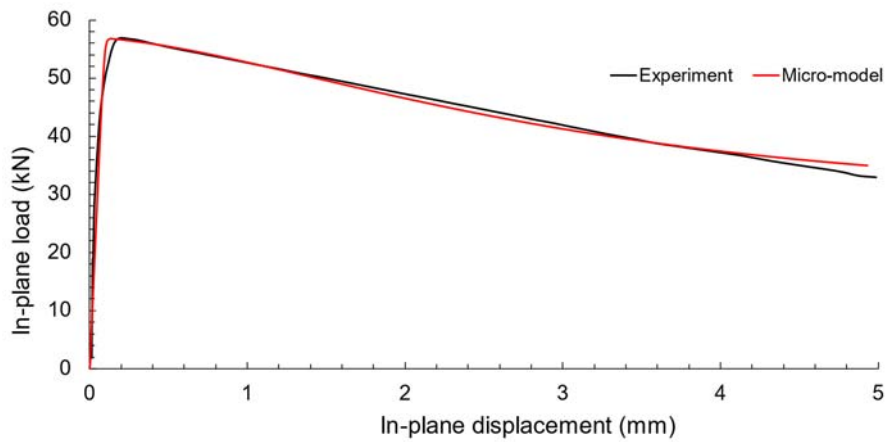
Figure 20 - Load-Displacement diagram of micro-model and experiment

The comparison between the experimental load-displacement diagram and the numerical C-S-C model can be seen in Fig. 20. The location used to extract the displacement is the same where LVDT was attached during the experiment. In-plane load represents the force obtained with load cell connected to the hydraulic jack used to apply the horizontal load during the experiment and in-plane displacement refers to the displacement observed experimentally via LVDT. From the figure, it can be observed that the C-S-C model allows an adequate representation of the experimental response in the elastic and inelastic ranges.

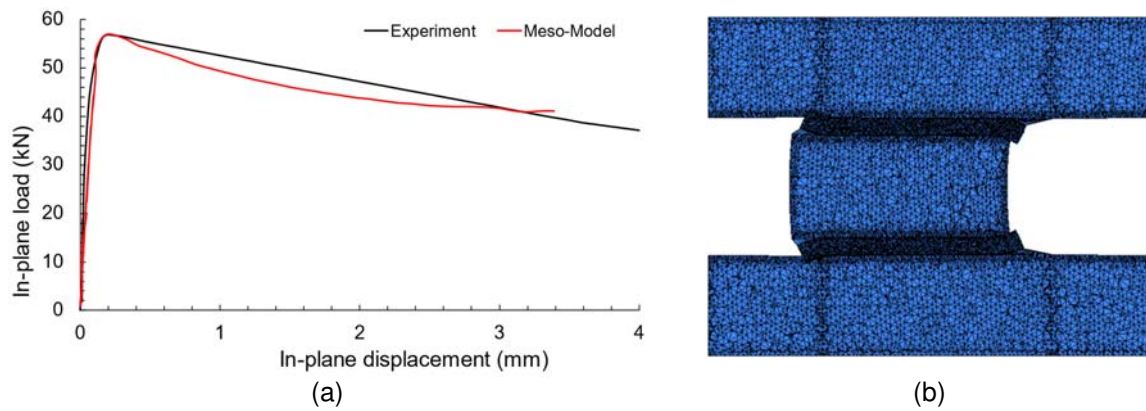
Fig. 26 - Meso-model results: a) load-displacement profile; b) in-plane displacement at failure

The mesh of continuous elements and interface mesh of the model are presented in Fig. 25. This final meso-model was then subjected to loading and boundary conditions similar to those of the micro-models. After loading, load-displacement data of the model was extracted in a similar location to those extracted from the micro-model and during the experiment with LVDT. The obtained behaviour of the meso-model can then be examined in Fig. 26. Again, the meso-model was considered to be in good agreement with the experimental results.
