Highway and Bridge Engineering 2007

Analysis of the functional quality of pavements from texture measurements

Elisabete Freitas and Paulo Pereira

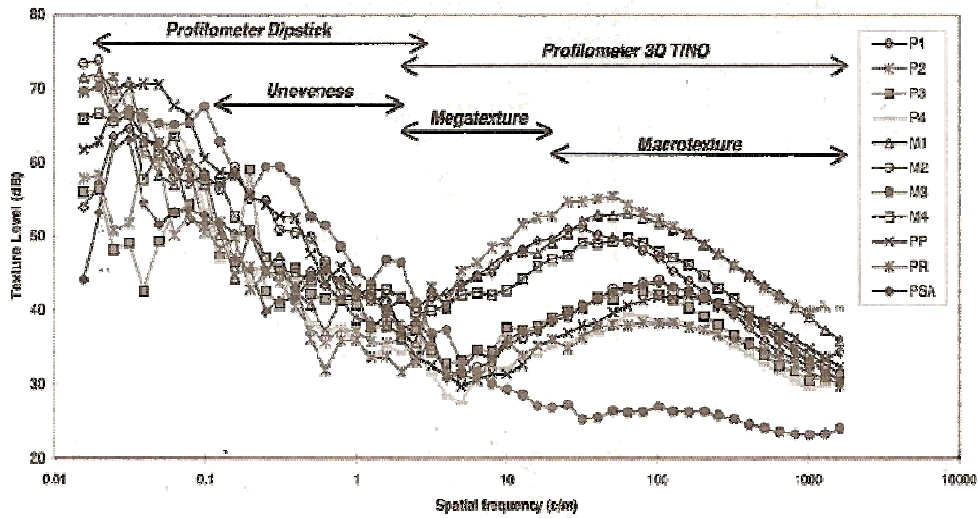
Figure 4 shows an example of the use of this indicator to define several texture spectra for comparison purposes, which include all texture ranges. The texture level is usually between 20 dB and 80 dB, [13].

Figure 4. Examples of texture spectra for 1/3 octave bands, [15]

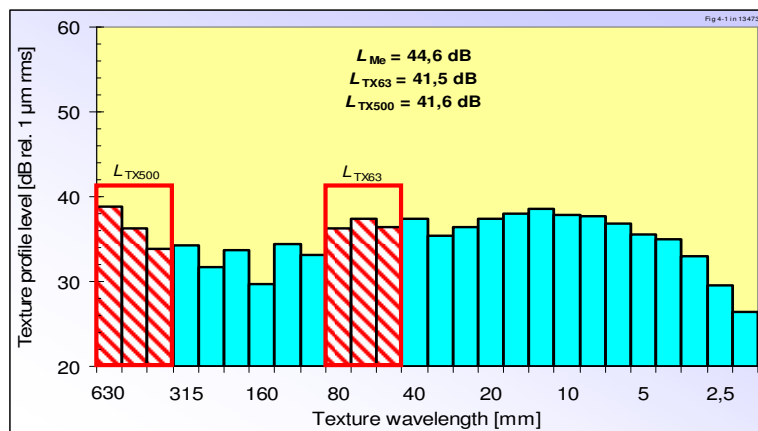
The L_{Me} is used when there is a requirement to characterise megatexture by a single measure. The L_{TX63} facilitates the characterisation of defects which correspond approximately to the length of a normal tyre/pavement contact patch and which, for this reason, play a direct role in the generation of tyre/road noise. The L_{TX500} indicator enables the characterisation of defects which can lead to tyres losing contact with the surface and therefore reduce safety (increase in stopping distances, loss of steering control in bends) and the comfort of the driver and passengers. This indicator is complementary to the information obtained by unevenness measurements at short unevenness wavelengths (0,7 m to 1,3 m). An illustration of these indicators is presented in Figure 6.

Figure 6. Example of one-third-octave band texture spectrum with indication of the texture levels of the octave bands L_{TX500} and L_{TX63} , [7]

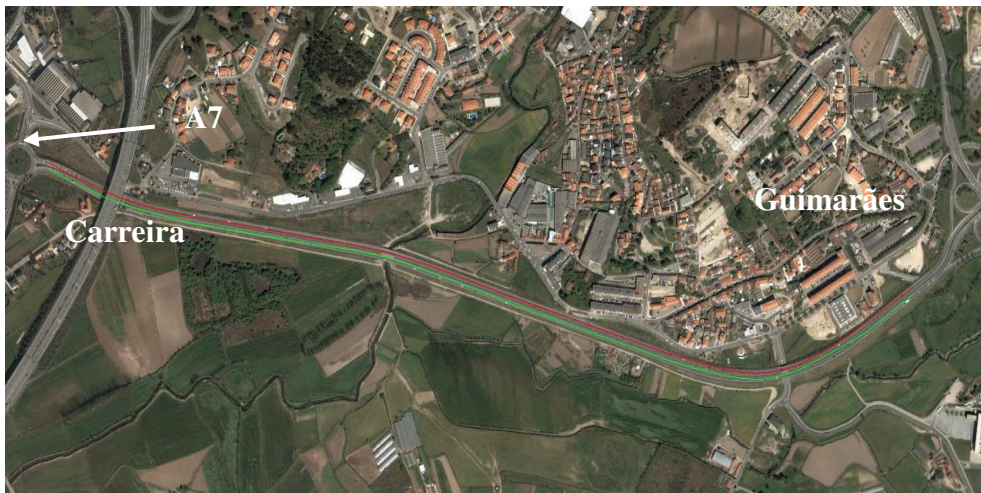
The study of the texture was carried out on the EN 206 Variant, between Carreira and Guimarães (Portugal) as shown in Figure 7.

Figure 7. General view of the EN 206 Variant

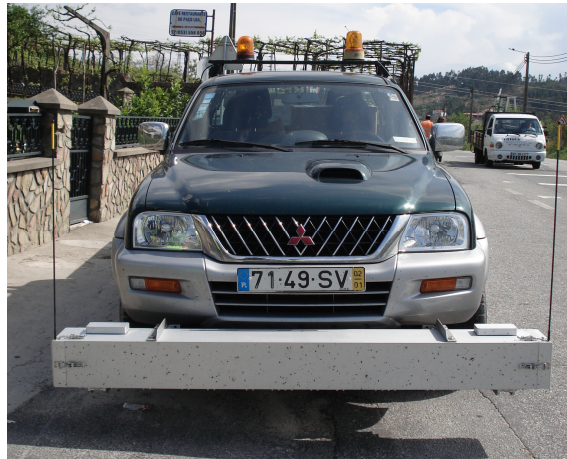
A high speed profilometer was used for data collection. It is equipped with 1 inertial motion sensor, 2 accelerometers and 5 lasers, 2 of which are prepared for measuring the macrotexture in both wheel paths (Figure 8).

Figure 8. University of Minho and Coimbra High Speed Profilometer

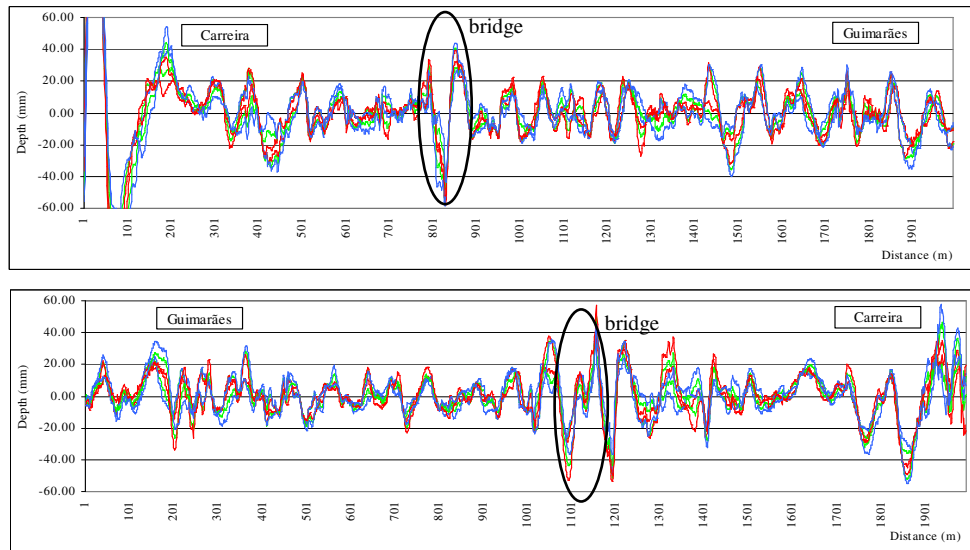
The longitudinal profile of a road is defined after removing the grade and very long undulations. Figure 9 presents 12 profiles which correspond to 3 measurements per lane.

In each direction, the profiles are similar. This is an indication of small transverse variations along the road. On the traffic direction, the profile is variable. In this case, the range of deviations is -20 mm to 20 mm. Higher deviations may be also found, specifically near Carreira and at a distance of 800 m from there. For the latter, insufficient bearing capacity is a possible cause. For the former, there exists the possibility of settlement of the embankment that supports a bridge.

Figure 9. Profile depth
