# Failure analysis of Monastery of Jerónimos, Lisbon: How to learn from sophisticated numerical models

P.B. Lourenço \*, K.J. Krakowiak, F.M. Fernandes, L.F. Ramos

*Department of Civil Engineering, University of Minho, Azurém, P – 4800-058 Guimarães, Portugal*

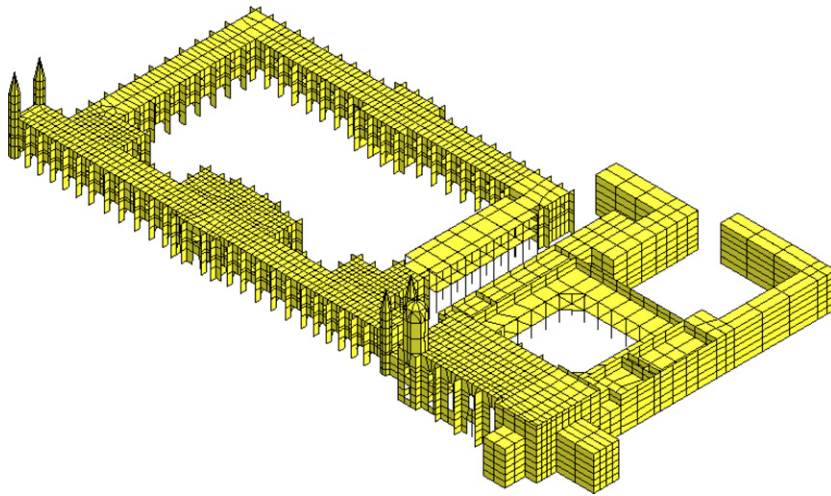
Fig. 6. Model of the complete Monastery.

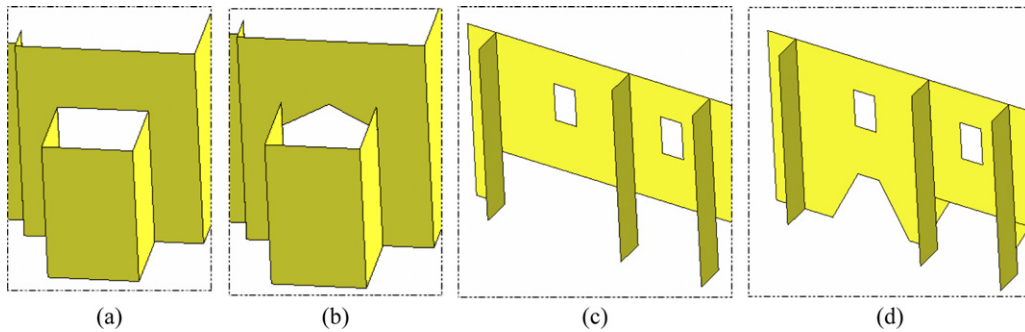
Fig. 8. Examples of the corrections in the geometry of the preliminary model: transept (a) before and (b) after correction; arcade (c) before and (d) after correction.

by introducing tyings at the flat shells, replacing the constant thickness of the vaults by variable thickness and introducing new elements to better represent the large openings, see Fig. 8. After these corrections, it was found that the maximum tensile stresses in the structure for vertical loading are still relatively large (up to  $0.35 \text{ N/mm}^2$ ) and occur in the buttresses. These stresses are related to the double curvature of the buttresses associated with the flexural behavior of the flat slabs, see Fig. 9a, and are questionable. Namely, an outwards displacement due to the thrust action of the vault cannot be found in the present model. It can be also seen that the tensile stresses in the corrected areas have been significantly reduced, see Fig. 9b. Finally, it is stressed that the average compressive stresses seem adequate (around  $0.7 \text{ N/mm}^2$ ), with higher values in the columns and in a wall not belonging to the monument, where little structural information exists.

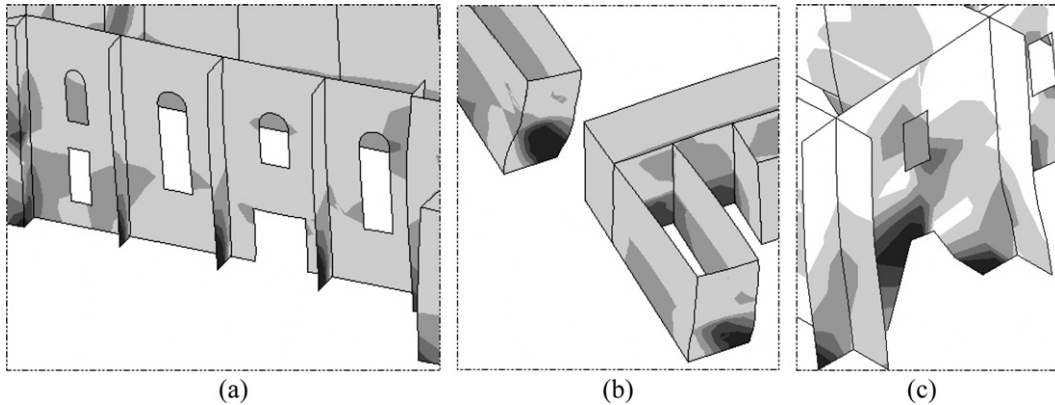
Fig. 12. Maximum compressive stresses for seismic action along Z axis: (a) buttresses; (b) adjacent bodies to the monument; (c) arcade. The maximum stress compressive is around 4.0 N/mm<sup>2</sup>.

Fig. 12 indicates the areas of maximum compressive stresses, which reach values up to  $4.0 \text{ N/mm}^2$ . These values are very localized in the buttresses, in one of the bodies adjacent to the monument and in the arcade. Given the fact that this is an accidental loading condition and that the stresses are very localized, it is assumed that the structure is not at risk. The average maximum values are around  $2.0\text{--}2.5 \text{ N/mm}^2$ , which seem acceptable [10]. Finally, Fig. 13 shows the force–displacement diagram for the critical seismic loading, along the  $Z$  axis. Here, the load factor represents the ratio between the design loads and the applied load and the displacement is the measured horizontal component at the tower top. The analysis was continued further until collapse of the tower, which occurred for a load 25% higher than the applied design load, at a displacement larger than 0.25 m.

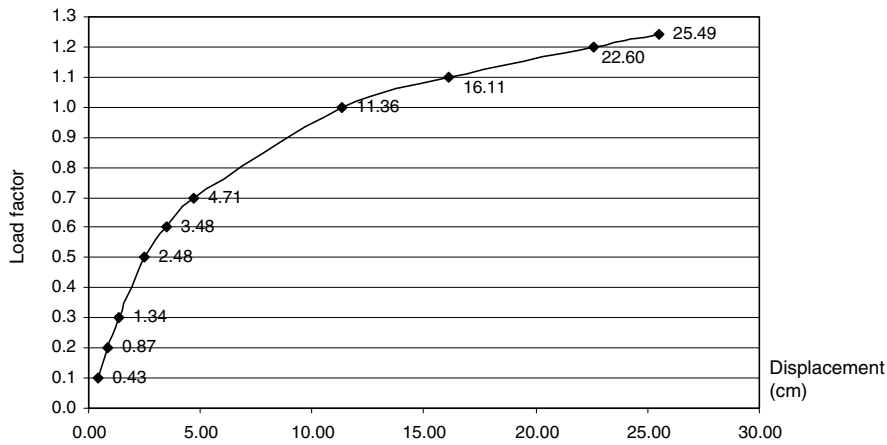
Fig. 13. Force–displacement diagram for seismic action acting along the Z axis.

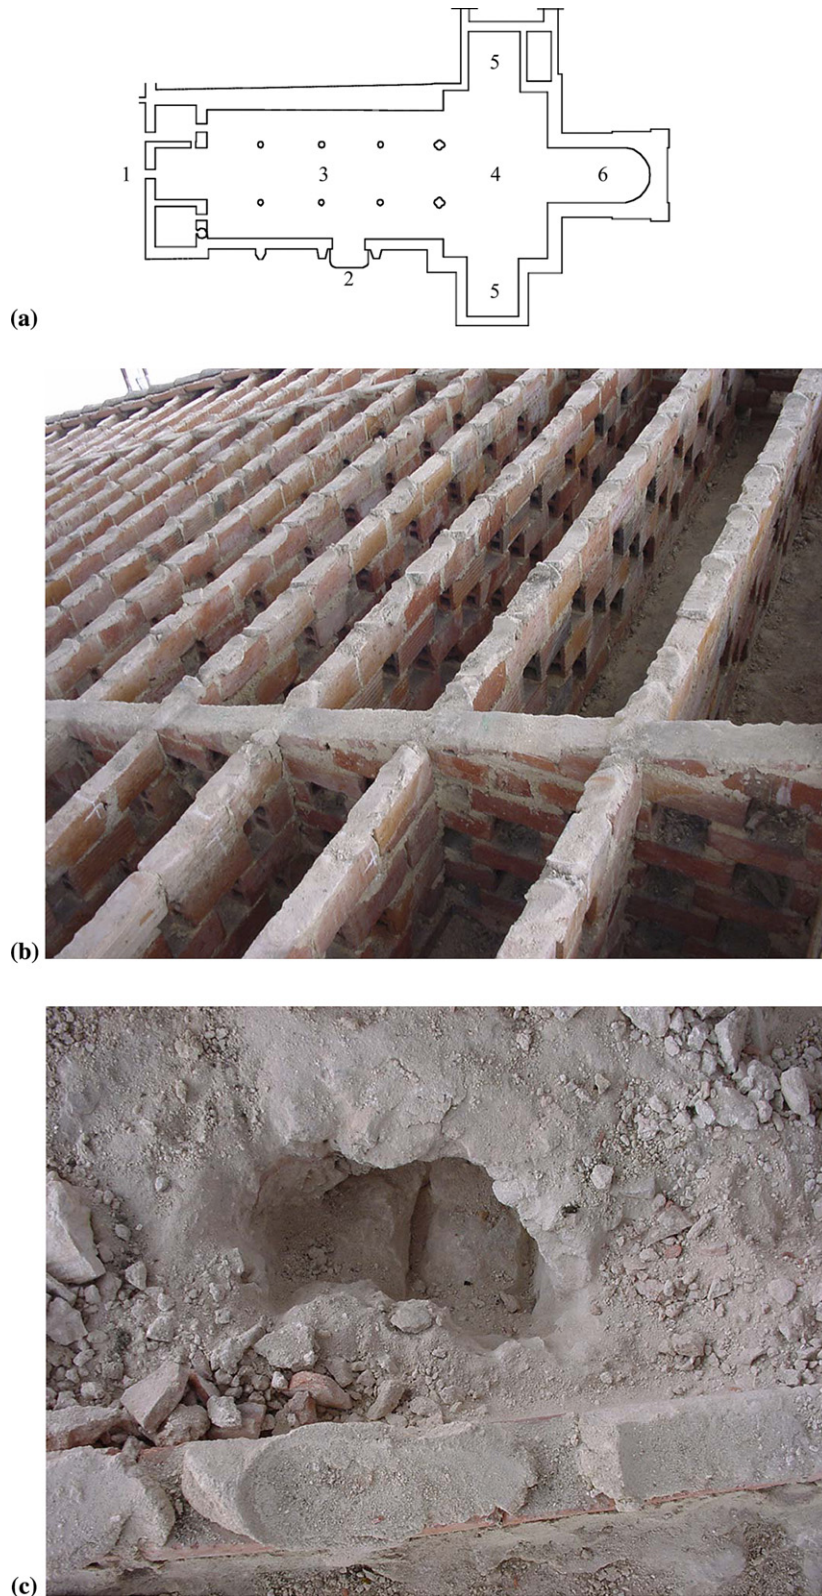
Fig. 14. Survey: (a) plan, with 1 – axial doorway, 2 – lateral doorway, 3 – nave, 4 – transept, 5 – side chapels, 6 – chancel; (b) removal of the roof and existing system to support the roofing tiles; (c) visual inspection of the infill and rib.

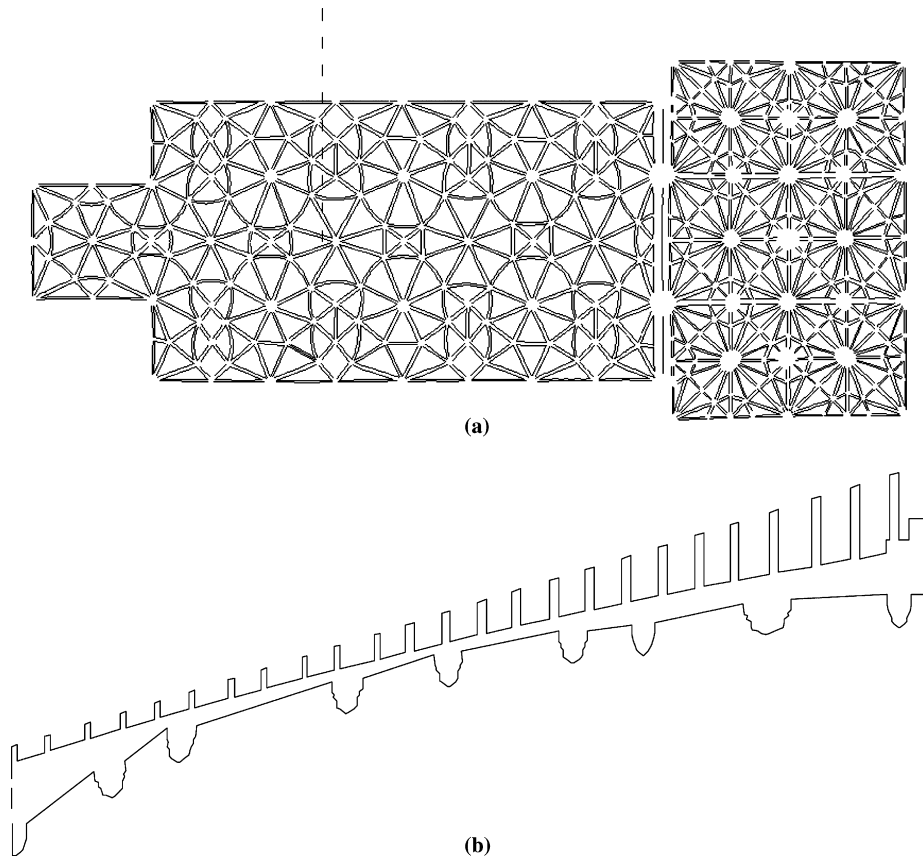
Fig. 15. Aspects of the vaults: (a) plan and (b) transversal cross-section of the nave (only half of the cross-section is shown, due to symmetry conditions at the vault key).

the columns by large fan capitals, see Fig. 15. Cross-section of the nave vault is, mostly, a slightly curved barrel vault, even if supported at the columns. Thin stone slabs are placed on top of the stone ribs. On top of the slabs, a variable thickness mortar layer exists. The part of the slab inside the capital is filled with a concrete-like material with stones and clay mortar. On top of the vaults, brick masonry wallets were built during the 1930s to provide support for the roofing tiles.

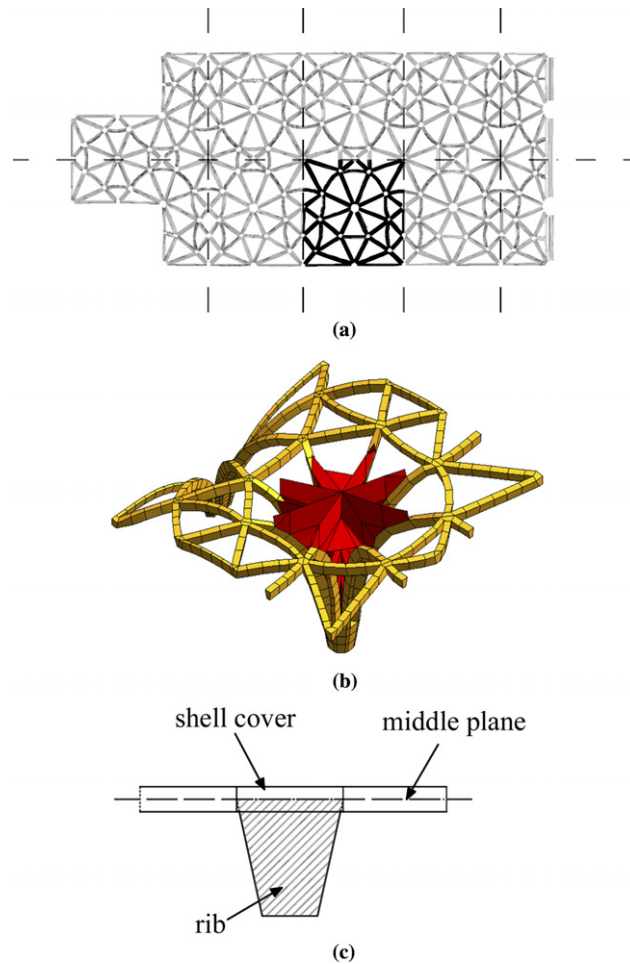
Fig. 16. Aspects of the model: (a) basic pattern, (b) details around capital and (c) detail of the connection between the rib and infill.

The adopted model for the main nave includes the structural detail representative of the vault under the most unfavorable possibility, see Fig. 16a, using symmetric boundary conditions. Therefore, the model represents adequately the collapse of the central-south part of the nave. The model includes three-dimensional volume elements, for the ribs and columns, and curved shell elements, for the infill and stones slabs, see Fig. 16b and c. The external (south) wall was represented by beam elements, properly tied to the volume elements. The supports are fully restrained, being rotations possible given the non-linear material behavior assumed. All elements have quadratic interpolation, resulting in a mesh with 33,335 degrees of freedom. The time-effort necessary for total mesh generation, including definition of supports, loads and thicknesses, can be estimated in three man-months.

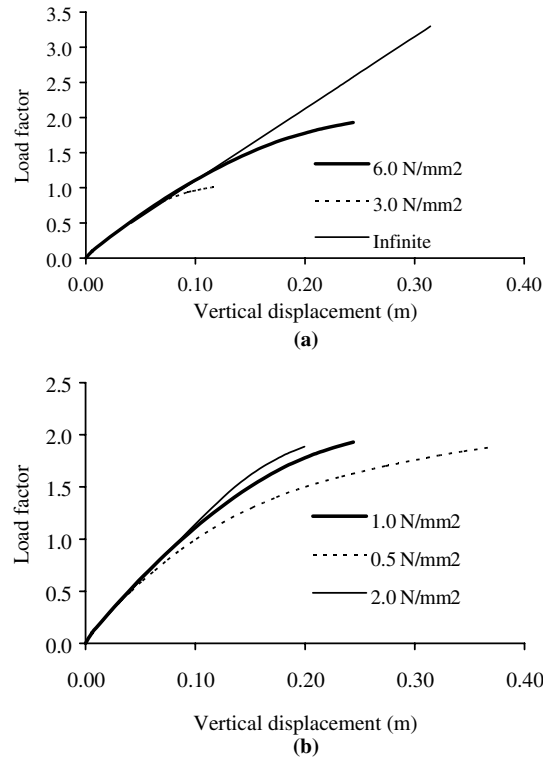
Fig. 18. Sensitivity analysis: (a) influence of the compressive strength of stone masonry and (b) influence of the compressive strength of the infill.

Fig. 18 presents the load–displacement diagrams for different compressive strengths of the stone masonry and infill. The influence of the compressive strength of the stone masonry is very significant, as shown in Fig. 18a. The ultimate load factor of the structure is reduced to 1.0, for a compressive strength of  $3.0 \text{ N/mm}^2$ , and increased to a value larger than 5.0, for an infinite compressive strength. On the contrary, the influence of the compressive strength of the infill is marginal, as shown in Fig. 18b. The ultimate load factor of the structure is kept constant and only minor changes of stiffness can be observed. The collapse mechanism remains unchanged in all the analyses.

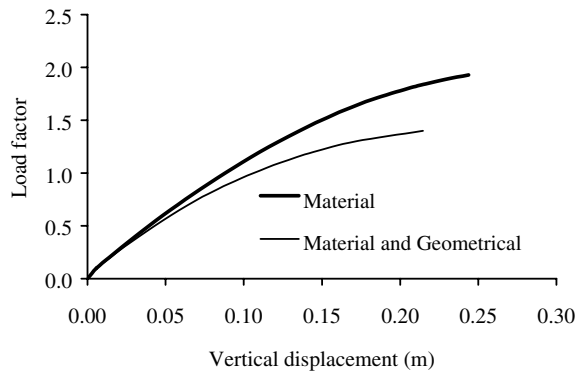
Fig. 19. Influence of geometrical non-linear behavior.

Finally, Fig. 19 illustrates the influence of the geometrical non-linear behavior in the analysis. It can be observed that this additional non-linear behavior, in the reference analysis, reduces the ultimate load factor to a value of 1.4, which is rather low. Again, the collapse mechanism remains unchanged.

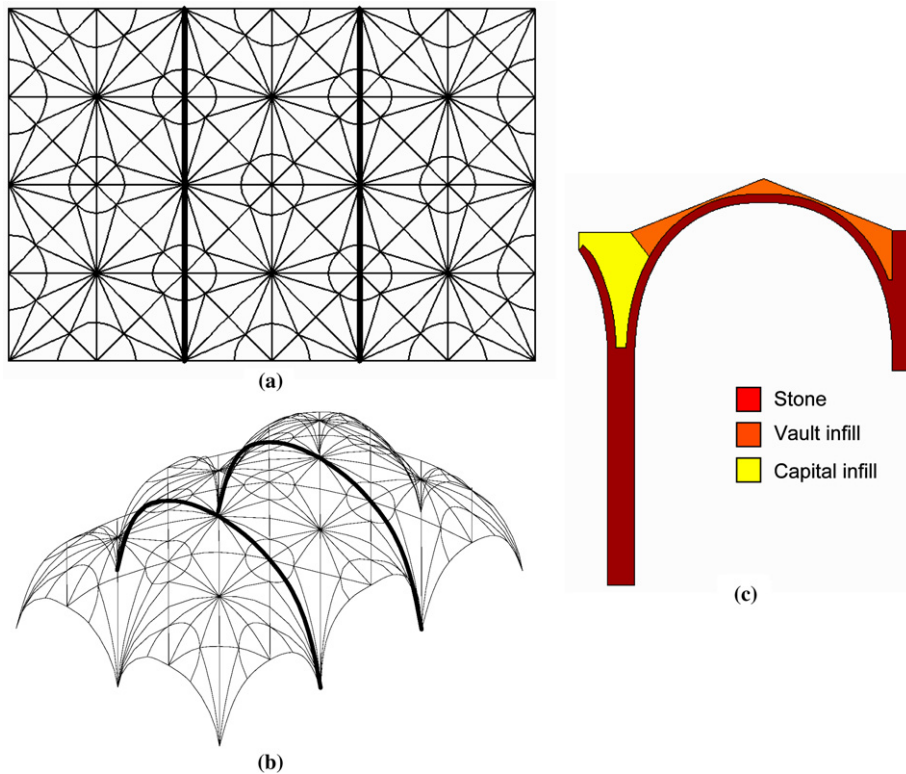
Fig. 20. Transept vault: (a) plan, (b) perspective and (c) finite element model.

to 0.4 m (height) by 0.28 m (width), with the exception of the two central ribs (arches) indicated with a thick line in Fig. 20a, showing a cross section of  $0.60 \times 0.40 \text{ m}^2$ . Therefore, the two arches are the most significant structural elements of the transept vault. Given the complexity of the vault and the time consumed in the model of the nave, a simplified two-dimensional model of these arches was adopted for the structural analysis. The time-effort necessary for total mesh generation, including definition of supports, loads and thicknesses, can be estimated in one man-week. Fig. 20c illustrates the conservative adopted model, which includes the arch, the infill, the nave column and the external wall, with appropriate stiffness values and boundary conditions, see [13] for a complete description. All elements have quadratic interpolation, resulting in a mesh with 3530 degrees of freedom. Again, the actions considered in the analysis include only the self-weight of the structure. For the materials, the reference values described previously are adopted.

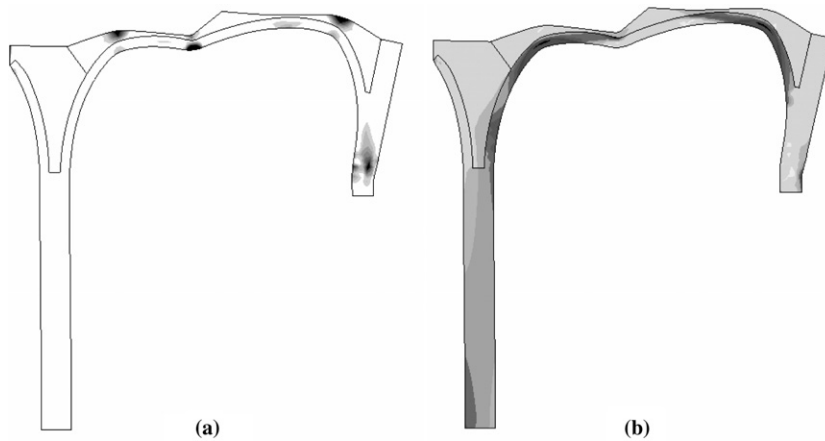
Fig. 21. Results of transept analysis at collapse: (a) maximum principal strains (equivalent to cracks) and (b) minimum principal stress (compression), depicted on deformed meshes.

The results for the transept analysis are shown in Fig. 21, in terms of maximum principal strain (equivalent to tensile damage) and minimum principal stresses (compression), depicted on the deformed mesh. The ultimate load factor is 1.7, which is again rather low for this type of structures, even if the model is simplified and conservative. Collapse occurs with a typical four hinges mechanism, being three hinges located in the vault and one hinge located in the right support, see Fig. 21. The collapse involving the right wall occurs due to the consideration that the nave prevents inwards movement of the (left) column. Fig. 21a indicates that the arch is cracked at the key (intrados) and both quarter spans (extrados). Significant cracking is also present in the right support. Fig. 21b demonstrates that compressive stresses concentrate in the arch and in the base of the right wall. The compressive stresses in the left column are moderate and do not govern collapse.

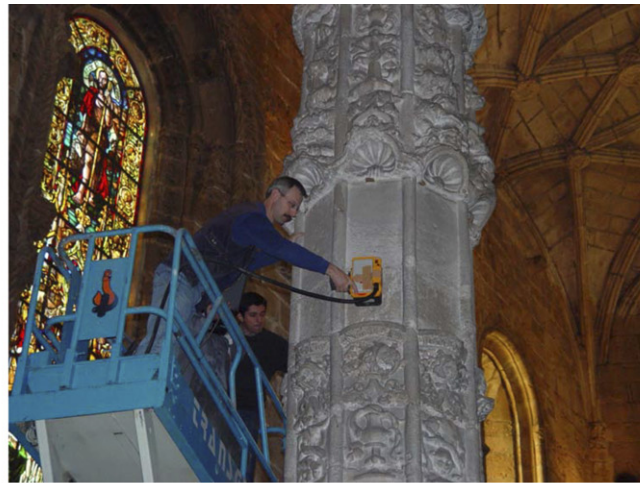
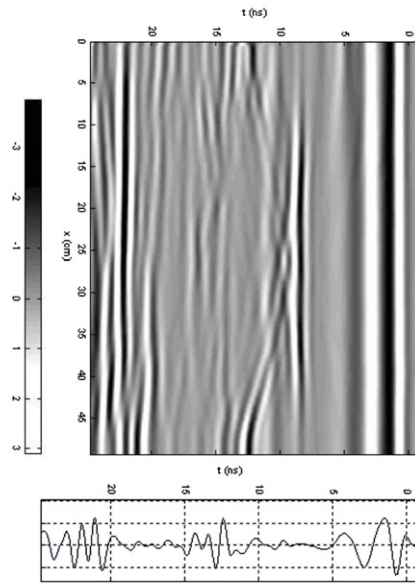
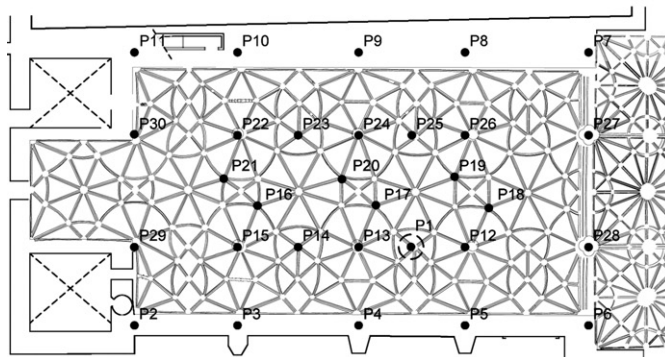
Fig. 22. Examples of in situ additional measurements for validation of numerical analysis: (a, b) GPR investigation of the columns, (c, d) dynamic modal investigation and (e, f) monitoring system with remote access.

monitoring were proposed, see Fig. 22. Validation and possible correction of the numerical results obtained previously seem essential to define possible future remedial measures on the columns of the church.

Given the major influence of the columns in the structural response of the columns, a radar inspection was carried out aiming at defining their internal constitution, see Fig. 22a and b. Radar measurements were performed in the four columns of the Church that feature larger slenderness, see [14] for details. This allowed to confirm that the columns are homogeneous, constituted by segments of a single block or two/three blocks with thin vertical joints. Therefore, it seems reasonable to assume a moderately high strength for the masonry of the columns. Tests are planned in such masonry to obtain a more reliable value. In addition, two monitoring systems have been installed in the main nave of the church, see [15], with the following objectives: (a) to better understand the structural behavior of the complex construction; (b) to identify any possible progressive phenomenon; (c) to detect damage at an earlier stage; and (d) to calibrate the boundary conditions and the modulus of elasticity of numerical models.
