# Sustainable Bridges

**Assessment for Future Traffic Demands and Longer Lives**

## **A new sensor for crack detection in concrete structures**

**Paulo CRUZ & Abraham D. de LEÓN**

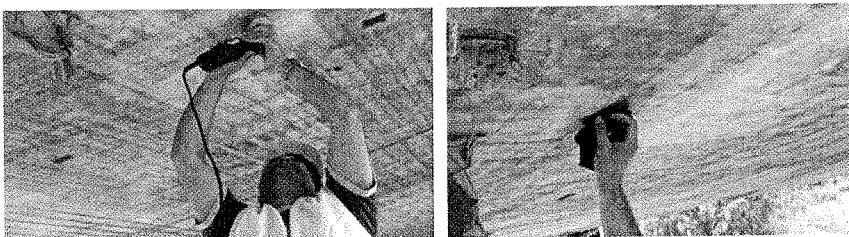
Figure 2. Surface blasting and cleaning

The establishment of a strong bond of the plate to the concrete surface is an important prerequisite for the successful performance of the sensor. For a successful bonding application, the strength of the substrate surface is equally as important as a clean and dry surface, the absence of contaminants, and the best profile that can be achieved. Surface blasting with hand held mechanical equipment can be used to attain a uniform surface texture and to remove the laitance (the weak alkaline surface residue), dirt, and dust until coarse aggregates are exposed (Figure 2, left part). Any oil and/or grease contamination on the concrete must also be removed prior to bonding (Figure 2, right part).

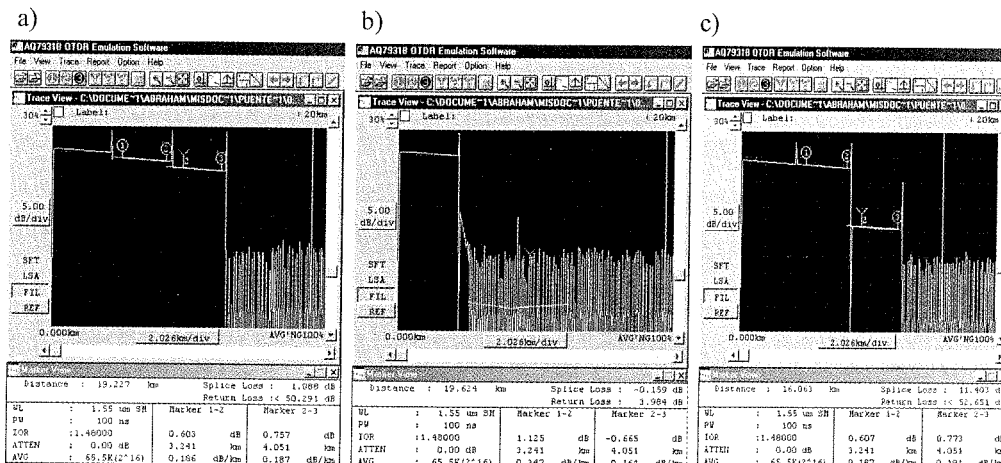
Figure 12. Images of the screen using the emulation software AQ7931B: a) reference loss, b) interruption of the acquisition, c) integrated loss

Figure 12 shows images of the screen using the emulation software AQ7931B to determine the reference and integrated loss in the post-processing of acquired data. Figure 12a shows the reference loss of 1.088 dB from the sensor at 30° before the second phase of the failure test was started. Figure 12b shows the interruption of the acquisition because of the rupture of the optical fibre in the sensor at 15°. Figure 12c shows the integrated loss of 11.403 dB from the sensor at 30° after completing the second phase.

By a simple subtraction of the integrated and reference losses a net optical power loss of 10.315 dB is obtained. By knowing the mean theoretical calibration model for the implemented sensor and assuming the same angle of crack direction for all cracks, the measured value corresponding to the total optical power loss was 1.19 mm with an absolute and relative error of 1.053% and 0.833% regarding the input range and true integrated size of crack opening.
