# Characterization of brick and brick–mortar interface under uniaxial tension

J. C. Almeida<sup>1</sup>, P. B. Lourenço<sup>2</sup>, J. A. Barros<sup>2</sup>

**ABSTRACT:** *Softening is a gradual decrease of mechanical resistance under a continuous increase of deformation imposed on a material specimen or structure. It is a salient feature of quasi-brittle materials like clay brick, mortar, ceramics, rock or concrete, which fail due to a process of progressive internal crack growth. Such mechanical behavior is commonly attributed to the heterogeneity of the material, due to the presence of different phases and material defects, like flaws and voids. The initial stresses and cracks as well as variations of internal stiffness and strength cause progressive crack growth when the material is subjected to progressive deformation. Initially, the micro cracks are stable which means that they grow only when the load is increased. Around peak load an acceleration of crack formation takes place and the formation of macro cracks starts. The macro cracks are unstable, which means that the load has to decrease to avoid an uncontrolled growth. In a deformation controlled test the macro crack g

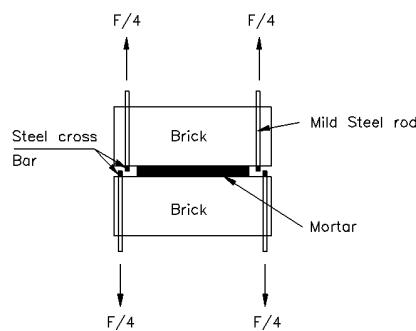
A different loading arrangement was developed by Taylor-Firth and Taylor (1990), allowing to test the specimen without the need to use clamping devices to hold the bricks. The load is applied by means of tie bars placed under the bricks, as shown in Fig 6.

Fig. 6 – Sheffield test

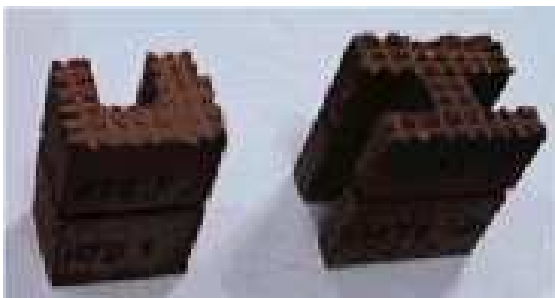
This brick has four horizontal holes and a rough surface on the top surface. Fig. 12 shows the specimens adopted to characterize the shell and web of the brick, respectively, to the left and right of the figure.

Fig. 12 – Specimens for HSH Units

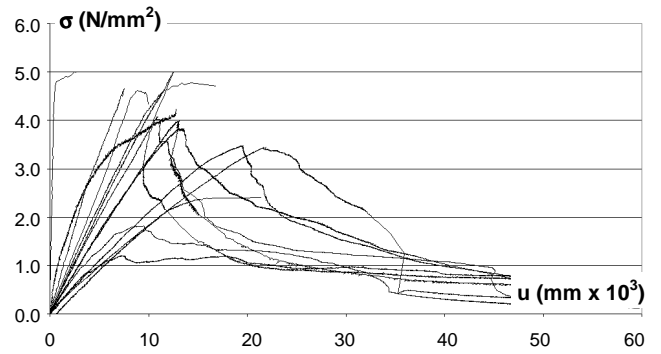
The stress-elongation relationships for specimens SV and SH are depicted on Figs. 20 and 21, respectively. The main data evaluated is included on Tables 7 and 8. The SV series had a tensile strength 18% higher and fracture energy 15% higher than the values obtained on SH series. Like in previous series, the scatter on the S series was also too high, particularly, on the tensile strength of SH series. After testing, internal cracks and voids in some bricks were observed, justifying the obtained scatter. The tensile strength and the fracture energy of S series were of the same order of the HS and HP series.

Fig. 20 – Stress-elongation on SV brick specimens
