SEISMIC SAFETY ASSESSMENT OF THE CHURCH OF MONASTERY OF JERÓNIMOS, PORTUGAL

Lourenço, Paulo B.¹; Roque, João²; Oliveira, Daniel V.³

Keywords: *Historical buildings, in situ investigation, seismic assessment, numerical analysis*

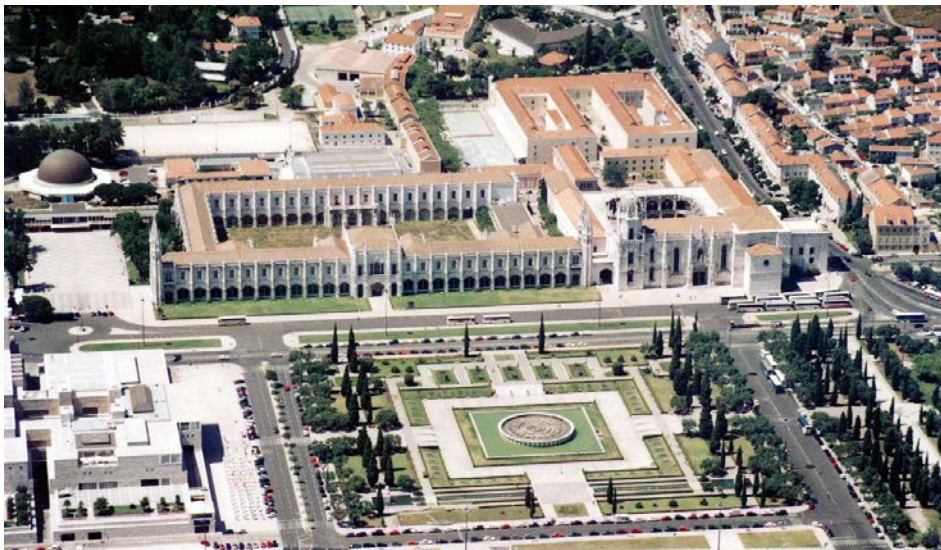
The monumental set has considerable dimensions in plan, more than $300 \times 50 \text{ m}^2$, and an average height of 20 m (50 m in the towers), see Figure 1. The monastery revolves around two courts. The larger court is bordered by a long arcade of two levels that hosts the Ethnographic Museum of Archaeology and the Maritime Museum. The smaller court or the Cloister is bordered by the Church, the Sacristy, the Chapter Room and the Refectory.

Figure 1: Aerial view of Monastery of Jerónimos

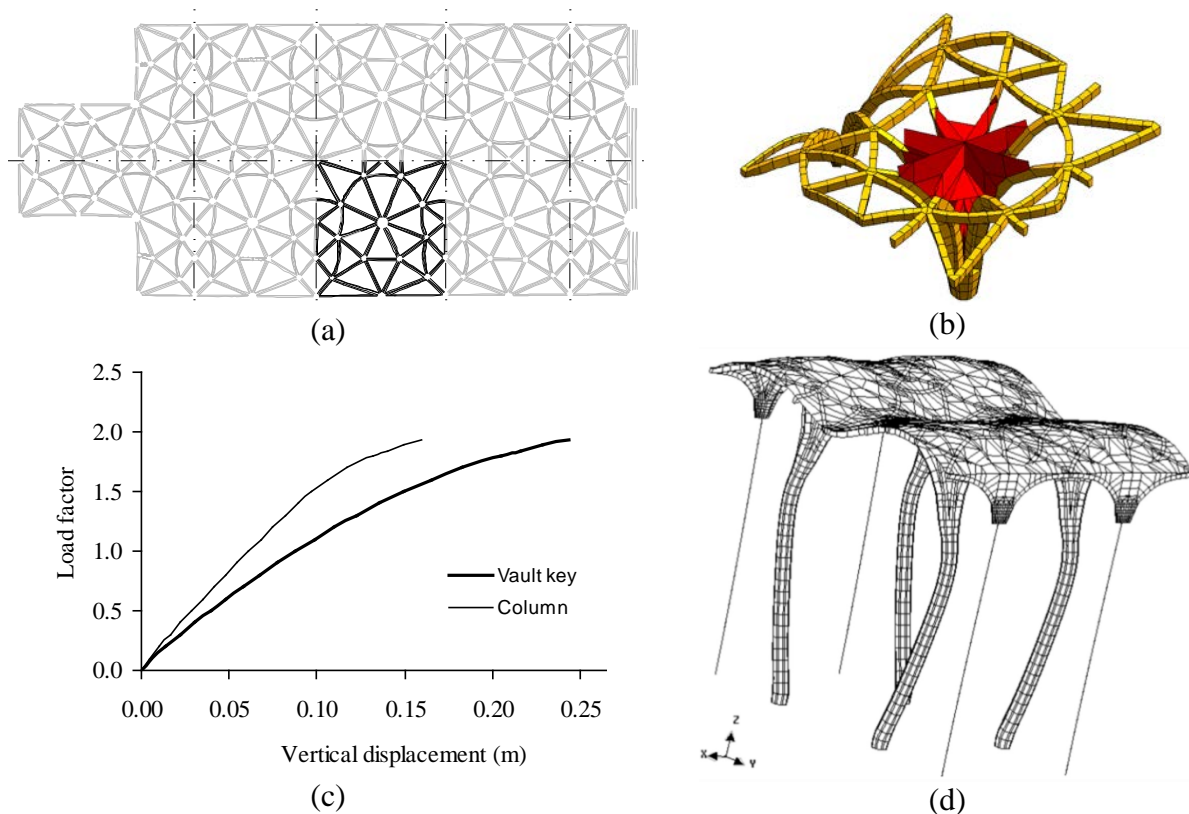
The adopted model for the main nave includes the structural detail representative of the vault under the most unfavourable possibility, see Figure 6a, using symmetric boundary conditions. Therefore, the model represents adequately the collapse of the central-south part of the nave. The model includes three-dimensional volume elements, for the ribs and columns, and curved shell elements, for the infill and stones slabs, see Figure 6b. The external (south) wall was represented by beam elements, properly tied to the volume elements. The supports are fully restrained, being rotations possible given the non-linear material behaviour assumed. All elements have quadratic interpolation, resulting in a mesh with 33335 degrees of freedom. The time-effort necessary for total mesh generation, including definition of supports, loads and thicknesses, can be estimated in three man-months.

The actions considered in the analysis include only the self-weight of the structure. Figure 6c illustrates the load-displacement diagrams for the vault key and top of the column. Here, the load factor represents the ratio between the self-weight of the structure and the applied load. It is possible to observe that the response of the structure is severely nonlinear from the beginning of loading, for the nave, and from a load factor of 1.5, for the column. The behaviour of the nave is justified by the rather high tensile stresses found in the ribs. The collapse of the columns is due to the normal and flexural action. The deformed mesh at failure, see Figure 6d, indicates that the structural behaviour is similar to a two-dimensional frame, with a collapse mechanism of five hinges (four hinges at the top and base of the columns and one at the key of the vault). The compressive strength of the columns controls the safety of the church for vertical loading. Nevertheless, there is some vault effect with slightly larger displacements at the central octagon, formed between the four capitals. The stresses are bounded in tension and compression, meaning that cracking and crushing occurs. Note that the results are shown for a conservative compressive strength of 6 N/mm². If the value found experimentally is used, the safety factor of the structure is larger than five, meaning that no damage due to the vertical loading should be expected in the structure.

Figure 6: Detailed model of the church for vertical loading: (a) church plan and basic plan; (b) details around capital; (c) load-displacement diagram; (d) incremental deformed mesh at failure

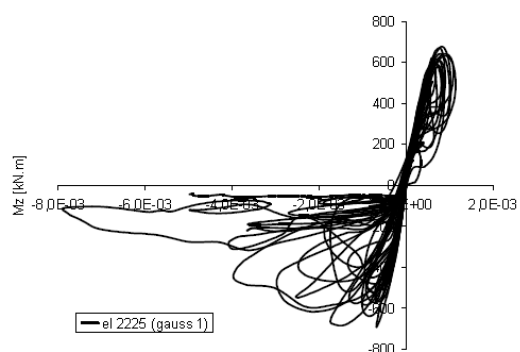
Figure 7: Detailed model of the church for horizontal loading: (a) finite element mesh; (b) pushover results, seismic action vs. displacement at given nodes; (c) example of failure mechanism; (d-f) virtual collapse mechanisms for different pushover analyses; (g) example of column response for time integration analysis

In order to further validate these observations about safety and discuss the damage introduced by an earthquake, non-linear time integration analyses were carried out, see Figure 7g for the typical results involving collapse of one of the columns in terms of moment-curvature relation. The results indicate that no local or total collapse is to be expected for a 475 or 975 years return period (yrp) earthquake, even if severe stress states and cracking occur in the vault and nave columns.
