# Post-earthquake numerical assessment and reinforcement of St James Church, New Zealand

This paper presents a numerical study on the seismic assessment and reinforcement of St James Church, affected by the 2011 New Zealand Earthquake. Numerical analyses were performed using a finite element model including the structural damage of the Church. The numerical model was calibrated against experimental results obtained from the dynamic identification tests carried out in situ. Nonlinear pushover analyses were performed in order to understand the structural behaviour of the damaged Church. The analysis of the results suggests that the damaged structure is not safe according to the new national specifications. Therefore, some reinforcement measures are needed to improve the seismic behaviour of the structure. A reinforcement solution is proposed taking into account the historical heritage value of the building, trying to maintain as much as possible the original aspect of the Church. Pushover analyses were also performed in the reinforced numerical model, proving its effectiveness.

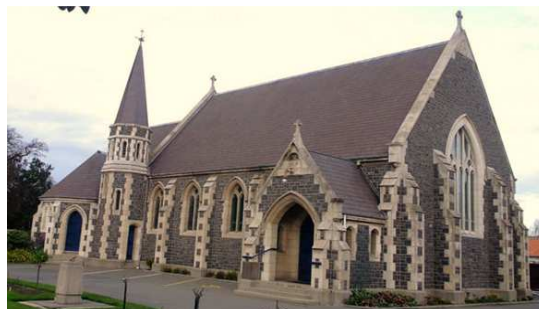
**Figure 1.** General view of St. James Church

The construction of St James Church was started in 1923, designed by the architects Alfred and Sidney Luttrell, to provide a permanent centre for Anglican worship. The Church has a simpler early English Gothic style (as can be seen in Figure 1) and is a place of worship because it was built as a memorial to the men of Riccarton, in Christchurch, who had died in the First World War.
