# THE IMPORTANCE OF PHYSICAL INDICATORS IN AREAS OF URBAN FLOOD

## THE CASE OF THE METROPOLITAN REGION OF BELÉM

R.S. Pegado, C.J.C. Blanco, J. Roehrig, C. Carocha, F.S. Costa and W.S. Tostes

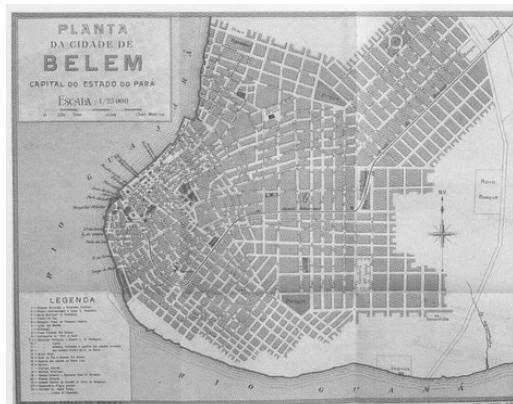
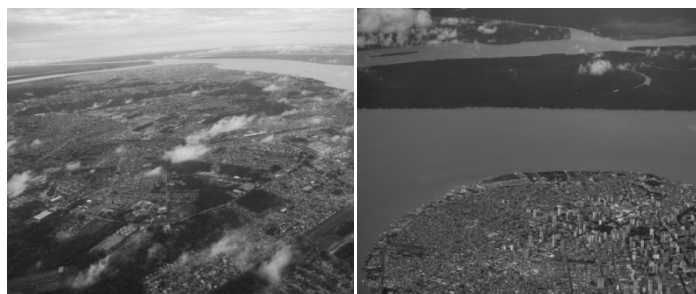
**Fig. 1**– (a) Belém City Plan; (b) and (c) aerial view of the city of Belém. Source: Macapuna (2009).

The rapid urbanization and the lack of planning has been responsible for various problems within the Brazilian urban centers, especially those related to the sewage system and urban drainage basins. According to the Brazilian Institute of geography and statistics [6], over 99% of the population of the city of Belém/PA live in urban areas concentrated around its rivers, which slows down the access to them (Figure 1).

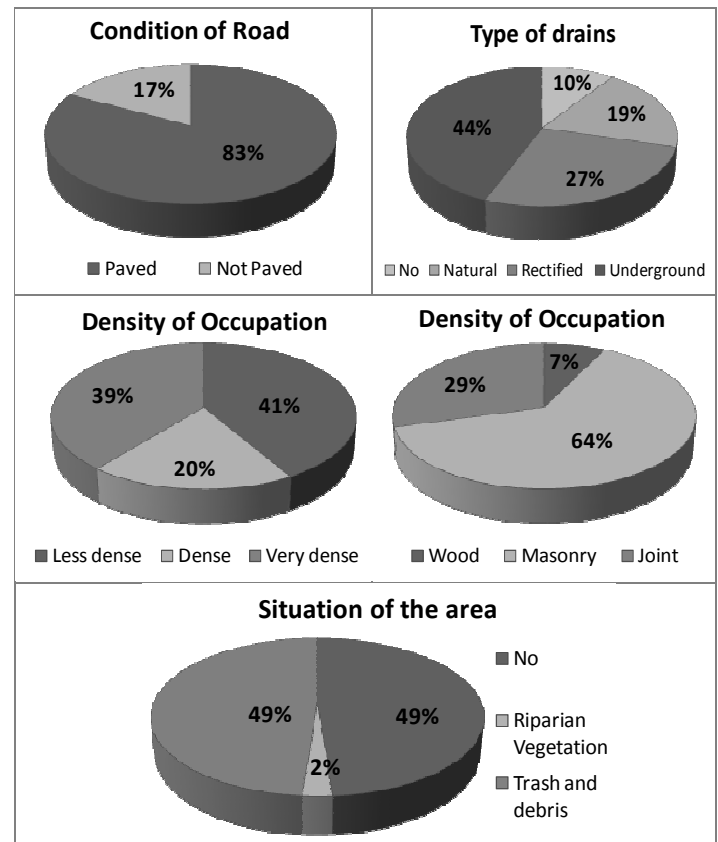
Fig. 2 – Pie charts illustrating the variables used for the construction of physical indicator.

The graphs in Figure 2 revealed the following findings:

- 83% of surveyed area is paved;
- the most frequent type of drainage is underground drainage and/or shallow with 44%;
- the "density" prevailed less dense with 41% considering the sign of the house above 4 meters followed by very dense 39% considering the sign of the house with less than 3 metres;
- the villas of masonry are prevalent with 63%;
- almost 50% of the channel is blocked by garbage and rubble.

The analysis of graphs characterizes the channels and show that most of them are paved pathways, with underground drainage or superficial, contained less dense population occupying the very dense, being primarily in masonry houses.

In Pearson's test, which achieved the largest variables were occupying density correlations and channel characteristics, that is, the more dense the study area, the greater the amount of garbage and rubble in the channel, with a view that this population is low-income and its occupation is chaotic. The disorderly urban occupation is a factor that exacerbates the impacts that the urban floods can cause, since in many cities or coastal communities, the waters can reach the villas, the public roads (streets, roads, and sidewalks), leisure areas, trade and industry.

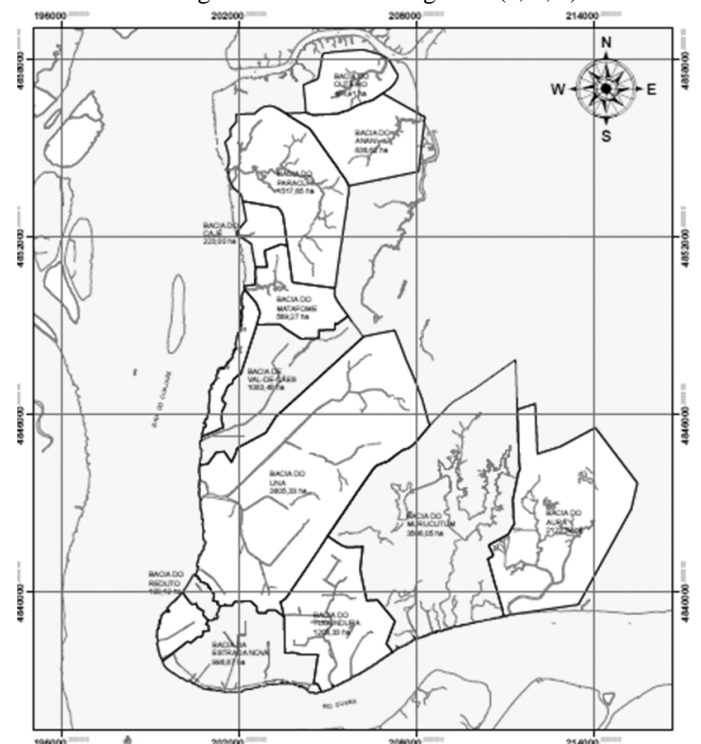
**Fig. 3.a** – Map of drainage basins and the city of Belém. Source: Map 1/50000 scale, Federal University of Pará on watersheds and drains on the region of Belém.

Belém since 12 January of the year of 1616 has been growing without a plan for minimizing human and property losses in case of floods. Currently, in many districts of the municipality of Belém the pavement was done without first provide the proper drainage system to the area. This led to increased flooding area as shown in Figure 3 (a, b, c).

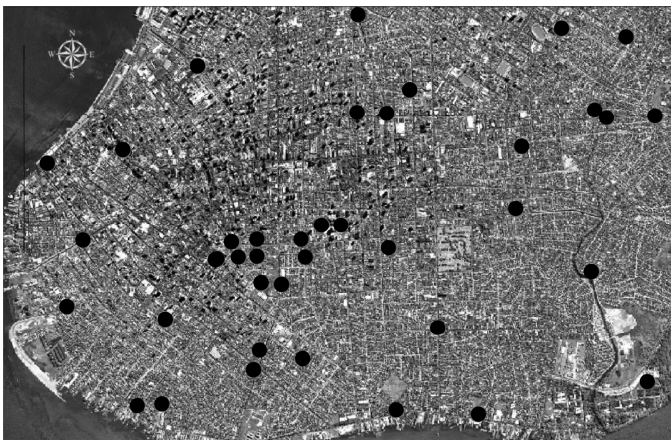
**Fig. 3.c** – Points of flooding in Belém. Source: Source: Map 1/50000 scale, Federal University of Pará on watersheds and drains on the region of Belém Google Earth, 2011.

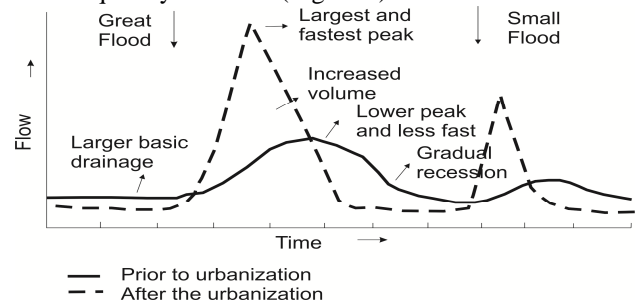
One reason for the scenarios of the drainage of Belém/PA is excessive paving, preventing the rainwater to percolate into the soil, reducing infiltration capacity and causing increased runoff and drainage density. To [19] this is characterized as flood areas of marsh due to urbanization or urban drainage, linked to increased impermeable areas and to the canalizing of water lines culminating in the saturation of drainage systems and consequently in floods (Figure 4).

**Fig. 4** - Changes in land use due to urbanization and its effect on the flood levels and hydrograph. Source: TUCCI, 1997.

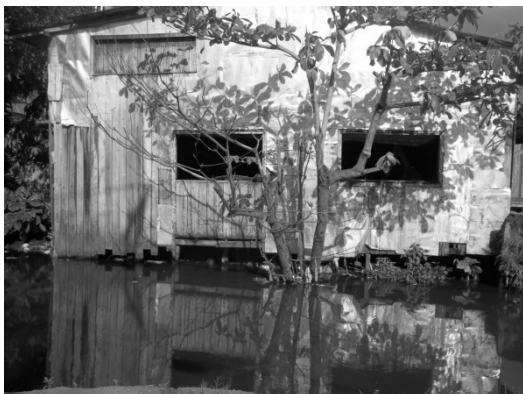
Another visual scenario in Belém results in construction over the canals, thus obstructing the free flow of water and increasing vulnerability, with obvious damage to housing residents (Figure 5).

**Fig. 5** - Homes on the canal, making the passage of water, source: PEGADO, 2011.

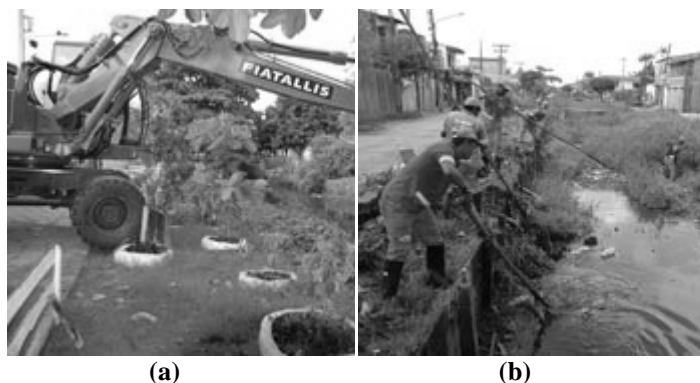
In addition to the above-mentioned scenarios, there is another, also very serious, that is the municipal solid waste dump in watercourses. The SESAN (Secretary) tries to minimize these problems with cleaning and unclogging of canals. The maintenance of the canals is through dredging, performed with the use of equipments that remove mud, deepening the channel bed. This activity is called "winter operation" takes place once a year, always occurring in the rainy season from December to May in the city of Belém/PA. Withdrawal is also made of rubble and the bank cleaning in these areas, procedure adopted by the municipality of Belém for the maintenance of the canals, so as to mitigate the flooding in the city. (Figure 6).

**Fig. 6** – Cleaning and unclogging of Belém-PA channels. (a) dredging, (b) manual cleanup. Source (SESAN, 2011)
