**Analysis of Christchurch  
Catholic Basilica,  
New Zealand**

Dissertação de Mestrado  
Mestrado Integrado em Engenharia Civil

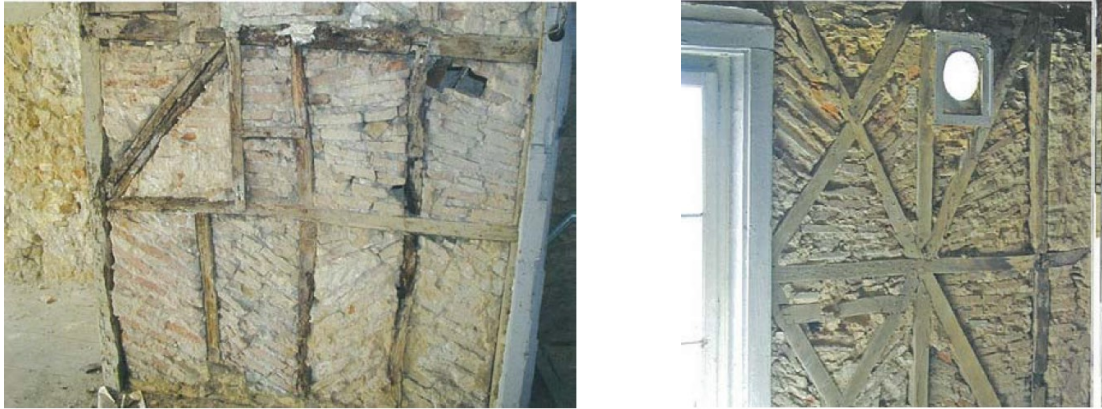
a) b)  
 Figure 8 – Wall system in Lisbon: (a) Before the earthquake; (b) After the earthquake, where an x-braced internal wooden frame is clear.

The constructive techniques before the earthquake, in the so-called pre-Pombalino period (reference to Marquis of Pombal, the prime-minister that coordinated the reconstruction of the city) were very diverse, given the large temporal line of construction evolution. In general, constructions were based on stone masonry and with low quality of construction. Thus, it is reasonable to assume that the ruin of most buildings was due to their low capacity to dissipate energy, and to the high inertial forces of these construction types [32, 33].

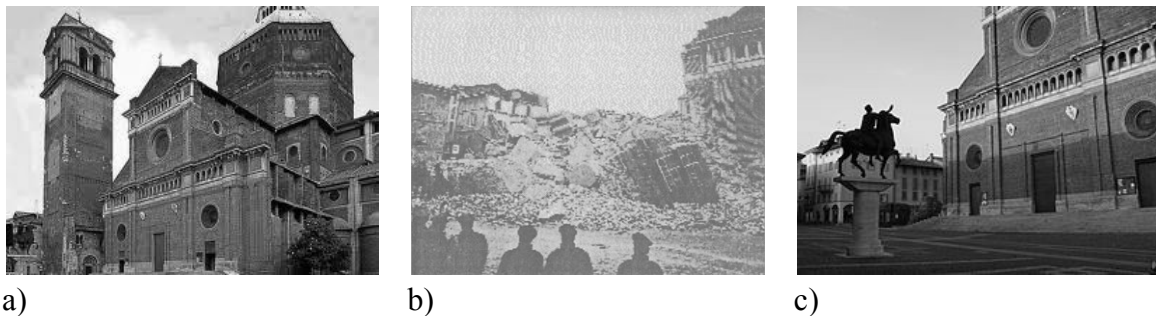
Figure 10 – The Cathedral of Pavia: (a) before the collapse of the civic tower in 1989 (Source: [http://www.4thfirst.com/interesting\\_sites.html](http://www.4thfirst.com/interesting_sites.html)); (b) After the collapse - ruins of the Civic Tower [43]; (c) At present (Source: Wikipedia).

The Civic tower was located in Pavia, Italy, adjacently to Pavia Cathedral. The tower had been built during the 11<sup>th</sup> and 13<sup>th</sup> centuries and the belfry was added only in the 16<sup>th</sup> century [42]. The tower walls' were made by two thin external brick leaves and by an internal core made from random layers of broken bricks and stones in a matrix of mortar, i.e. a sort of concrete with coarse aggregates. The belfry was made by a regular masonry wall, see Figure 10(a).

The Civic Tower of Pavia suffered a sudden collapse on 17<sup>th</sup> March, 1989. The collapse was unexpected and beyond the physical consequences (severe damage to nearby buildings), four people died, see Figure 10(b) [42]. The study of its sudden collapse attracted many experts, which sought to explain the reasons for failure. The conclusion was that damage was mostly related to stress redistribution phenomena. The non-uniform stresses caused by masonry creep, shrinkage and carbonation associated to factors such as fatigue, due to wind and thermal actions, increased the compressive stress of the external walls due to redistribution. This failure mechanism is associated to tall structures or elements - as bell towers, columns, pillars and so on [42-44]. Thereby, the Civic Tower of Pavia sudden collapse was not an isolated accident, as corroborated by other similar examples: (i) St. Marco's bell tower at Venice (Italy) in 1902; (ii) the St. Martinus Church at Kerksken (Belgium) in 1990 (5) the St. Magdalena Church at Göch (Germany) in 1992 [5]. Despite the cultural importance of the Civic tower, as a symbol that integrated once the built heritage of Pavia city, it was not rebuilt, mostly due to the high cost involved and the impossibility to raise the necessary public and private funds, see Figure 10(c).

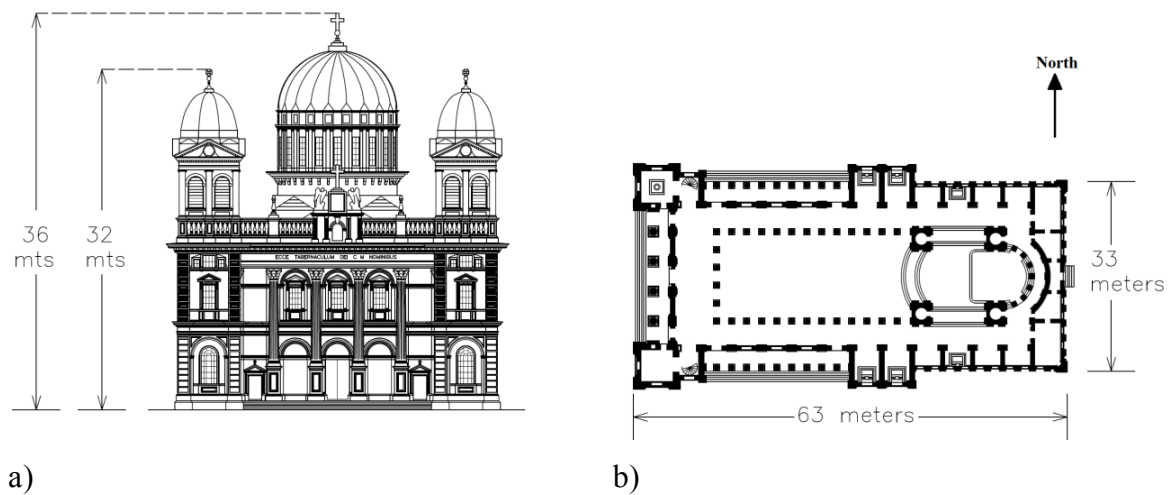
a) b)  
Figure 18 –Basilica of the Blessed Sacramento geometry (a) West elevation; (b) Top plan.

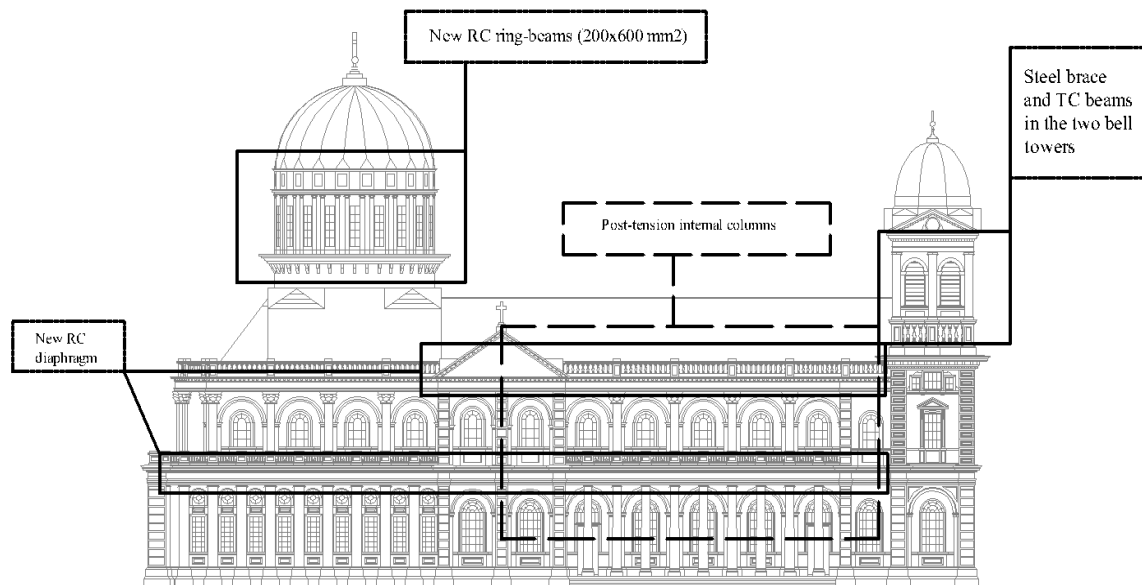
Figure 22 – Introduced elements in the 2004 strengthening of the Basilica of the Blessed Sacramento [3].

The strengthening process, see Figure 22, introduced: (i) a new reinforced concrete slab (RC) with 100 mm of thickness in the first floor and roof level, aiming a diaphragm action; (ii) a steel brace with 32 mm of thickness and RC ring-beams with a section 200 x 600 mm<sup>2</sup> in the front of the two bell towers, above and below the window openings; (iii) RC ring beams with a section of 200 x 600 mm<sup>2</sup> in the top section of the main dome, above and below the windows; (iv) post-tensioning in alternating columns of the nave colonnade and grouting of external parapets and ornaments; (v) fixing of the gable ends of the roof, the transepts and ornaments [7].

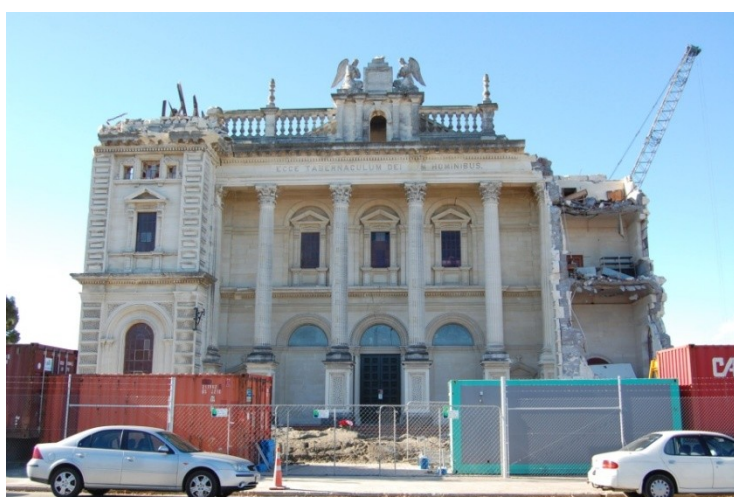
Figure 23 – West façade of the Christchurch Catholic Basilica and the damage in the two bell towers, North (left) and South (right).

- i. North and South tower belfries collapsed. Failure occurred in a north-west and south-west direction, respectively. Additionally to the top section complete collapse, the entire west wall of the south tower felt down.

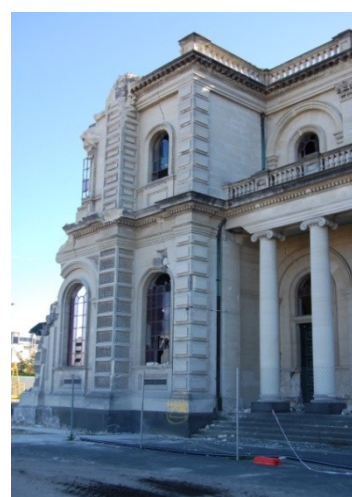
Figure 24 – Detail of the West wall collapse of the South bell tower.

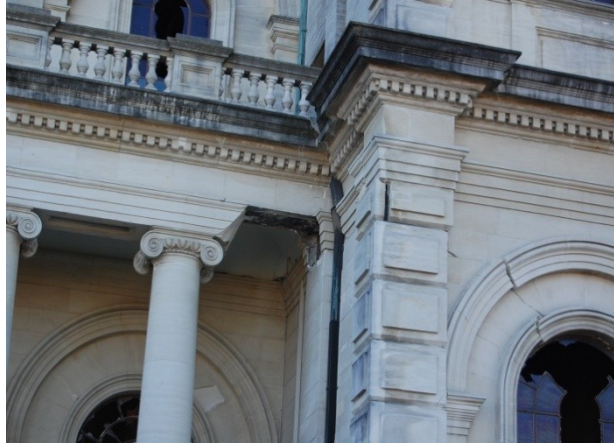
Figure 26 – Detail of shear cracking around South transept window and local collapse of the architrave.

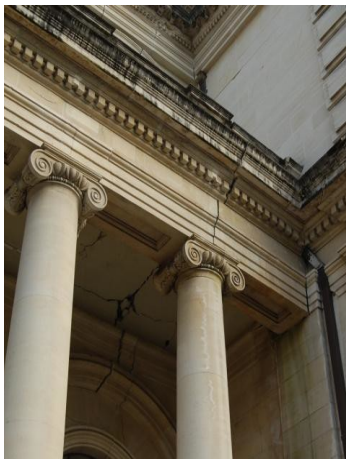
Figure 27 – Large diagonal crack in the entablature near to the north transept.

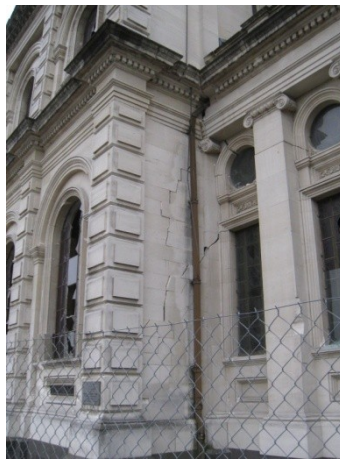
Figure 28 – Shear cracks in the transept-main nave connection.

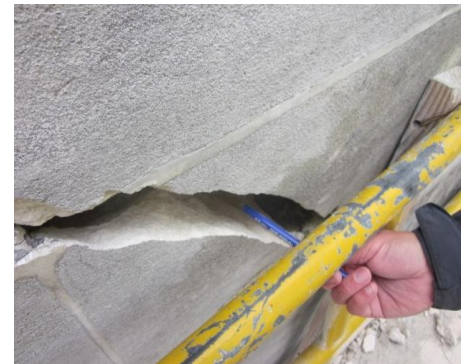
Figure 29 – Lateral displacements of the main dome drum or rotunda.

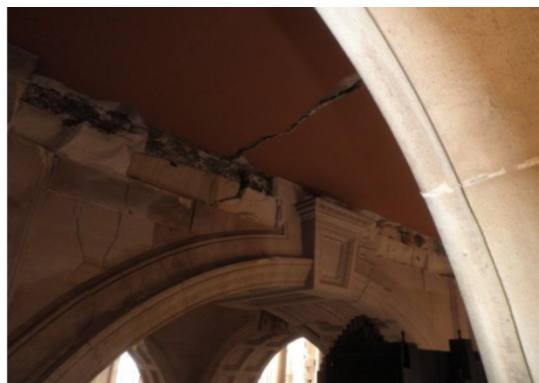
Figure 31 – Severe damage to the south arch spandrel.

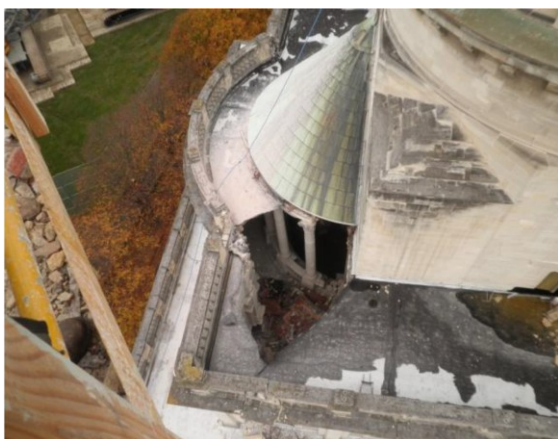
Figure 32 – Collapse of a part of the RC sanctuary flat.

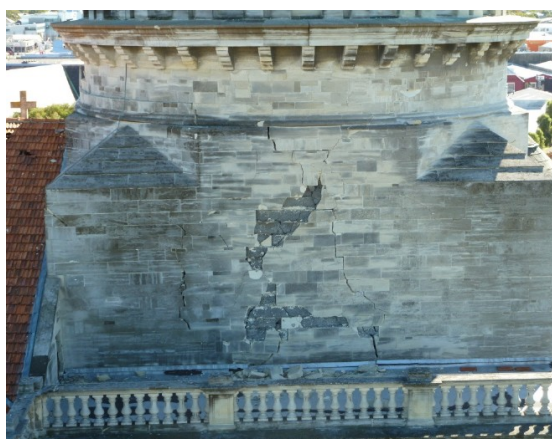
Figure 33 – Damage to the South supporting wall of rotunda.

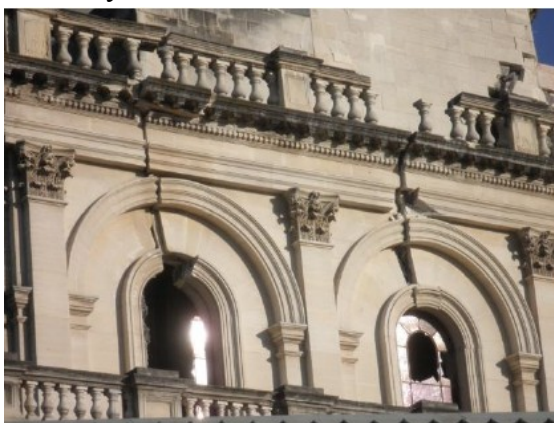
Figure 34 – Shear cracks around the upper arcade of the North elevation.

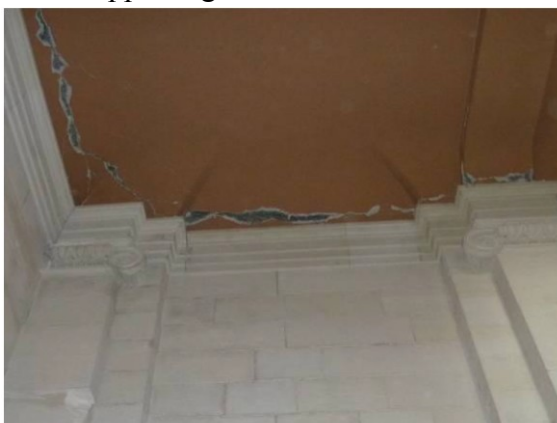
Figure 35 – Diaphragm damage at the first floor (its exact position is unknown).

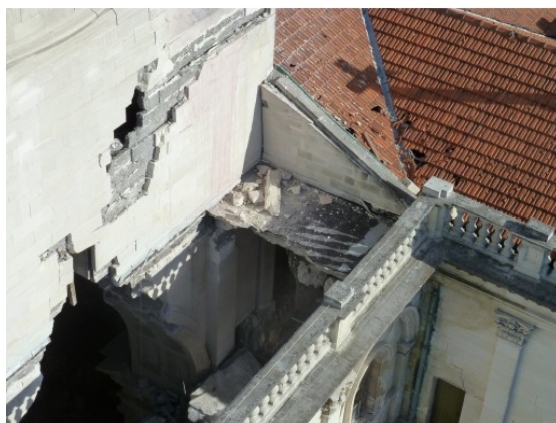
Figure 36 – Collapse of a fraction of North rotunda wall, part of the adjacent RC flat roof and North interior arch.

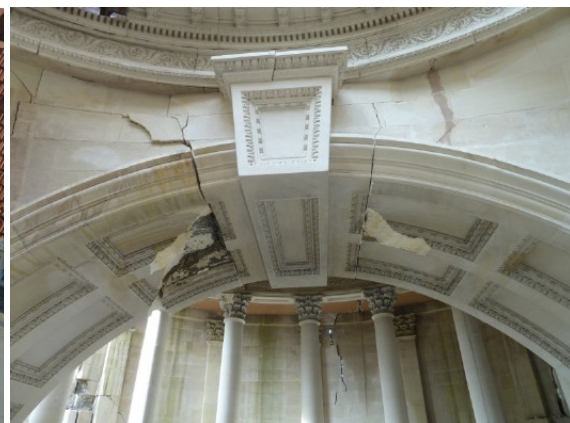
Figure 37 – Damages to the key stone of the East arch.

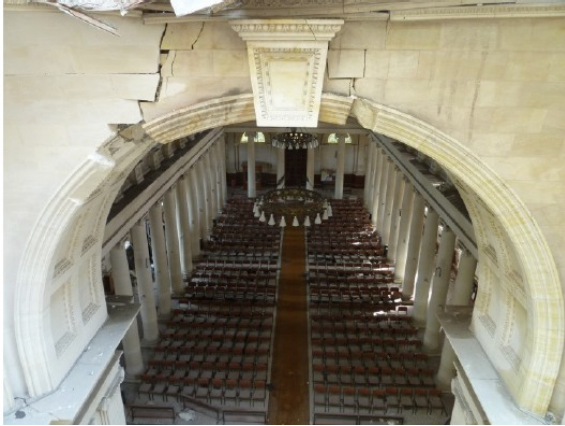
Figure 38 – Damage along the West arch.

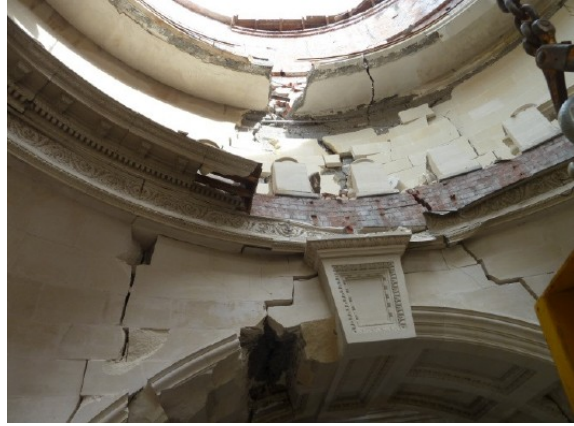
Figure 39 – South arch severe damage.

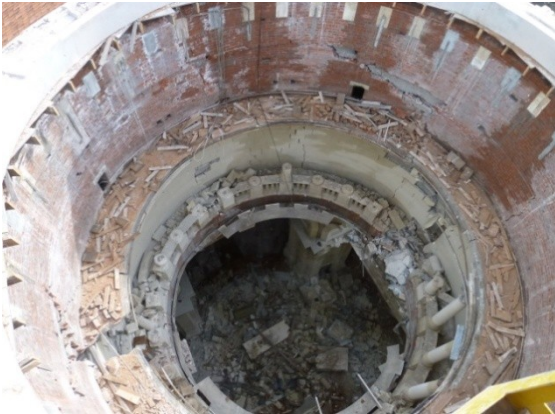
Figure 40 – Visible damage to the main dome drum (after the removal of the internal dome in 25 August, 2011).

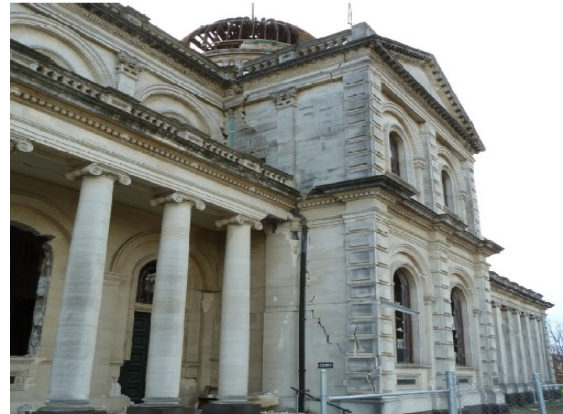
Figure 41 – Developing of a diagonal block failure in the South transept façade.

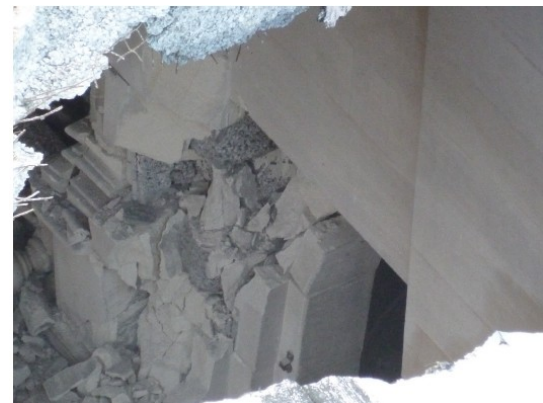
Figure 42 – Crushing of the top South-West column.

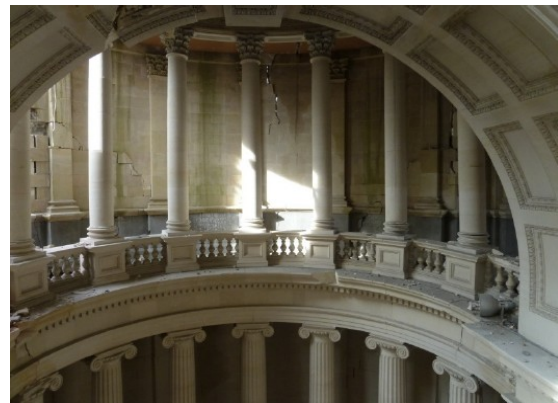
Figure 43 – Vertical crack in the East wall of the first floor.

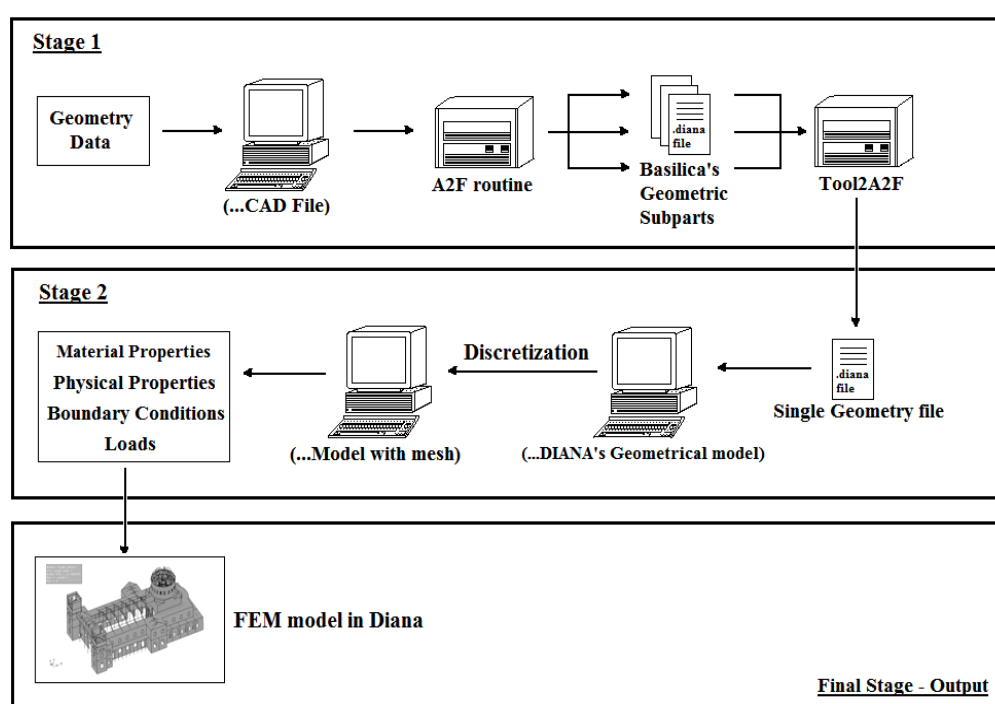
Figure 44 – Schematic description of the FEM numerical model preparation.

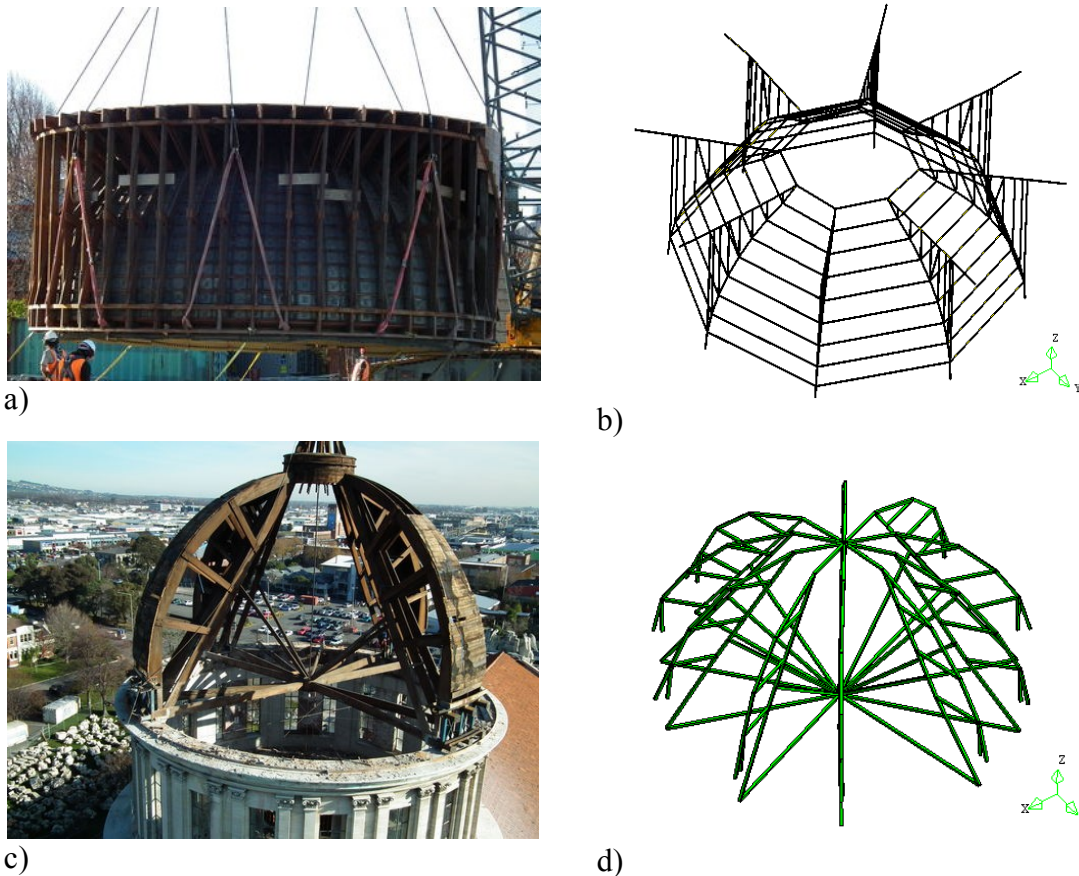
Figure 45 – Main dome: (a) Interior dome of the rotunda during its removal; (b) Interior dome of the rotunda modeled in DIANA, using beam elements; (c) Wooden-frame of the main dome, after the copper cladding removal; (d) Wooden-frame of the main dome modeled in DIANA, using beam elements.

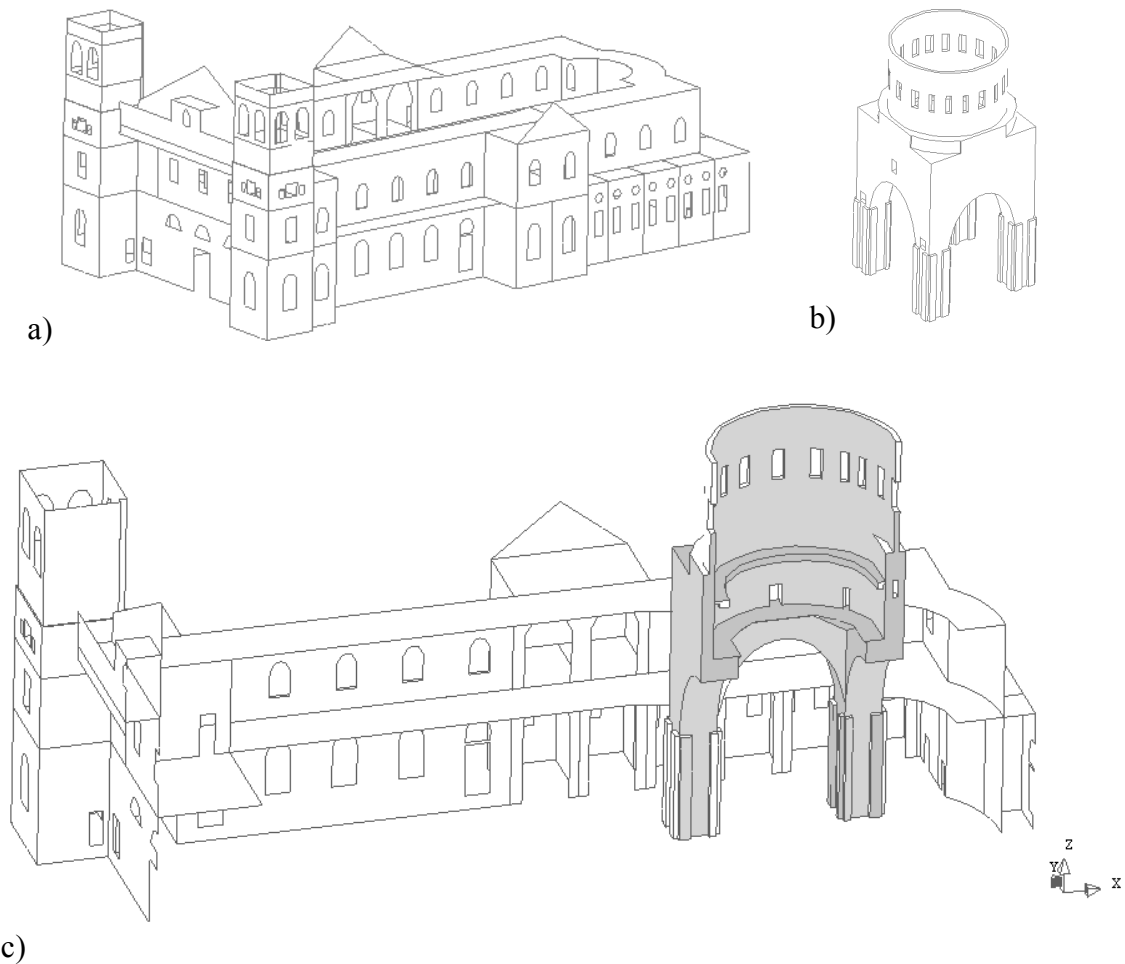
Figure 46 – Shell and solid elements: (a) General overview of the shell elements; (b) General perspective of solid elements; (c) West-East cut-away perspective with shell elements (colored as white) and solid elements (colored as grey).

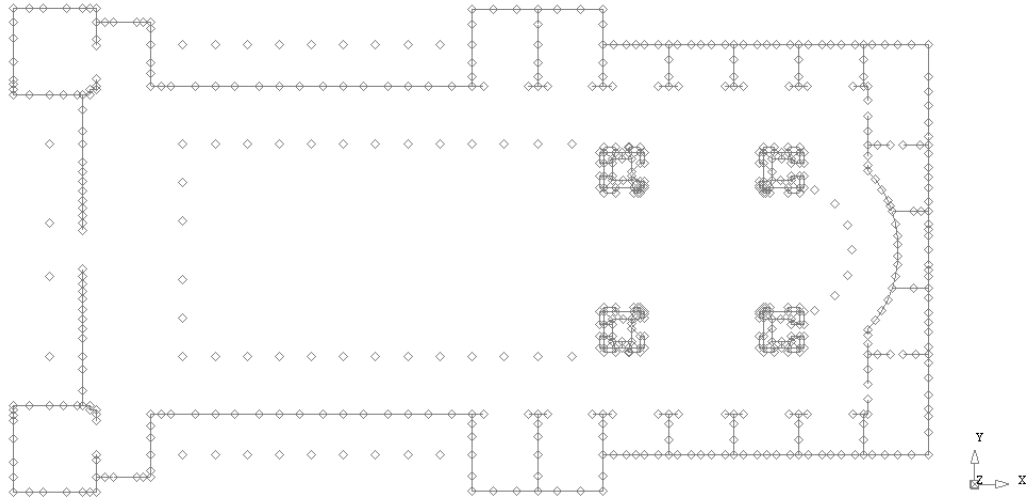
Figure 53 – Top view of the first type of boundaries constraints considered.

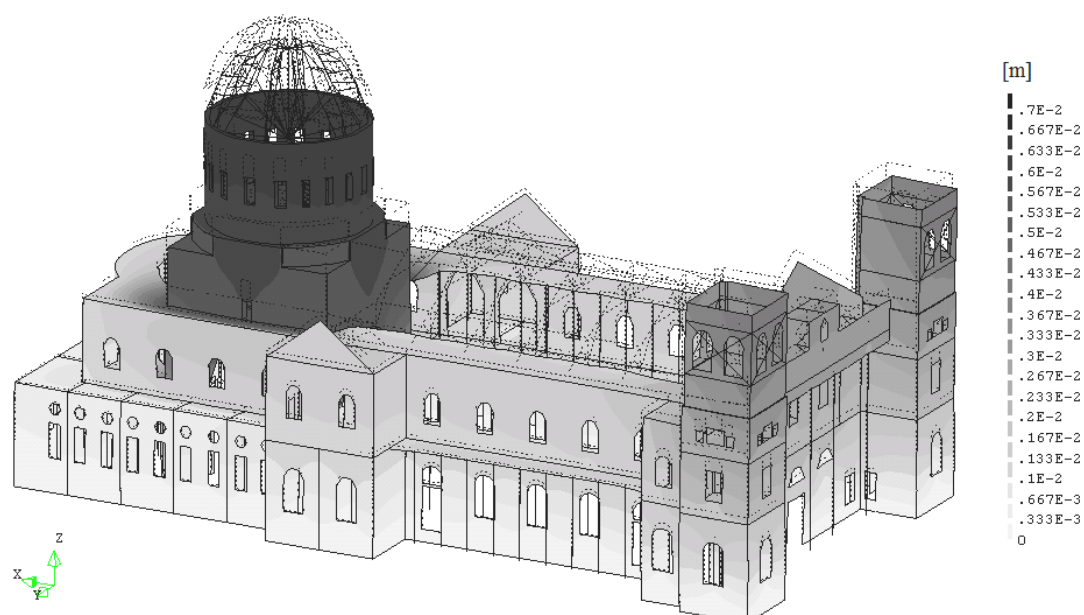
Figure 54 – Deformation of the Basilica under its self-weight (magnification factor: 300).

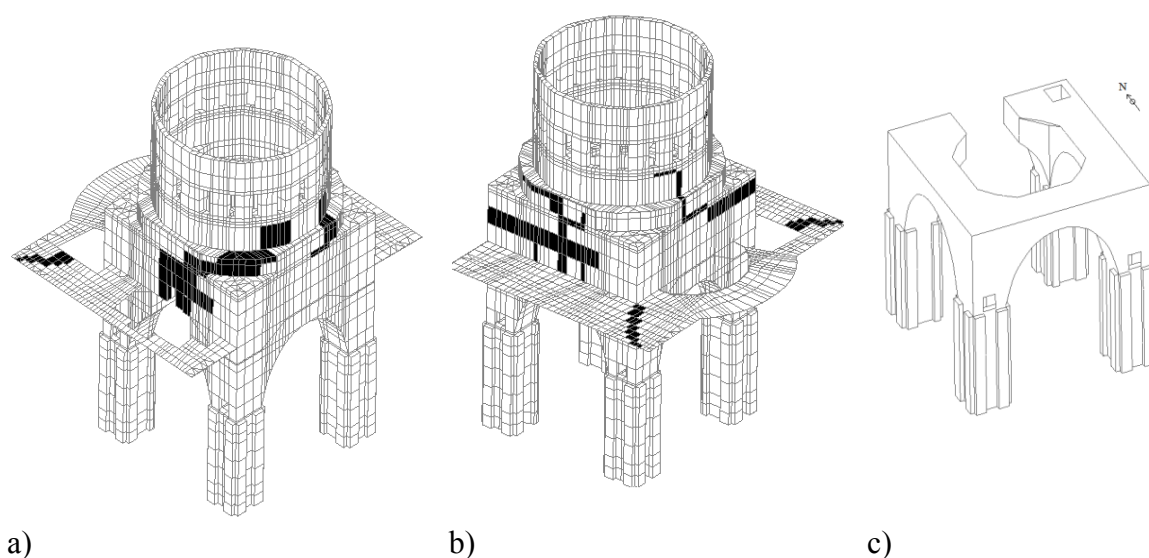
Figure 58 – Damage in solid elements (shadowed elements): a) North-West perspective; b) South-East perspective; c) Deleted elements of the North arch.

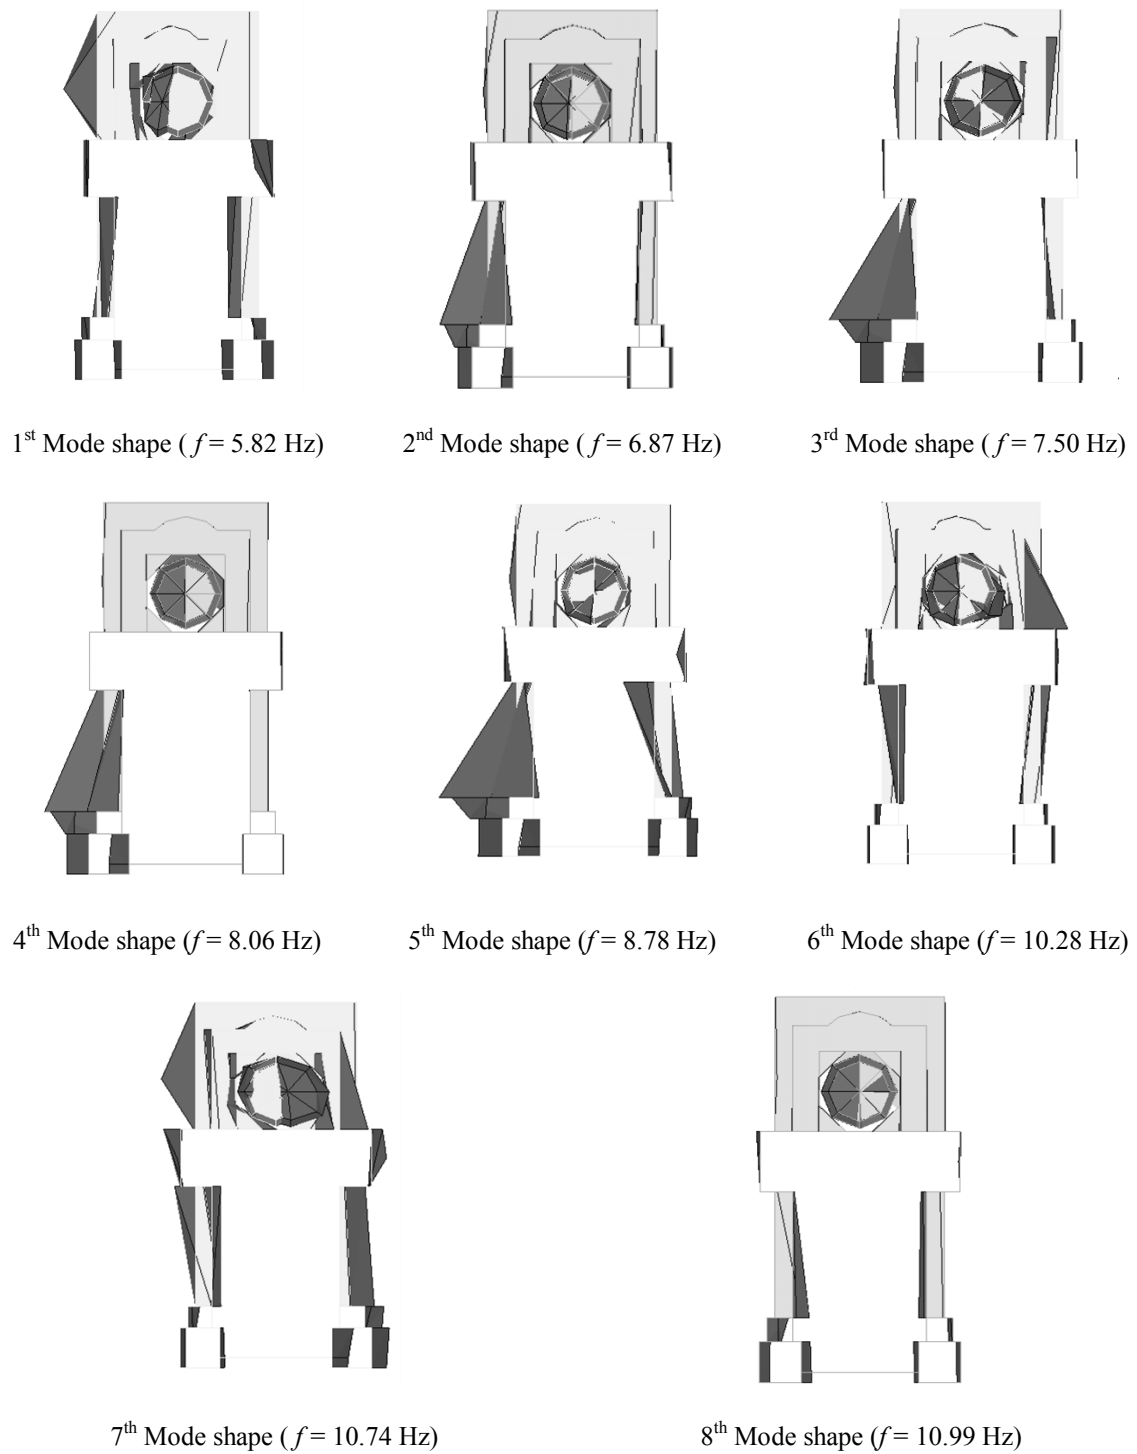
Figure 59 – Experimental mode shapes and frequencies [58].

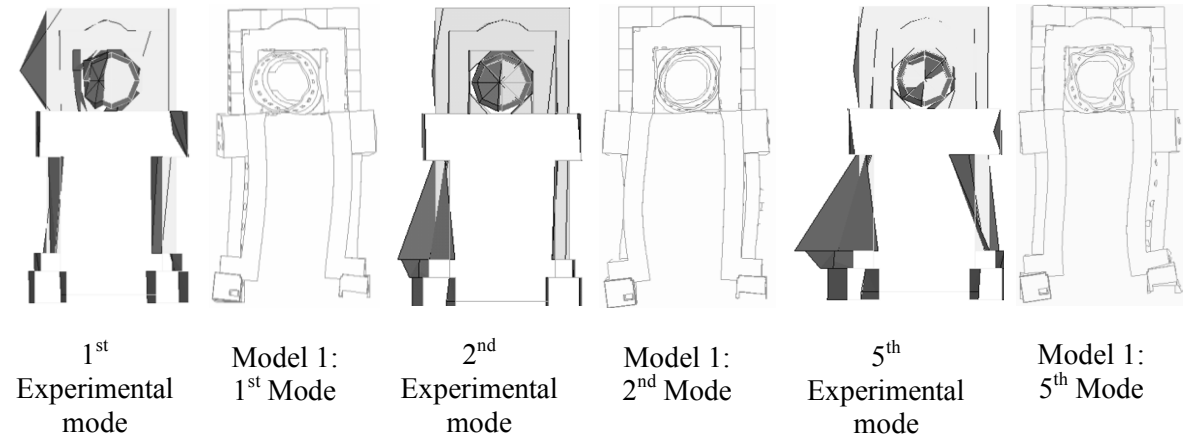
Figure 60 – Comparison between the 1<sup>st</sup>, 2<sup>nd</sup> and 5<sup>th</sup> experimental and numerical mode shapes.

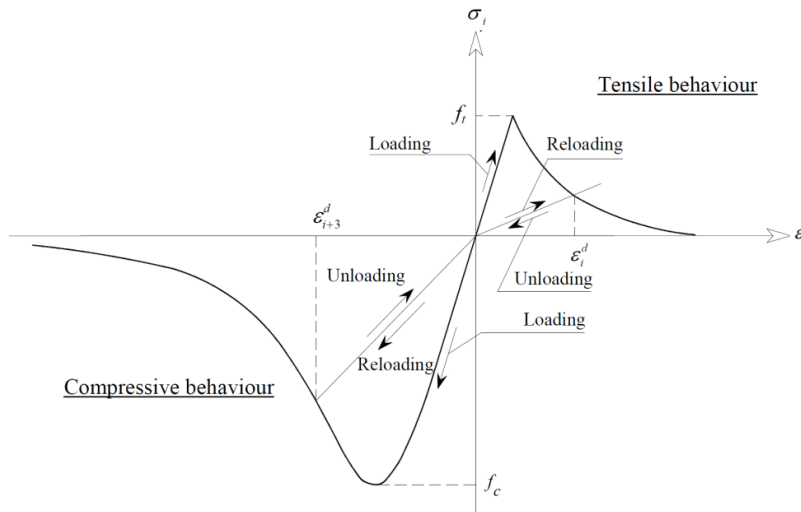
Figure 61 – Adopted hysteretic behavior for masonry and concrete [99].

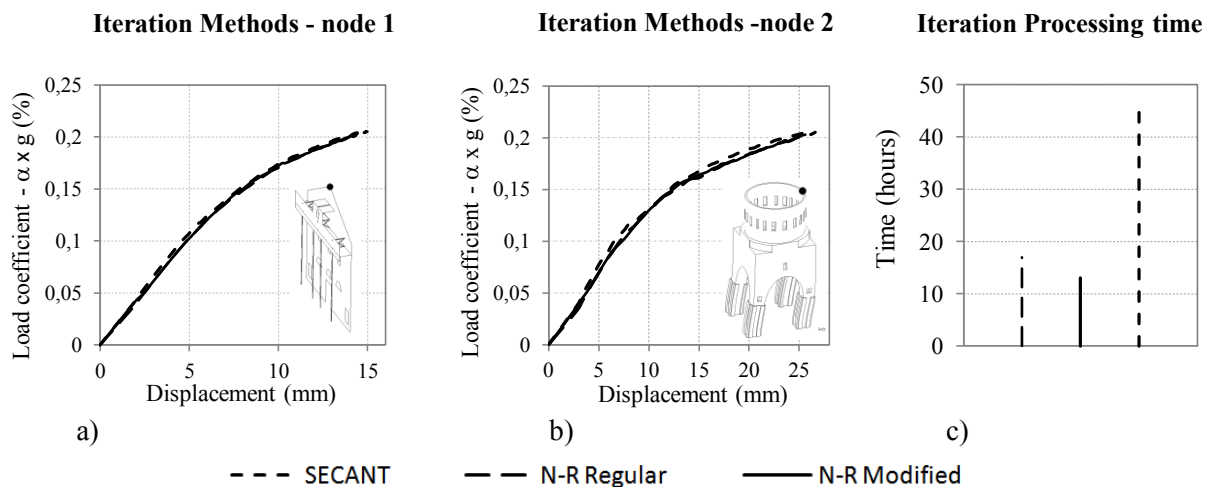
Figure 63 – Iterative methods: (a) Capacity curve in the main dome control node; (b) Capacity curve in the West tympanum wall control node; (c) Processing time.

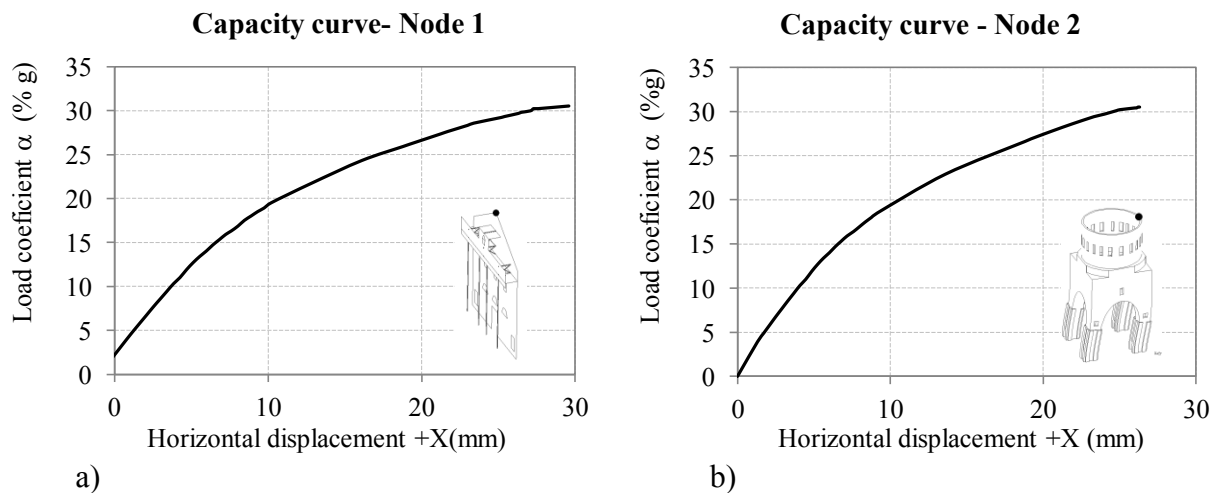
Figure 65 – Capacity curve in +X direction: (a) Node 1; (b) Node 2.

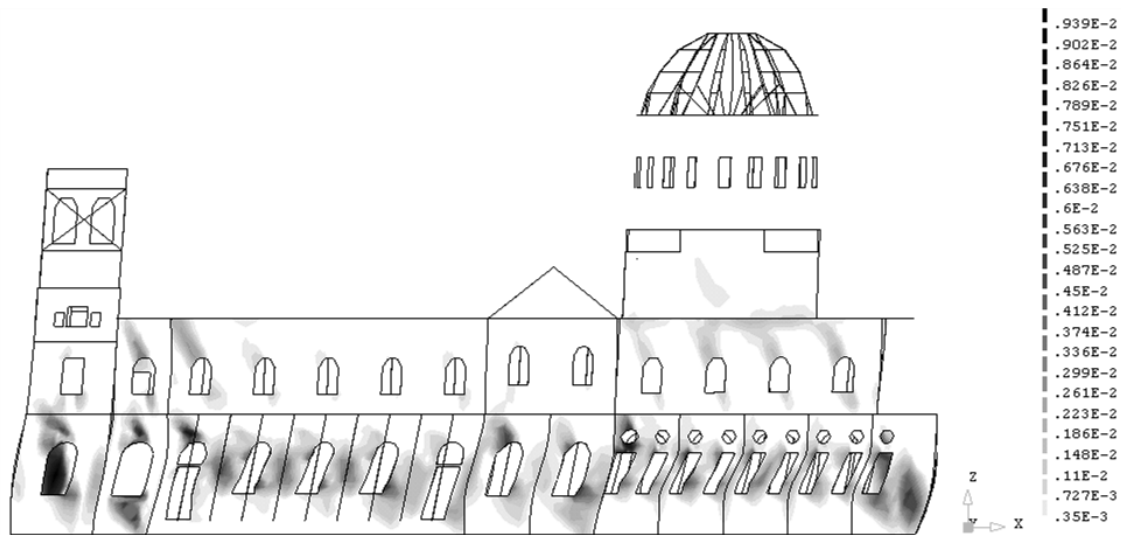
Figure 66 – Principal tensile strains of the south façade walls for a horizontal load of 0.3g in +X direction (the nave roof frame is not represented).

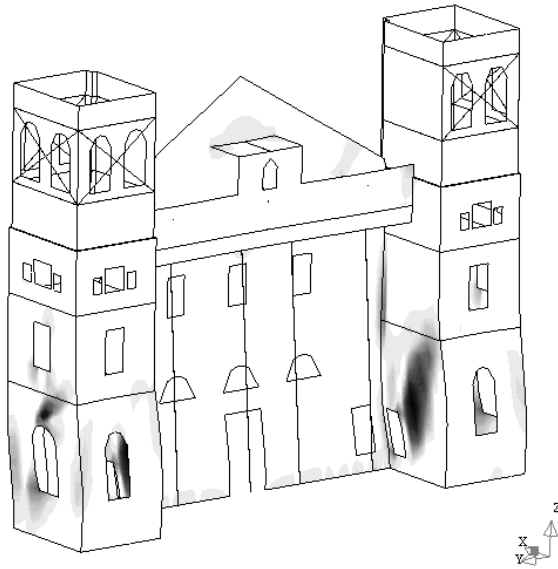
Figure 67– Principal tensile strains for the West façade due to a horizontal load of 0.3g, in +X direction (External surface).

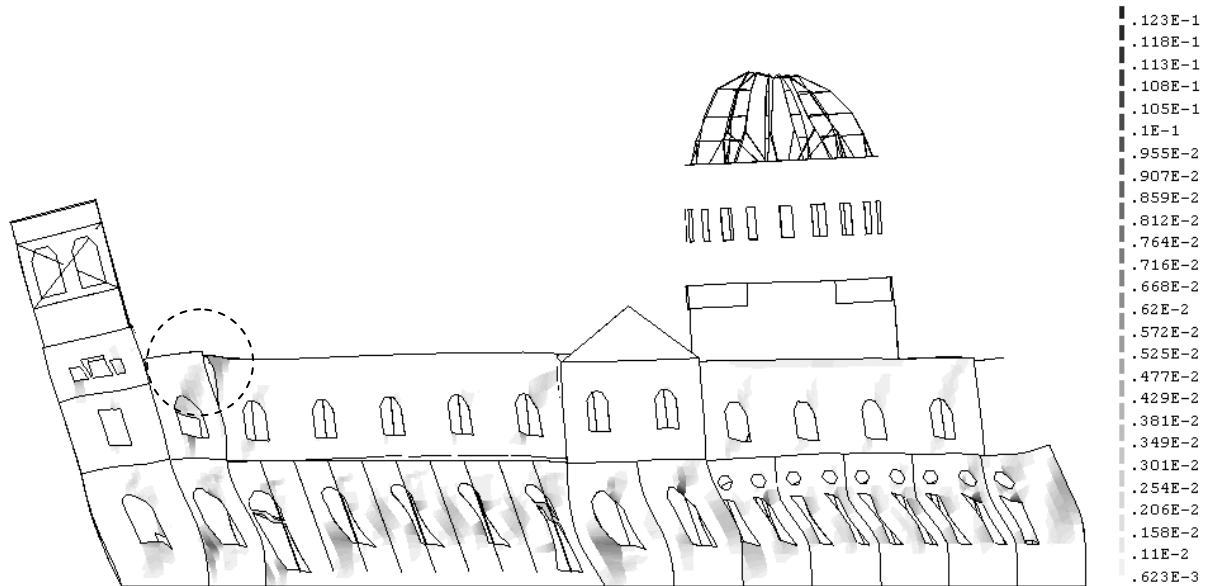
Figure 70 – Principal tensile strains of the South façade walls for a horizontal load of 0.27g in  $-X$  direction (the nave roof frame is not represented).

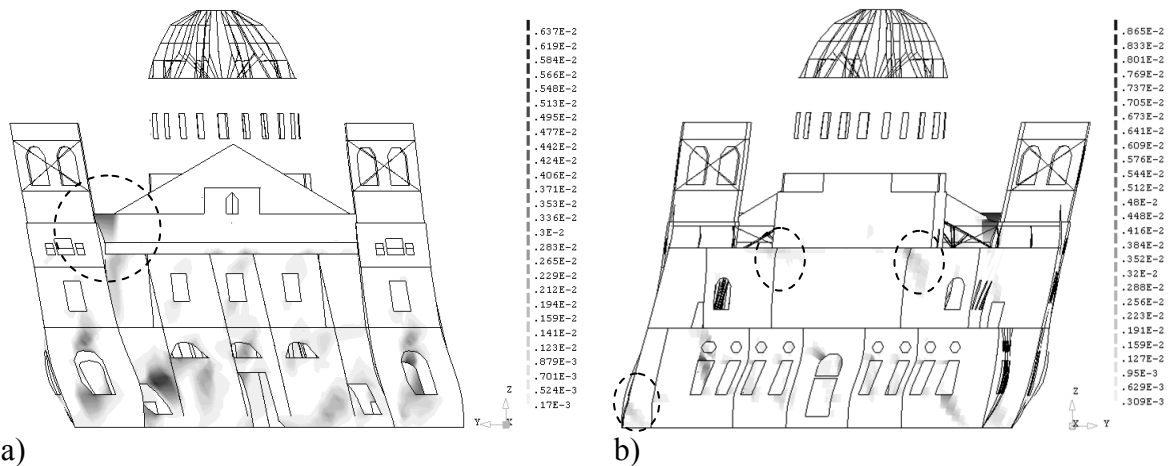
a) Figure 74 – Principal tensile strains due to a horizontal load in +Y direction: (a) West façade; (b) East façade.
