SAHC2014 – 9th International Conference on
Structural Analysis of Historical Constructions
F. Peña & M. Chávez (eds.)
Mexico City, Mexico, 14–17 October 2014

THE IMPORTANCE OF INTEGRATED PROJECTS IN HISTORIC CONSERVATION EDUCATION

David T. Biggs¹, Paulo B. Lourenço²

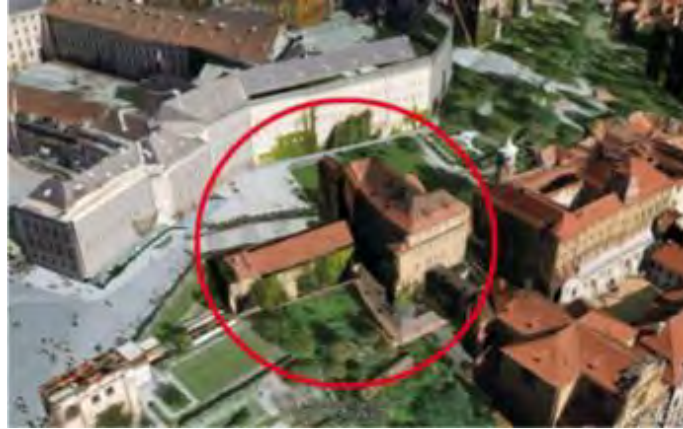
Figure 1 – 13th Century House, Aerial View

This SA-7 project is a very large house dating to the late 13th century near Prague Castle. Figure 1 shows an aerial view in 2011. Prague Castle and the east stairs are above the building. North is to the right. It appears in early drawings and first shows up in written records in 1407. The house was added onto several times. In 1672, it became a Theatine Monastery and functioned as such until 1883 when the monastic order was abolished. Figure 2 is a drawing from 1632 showing the east elevation.

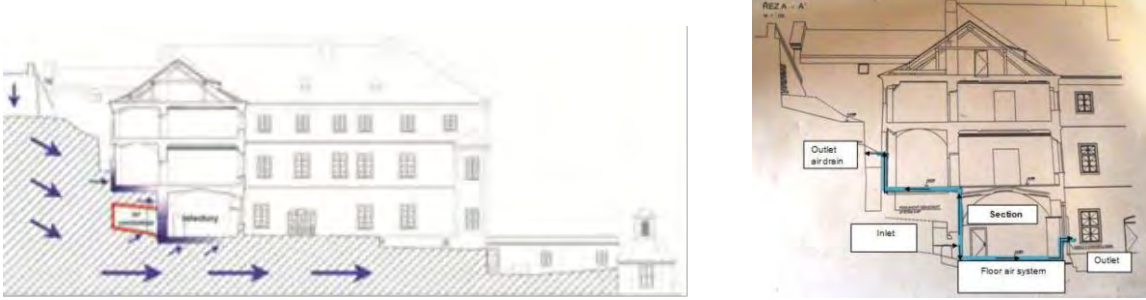
Figure 3 – Cross-section showing groundwater flow (left); air ventilation system (right)

and laboratory testing for materials and moisture content; assessment of deterioration and overall building moisture (Fig. 3); evaluate possible interventions; design a building damp-proofing and ventilation system; develop cost estimates; (b) Crack assessment: site investigations; analysis of masonry arch; evaluate and propose a structural intervention; (c) Medieval arch: historical review; visual assessment; materials characterization; moisture analyses and crack assessment; evaluate possible interventions.

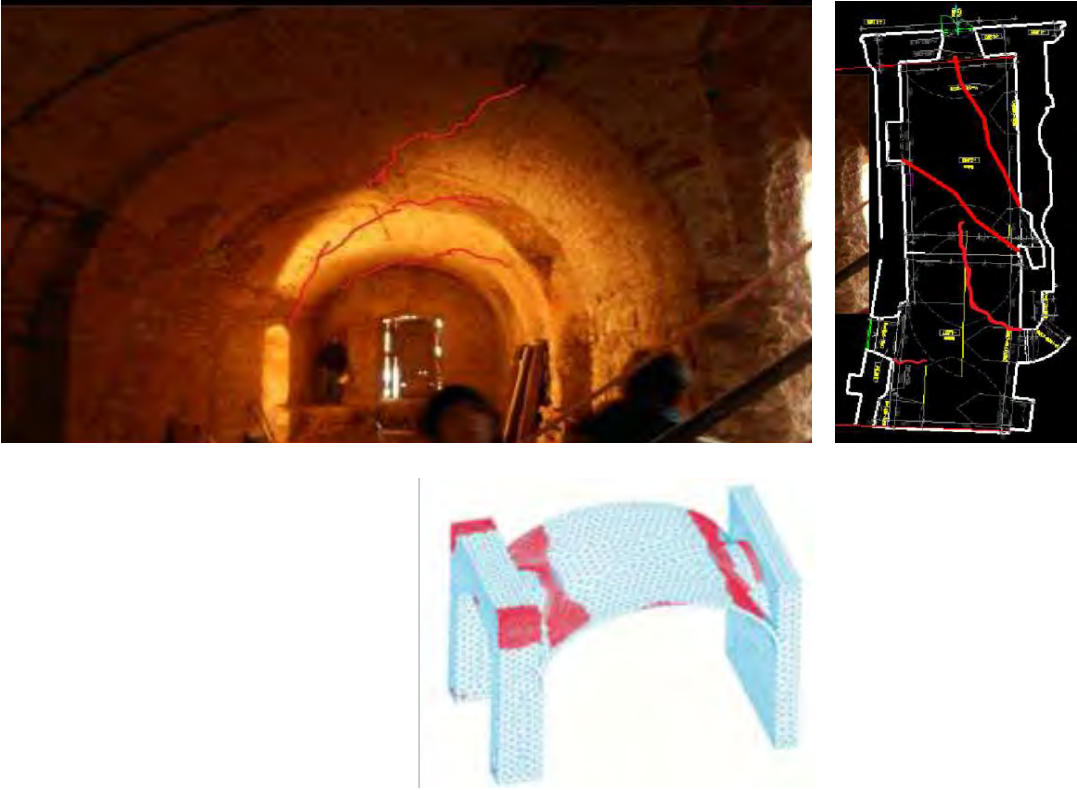
Figure 4 – Interior view of vault (left); crack mapping (right); non-linear analysis of vault to determine crack locations (lower center)

The Masonry Vaults Group studied vaults in two areas of the building. The group performed material characterization; visual assessment of vaults and supports; graphical analyses of vaults as constructed; FEM analyses of current conditions; development of interventions for repair and strengthening and FEM modeling of strengthening interventions (Fig. 4); develop cost estimates.

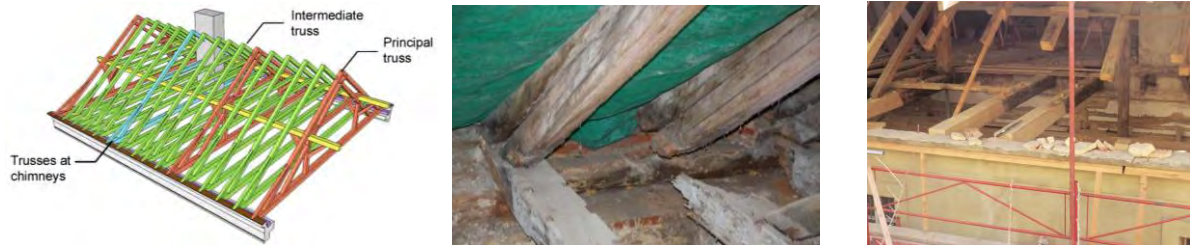
Figure 5 – Schematic of existing roof system (left); rotted ends of trusses (center); timber repairs during restoration (right)

The Timber Roof Group performed an assessment of the existing timber roof in the south wing and studied possible repair and strengthening interventions. The roof system had become deteriorated from water penetration and suffered severe rotting of the ends of the trusses (Fig. 5). The students actually were able to observe the repairs during construction.

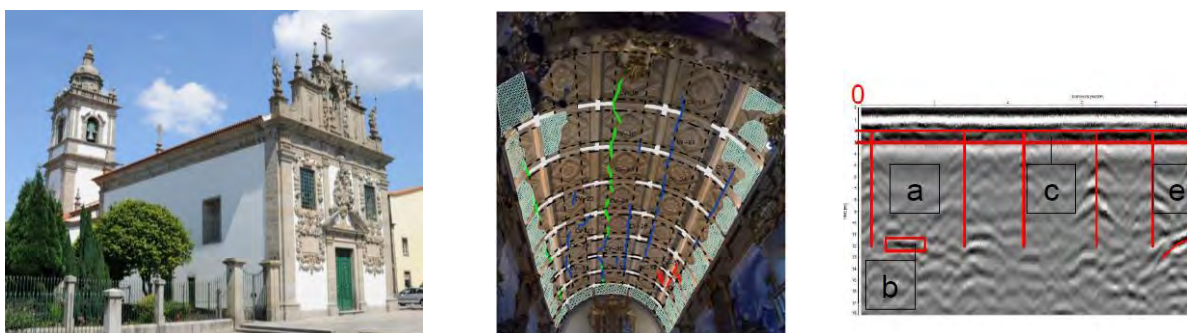
Figure 6 – Details of the St. Vincent Church in Braga - elevation (left); damage and deterioration in the main vault (center); GPR inspection (right).

The Church was completed in 1694; the vault and the façade present a mix of mannerism and baroque (Fig. 6). During the 18th century, the interior of the church changed to golden baroque style and also important constructions were made. The SA-7 work included: historical research; visual inspection; damage mapping; non-destructive testing of masonry and timber, with GPR, boroscopic (endoscopy) camera, Schmidt hammer test, Pilodyn and Resistograph tests, and moisture measurement; structural analysis of roof and main vault; proposal for remedial actions and monitoring system including cost estimating.

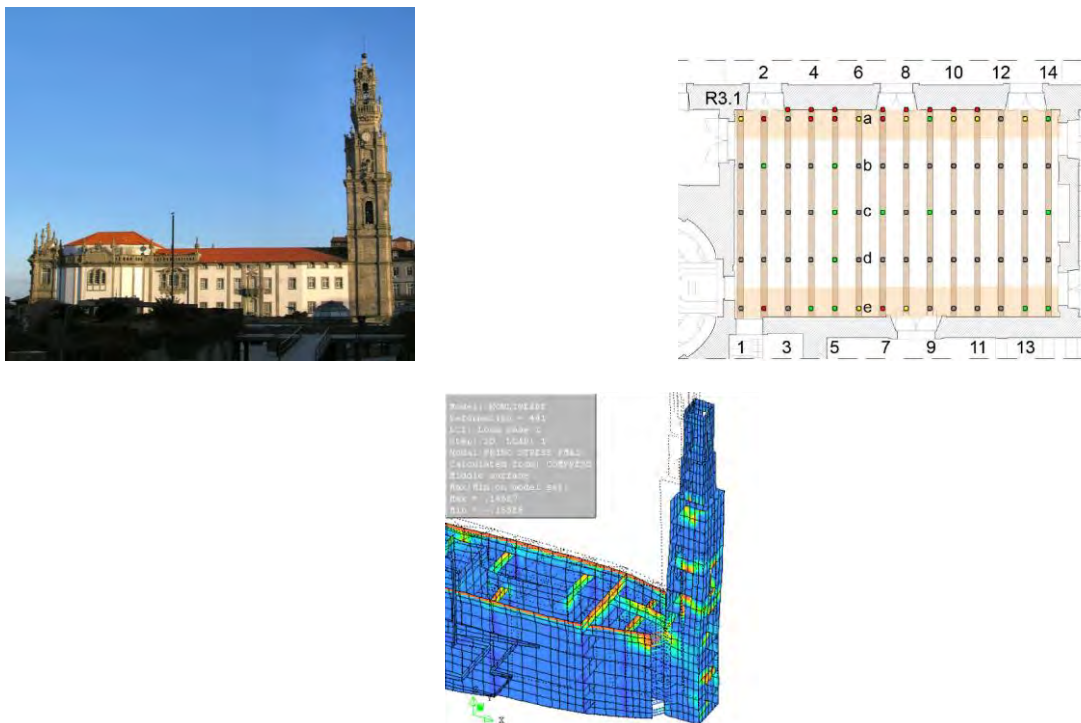
Figure 7 – Details of the Clérigo’s Church in Porto: view (left); deterioration in the main floor (right); FEM model and damage predicted (lower center).

authored by Nicolau Nasoni, the Italian architect who left a strong artistic imprint on Porto. The SA-7 objective was to evaluate the safety condition of the building (including the tower), to detect unstable phenomena, and to propose and design strengthening measures to solve the existent problems (Fig. 7). The study included: historical and geometrical survey (the team confirmed the dimensions on site and completed the survey, including the dimensions of the cross sections of the timber and masonry elements); structural identification with detailed drawings of the structural systems); damage survey, NDT, monitoring, and dynamic identification; structural analysis with modal updating and safety assessment; design of the remedial measures for the main timber floor and roof. The building was suffering important conservation works, meaning that full access was possible internally and externally, and the structural elements could be verified in details (including sections of timber beams, after removal of floor boards, and typology of masonry walls after removal of plaster).

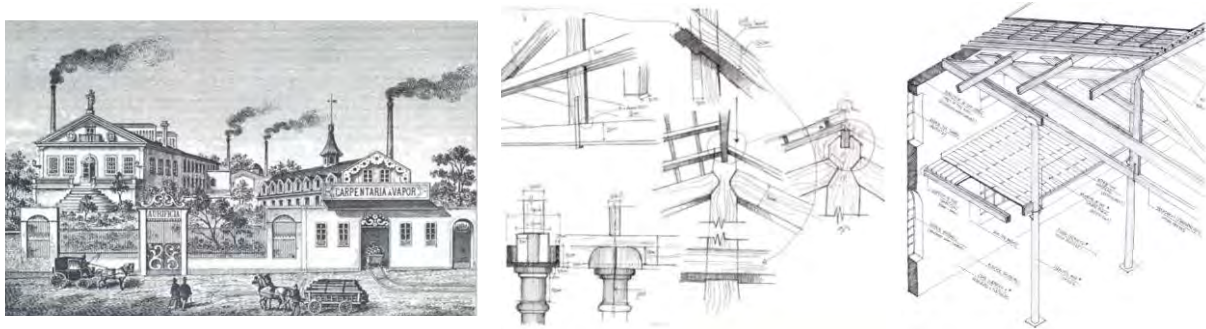
Figure 8 – Details of the Aurificia Company in Porto: old print (left); hand drawings of some of the details (center); summary of the recommended actions (right).

The Aurificia Company is one of the pioneer’s enterprises in the field of metallurgic in Portugal. Initially in 1864, it was a public enterprise, but later, in 1869 for economic reasons, it was transformed in an anonymous company with the name of Aurificia Company. Originally, the factory was constituted by three buildings. Behind them, the complex expands in a kind of triangular shape, being functionality the main purpose. A large space with a succession of cast iron columns and trusses can be found, or a space with only the main walls of masonry that supported the trusses, with a span no larger than 6 m. The whole complex has several interesting architectural details as arches, nice staircases or large windows that allowed the entrance of light and good ventilation. The study included the following steps in the main building of the complex (Fig. 8): brief review on modern heritage conservation; histori-

cal and geometrical survey; damage survey, NDT and monitoring; structural analysis and safety assessment for the timber and masonry; definition of the remedial actions.
