Assessment of the Efficiency of Prefabricated Hybrid Composite Plates (HCPs) for Retrofitting of Damaged Interior RC Beam-Column Joints

The effectiveness of prefabricated hybrid composite plates (HCPs) as a seismic retrofitting solution for damaged interior RC beam-column joints is experimentally studied. HCP is composed of a thin plate made of strain hardening cementitious composite (SHCC) reinforced with CFRP sheets/laminates. Two full-scale severely damaged interior beam-column joints are retrofitted using two different configurations of HCPs. The effectiveness of these retrofitting solutions mainly in terms of hysteretic response, dissipated energy, degradation of secant stiffness, displacement ductility and failure modes are compared to their virgin states. According to these criteria, both solutions resulted in superior responses regarding the ones registered in their virgin states.

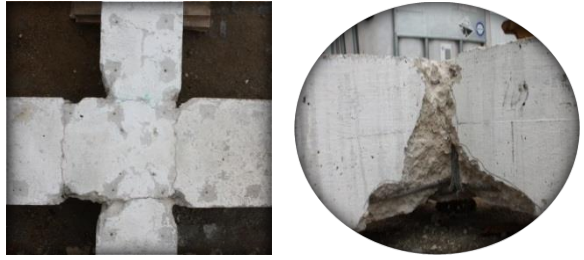
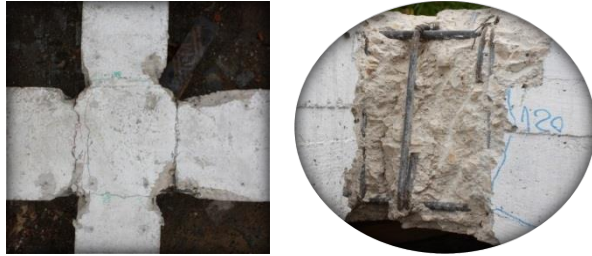
Figure 4: The extent of damages before retrofitting (a) JPA0 and (b) JPC.

As consequence of deficient bond between smooth longitudinal bars and the surrounding concrete, the damages at the end of the test were mainly localized in the vicinity of the joint region into the beams and columns. As shown in Figure 4, the extent of the damages includes concrete crushing and spalling off at the intersections of the beams and the columns, severe sliding of longitudinal reinforcement due to significant bond deterioration and, eventually, flexural cracks localized at the beam-joint interfaces or column-joint interfaces. In JPA0 one of the flexural cracks was, however, localized at a certain distance from the joint region (Figure 4a). Additional information about experimental program and test results of the virgin specimens can be found elsewhere [21].

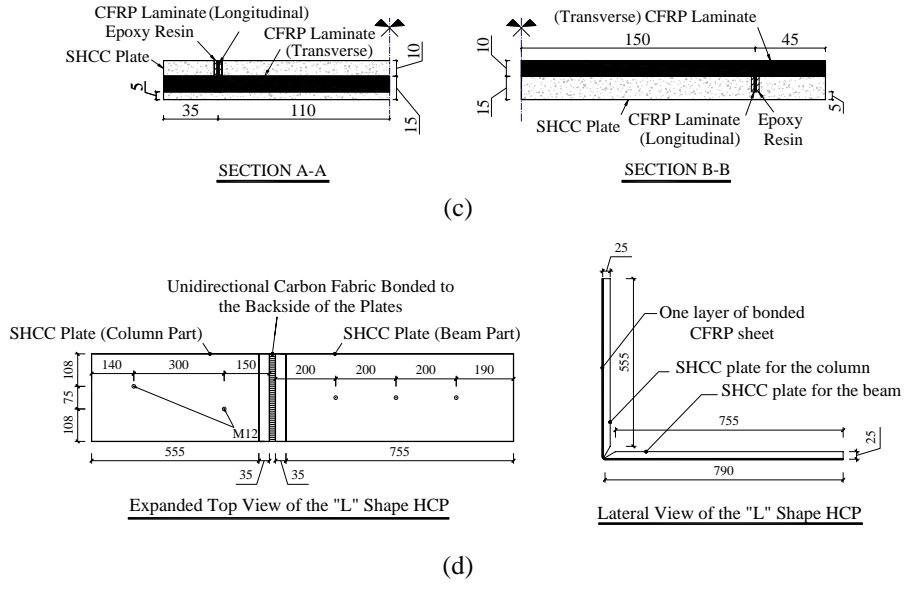
Figure 5: Details of the HCPs used for the repair of the damaged specimens (a) cross shape HCP for JPA0-R, (b) cross shape HCP for JPC-R, (c) section views of the cross shape HCPs, and (d) "L" shape HCP for JPC-R.

The retrofitting schemes for the both damaged specimens were based on attaching cross shape HCPs to the front and rear faces of the beam-column joint. However, for the case of JPC, additional “L” shaped HPCs were also attached to the lateral faces of the beam-column at each corner. The cross shape HCPs have partially covered the overall length of the specimens (Figure 5). The depth of the sections covering the beams was 390 mm, while for the columns was 290 mm. The HCP had an overall thickness of 25 mm, which was sufficient to accommodate two layers of CFRP laminates of cross section of 10 mm×1.4 mm, in two different levels (in orthogonal directions). This

configuration provided a 5 mm protecting cover against the environmental actions for the epoxy used to fix CFRP laminates inside the grooves of the HCP. The grooves were cut with 5 mm of width, and 10 mm or 20 mm of depth, depending on the level that CFRP laminates were supposed to be placed (Figure 5c).

The longitudinal reinforcement of the HCPs included pairs of continuous laminates in the direction of beam's and column's axis (Figure 5a to Figure 5c). Consequently, the laminates located in the beams were placed in a different level than the ones of the columns. In the HCPs used to retrofit JPA0, the spacing of the transverse CFRP laminates was 100 mm (Figure 5a). This distance was maintained in the portions of the HCPs that were covering the columns of the JPC-R specimen, while in the part of HCP applied in the beams of this specimen the spacing of the transverse CFRP laminates was increased to 200 mm in order to take into account the smaller spacing of steel stirrups in the beams (Figure 5b). At the joint region of both series of the HCPs, pair of CFRP laminates forming an "X" shape configuration was mounted in an attempt of increasing the shear resistance of the joint. A combination of the S&P 220 epoxy resin and chemical anchors (Hilti HIT-V 8.8 with 10 mm diameter) was used as the attaching system for the "Cross shape" HCP to the concrete substrate. As it was already mentioned, for the case of JPC, additional HCPs, composed of two SHCC plates reinforced with one layer of externally bonded unidirectional CFRP sheet with an "L" shape configuration, were attached to the faces of the columns and the beams at each corner (Figure 5d). In the case of "L" shape HCPs, S&P 50 epoxy resin and chemical anchors (Hilti HIT-V 8.8 with 10 mm diameter) were used to fix these panels to the lateral faces of beams and columns. To the retrofitted JPC and JPA0 specimens, the nomination of the JPC-R and JPA0-R was attributed, respectively.

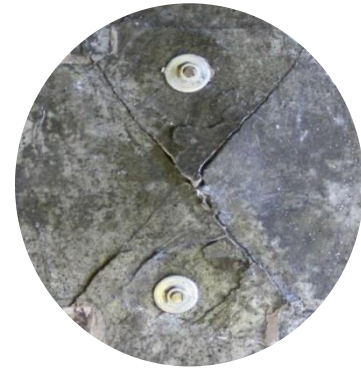
Figure 9: Inclined cracks and bulging of the joint region of JPA0-R at the end of the test.

drift of 2.0%, the retrofitted corners at the intersection of beams and columns started to spall off. The widening and propagation of the cracks inside the joint region may have governed the failure mode of the JPA0-R specimen. The visual inspection of the joint panel after the test revealed the bulged faces of the HCPs in the joint region with X shape cracks along with crushing of the old concrete, which was confined inside the HCPs.

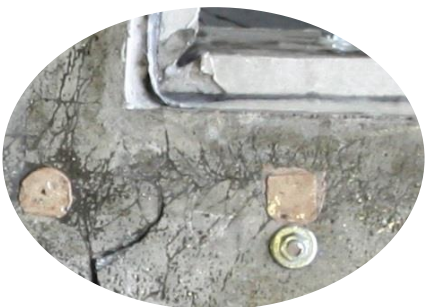
Figure 10: Damage distribution along the beam-column joint elements with close up views of micro-cracks at the end of testing of the JPC-R corresponding to (a) positive loading direction and (b) negative loading direction.

During both the positive and the negative displacements of the cycles corresponding to 1% drift, further cracks on both the left and right beams adjacent to the beam-column interfaces were formed (Figure 10). The sequence of the cracks occurrence was at: i) inferior face of the left beam; ii) inferior face of the right beam; iii) superior face of the right beam; iv) superior face of the left beam. By increasing the drift up to 1.3%, these cracks on the left beam intersected each other. The crack on the inferior face of the right beam has widened and propagated, while the crack at the superior face in this region has only experienced a small increase in its width. This was due to the action of the previously cracked region of the right beam out of the retrofitted zone, which acted as the governing damage region on the right beam. By repeating the cycles with the same level of the drift, the cracks at the vicinity of the beam-column interfaces progressed into the bonded region of the CFRP sheet on the left side of the superior and inferior column, as well as towards the right side of the inferior column. When the drift cycles corresponding to 1.67% were

imposed, this detachment progress met the first level of anchors positioned in the superior and inferior columns. Further detachment of the CFRP sheet in normal and tangential directions was resisted by the flexural resistance of the SHCC plate and bearing capacity of the anchors, respectively. At a drift cycle of 2.67% the SHCC plate reached its flexural-tensile capacity and failed. At the higher levels of drift, only the width of these cracks has increased without any further crack formation. By the end of the test, to visualize the developed micro-cracks, the surface of the HCPs that was varnished before testing, was sprayed with a penetrating liquid. As a result of this technique, it was visible multiple diffuse micro-cracks inside the joint panel zone with diagonal orientation, fish spinal shape micro-cracks along the longitudinal CFRP laminates on the cross shape HCP, and diffuse micro-cracks in the vicinity of macro-cracks around the anchors in the joint region and in the first slice of both beams (see Figure 10 and also Figure 7).

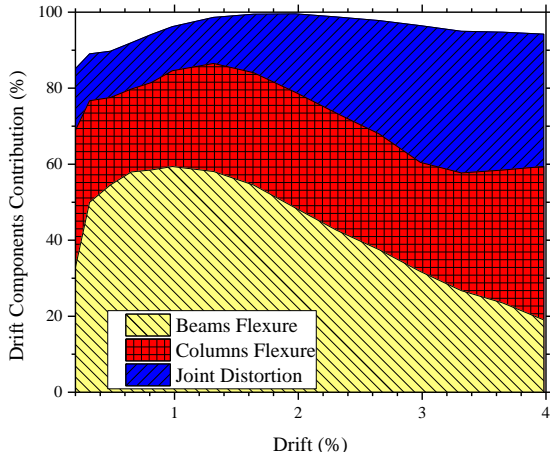
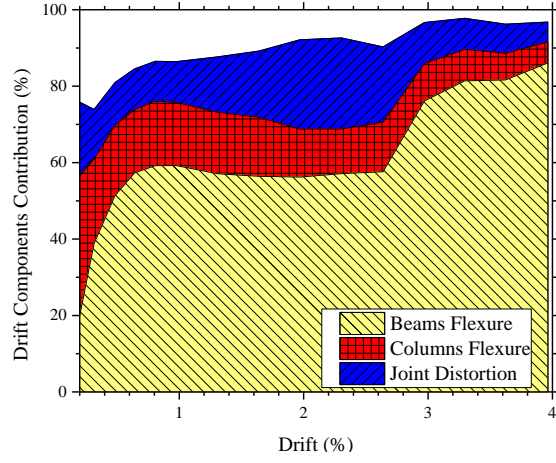
Figure 12: Contribution of the beams flexure, the columns flexure, and the joint shear distortion to the overall drift of (a) JPA0-R, and (b) JPC-R

Figure 12 illustrates the contribution of each of the abovementioned components as the percentage of each level of the interstory drift during the steps of the positive displacements. The remaining portion of the graphs includes the shear deformation of the beams and columns, rigid body motion of the specimens due to the flexibility of supporting frames and finally local deformations at the supporting regions of the specimens.

According to the Figure 12a, the contribution of the beams flexural deformation in lateral displacement of JPA0-R increased up to 59% at the level of 1% drift. After this level of the drift the beams flexural contribution started decreasing, and reached to its minimum contribution of 19% at 4% drift. The joint distortion contribution started increasing after the drift level above 1.3% and at 3% drift has reached 35%, which was larger than the contribution of the other components. The maximum contribution of the joint distortion, 37%, has occurred at 3.33% of drift. The flexural contribution of the columns varied between 22% and 40%. Considering the observed damages and Figure 12a, it can be concluded that at 4% of drift the fixed end rotation of the column, due to the excessive sliding of the unbounded longitudinal reinforcements inside the joint region, and the joint shear distortion have dominated the interstory drift.

Figure 12b shows the contribution of the drift components in the interstory drift of JPC-R. It can be seen that the beams flexural contribution up to 1% of drift has increased up to 59%, similar to what was observed for JPA0-R. Between this drift level and 2.64% drift, the contribution of the beams flexural deformation was almost constant, but above 2.64% drifts the beams flexural contribution has increased and reached its maximum contribution of 86% at 4% of drift. Except at the drift level of 0.2%, where the contribution of the joint distortion was more than 20%, up to a drift level of 1% the joint distortion had almost a constant contribution with an average value of 12%. By increasing the imposed drift the contribution of the joint distortion has also increased and reached its maximum value of 23.8% at a drift level of 2.33%. Above this level of drift, the joint distortion had a reduction tendency so that at 4% of drift its contribution was only 5.2%. The column flexural contribution had a general tendency to decrease with the increase of the drift, with a 39% of contribution at a drift level of 0.2%, and 5.5% at the end of the test. This hierarchy of the contribution of each drift components for lateral displacement of JPC-R explains how the retrofitting system was efficient to decrease the joint shear distortion and, therefore, to maintain the columns undamaged.

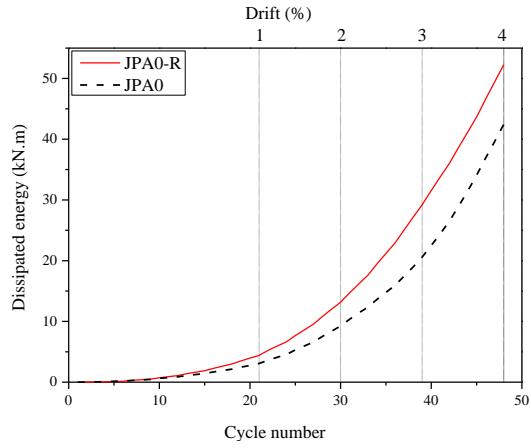
Figure 13: Evolution of the dissipated energy during the cyclic loading of (a) JPA0-R and JPA0, and (b) JPC-R and JPC.

Energy dissipation and inelastic deformations of a lateral load resisting system indicate the potential of the structure to withstand the loading demands of seismic events. The amount of dissipated energy can be calculated from the enclosed area in each loading cycle as presented by the hysteresis response of lateral load *versus* lateral displacement. Integration of the dissipated energy with respect to the increment in lateral drift can result in total dissipated energy at each given level of interstory drift. The evolution of the dissipated energy for retrofitted and corresponding specimen in virgin state is presented in Figure 13. Both retrofitting solutions have provided an energy dissipation capacity higher than the one registered in the corresponding specimen in virgin state during all loading steps. In this respect, the retrofitting solution applied in JPC specimen was more effective. In fact, at 4% drift, the dissipated energy of JPA0-R was 52.3 kN·m, which is 23% larger than the energy dissipated in JPA0, while the JPC-R reached 54.03 kN·m corresponding to an increase of 84% comparing to dissipated energy of JPC.

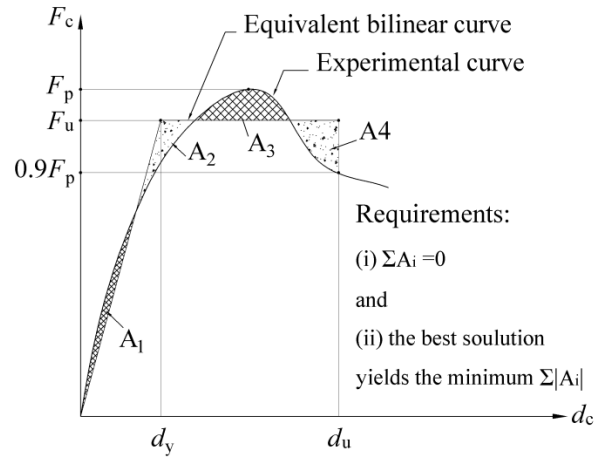
Figure 15: Schematic representation of the definition of the equivalent bilinear curve for the evaluation of the displacement ductility index
