Master's Thesis

Structural characterization and analysis of the Castle of Arbeteta, Spain

University of Minho

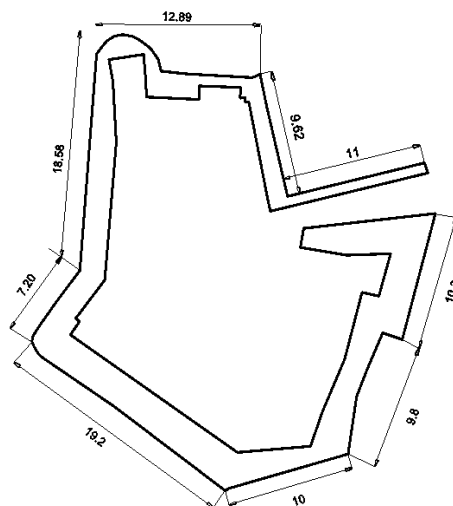
Figure 3:Plan of the Castle (measurements in meter)

The castle has an irregular polygonal shape of approximate area of 1,440 square meter. It was once a two storey structure, of which only the ruins of the external wall exist. The thickness of the external walls vary in between 0.75 m to 2.6 m, as it will be further discussed in Chapter 3. The general external dimensions of the castle can be seen in Figure 3.

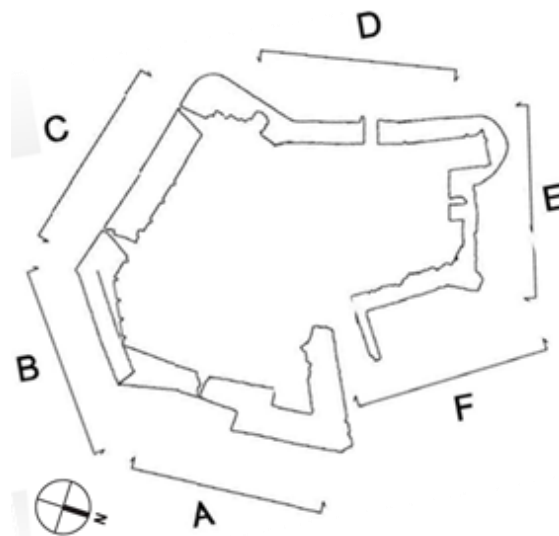
Figure 5: Nomenclature used for the facades of the castle

Each wall of the castle is annotated for better understanding. The following Figure 7 shows the nomenclature that is used to represent the constructive elements of the fortress. The same nomenclature is used to refer to exterior and interiors sides of the wall. This will further prove to be useful while understanding the character of the walls.

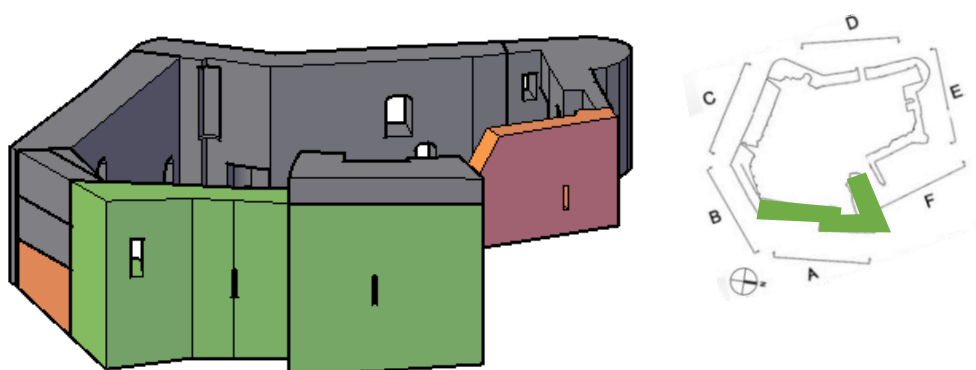
**Figure 7:View and key plan of wall A constructed in Phase II**

Phase II focuses on the entire south east and the eastern side, Zones A and a middle area of zone B. as seen in Figure 7 Facade A shows construction of the modulus of the frontal tower, called the tower. Only the base of the tower remains now. No evidence of a previous phase can be seen here.

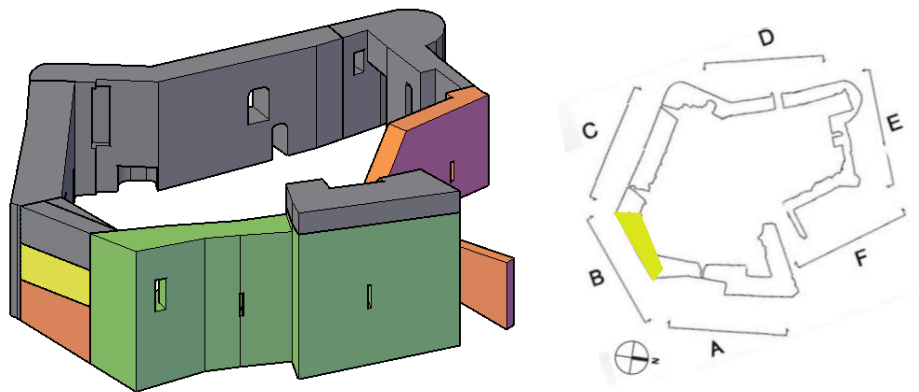
Figure 8:View and key plan of wall B constructed in Phase II

Much information of this phase is unavailable. Only remains from this phase are observed on the wall B, the masonry from this phase rests between Phase I which is the base of wall B and Phase III, which is the top of the wall B. It can be seen in Figure 8.

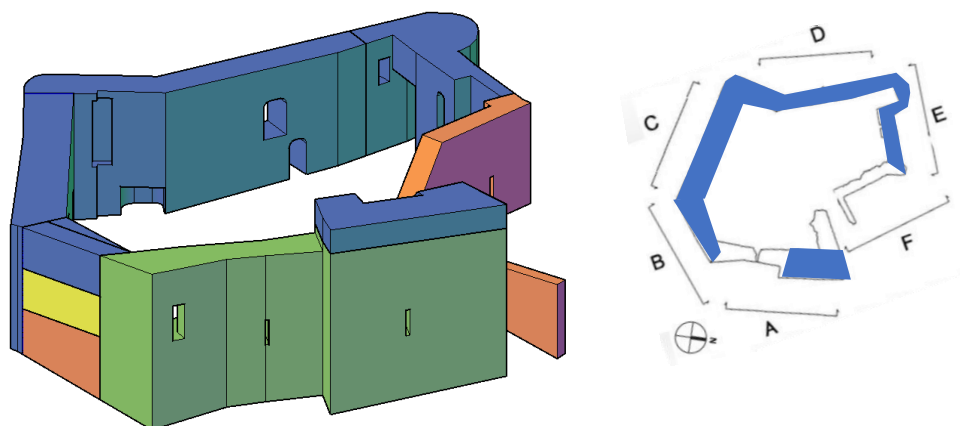
Figure 9: View and key plan of wall B, C, D and E constructed in Phase III

In this Phase, the entire west front, wall C, the north, zone D and the east, zone E, are built. This Phase of construction is supported by the remains of walls constructed in previous phases, walls A, B and F. In the area of exit, confluence of this Phase III on Phase I, with the conversion of a wall in a gate can be seen, while on the west and the new work surpasses part of the walls of Phase I, II, and IIB.

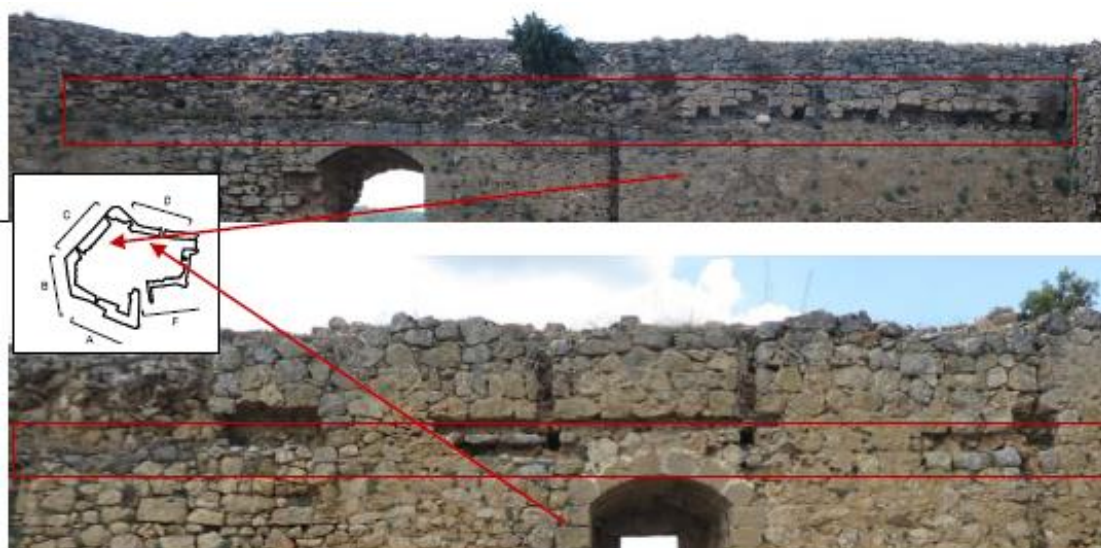
Figure 10: Niches in walls where wooden joist rested

It is possible that there were other vertical structural elements of wood as seen in Figure 10. Niches in the walls can be seen which suggest that a second floor existed. There was a possible existence of chimney in wall D as seen in Figure 11

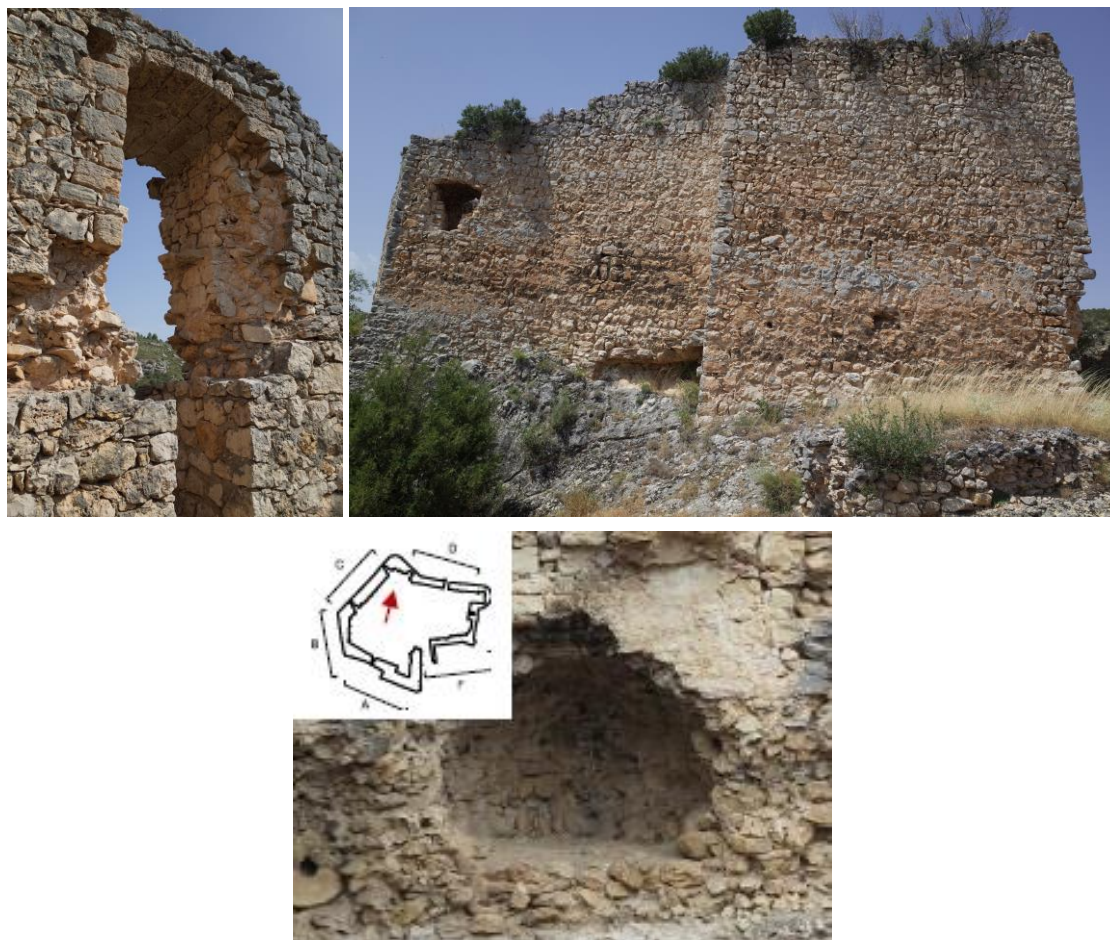
Figure 12:Castle in the state of degradation due to abandonment

During this phase, a section of a wall on the northern ridge from the west was repaired. In this area, even today at the same point, the buckling of the walls towards the interior of the castle can possibly be observed as is not visible in photographs is marginal. On the other hand, from within it seems that there is a part of the masonry of less thickness, possibly one of the chimney shots and, as it is on its left side, it has been reconstructed, see Figure 12

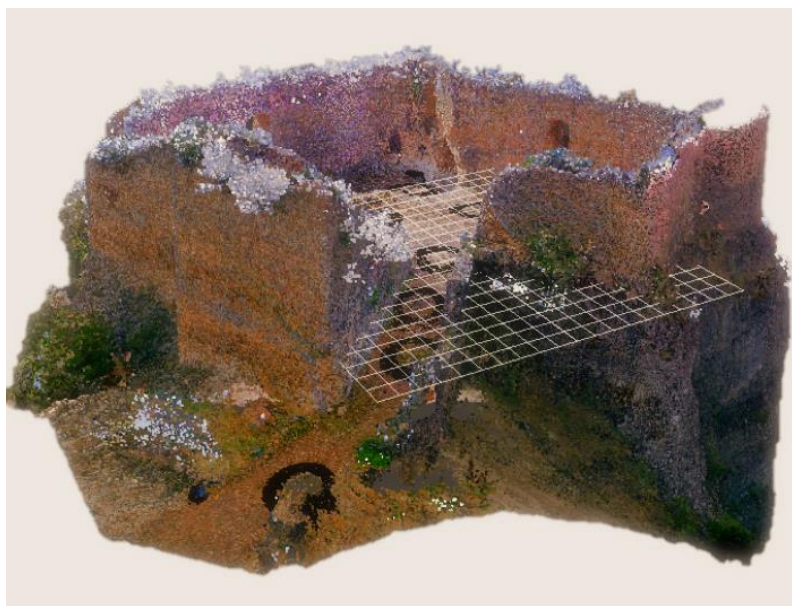
Figure 13: Point cloud Model of the castle in ReCap

AutoCAD and Recap, because of being Autodesk products, they allowed to easily cut the required level of section in ReCap and import it in Autocas and use it as a base map.

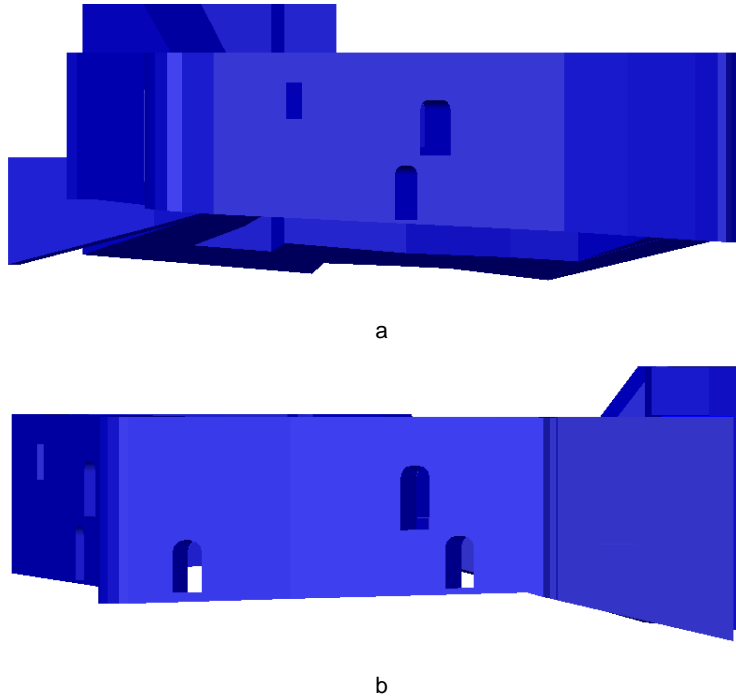
Figure 14:Final model with different level of base from a. front side b. back side

As the castle is situated on a countour site, first model was created using exact dimentions of the site. But as a side effect, extra small surfaces were created at the base of the model in AutoCAD due to too much detailing , complicating the model. Hence, a little liberty was taken with respect to the dimentions of the base while slicing the model. Final model as seen in Figure 14

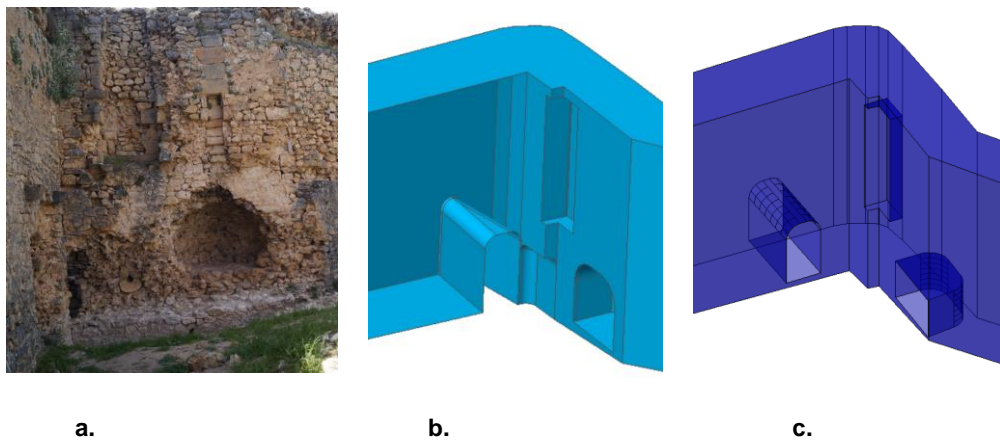
Figure 15:showing the simplification of detailing damage with respect to the ruins of castle a. Image of the damage b. model in DIANA c. After Meshing of the model

As the model shows quiet high degree of deterioration at the top and loss of stone units at a lot of places, As in Figure 15 below, it was simplified using measurements as close as possible to the pointcloud model. Care was taken that it match the minimum dimention of the mesh to be used further for FEM.

As seen in Figure 15. b, the window openings are in a funicular shape and narrow down on its way to external façade. In the first model Figure 15. b, the exact same window was modeled, but as it caused complications in meshing, it was simplified to a regular opening . The degraded walls were modelled as in Figure 16.

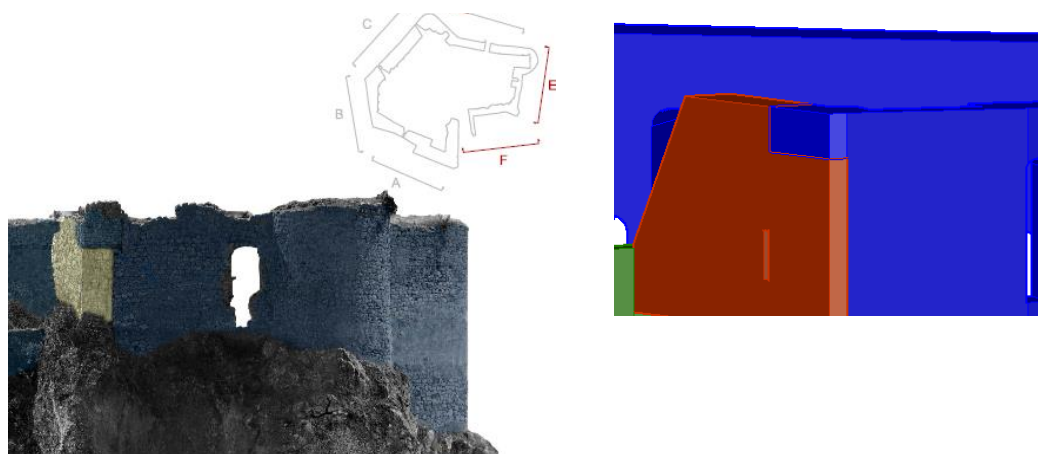
Figure 17:Division between wall E and F

As seen in the Figure 17, the connection in between wall F and E was divides such that they formed two separate solids. This was done as it was anticipated that the connection between the two walls shall be weak or even completely disconnected.

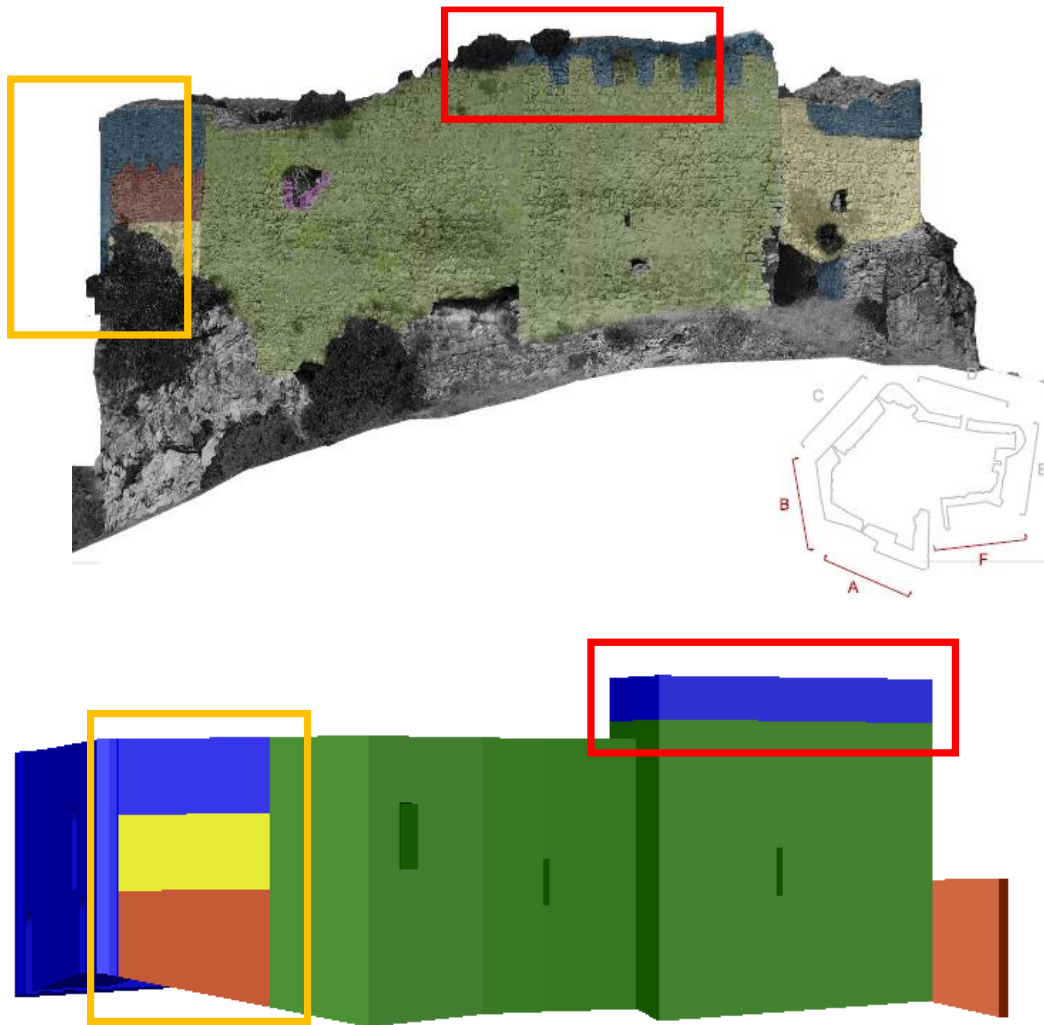
Figure 18: Division between wall B (left) and A according to construction phases

As said before, the model was based on the chronology of construction of the castle and hence it was further divided into parts according to the archaeological drawings. This was done as the archaeological drawings suggests difference in construction technique in each phase and the structural and dynamic behaviour of the castle is hoped to be affected by it. Also the model was further simplified to make the meshing and application of material properties easier.

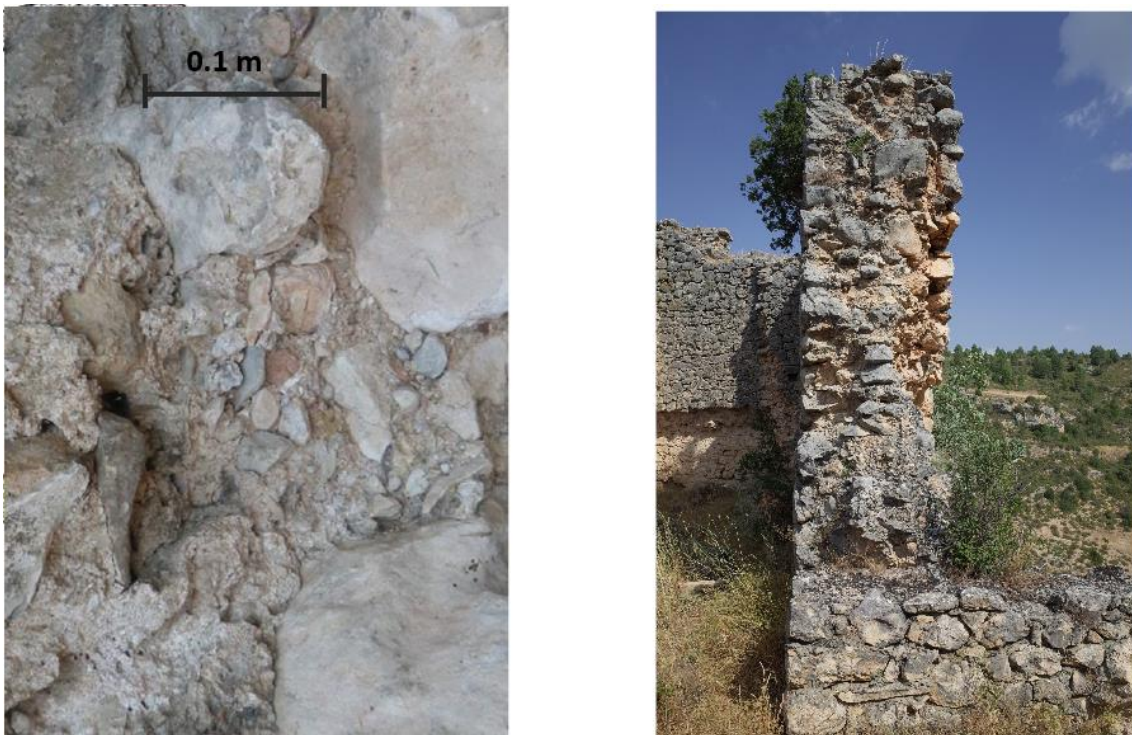
Figure 19: Broken wall exposing inner leaf and Inner leaf of the masonry wall

such as dimension and shape of stone units of the wall, wall leaf connections, horizontal and vertical joints character and mechanical properties of the mortar. The masonry quality index shall refer to its quality of masonry and therefore its capability to withstand loads. As the cross section of each of the wall wasn't visible, it was assumed to be a three-leaf stone masonry wall. The inner leaf probably consisted of small stones from ravine with mortar. This was considered as it is mentioned above in Chapter 2 that the stones from ravine were used for construction. The same can be concluded from the inner leaf of the masonry visible in Figure 19. Upon visual inspection, the stone units do not appear to be bigger than 0.4m x 0.6m in dimensions. Also the dimensions of the stones units is smaller as in comparison to its thickness which is 1.4 m, as seen in the Figure 19. No through stone can be seen in the broken section of the masonry, which means that the inner and outer leaf may lack a good connection, which is usually achieved by the presence of a through stone.

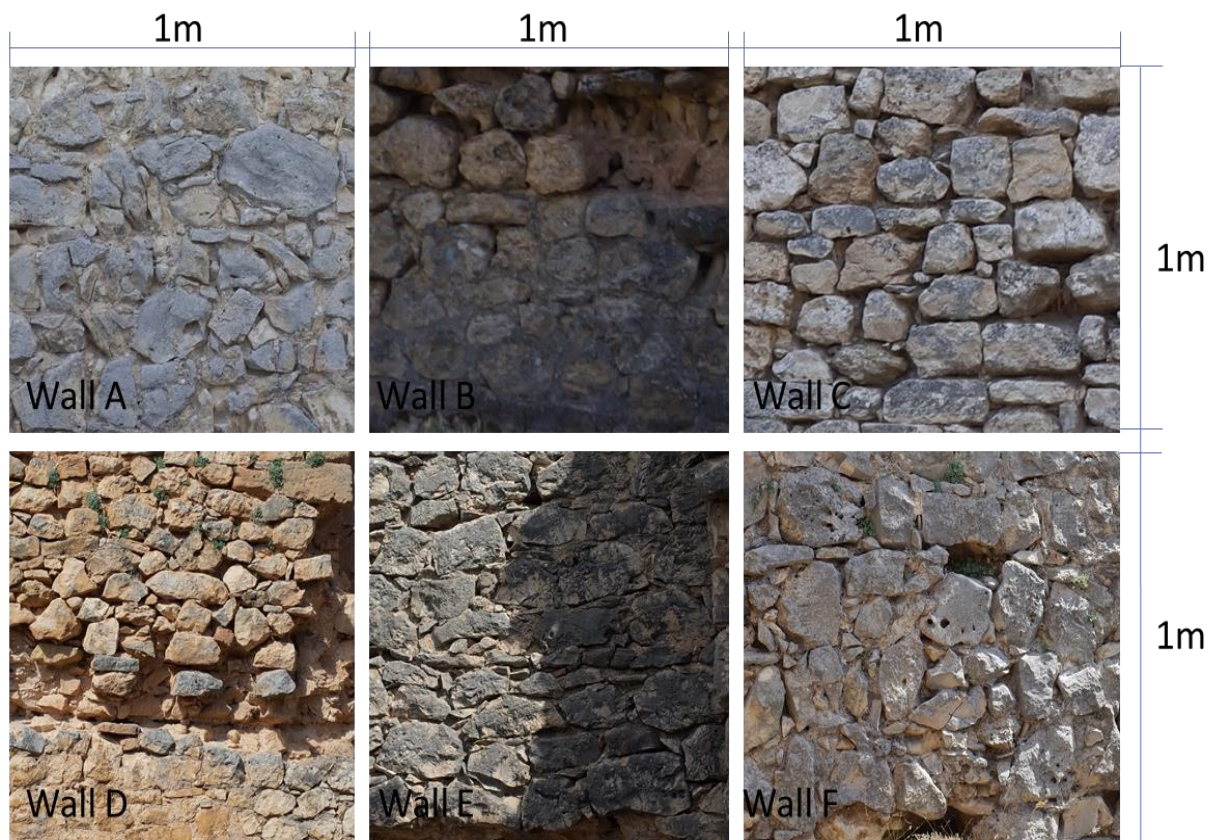
Figure 20: Difference seen in the morphology of each wall

The following figure 20 shows 1m x 1m of the masonry of each wall of the castle which represents the condition of the entire façade. It was difficult to come to a conclusion about MQI of each wall as different areas of the same wall exhibit dissimilar deterioration. For example, wall D is the longest wall in the structure and in some places it shows loss of mortar of different depth, ranging from surface erosion to exposure of the stone units in the masonry up to 0.15 m in depth. Therefore, taking this in consideration, MQI was calculated for the entire façade of the wall.

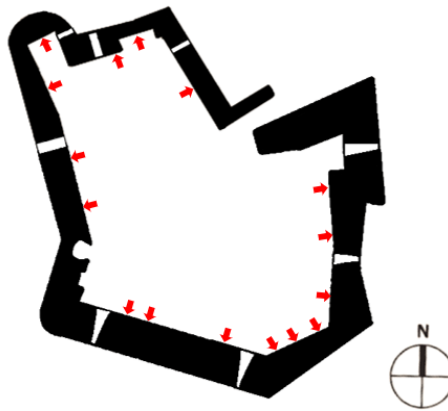
Figure 21: showing the locations of indirect sonic tests.

For better understanding of the morphology of the structure, two to three locations were chosen on each wall. An average of the obtained values was considered to calculate the material properties. Each test set consisted of three hammering points and three receiving points. The impact was applied always on the uppermost point and the accelerometer was placed sequentially on each of the corresponding reception point, approximately 1m below it. A series of ten to fifteen readings were performed at each point. The location for the tests can be seen in Figure 21. The outcome and morphology of each wall is analysed further.

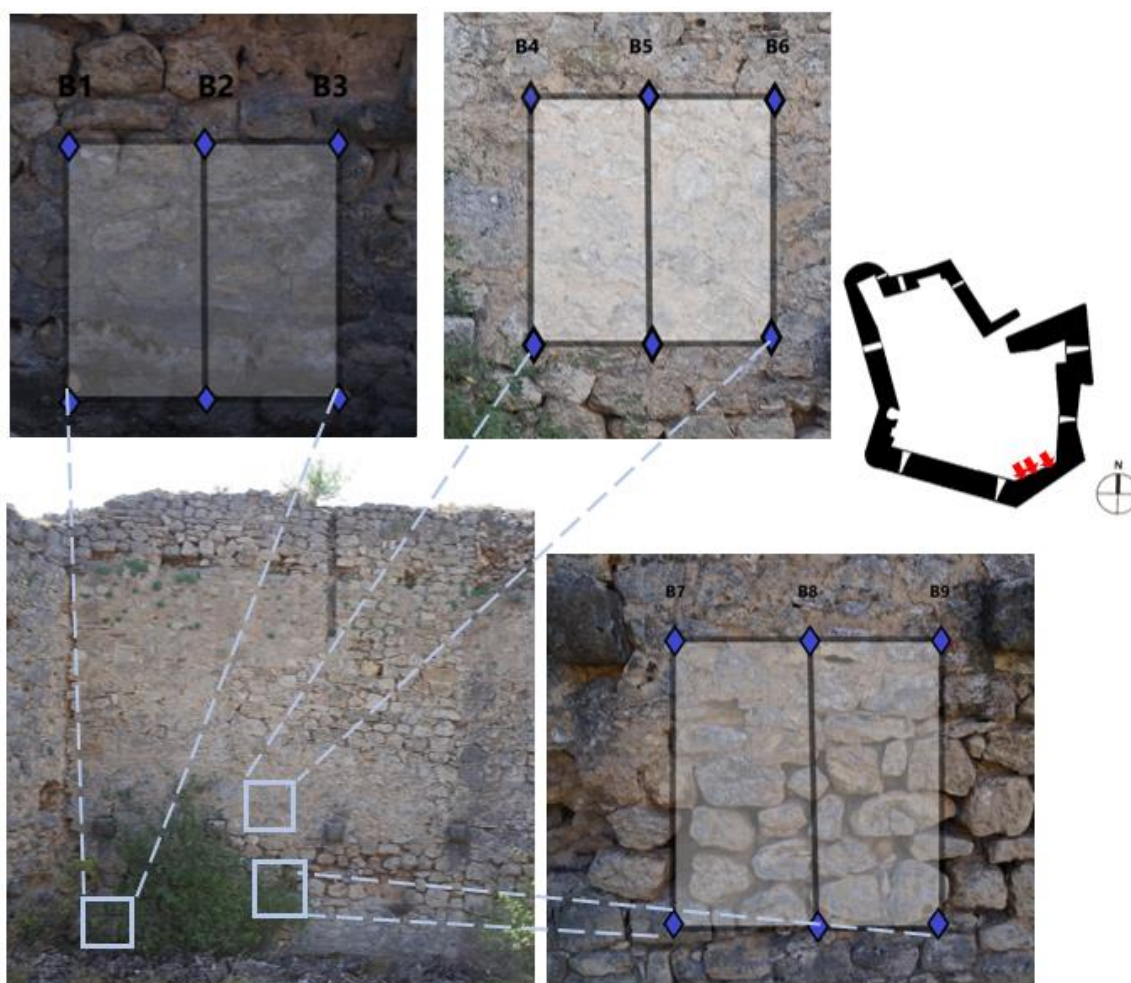
Figure 23(a): Location of testing points on Wall B

Wall B can be said to be the wall with smallest width and maximum number of construction phases. The wall is made up of coursed stone masonry. The wall appears to have undergone degradation of the surface of the stone units and loss of mortar. This can be seen in Figure 23 showing the testing points selected for indirect sonic test. Three locations were selected, the first one comprising of points B1, B2 and B3. On visual analysis, this location had less variation in dimensions of the stone units ranging from 0.3 m to 0.2m and the degree of loss of mortar is less. As seen in Figure 23 a and b, this location has a higher frequency of closer to 2000 m/s with respect to other test points.

The second location which consists of points B4, B5 and B6 appears to have smaller units of stone with dimension of 0.1m to 0.3m with thicker layer of mortar. And the final location consisting of points B7, B8 and B9 had same dimensions of stone units 0.3m to 0.4m as the first but has suffered greater loss of mortar. The average V_p for wall B was 1213 m/s with coefficient of variation between 2% to 12% for each point. Upon calculations, the Young's modulus is computed to be 2.51 GPa. The selected test locations for Wall B as seen in the Figure 23.

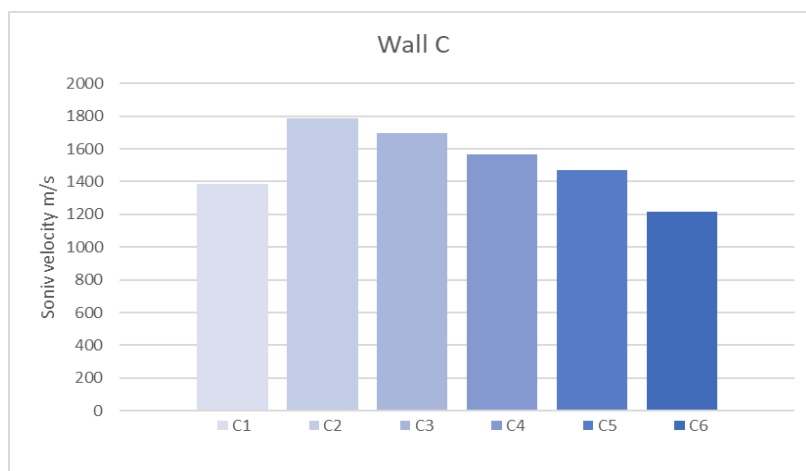
Figure 24(a): Sonic velocities obtained at each point : C1, C2, C3, C4, C5 and C6

Upon visual inspection, it can be said that the Wall C and D were a target of plundering for the stone units as they appear to be removed from the masonry. Also loss of mortar is quite evident in this façade. The wall is made up of coursed stone masonry but with undressed stones. This can be seen in Figure 24 a and b, showing the testing points selected for indirect sonic test. Two locations were selected, the first one comprising of points C1, C2 and C3 and the second one which consists of points C4, C5 and C6. The dimension of stone units 0.1 m to 0.4 m approximately. The average V_p for wall B was 1624 m/s with coefficient of variation of 7% for each point. Upon calculations, the Young's modulus is computed to be 2.1 GPa. The selected test locations for Wall C as seen in the Figure 24 a and b

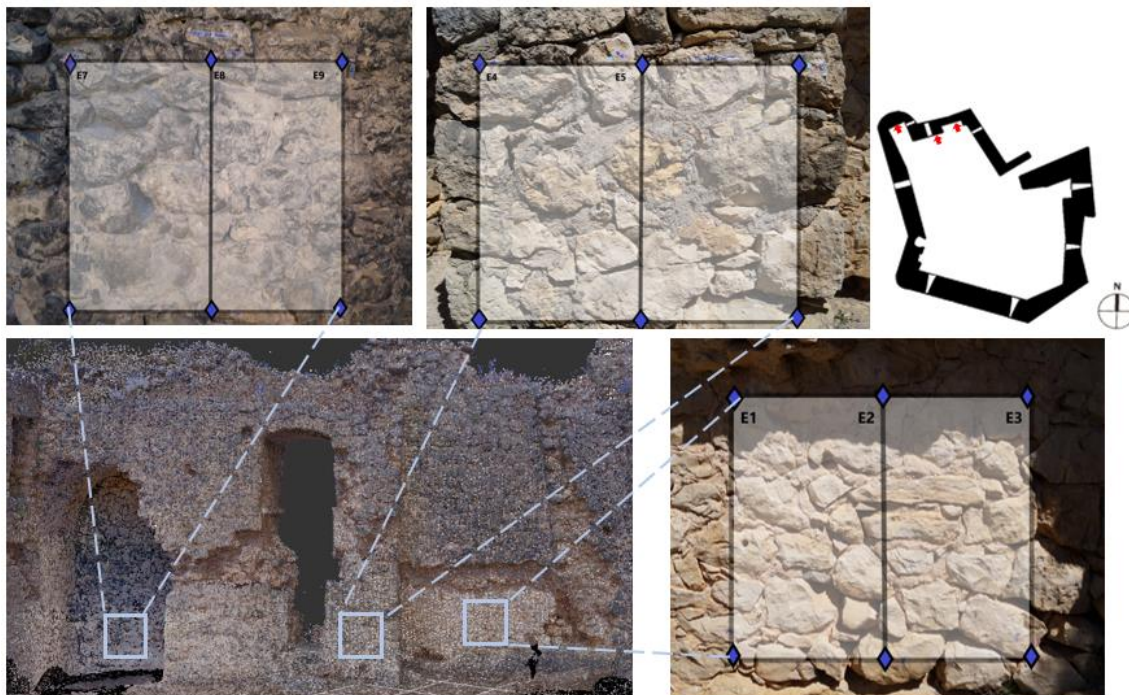
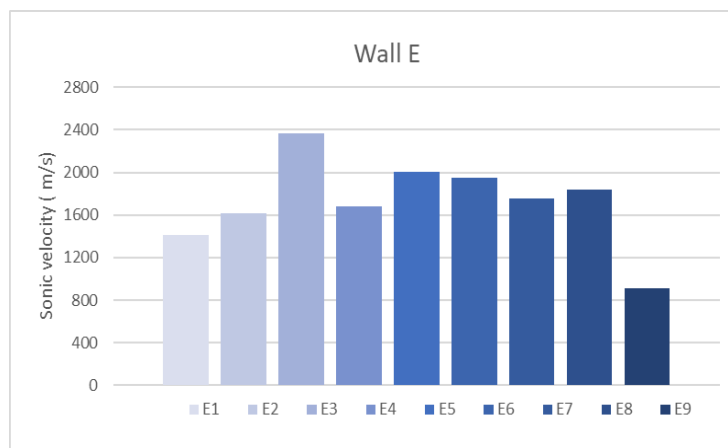
Figure 26: Location of testing points on Wall E and the sonic velocities obtained at E1, E2, E3, E4, E5, E6, E7, E8, E9

Wall E shows a lot of variation even though it seems to be constructed simultaneously. The wall is made up of coursed stone masonry. The wall appears to have undergone heavy degradation of surface of the stone units and loss of mortar. This can be seen in Figure 26 showing the

The average V_p for wall E was 1801.58 m/s with coefficient of variation between 8% for each point. Upon calculations, the Young's modulus is computed to be 3.9. The selected test locations for Wall E as seen in the Figure 26.

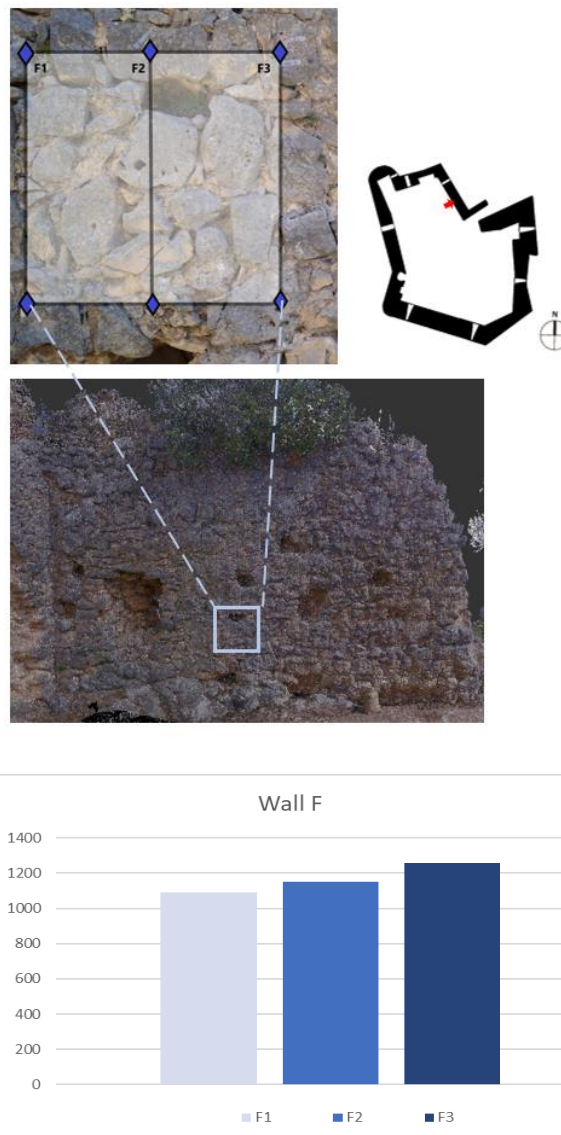
Figure 27: Location of testing points on Wall A and the sonic velocities obtained at each point : F1, F2 and F3.

The wall is made up of uncoursed stone masonry. It can be said to be the wall with a lot of damaged parts and loss of material. The locations were selected, the first one comprising of points F1, F2 and F3. On visual analysis, this location had quite a variation in dimensions of the stone units and but the stone units and mortar binding seems to be compact. In the testing point F2, there is presence of a void between impact and receiver point. But it doesn't seem to affect the velocity of sonic waves as there doesn't seem to be much variation in the velocity of the three points.

The average V_p for wall F 1166 m/s with coefficient of variation between 3% for each point. Upon calculations, the Young's modulus is computed to be 2.01 GPa. The selected test locations for Wall B as seen in the Figure 27.

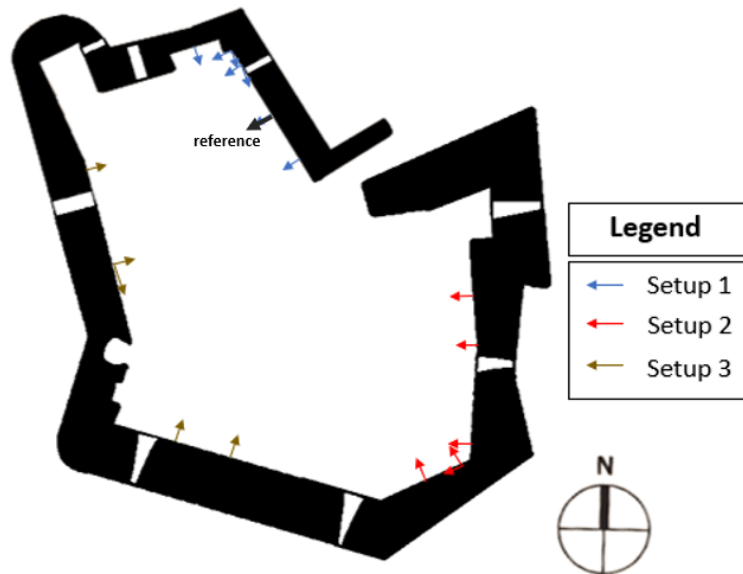
Figure 28: showing the location of accelerometers

To completely understand the behaviour of the castle, three setups were planned. One reference accelerometer was placed in wall F as seen in Figure 28. Setup 1 comprised of 8 accelerometers which were placed in Walls E and F. Setup 2 was arranged to cover walls A and B and consisted of 7 accelerometers and finally Setup 3 was positioned at Walls C and D and consisted of 5 accelerometers. The accelerometers were oriented to measure the out of plane accelerations of the structural. Additionally, other accelerometers were placed for the in-plane measurements for one point of each setup. Figure 28 shows the position of the accelerometers. Reference accelerometers was placed on Wall F, as in Figure 28

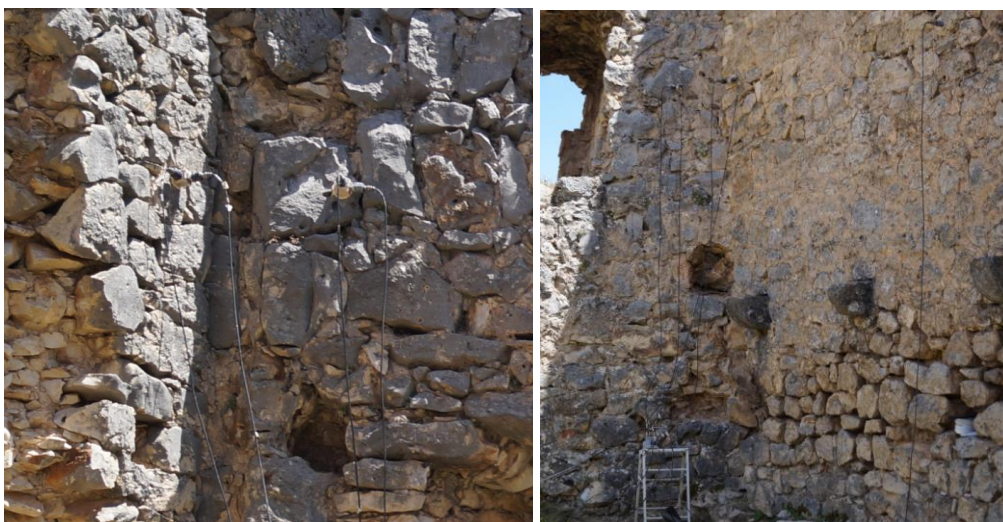
Figure29 :The in-plane and out of plane placement of accelerometer on wall connections E-F and A-B

As in Figure 29, the accelerometer were placed to check the connection between the walls A-B and E-F. This was done as the archaeological data suggests that the above mentioned wall connections shall be weak as they were constructed in different phases. Presence of a crack can also be observed in these two areas.

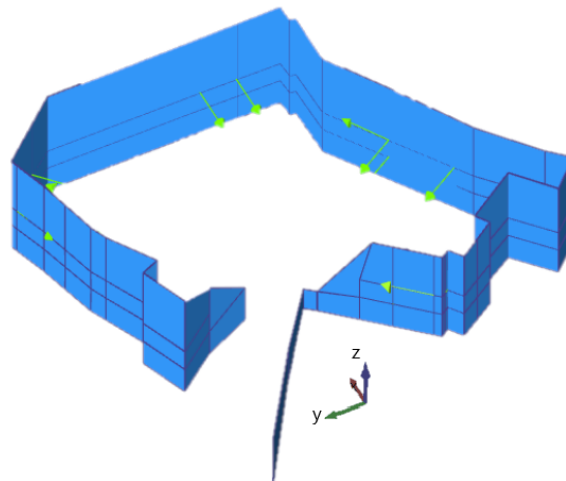
Figure 30: ARTeMIS model with accelerometers in positions

The geometry of the structure was first constructed in AutoCAD 3D and then was defined in the configuration file, where the different points, lines and surfaces as well as the boundary conditions for the nodes at ground level were defined. The geometry which was imported in the software can be seen along with the location of accelerometers in Figure 30. The orientation of the arrows gives the direction of the measured accelerations.

Two methods have been used for the identification of the modes, namely FDD (Frequency Domain Decomposition) and SSI (Stochastic Subspace Identification). The FDD method is a non-parametric method developed in the frequency domain (FD). It is based on the estimation of the modal parameters from the power spectral densities of all the measurement points after the application of the Fast Fourier Transform (FFT) process to the signals. With this method, it is possible to choose manually the possible principal modes of the structure, selecting the top of the peaks of the spectral density graph accelerometers were located in the corresponding point.

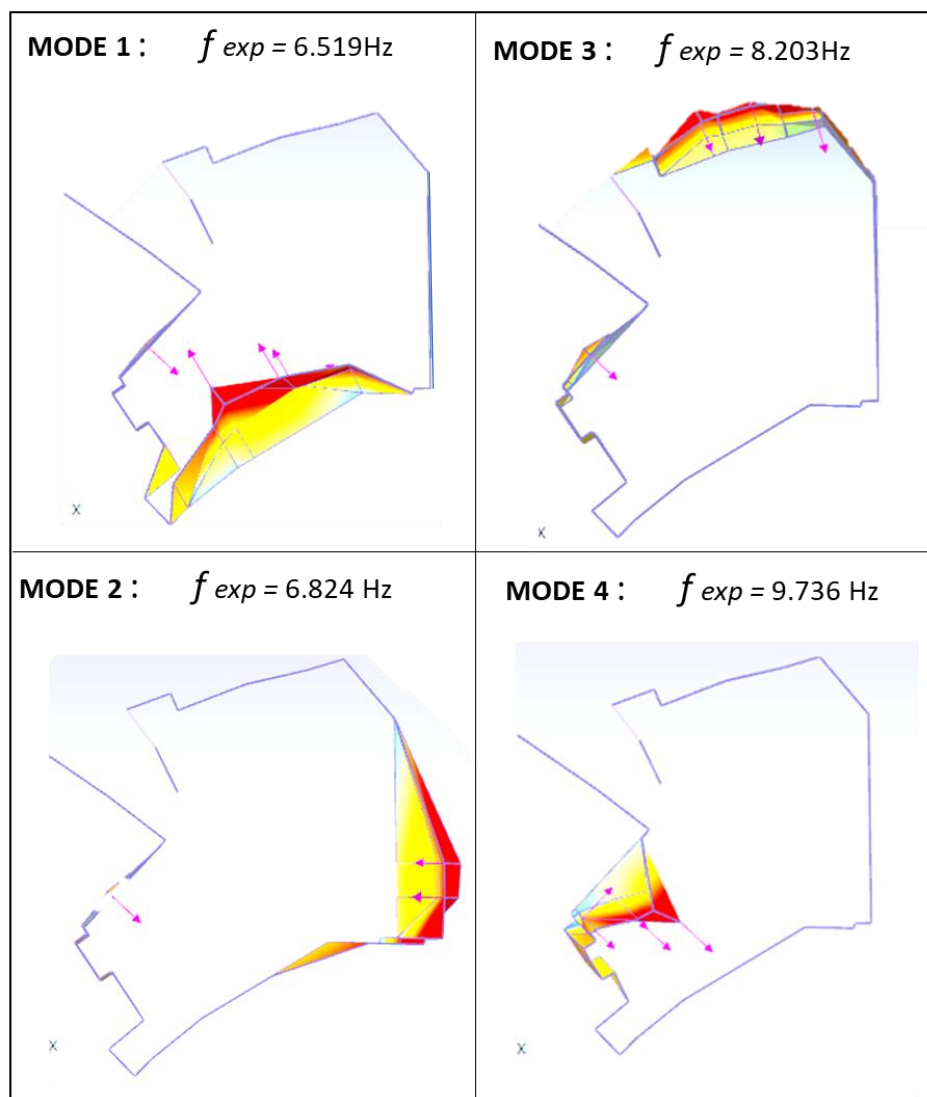
Table 5. Final Modal shapes and frequencies of the different modes obtained with ARTeMIS

These selected modes can be seen in Table 5. Which presents the estimated mode shape configurations of the structure. The natural frequencies of these modes range from 6.5 to 9.7 Hz. Rather close frequency values were found for the first (6.5 Hz) and second (6.8 Hz) modes, but in general the frequencies are well spaced.

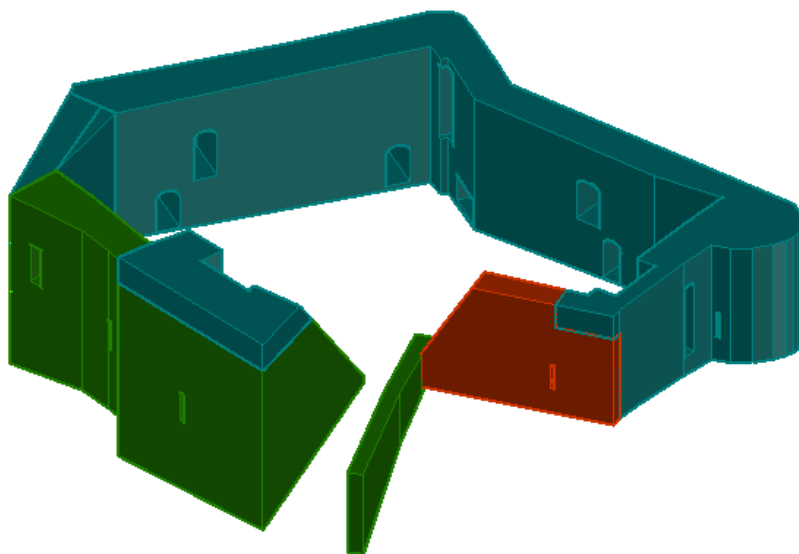
Figure 31:Final AutoCAD model divided into phases

Once the model was complete, it was divided into eleven parts based upon its phases of construction from the archaeological data and material properties (Table 6) derived from the NDT's as seen in Figure 31

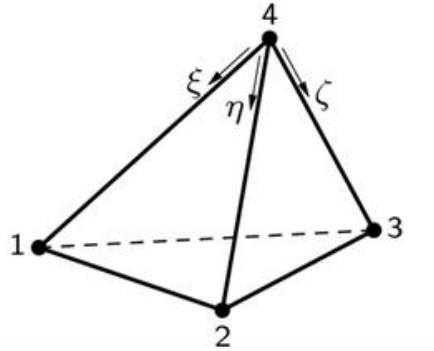
Figure 32: three node iso-parametric solid tetrahedron element – TE12L (TNO DIANA BV, 2009).

The TE12L element is a four-node, three-side iso-parametric solid tetrahedron element. It is based on linear interpolation and numerical integration. The polynomials for the translations u, v, w . During the process of meshing, mechanical properties of Young's modulus, Poisson's ratio and mass density were applied according to Table 6. Regarding the boundary conditions of the model, all degrees of freedom of nodes at ground level were restricted.

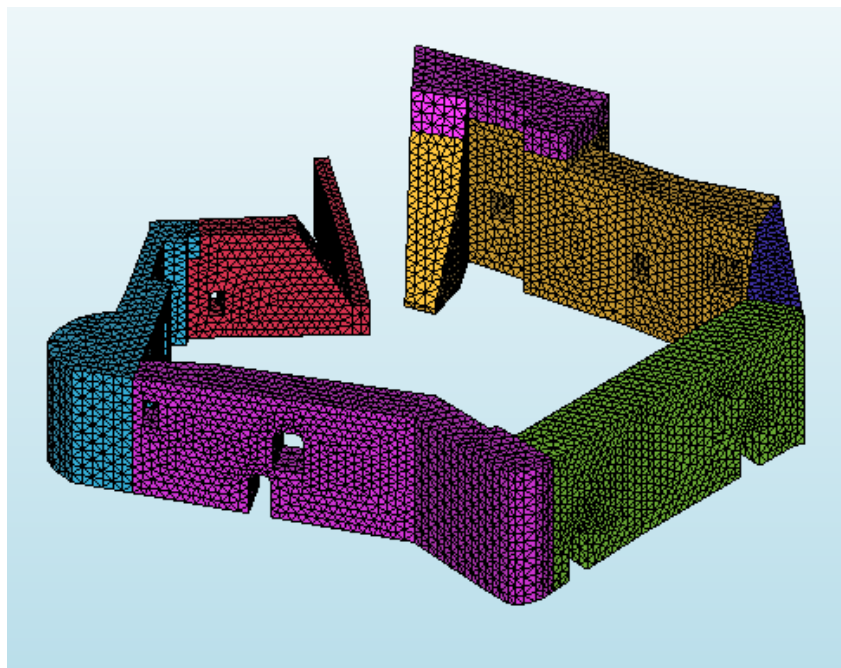
Figure 33: Final DIANA meshed model- with Walls C,D,E further sliced to behave as individual solids

of indirect sonic test, see Figure 31. This decision was taken because even though the walls were built simultaneously, over the period of time and depending upon the degree of degradation, mechanical properties may change. Once the model was imported in FX+ Midas, a mesh of dimension 0.5 m was applied and rectified. Nodes under the range of 0.1m were merged together to avoid complications during calibration. The TE12L element was used for meshing the model ,see Figure 32.

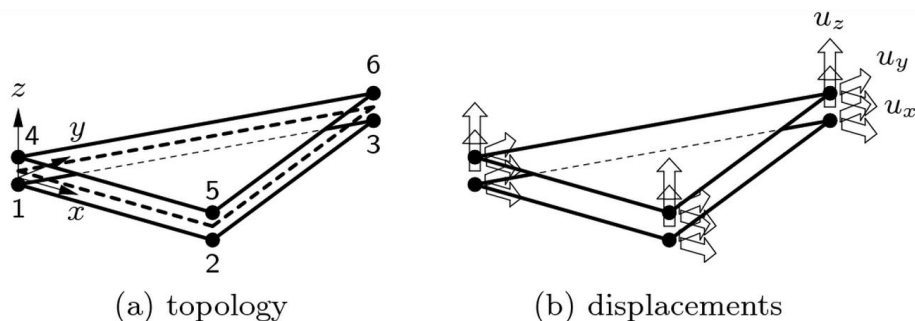
Figure 24:Interface element placed at located indicated with red box

As seen in Figure 34 , the T18IF element was chosen for to be placed in between two solids to further calibrate the models. It is an interface element between two planes in a three-dimensional configuration The local xyz axes for the displacements are evaluated in the first node with x from node 1 to node 2 and z perpendicular to the plane. Variables are oriented in the local xyz axes. The element is based on linear interpolation. By default DIANA applies a 3-point integration scheme. [nlc = 3] .(TNO DIANA BV, 2009).

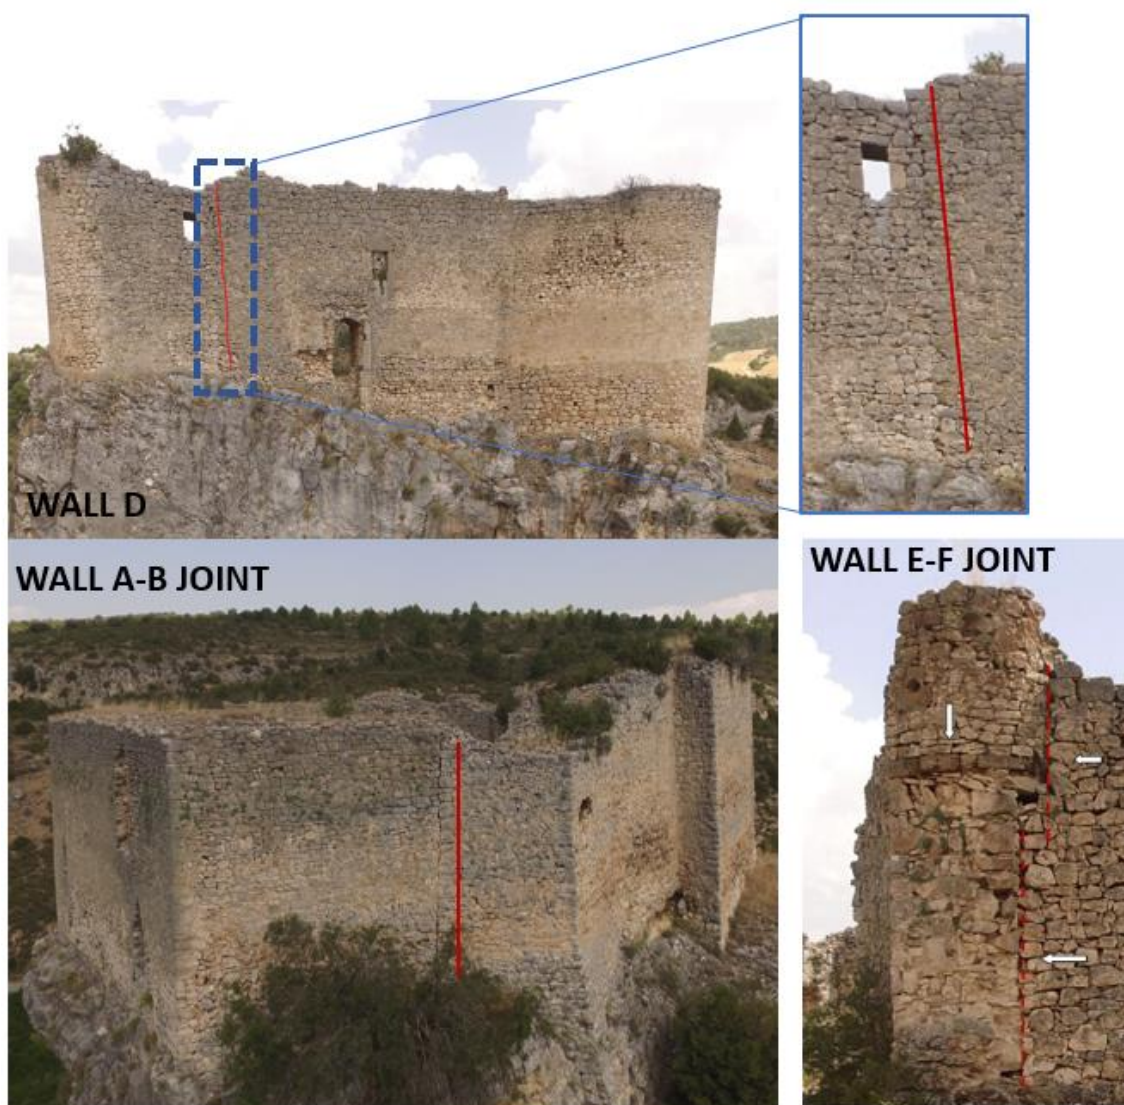
Figure 36: Separation seen between the wall joint of wall A-B , E-F AND wall D

The separation between the wall A-B was shown at a different location. Hence it was remodelled. Secondly, a crack/separation was found in external façade of wall D. This change was incorporated in the model as it may prove necessary for the calibration. Finally the connection between the walls E-F was found to be weak too. But the crack seen in picture was different than seen in the archaeological drawings. See Figure 36. Also, as said in chapter 2, liberty was taken while modeling the geometry of castle with respect to the countour slopes. For better results, the countours seen in wall C were added too. The changes made in the model can be seen in Figure 37

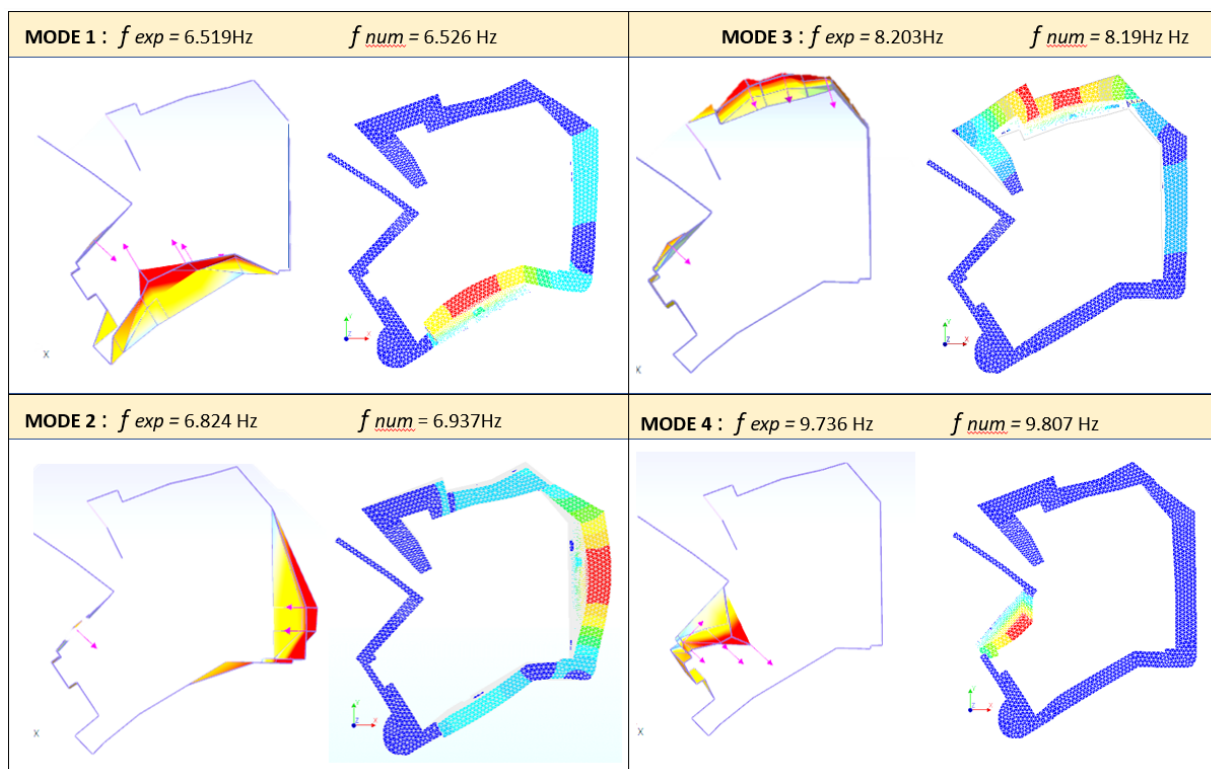
Table 9: Modal shapes and frequencies of the updated FEM and OMA

After the model was calibrated, MAC calculation was also performed to confirm the calibration of the two models. For this, nodes which represented the position of accelerometers were manually selected from FEM. Then the values for the modal shapes of those points were compared with the data obtained from ARTeMIS. This process was done with the implementation of the formula shown in Equation 4 in a spread sheet.
