1 **Lessons from structural analysis of a great Gothic cathedral:**
2 **Canterbury cathedral as a case study**

3 Georgios Karanikoloudis, Paulo B. Lourenço, Leslie E. Alejo*, Nuno
4 Mendes

12 Damage in Gothic cathedrals can occur due to single extreme events or long term
13 processes, often associated to large deformations and cracking. This paper,
14 presents the damage survey and structural assessment of a UNESCO world
15 heritage site and one of the oldest, most visited and most known Christian temples
16 in the UK: Canterbury Cathedral, in Kent. Inspection and damage survey showed
17 repetitive crack patterns on the vault's intrados, with more severity in the south
18 aisle, including namely outward rotating movement and cracking in the south
19 flying buttresses. Ambient vibration tests were carried out to identify the structure
20 modal properties. A FE model of a typical transversal section of the nave and
21 lateral aisles was prepared, and calibrated based on the tests. Nonlinear static
22 analyses were performed, considering the main parameters of influence to the
23 structure, as the construction process, the infill volume, the presence of lateral

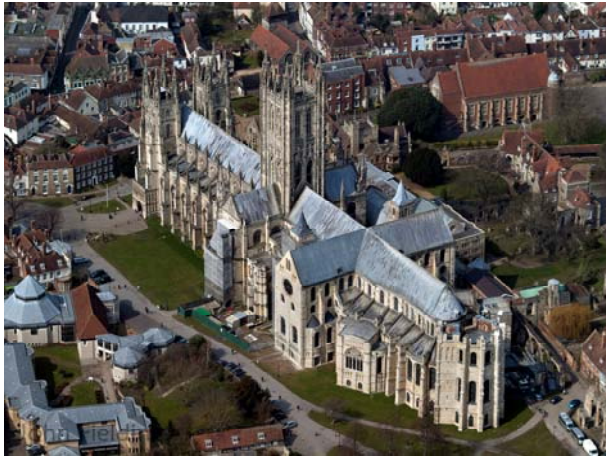
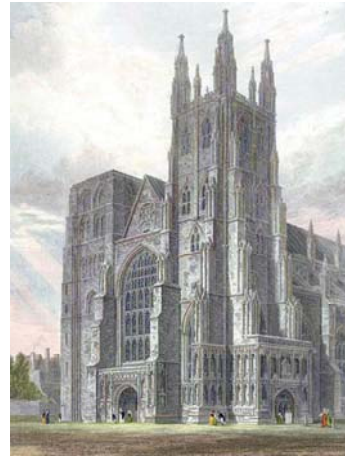
- 1 Figure 1. (a) Aerial view of Canterbury Cathedral from southeast (photo by John
- 2 Fielding 2013). (b) The west front aspect of the cathedral in 1821 before the completion
- 3 of the north-west tower (Collinson, Ramsay, and Sparks 1995).

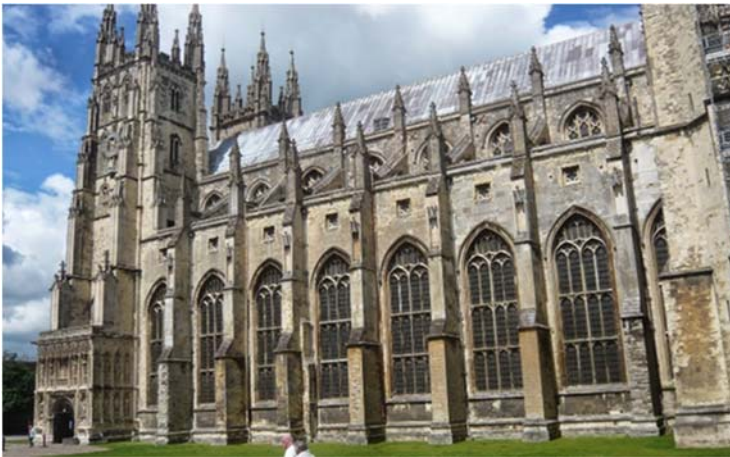
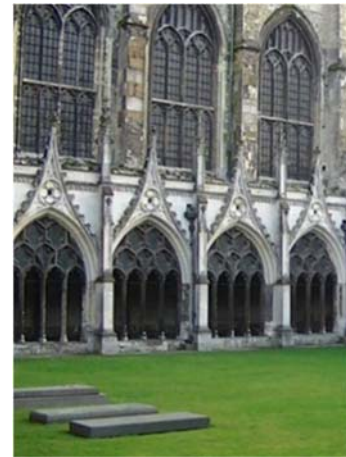
10 Figure 3. (a) Top plan of Canterbury Cathedral in present time, depicting the nave and
 11 lateral aisles area (Wright 2011), (b) geometrical model of the nave, lateral aisles and
 12 the adjoining part of the cloister, (c) view of the south aisle, presenting the system of
 13 vertical and flying buttresses, (d) view of the cloister arcade, attached to the north aisle.

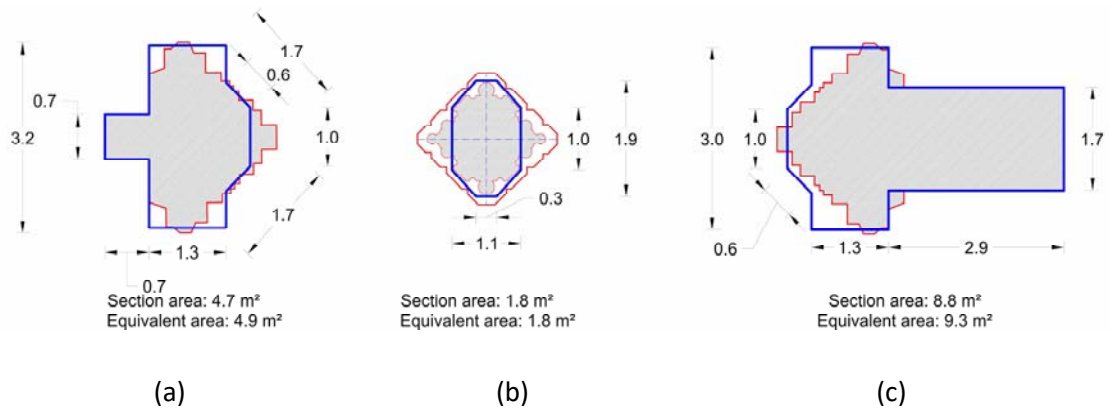
23 Figure 5. Sections depicting the actual (red) and chosen (blue) equivalent dimensions
 24 (meters) and area of the piers and buttresses, for (a) the north buttress, (b) the pier and
 25 (c) the south buttress.

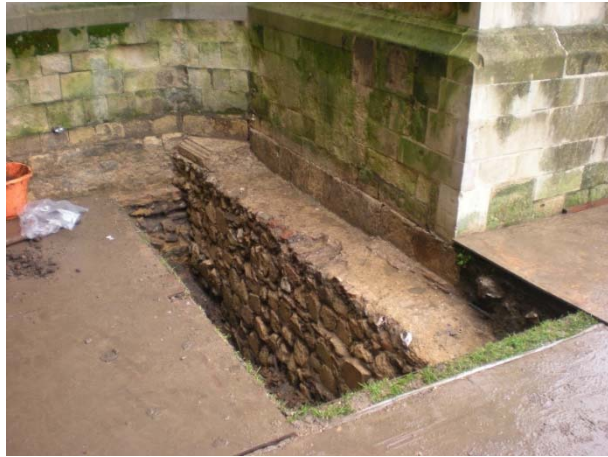
26 Figure 6. Part of the exposed foundation at the west corner of the southwest transept.

260 this trench, the external walls present continuous foundations. The foundation is made of
261 coursed rubble stone masonry, exceeds out at 0.5 m from the footprint of the buttress and
262 is extended down at approximately 2.5 m from the ground level (**Erro! A origem da**
263 **referência não foi encontrada.**). There is no information available on the foundations of
264 the piers, the soil properties and the water table.

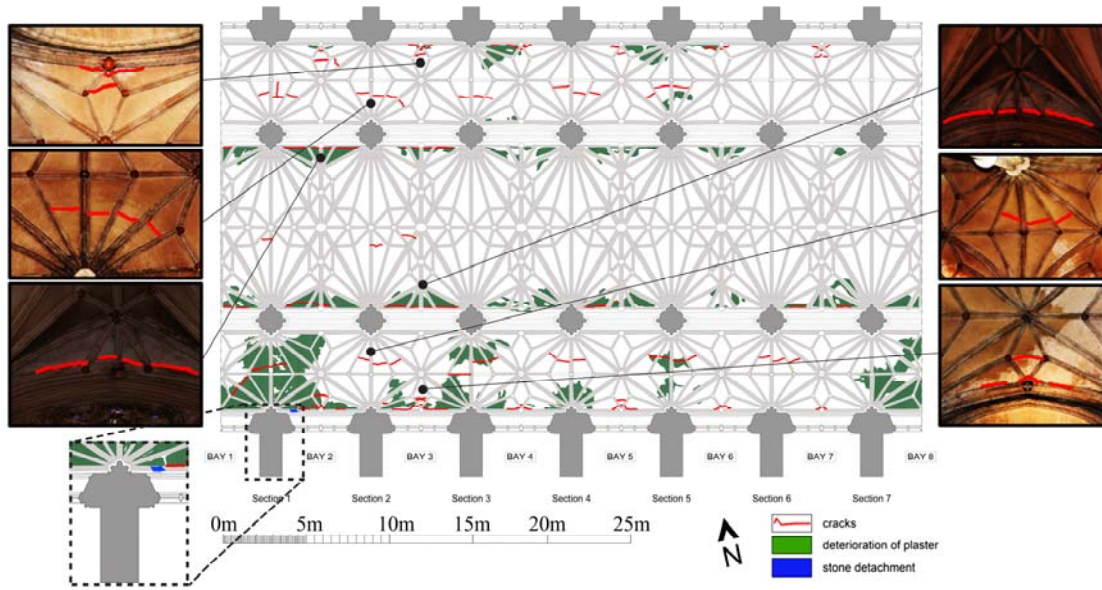
40 Figure 10. Damage map of the intrados of the vault system in the nave and lateral aisles
 41 of the cathedral.

350 A damage survey was carried out in the central nave and lateral aisles of the
351 Canterbury Cathedral during May 2014, by the Civil Engineering Department of the
352 University of Minho, Portugal. In the intrados of the vault system, the main documented
353 damage was a distributed crack pattern in the webs, along with moisture stains and
354 discoloration areas. The cracks follow a repetitive pattern throughout the whole nave and

355 lateral aisles, but without resulting to continuing fragmentations. Still, a potential
356 fragmentation of large structural parts is evident. The number and size of the cracks
357 intensifies in sections 2 and 3 (**Erro! A origem da referência não foi encontrada.**).

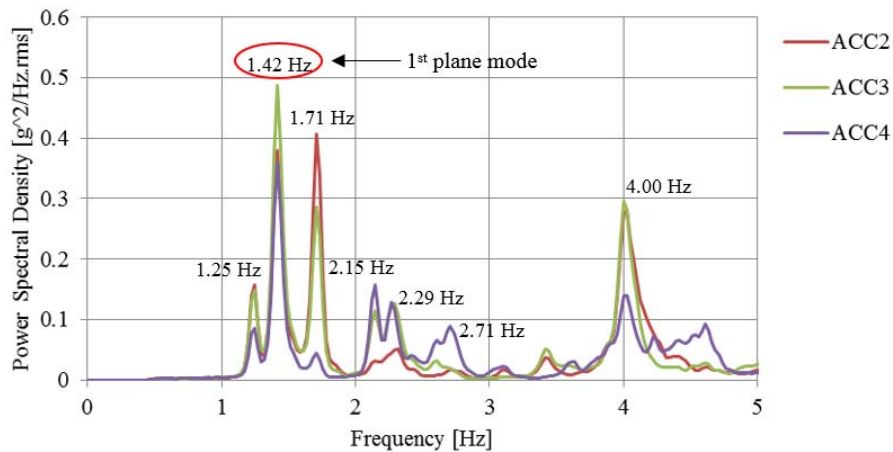
49 Figure 13. Dynamic identification tests in the South Aisle: (a) first eight mode shapes
 50 obtained from the Setups 1, 3 and 4; (b) averaged Normalized Power Spectral Density
 51 for the horizontal accelerometers of setup 5.

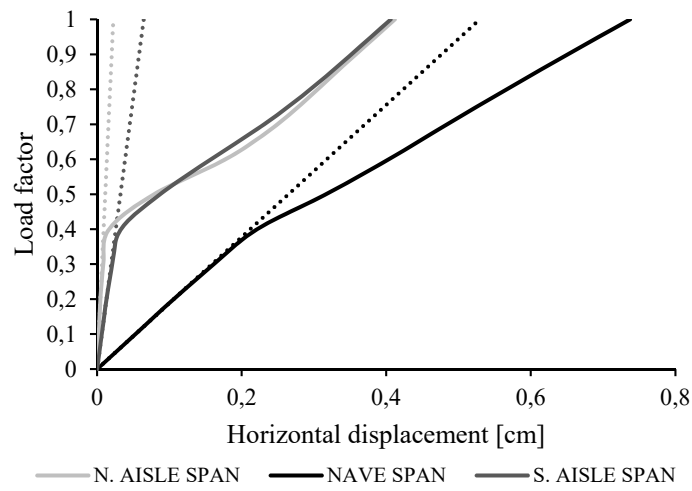
56 Figure 16. (a) Deformed shape (x100) at last load step; (b) load displacement diagram
 57 of the span opening in the nave and lateral aisles versus the load factor of the self-
 58 weight, superposed with the linear response in dashed lines.

471 As seen in Figure 16, the bay appears to deform in a symmetric way, with the
472 upper part of the piers and the clerestory walls spreading and bending outwards,
473 counteracting the thrust from the main vault, which does not appear to be taken by the
474 system of flying buttresses. At the springing of the aisle vaults, the lateral thrust pushes
475 the piers inwards, whereas the vertical buttresses deform by rotating outwards, as
476 observed in many Gothic cathedrals. The cloister appears to restrain and stiffen the lower

485 From the load displacement diagrams, depicting the spreading at the cross section
486 of the nave and lateral aisles vaults, it is evident that at around 40% of self-weight there
487 is a significant loss of stiffness, which amounts to 26% for the nave vault and 52% for
488 the lateral vaults. The above loss of stiffness corresponds to damage in the lateral vaults,
489 with cracking at the intrados, surrounding the columns and located at the level of the
490 infill, which agrees well with the documented cracks. In the extrados of the vault, close
491 to the level of infill there is also cracking, while at the transition between the vaults and
492 the aisle windows, cracks are formed, which match the existing Sabouret's cracks (Figure
493 16 and **Erro! A origem da referência não foi encontrada.**).

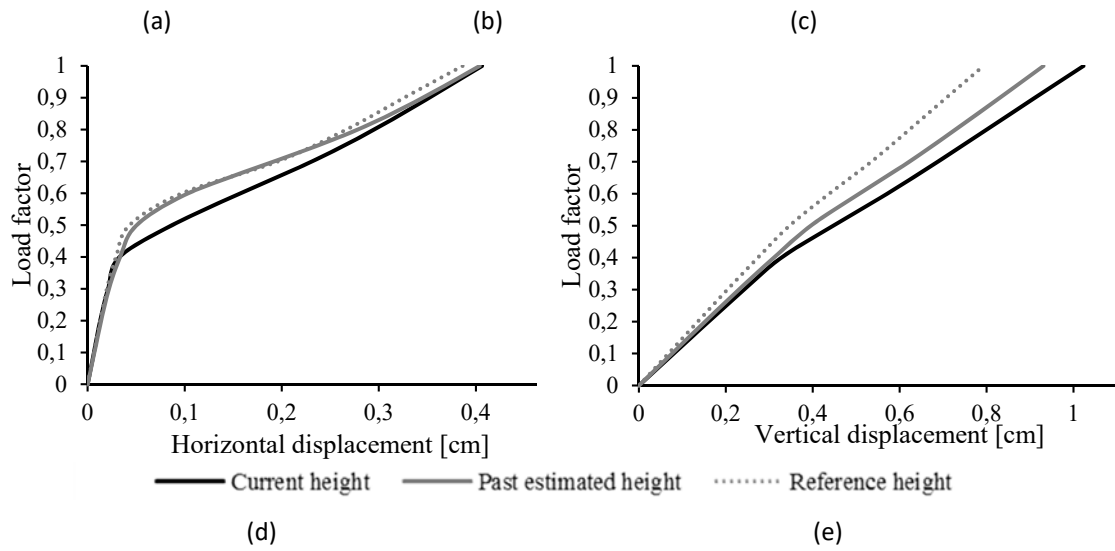
62 Figure 18. Distribution of maximum principal strains at last load step, in a slicing
 63 plane, at the symmetry axis for the current (a), the past estimated (b) and the reference
 64 infill height (c), (d) load versus horizontal displacement diagram of the south aisle's
 65 crown, (e) load versus vertical displacement diagram of the nave's crown.

519 The crack pattern is related to the spreading and deformation of the aisle vaults
520 and to the additional level of infill, as shown in **Erro! A origem da referência não foi**
521 **encontrada.a-c**. The total displacements in all three cases are very low but it is interesting
522 to observe that the reference height of traditional Gothic provides the stiffer (i.e. less
523 cracked) condition. The cracks produced from the inward spreading of the piers, in both
524 lateral vaults, appear close to the longitudinal vertex and their exact position is associated
525 with the level of infill, except in the case of the reference infill height. The tensile damage
526 of the current infill state is magnified, with a wider distribution along the thickness of the

527 vault, compared with the other two cases. This difference is related to the additional
528 stiffness from the infill, which suppresses the vault from deforming and thus it cracks at
529 the less stiff part, close to the longitudinal vertex. Nevertheless, all three models are not
530 able to reproduce the crack pattern in the intrados of the south flying buttress, near the
531 springing line with the clerestory walls, which indicates that the typical bay, besides the
532 dead load, is subject to additional effects that compromise its structural stability.

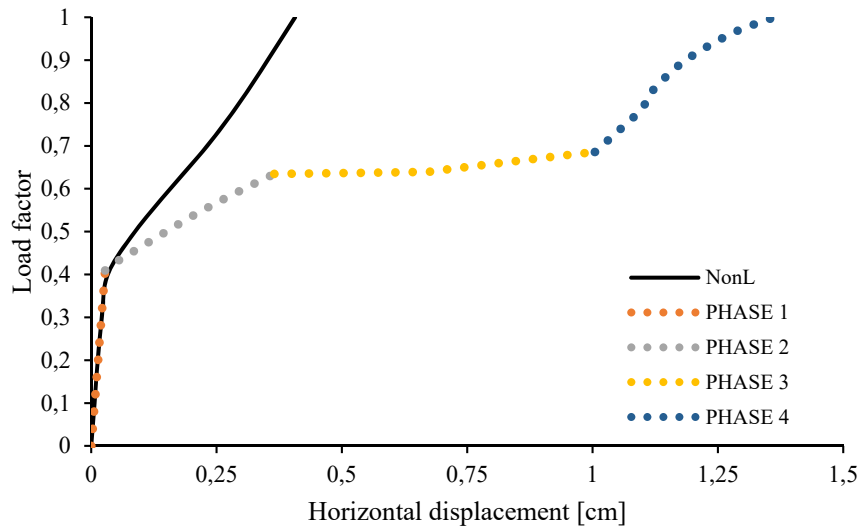
67 Figure 20. Load factor versus horizontal displacement diagram of the south aisle span
 68 opening, for the nonlinear static analysis (NonL) and the phased nonlinear analyses
 69 (phase 1 to 4).

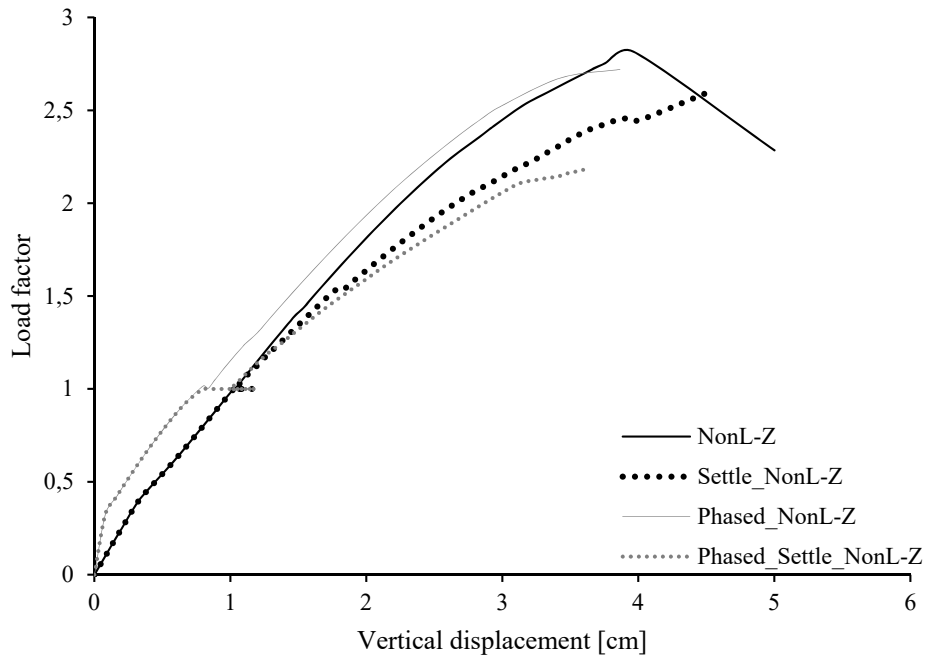
84 Figure 23. Load displacement diagram, depicting the vertical capacity in terms of
 85 vertical displacements of the nave crown: 1) conventional nonlinear analysis in vertical
 86 direction (NonL-Z); 2) case 1) with settlements (Settle_NonL-Z); 3) phased analysis
 87 followed by nonlinear analysis in vertical direction (Phased_NonL-Z); and 4) case 3)
 88 with settlements (Phased_Settle_NonL-Z).

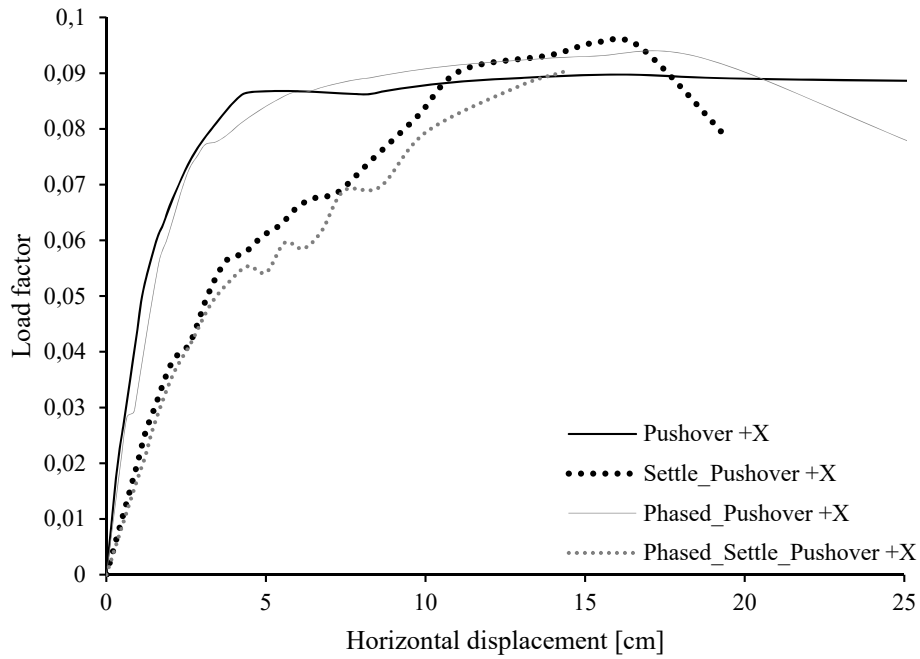
96 Figure 26. Load displacement diagram, depicting the lateral capacity in terms of
 97 horizontal displacements of the nave crown: 1) pushover in lateral direction
 98 (Pushover+X); 2) case 1) with settlements (Settle_Pushover+X); 3) phased analysis
 99 followed by pushover in lateral direction (Phased_Pushover+X); and 4) case 3) with
 100 settlements (Phased_Settle_Pushover+X).

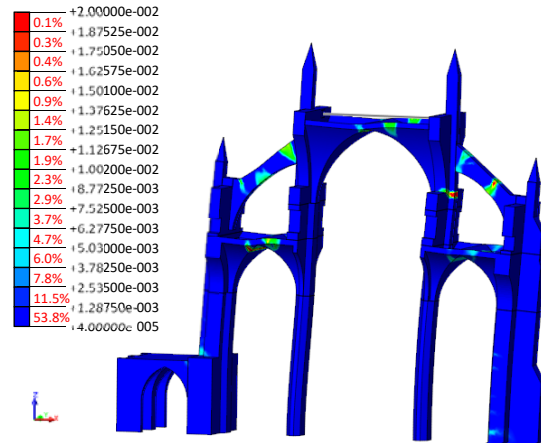
101 Figure 27. (a) Deformed shape (x100) with incremental displacements, at a
 102 corresponding load step of 0.08g of lateral force, under dead loading, (b) distribution of
 103 maximum principal strains, at a corresponding load step of 0.08g of lateral force, under
 104 dead loading, (c) deformed shape (x100) with incremental displacements, at a
 105 corresponding load step of 0.09g of lateral force, under dead loading and settlement, (b)
 106 distribution of maximum principal strains, at a corresponding load step of 0.09g of
 107 lateral force, under dead loading and settlement.

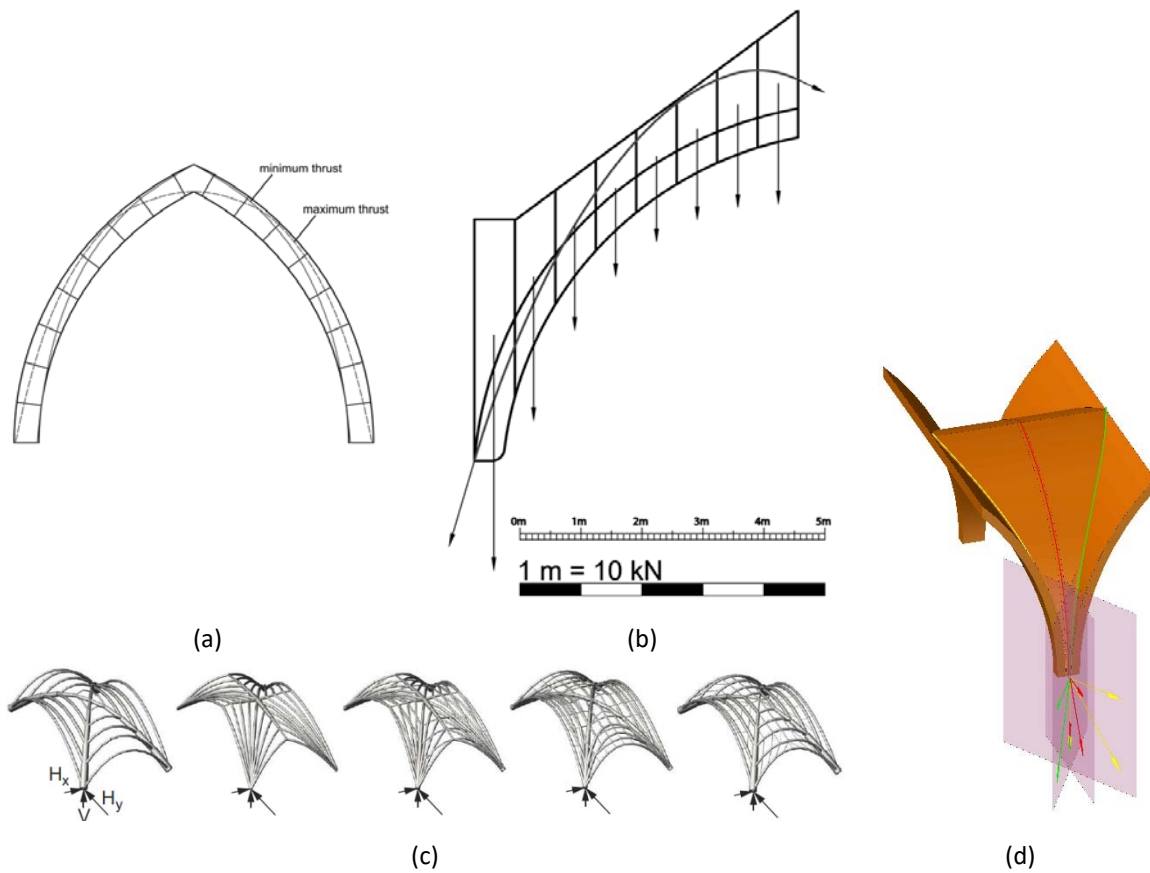
108 Figure 28. (a) The minimum and maximum thrust line that defines the boundaries of the
 109 stability of a pointed Gothic arch, (b) line of thrust in flying buttress of the south aisle in
 110 corresponding bay 3, (c) Thrust trajectories in cross vaults in three dimensional view,
 111 targeting the springings with different configurations, (d) schematic representation of
 112 the resultant thrust in the springing of a Gothic cross vault.
