Methodologies for assessing the structural integrity of historic masonry domes and vaults

Danielli Cristina Borelli Cintra^a Deane de Mesquita Roehl^a Emil de Souza Sánchez Filho^b Paulo B. Lourenço^c Nuno Mendes^c ^aPontifícia Universidade Católica do Rio de Janeiro – PUC-Rio, Programa de Pós-graduação em Engenharia Civil, Rio de Janeiro, RJ, Brasil^bUniversidade Federal Fluminense – UFF, Programa de Pós-graduação em Engenharia Civil, Niterói, RJ, Brasil^cUniversidade do Minho, Departamento de Engenharia Civil, Guimarães, Portugal

Abstract: Modern non-destructive investigation techniques and computational tools for nonlinear analysis allow understanding the structural behavior and damage of existing buildings, aiming at the least possible extent of intervention. Careful and minimal intervention is essential to preserve the authenticity of the built cultural heritage. An investigation with a historical, experimental, and numerical approach was carried out in the Theatro Municipal do Rio de Janeiro, in Brazil, a building with an eclectic architecture from the beginning of the twentieth century. Its masonry domes and vault have paintings by renowned artists on their intrados and we

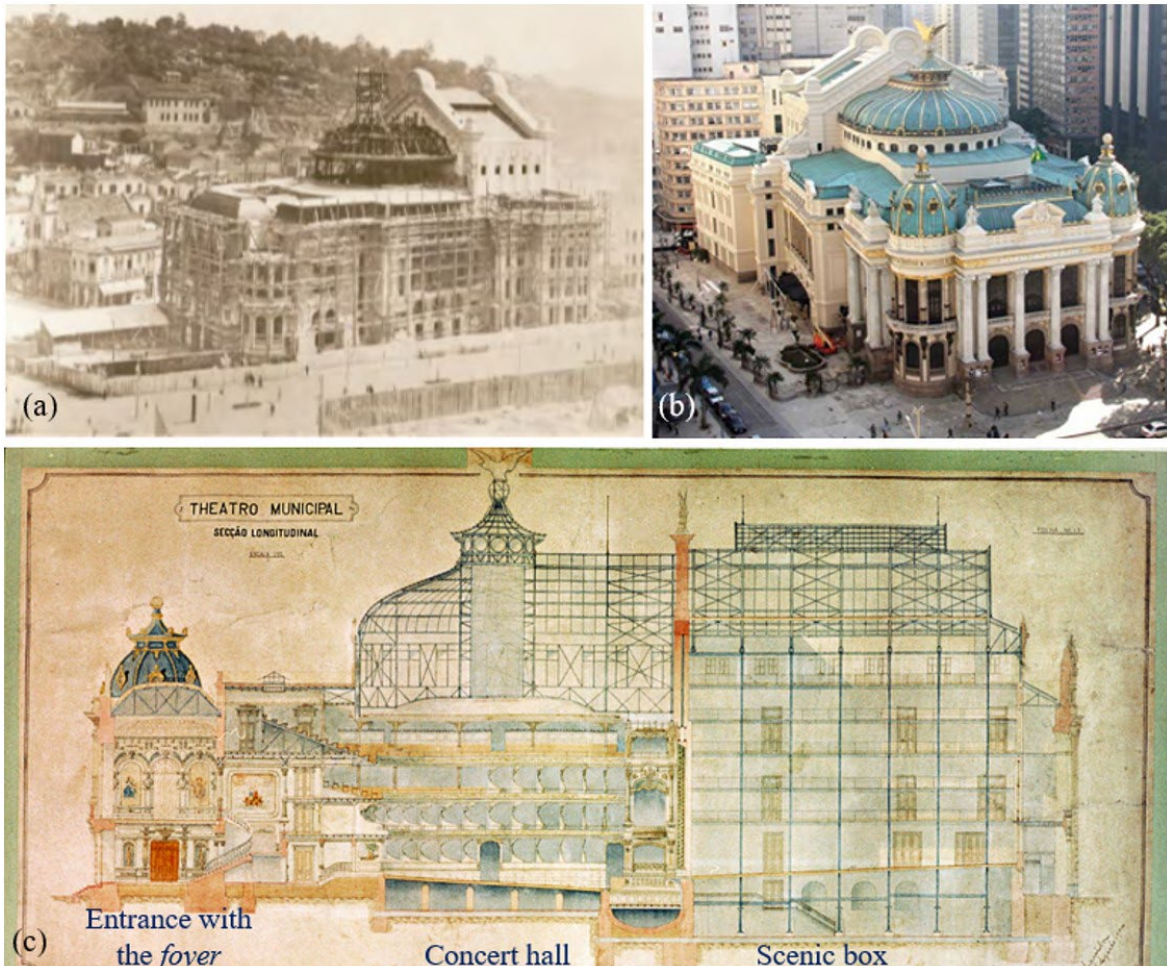
Figure 1 – TMRJ: (a) roof building image by Augusto Malta (1906); (b) current facade; (c) longitudinal section by Francisco Oliveira Passos, 1904 [48]. *Sources:* (a; b; c) collection of Centro de Documentação do TMRJ (CEDOC).

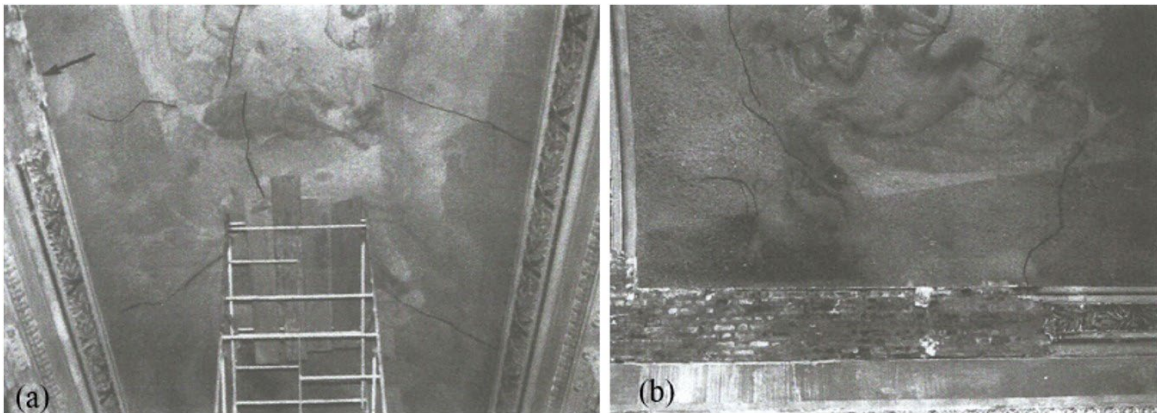
Figure 4 – Photos of the damage in the vault in the 1970s, by Schiros [55]: (a) cracks; (b) moisture in the masonry.

Lack of maintenance, festive events, vandalism, water infiltrations from the roof, construction works in the surroundings, such as the subway, among other events, damaged the building (Figure 4a, b). According to reports from the 1970's [54], [55], the paintings in the intrados of the masonry domes and vault were at risk of collapse mostly due to differential settlements and moisture in the masonry.

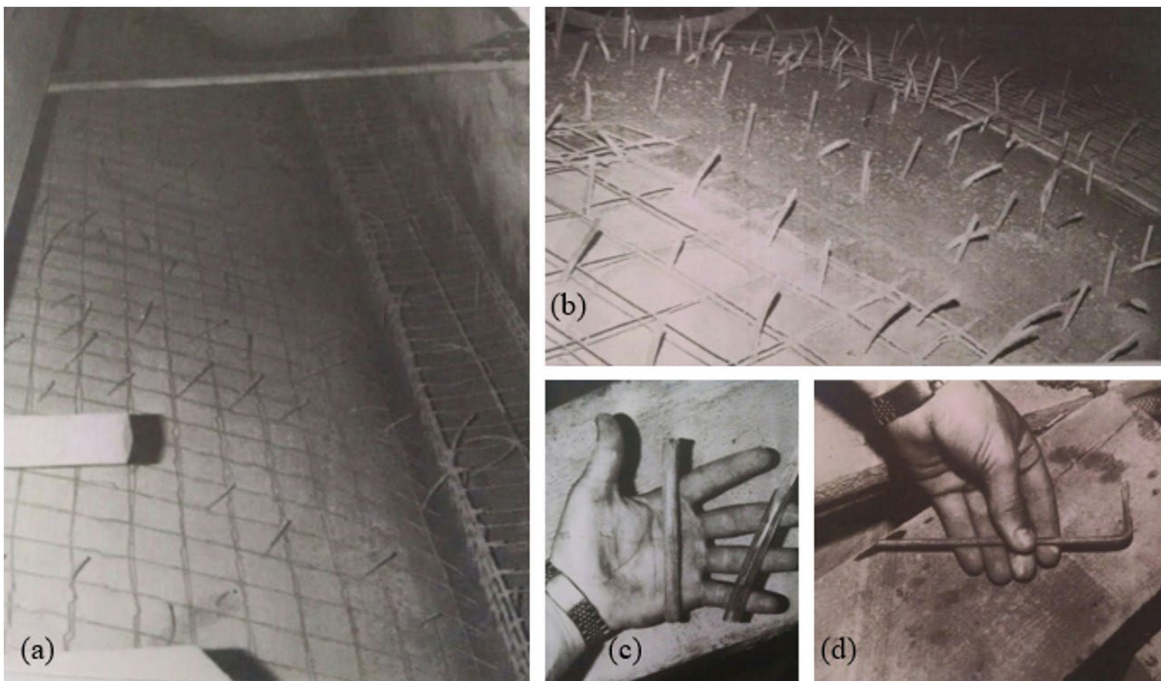
Figure 5 – Photos of the strengthening of the extrados of vault in the 1970s, by Schiros [55]: (a) reinforced concrete collar beam (right-side of the photo), with steel mesh in shotcrete layer and injection tubes for epoxy; (b) the creation of arches, using shotcrete; (c) resin injection plastic tubes for cracks filling and fixing of metal anchors; (d) detail of metal anchors for shotcrete overlay.

- a) **step 1** – construction of reinforced concrete collar beams and an overlay of shotcrete reinforced with welded wire mesh at the extrados, as shown in Figure 5a. By casting, priority was given to the creation of arches crossing the largest transverse cracks (Figure 5b);
- b) **step 2** – injection of epoxy resin in the cracks to restore the monolithism of the shells, using plastic tubes, according to Figure 5b;
- c) **step 3** – fixing of metal anchors in drilled holes filled with epoxy resin, in order to promote adhesion between the original masonry shell and the new concrete overlay (Figure 5c, d).

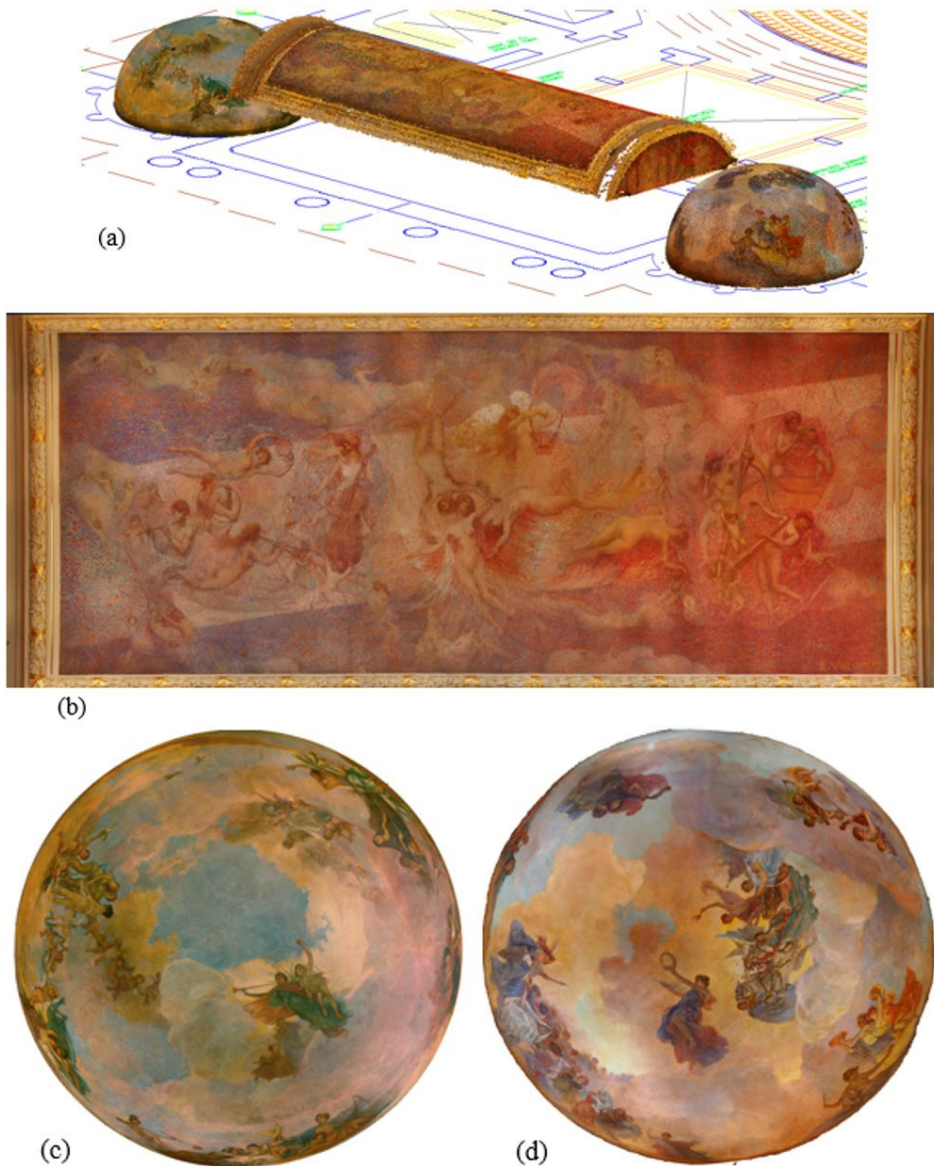
Figure 6 – Intrados of the domes and vault [60]: (a) point cloud; (b) orthophoto of the vault; (c) orthophoto of the dome of Av. Treze de Maio; (d) orthophoto of the dome of Av. Rio Branco. Images: Adolfo B. Ibáñez.

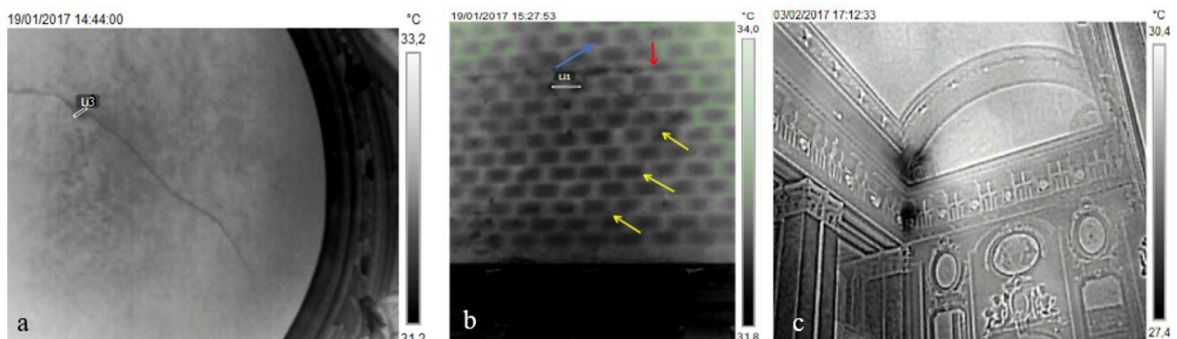
Figure 7 – Infrared image: (a) dome of Av. Rio Branco; (b) vault with indication of metal cramp in blue, treated cracks at the vertex in red and at the lateral in yellow; (c) moisture indication on the vault and walls. Images: (a, b) Eduardo Azambuja; (c) Flávia Lamim.

Passive infrared thermography with natural thermal excitation from insolation on the roof at the beginning of a summer afternoon, allowed to detect treated cracks (Figure 7a, b), the arrangement of the clay bricks (or masonry bond), hidden metal cramps (Figure 7b in blue), spots of moisture in the masonry (Figure 7c) and other construction details, all hidden by the works of art and decorative elements on the intrados and the concrete on the extrados. It is a useful tool for inspection and qualitative evaluation of masonry with a finished surface and difficult to access.

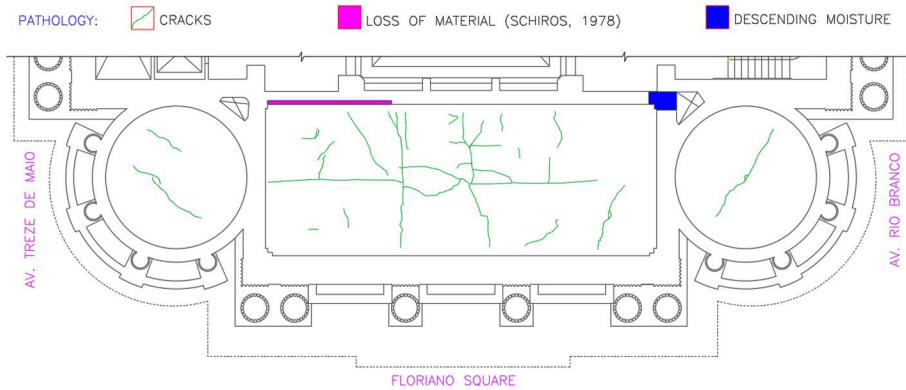
Figure 8 – Damage map in the intrados of the domes and vault, with indications of the cracking pattern and loss of material that were treated in the 1970s, and the current moisture, all revealed by the thermography.

The images of photogrammetry and infrared thermography were used in a combined way to elaborate the damage map (Figure 8), which will be useful in damage monitoring, planning and control of future interventions, focusing on the trend towards interoperability with the use of advanced technologies such as Heritage Building Information Modelling (HBIM), Building Energy Modeling (BEM) and Artificial Neural Networks (ANN) [10], [61], [62]. Photogrammetry was applied to correct distortions in the thermal images from the curvature of the domes and vault.

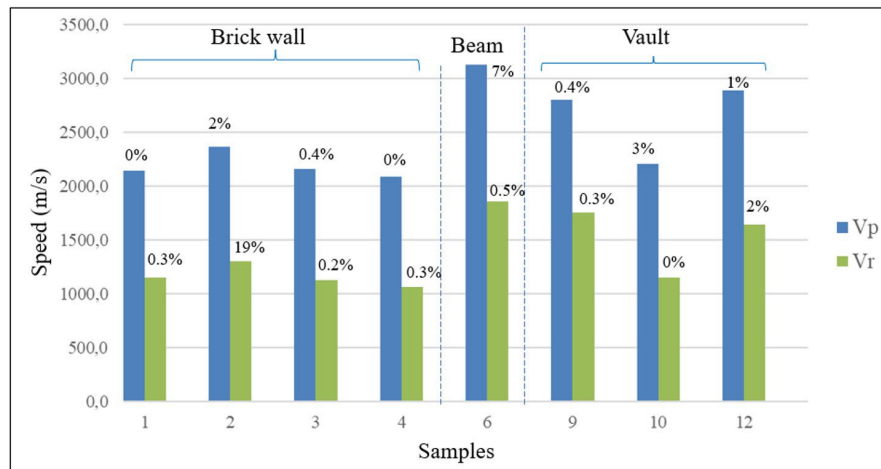
Figure 10 - Average velocity of longitudinal (V_p) and surface (V_r) waves and standard deviation (%).

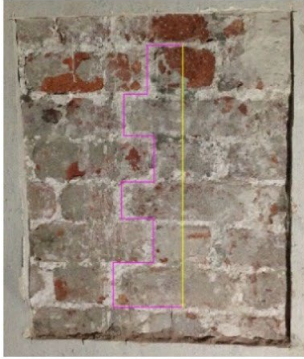
Description		Regular masonry wall of ceramic bricks laid with cement mortar and lime, with a thickness of about 1.1 m. The joint thickness is between 1cm and 1.5 cm.																																																			
Description

Typical brick dimensions: h: 7.5 cm l: 23 cm s: 11 cm

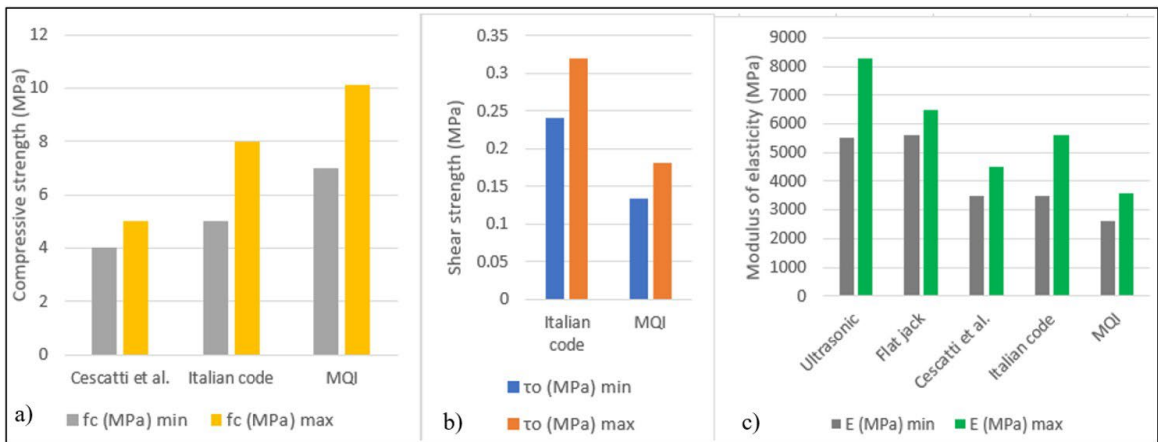
Figure 13 - Elastic properties of brick masonry by different methods (f_c means compressive strength; τ_o means shear strength and E means elasticity modulus).

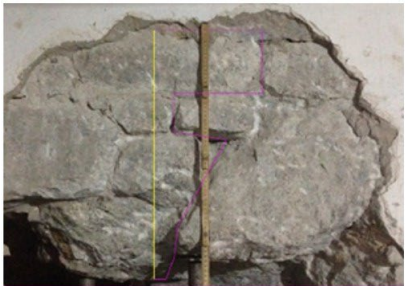
Irregular masonry wall of stones laid with cement and lime mortar, with a thickness of about 1.25 m. The joint thickness is between 0.5 cm and 1.5 cm.

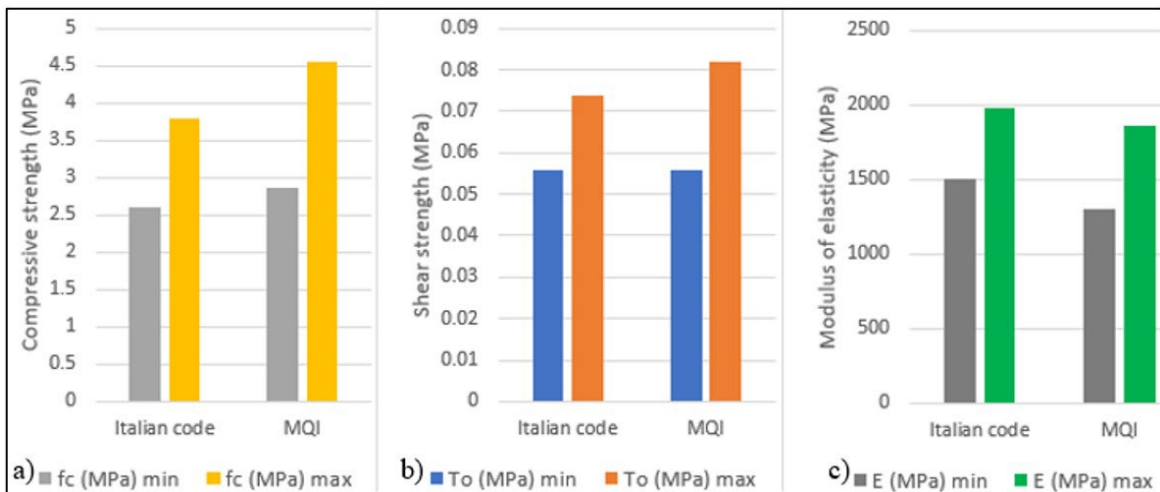
Figure 14 - Elastic properties of stone masonry by qualitative methods (f_c means compressive strength; T_o means shear strength and E means elasticity modulus).

Table 4 presents the definition of the MQI and the estimate of the mechanical properties of the stone masonry of the walls. Figure 14 shows the minimum and maximum intervals for the values of elastic properties of stone masonry defined by the MQI method and by the Italian code for cut stones with good adhesion. The values are close, and the difference between the limits is between 0 and 16%.

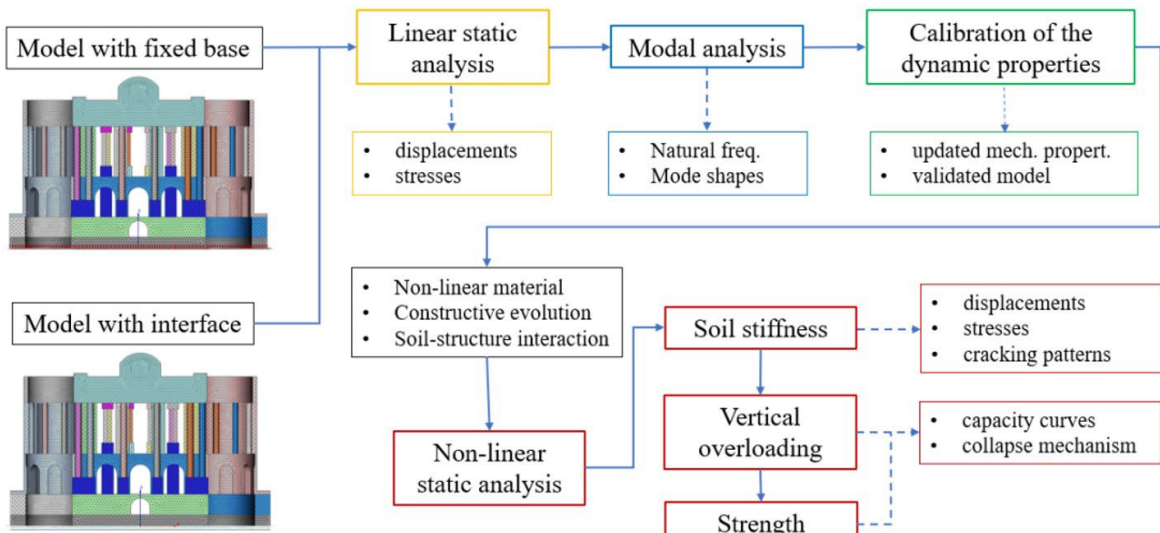
Figure 17 – Scheme of the numerical analysis performed.

The adopted sequence of structural analysis using the finite element method in the DIANA software [76] is as follows: (a) a preliminary linear static analysis as model validation and to understand the behavior of the structure; (b) modal analysis to obtain the frequencies and mode shapes. These were calibrated with respect to the experimental results obtained from the dynamic identification tests; (c) non-linear static analysis under gravitational loading, considering the effect of soil-structure interaction and discussing the structural safety of the domes and vault.

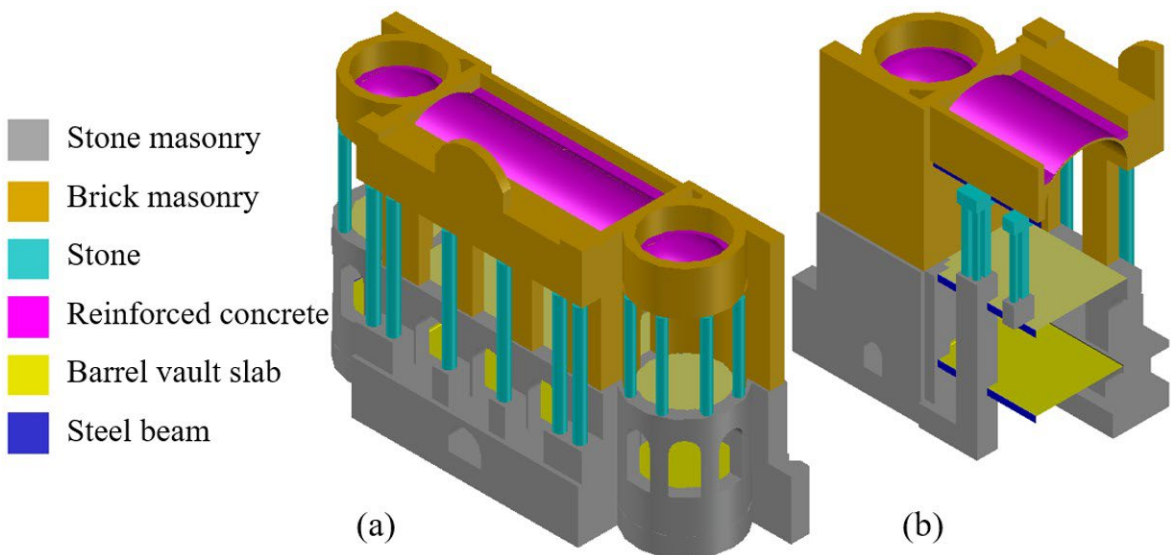
Figure 18 – Identification of the different materials of the model: (a) front view; (b) sectioned back view.

The numerical model consists of 1,485,894 solid tetrahedral elements that represent the masonry, the stones, and the concrete, 8,742 triangular shell elements for the jack-arch slabs, 196 beam elements for the metal beams simply supported on the walls, 2,690 three-dimensional flat triangular elements to represent the interface between the foundation and the ground, and 1,410 one node translation spring elements to represent the axial stiffness of the walls omitted in the model. The adopted finite elements consider a linear interpolation of the displacement field with a total of 4,481,552 degrees of freedom.

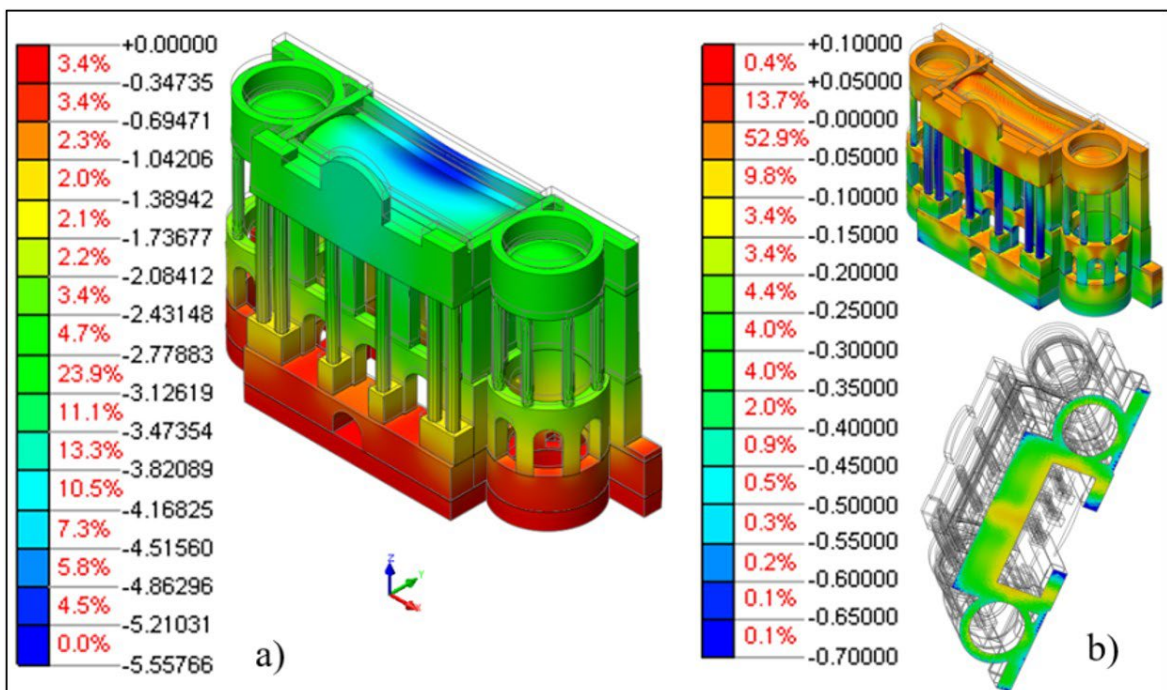
Figure 19 – Linear static analysis: (a) vertical displacements (mm); (b) vertical stress (MPa).

A second validation was made from the displacements, which, in general, are small, considering only gravitational actions and fixed support conditions. According to the analysis (Figure 19a), the maximum vertical displacement of the structure is 5.6 mm and occurs in the central region of the vault, close to the internal support, which is composed of transition pillars, representing 0.08% or 1/1250 of its transverse span and 0.03% or 1/3121 of the longitudinal span. The range and distribution of displacements are in line with expectations and show that the most vulnerable part is likely to be the span between the entrance (foyer) and concert hall.

As a final validation, the stresses present in the linear behavior domain for all materials, with the maximum compressive stress being close to 0.7 MPa in the masonry, predicted for the granite columns and stone masonry of the facade (Figure 19b). The average compressive stress on the foundation is about 0.35 MPa, in accordance with the value foreseen in the hand calculation and in the report on the foundations [53].

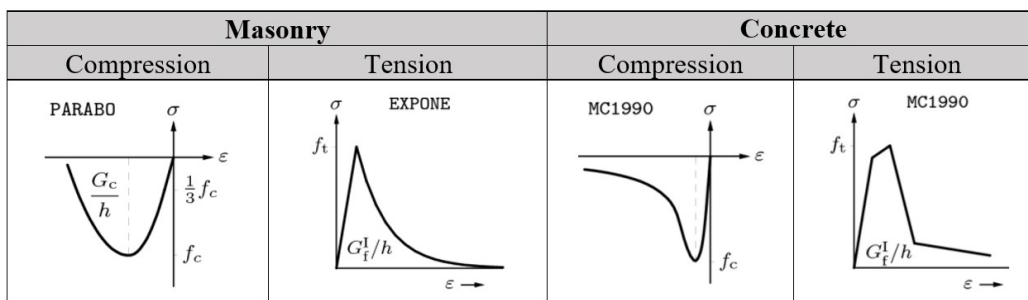
Figure 21 - Non-linear behavior of materials [82].

In the non-linear analysis with DIANA, the standard Newton-Raphson iterative method was used combined with an energy convergence criterion with a tolerance of 0.001. The constitutive model adopted, called Total Strain Crack Model (TSCM), simulates the tensile and compressive behavior of material through the relationship between stress and strain in Figure 21. The Rotating Crack concept was considered, in which the relationship between stress and strain is evaluated in the principal directions of the strain tensor, which defines the direction of the crack opening [82].

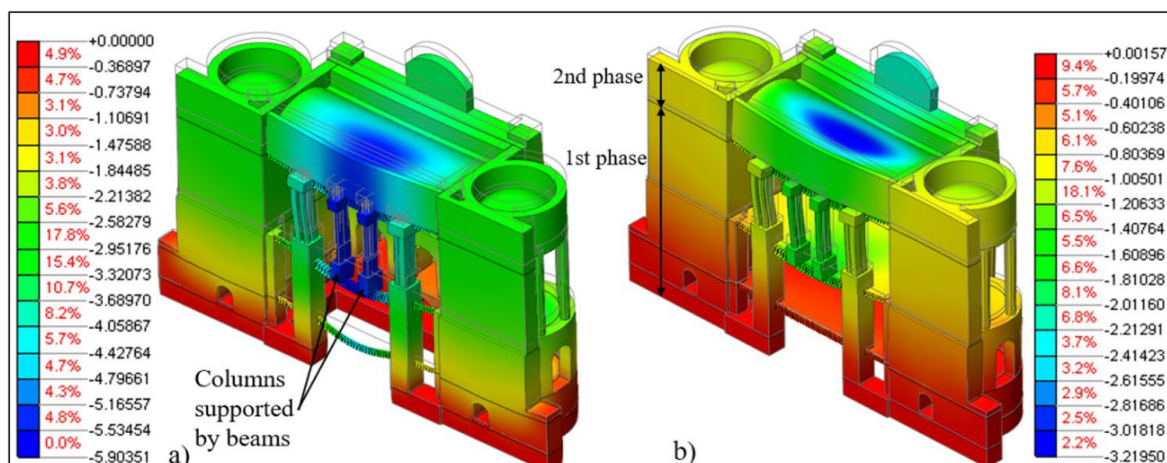
Figure 22 – Vertical displacements (mm) of numerical model elements (%): (a) instant load; (b) with two construction phases.

As the gravitational actions were applied, the maximum displacement of the model remains very small, about 3.2 mm or 1/2200 of the span, occurring in the central part of the vault. This region is identified as the most vulnerable, although no significant crack was observed in the analyses. The displacement of the non-linear analysis in stages is smaller than the linear analysis (about 5 mm), which incorporated the displacements of the transition beam.

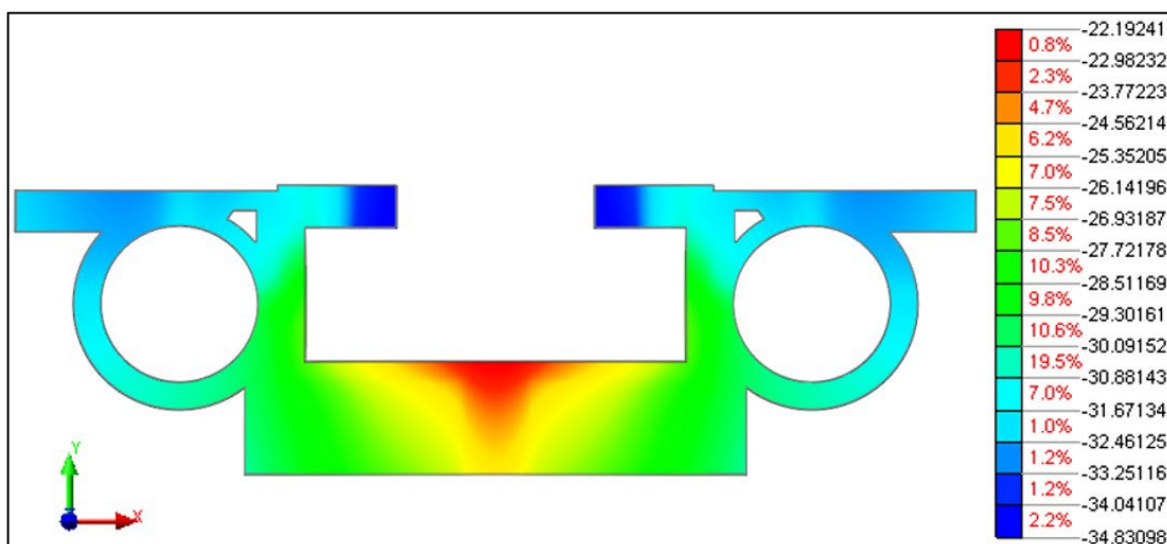
Figure 24 – Vertical displacements (mm) of the foundation in the last gravitational loading step.

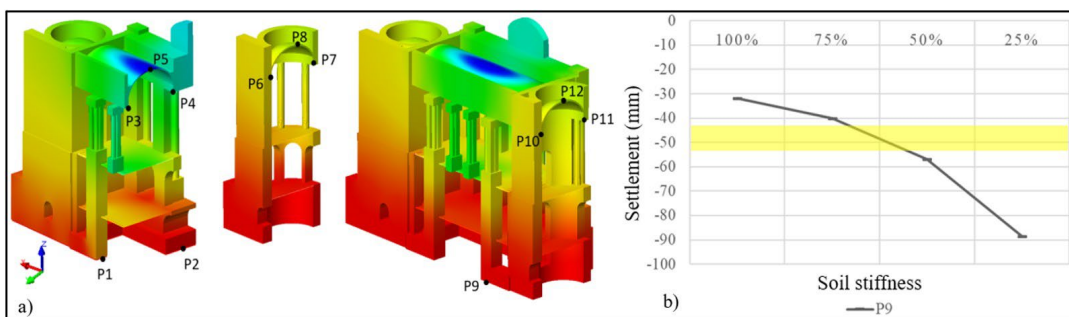
Figure 26 – (a) Position of the displacement control points; (b) vertical displacement (mm) in P9 for Case 3.

In Case 3, a reduction of 25%, 50% and 75% of the vertical and horizontal stiffness coefficient of the soil was analyzed. The points considered representative for the control and assessment of displacements in the structure are shown in Figure 26a. The vertical displacement at the base of the pillar of Av 13 de Maio with the gradual reduction of soil stiffness is shown in Figure 26b, which indicates the initial settlement of 32mm with the soil stiffness before the subway works. Considering that this base has characteristics similar to the foundations studied by Jucá [7], it is estimated that a settlement between 1 cm and 2 cm occurred during the excavations of the subway (Figure 3c), which corresponds to the effect of 75% to 50% of the soil stiffness, as highlighted in yellow in Figure 26b.

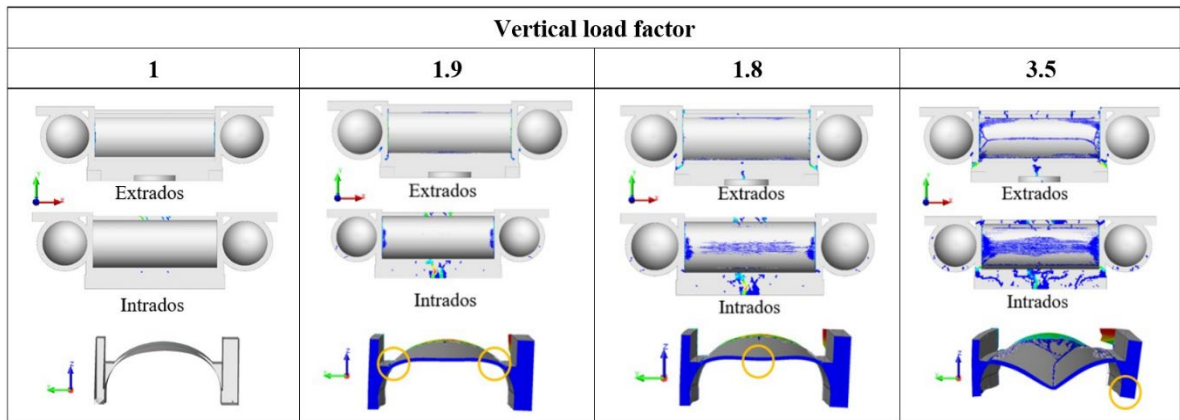
Figure 29 – Collapse mechanism due to gravitational loads in the original model.

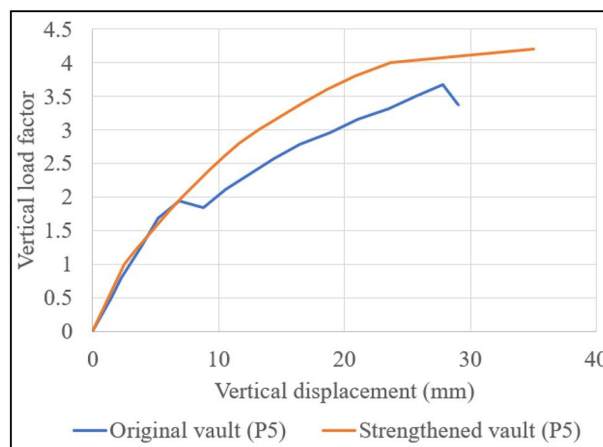
Figure 30 – Gravitational load capacity of vault in the original and strengthening condition.

The efficiency of the strengthening in the vault is evaluated by a comparison between the load factors in the original and strengthened condition, concerning the vertical displacements at the vault key (Figure 30). The properties adopted for the shotcrete reinforcement layer with a reinforcement rate of 0.5% are in Table 6 and the compressive strength of the steel was considered null, due to the mesh is composed of thin bars and unlikely to contribute to the compressed regions. The reinforced vault maintains a predominantly linear behavior up to a load factor 3.0 times its own weight, about 60% higher than the original model, with a factor of 1.9. From that point on, the strengthened structure loses linearity, converging to the original condition. It can be thus stated that the applied strengthening measures provided increasing capacity against cracking but, in terms of ultimate condition, the gain is marginal.
