# Field Investigation and Numerical Modeling for the Seismic Assessment of the Castle of Lanjarón, Spain

**Abstract:** The Castle of Lanjarón is a 16th century stronghold located in Andalucía, Spain. After losing its military function, the castle was abandoned, leading to significant decay. Designated a national heritage site in 1985, recent efforts have sought to preserve its historical and cultural value. This study outlines an inspection and diagnosis campaign carried out on the castle. Non-destructive tests (NDTs) were employed to characterize the properties of the masonry, using both mechanical and wave-based methods. Dynamic identification was performed to determine dynamic and modal properties of the structure, which were used to develop and calibrate a three-dimensional (3D) finite element model (FEM) of the west wall, based on homogenized masonry material. Limit analysis and non-linear static (pushover) analysis under various boundary conditions were conducted to determine the maximum relative load factor in the out-of-plane direction. The results were compared to the expected peak ground acceleration (PGA) of the area, showing that the maximum load capacity of the wall e

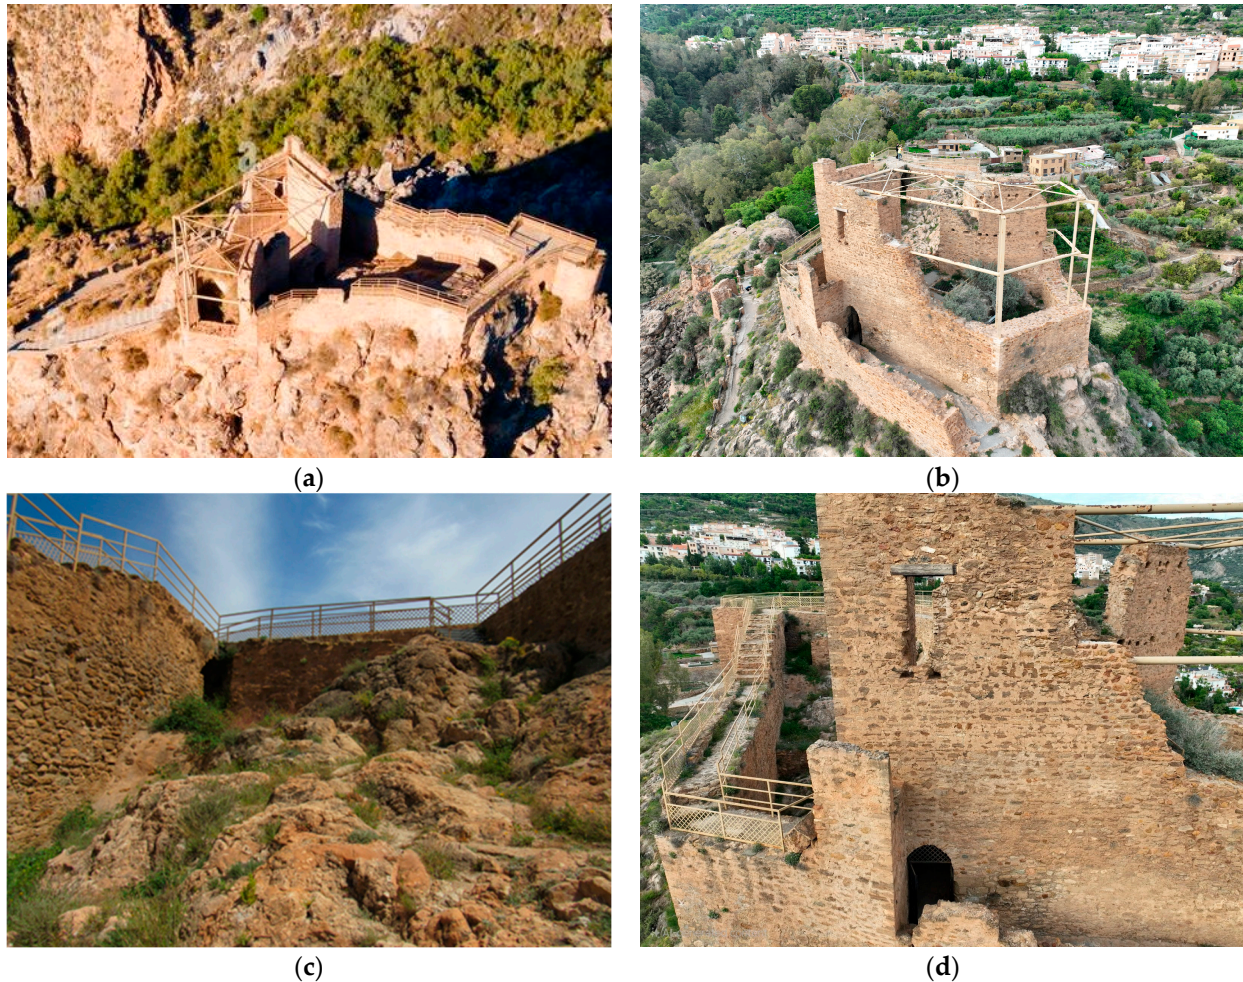
**Figure 1.** Visual overview of the Castle of Lanjarón: (a) aerial view of the castle looking west [13]; (b) view of the castle from the south showing the barbican and keep; (c) view of the inner enclosure from the entrance under the keep; (d) view showing the long west wall.

The Castle of Lanjarón (Figure 1a) is a 16th century Christian stronghold that occupies a strategic position upon the southern slopes of the Penibaetic Mountains of the Sierra Nevada adjacent to the town of Lanjarón [10]. It sits atop a steep rocky slope and is, today, composed of two main components that have largely fallen into a state of decay: a keep, on

the southern side of the compound (Figure 1b), and the outer enclosure that surrounds it to the north (Figure 1c). A barbican flanks the entrance to the south, running parallel to the walls of the keep above. In this way, the castle is very characteristic of a stronghold on the Iberian Peninsula from its time: the angled approach created by the barbican and the keep above the entrance echo the influence of the Muslim cultures that occupied the region before [11,12].

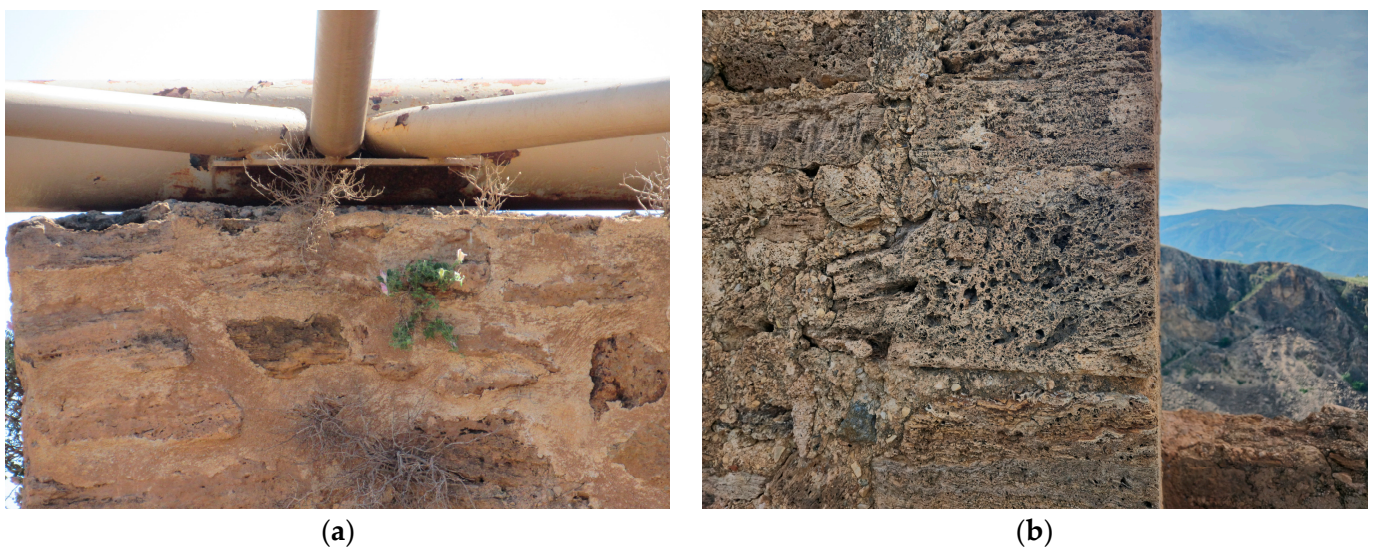
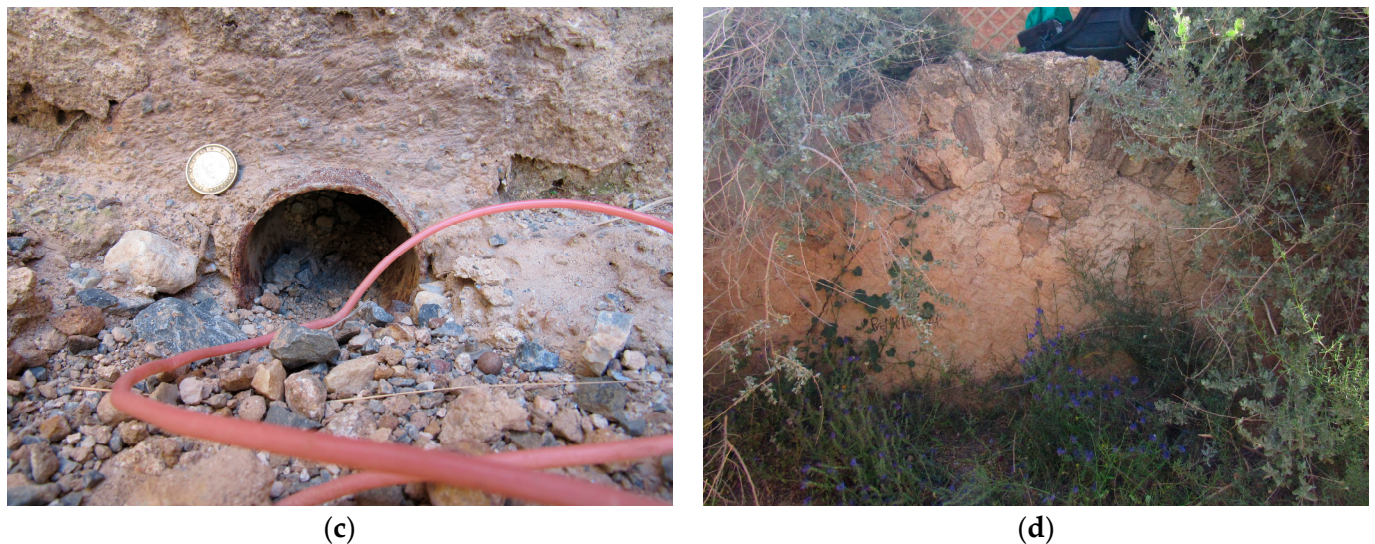
Figure 2. Cont.

**Figure 2.** Current conservation state of the Castle of Lanjarón: (a) state of metallic elements in the castle; (b) alveolized limestone ashlar; (c) blocked drainage tube; (d) significant plant growth on structural elements hides a masonry arch.

Even with the recency of the intervention in 2007, the conditions of many of the elements continue to decline. Much of the paint on the metal elements has chipped or been removed, exposing these elements to decay. Many of the limestone masonry units have been heavily exposed to alveolization. Two drainage tubes are present to remove water and could easily become blocked. Significant plant growth threatens the state of the masonry slowly. For an asset of significant cultural interest such as the Castle of Lanjarón, the main elements and materials of a site are often fragile and of significant value in their current state. Figure 2 demonstrates some of these damages.

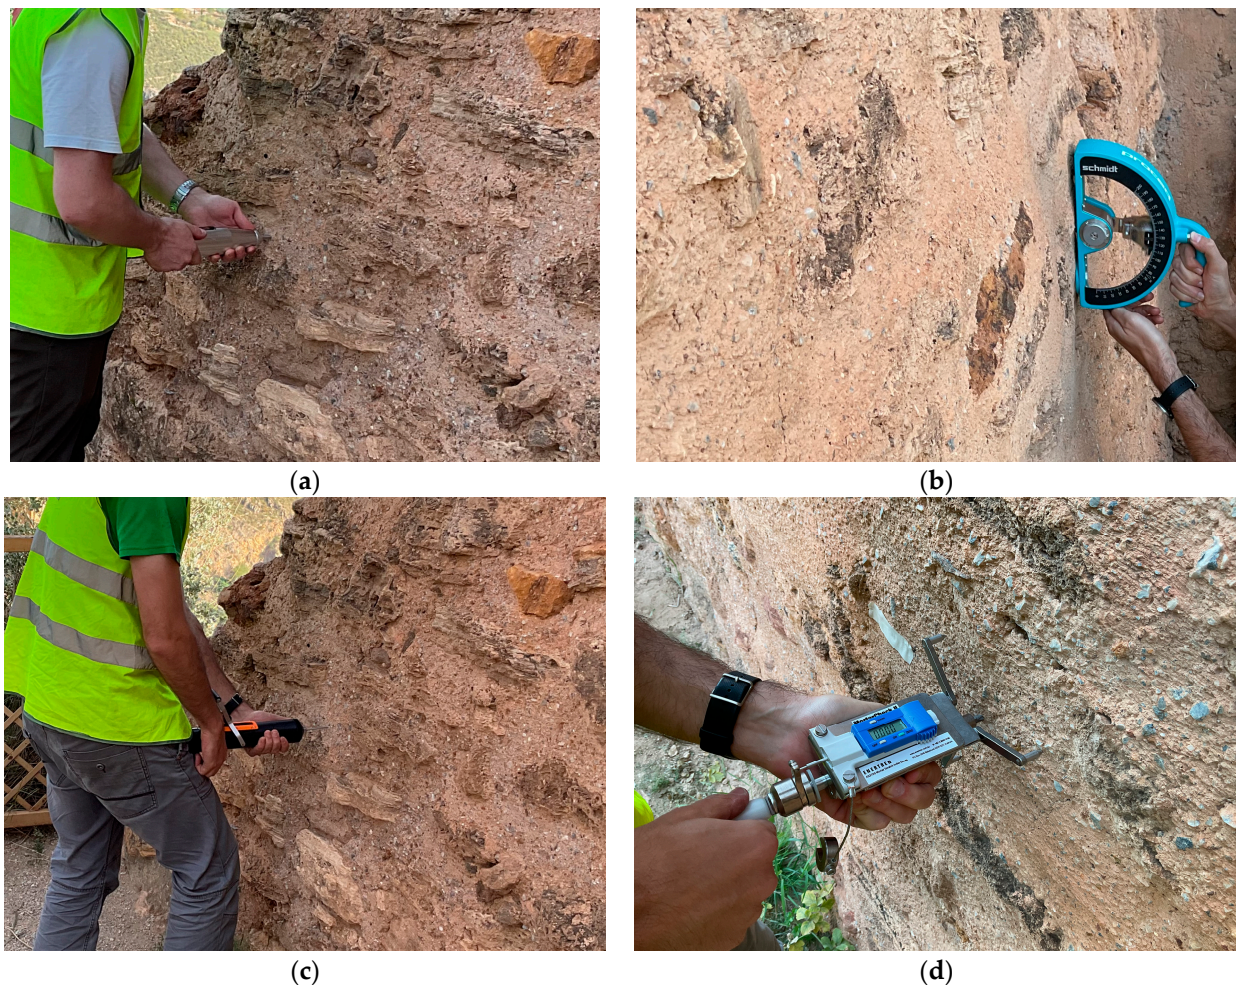
**Figure 3.** (a) Schmidt hammer; (b) Schmidt pendulum hammer; (c) penetrometer; (d) scratch test instrument.

To quantitatively assess the compressive strength of the mortar of the castle, a Schmidt hammer (PASI SRL Type M) with an impact energy of 0.169 Nm was used (Figure 3a). Using this apparatus, a spring-loaded mass is propelled to impact the surface of a mortar three times in succession before measuring the rebound number. The resulting value was then converted to compressive strength using the operation instructions [20]. Each location was tested in accordance with common application methods from the EN Eurocodes for the application of a Schmidt hammer [21].

An alternative to the Schmidt hammer that uses similar principles is the Schmidt pendulum hammer, which instead uses gravity to swing a pendulum and impact a surface to return a rebound number measurement (Figure 3b). This process was performed using the ‘measuring’ instructions outlined in the device’s guidelines for vertical surfaces [22]. The hammer was placed upon the surface of the mortar with the head facing downwards as vertically as possible using light pressure, and the head was raised into the loaded position. When well positioned, this allows the head to fall and impact the surface, rebounding and returning an analog measurement that can then be used to qualitatively assess the mortar from the operation manual.

With the advantage of not being as restricted by the required available surface area of the Schmidt hammer tests, a penetrometer (Diagnostic Research Company SRL RSM-15) was also used to quantitatively evaluate the compressive strength of mortar (Figure 3c). The device is based on the same principles as the Schmidt hammer, using an impact-driven accelerated mass to drive a small needle into a mortar. It is considered non-destructive. The ‘Type-A—Fast’ procedure from the user manual was followed, in which ten consecutive blows from the device drove the needle perpendicularly into the mortar. The needle was then removed, and the depth of penetration was measured. The resulting depth can be converted into a compressive strength value [23].

A scratch test instrument (Enertren Pty. Ltd. MortarCheck II) was used for further onsite evaluation of the mortar condition and strength (Figure 3d) [24]. The device was placed upon a flat surface of mortar, and properly oriented by placing its legs on the surrounding wall. The abrasive probe was then lowered onto the surface with the spacer still attached and zeroed accordingly. The device was locked into place, the spacer was removed, and the force of the spring drove the probe into the mortar as the yoke was turned using two full rotations. Care was taken not to apply additional pressure to the probe while supporting the legs, and the resulting reading (in inches) was used to qualitatively evaluate the mortar scratch index.
