# Seismic Damage Assessment of Minarets: Insights from the 6 February 2023 Kahramanmaraş Earthquakes, Türkiye

**Keywords:** 2023 Kahramanmaraş (Türkiye) earthquakes; masonry; four-legged minaret; modal analysis; nonlinear time history analysis; structural damage

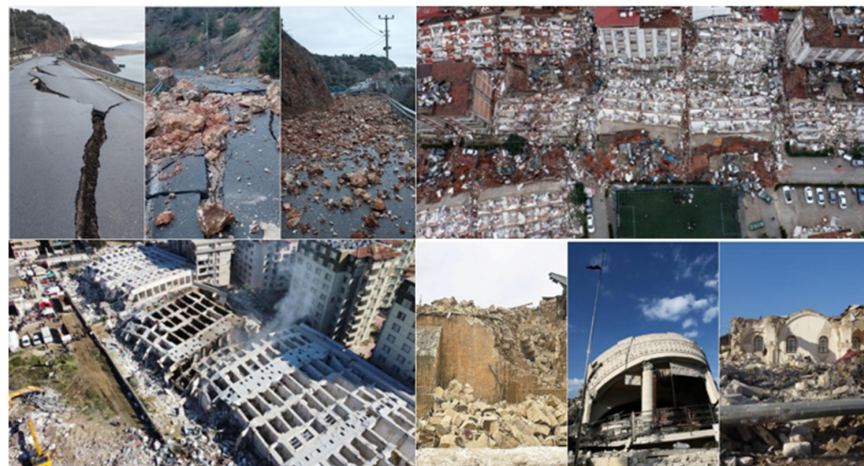
**Figure 4.** Examples of the widespread destruction caused by the 2023 earthquakes in the region, including surface ruptures, landslides, and the collapse of residential, historical, and public buildings [7].

vironment, Urbanization, and Climate Change [6], 36,932 buildings in the region collapsed during the earthquakes. At the end of 8 months, 311,000 buildings became unusable due to the damage they received. Examples of the widespread destruction caused by the 2023 earthquakes in the region, including surface ruptures, landslides, and the collapse of residential, historical, and public buildings, are given in Figure 4. Among them, many masonry buildings were destroyed and damaged. Figure 5 shows some of the collapsed and damaged historical buildings in the 11 districts affected by the earthquakes.

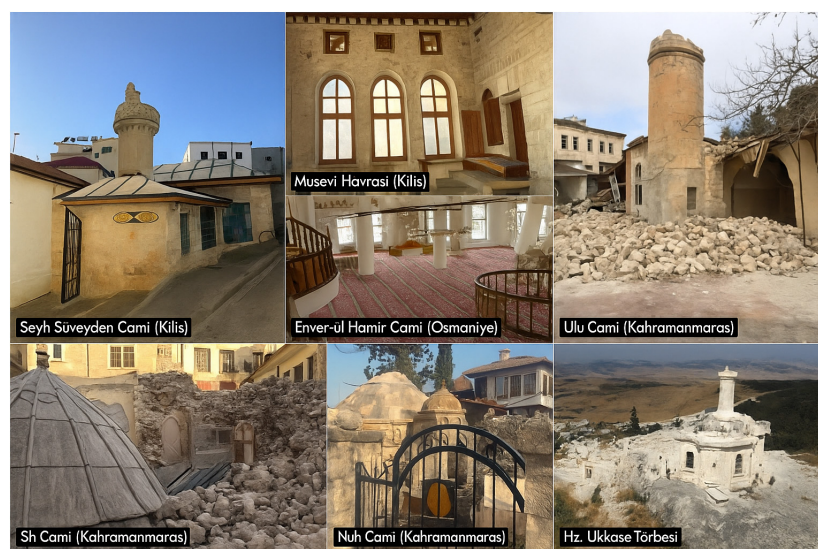
**Figure 5.** Examples of historical buildings damaged or destroyed in the 11 provinces impacted by the 6 February 2023 Kahramanmaraş earthquakes [8].

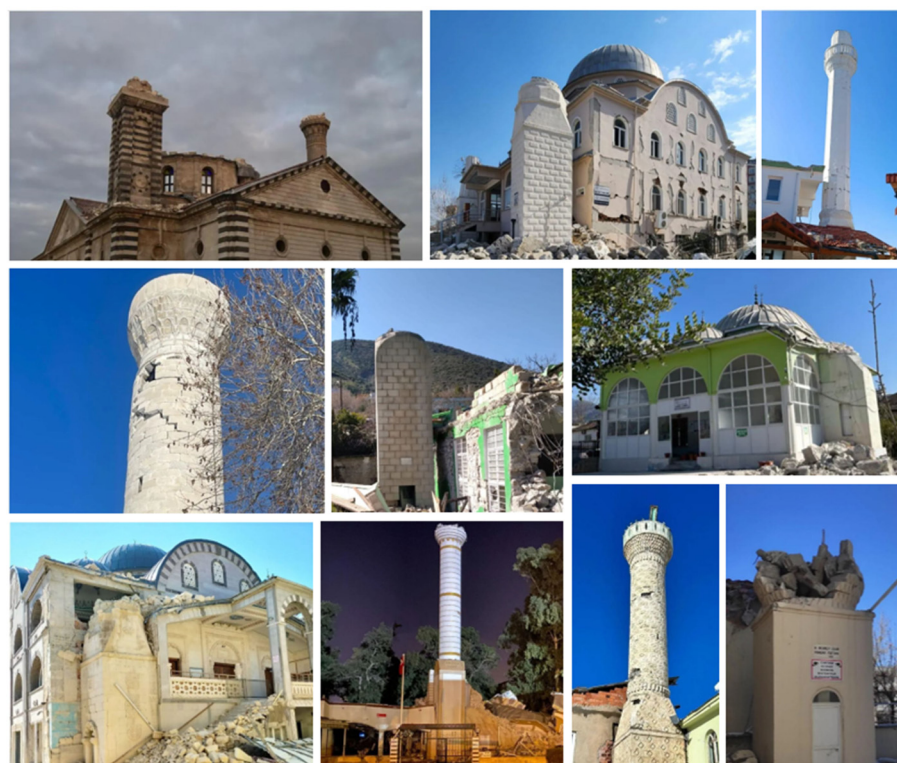
**Figure 6.** Examples of minarets damaged in the 2023 Türkiye earthquakes [28].
