LUIZ BANDEIRA BRIDGE: ASSESSMENT OF A HISTORICAL RC BRIDGE

Abstract (100-200 words):

Keywords: RC bridge; Assessment; Material characterization; Mechanical characterization; Inspection; Dynamic Analysis; Safety analysis;

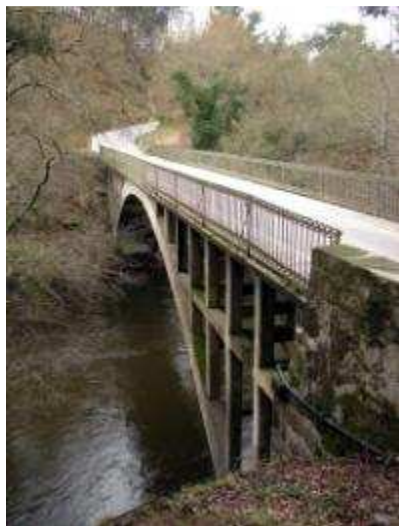
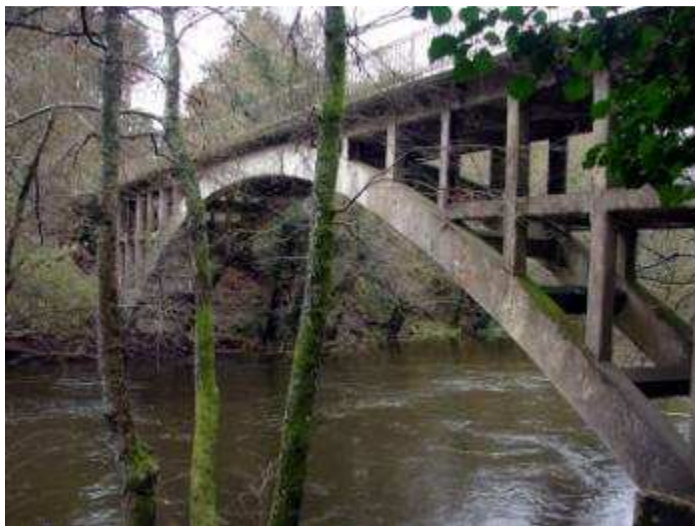
Fig. 3: Views of the Luiz Bandeira Bridge revealing its current state.

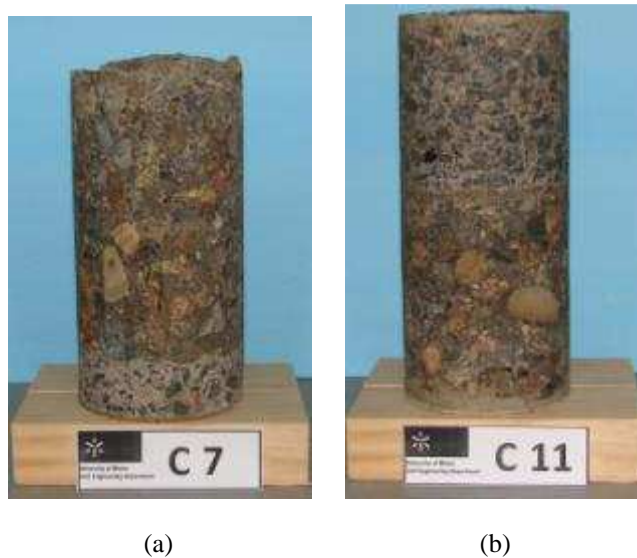
Fig. 6: Concrete cores taken from bridge. (a) C7 – transversal beam, (b) C11 – bridge deck.

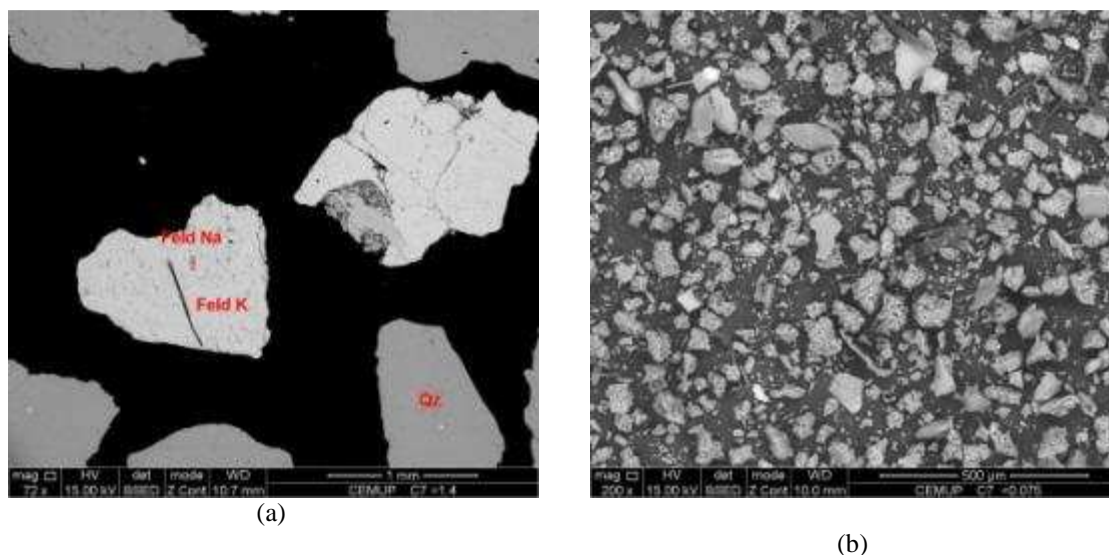
Fig. 7: SEM images of sample C7 - (a) fraction > 1.4 mm, (b) fraction < 0.075 mm

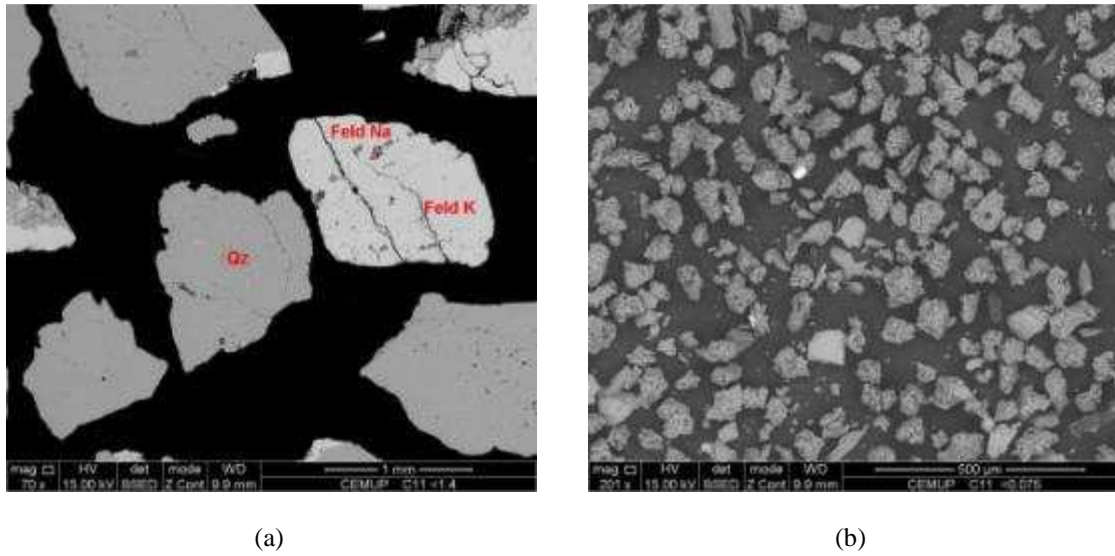
Fig. 8: SEM images of sample C11 - (a) fraction > 1.4 mm, (b) fraction < 0.075 mm

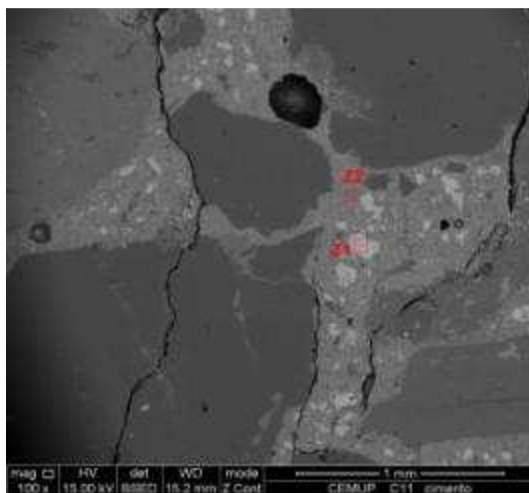
Both samples show similar chemical composition. **Fig. 10** shows a SEM image in which two main phases in the binders have been identified: tri-calcium silicate (Z1) and bi-calcium silicate (Z2).

Fig. 10: SEM image with atomic contrast showing microstructure of the mortar. Two binder phases has been identified: tri-calcium silicate (Z1) and bi-calcium silicate (Z2)

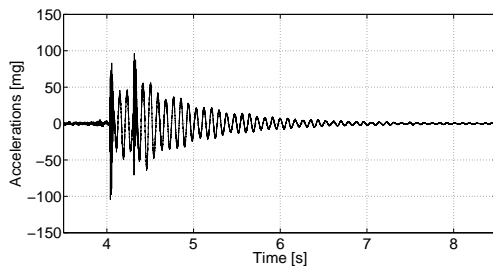
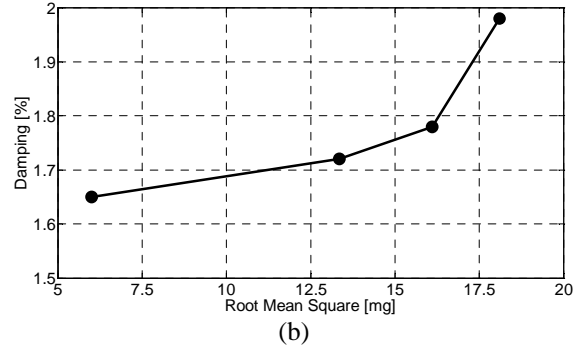
Fig. 24a presents the time domain response in the vertical direction of the bridge for the case of 40 km/h. It is possible to see the two impulses induced by the vehicle. The damping was estimated by taking the transient response after the last impulse. It should be stressed that the bump tests excited very well the second vertical mode at around 11.30 Hz.

The estimated damping results are presented in **Table 7**, together with the velocity and root mean square (RMS) of the signals. **Fig. 24b** shows the damping variation according to the excitation level by means of the RMS of the signal. The damping values range between 1.65 and 1.98% and varies according to the level of

Fig. 24: Damping estimation: (a) transient response of the bridge when the vehicle passed with 40 km/h over the bump; and (b) the damping variation according with excitation level

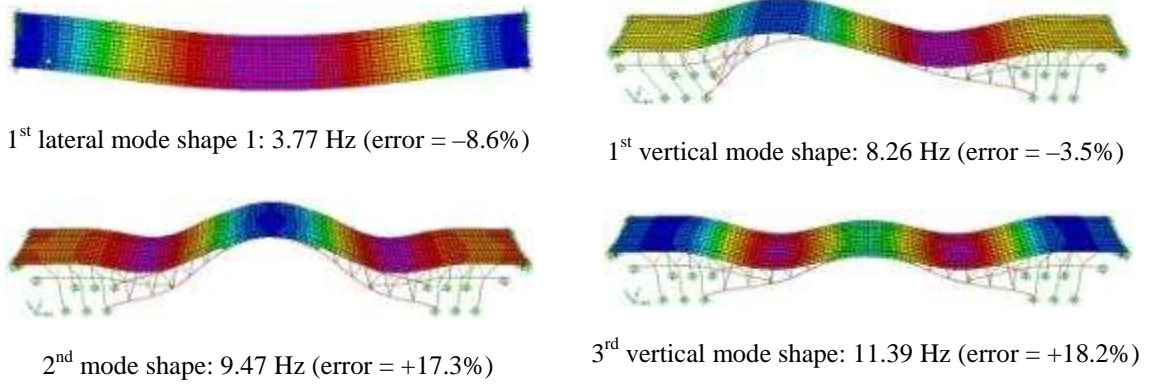
Fig. 25 presents the tune model for the first horizontal mode shape and the first three vertical mode shapes. The relative error for the frequencies values are computed by taking the results from the SSI presented in **Table 6** as reference. As it can be seen, although the mode shape configuration are close to the experimental ones, only the first and the second mode have relative frequency errors lower than 10%, indicating that further optimization analysis is necessary to tune frequencies. Since the numerical mode shape configuration were similar to the estimated and the structure exhibits a high complexity, the results from the calibration analysis were considered acceptable for the safety analysis.

Fig. 25: First four numerical mode shapes (frequency errors are related to the SSI estimation values)

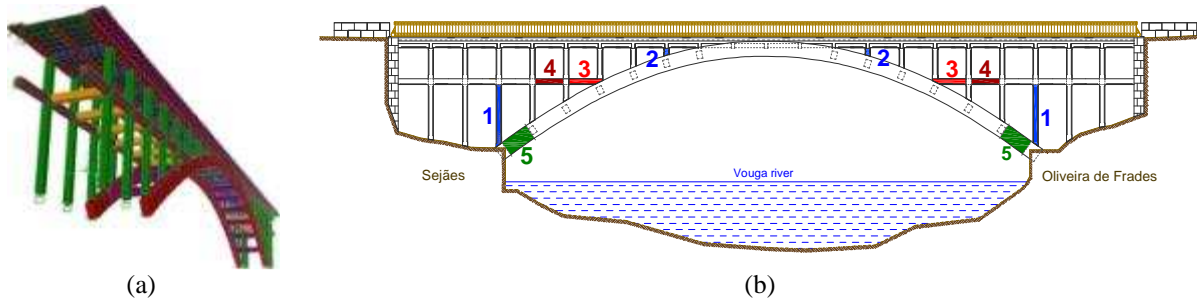
Using the calibrated model described in the previous section safety analysis of the bridge was performed following the recommendations of the R.S.A. (1983), NP EN 1990:2009 e NP EN 1991-1-1:2009 and NP EN 1992-1-1:2010 standards. **Fig. 26** includes the structural model adopted for the safety analysis, as well as the structural components studied. The analysis indicated that these elements verify the strength ultimate limit state.

(a) (b)
Fig. 26: (a) Structural model adopted for the safety analysis; (b) Structural components analyzed
