Analysis and restoration of ancient masonry structures

Guidelines and Examples

PAULO B. LOURENÇO

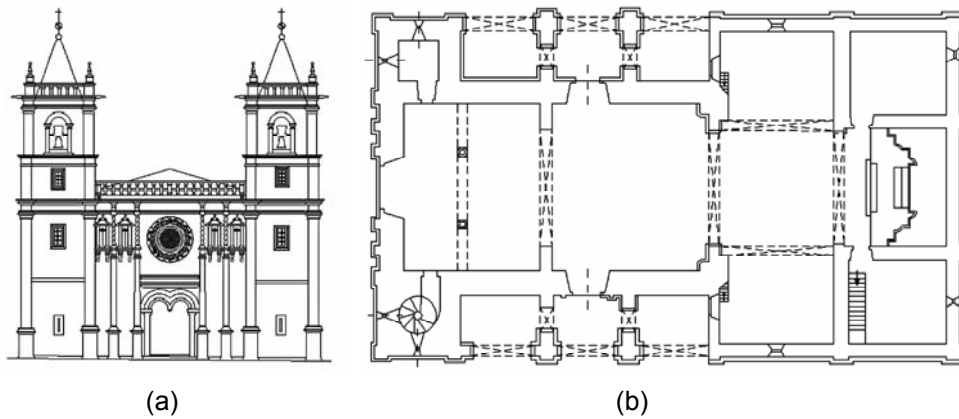
The structure is of moderate size ($38 \times 22 \text{ m}^2$ for the plan view, 13 m height for the nave and 22 m height for the towers), see Figure 2. The façade is a piece of large architectural value due to the false twin arch and the cladding in granite. It possesses a large opening and a balustrade that connects the towers. The side view shows framed galleries, forming three chapels. The interior of the church has a single nave (Latin cross) with crossed vaults, split in three parts by two arches. The arches are supported by the side walls and the transversal walls that divide the chapels, acting as buttresses.

Figure 2 - Geometry of Saint Christ church: (a) front view and (b) plan section
