# Experimental investigation of the structural response of adobe buildings to lateral loading before and after the implementation of compatible grout repairs

Rogiros Illampas<sup>1</sup>, Rui A. Silva<sup>2</sup>, Dimos C. Charmpis<sup>3</sup>, Paulo B. Lourenço<sup>4</sup> and Ioannis Ioannou<sup>5</sup>

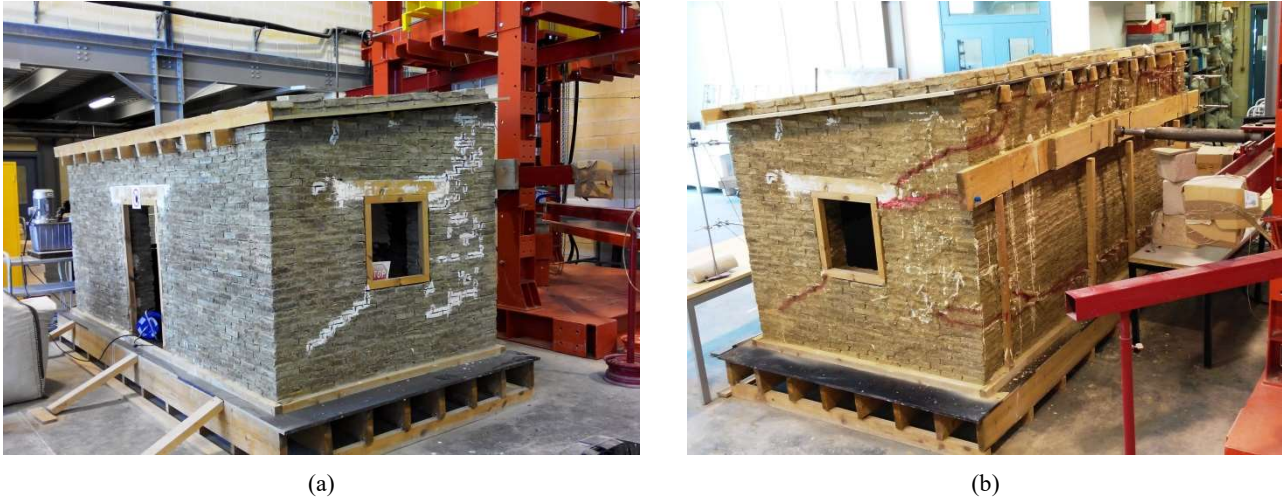
**Figure 1.** Front (a) and rear (b) views of the tested scaled adobe building. In the rear view of the structure, the load imposition timber beam and the hydraulic jack used for exerting horizontal forces are shown.
