Architectural heritage of the north eastern Portugal: History, construction and valorisation

L. Martins, G. Vasconcelos & P.B. Lourenço

Department of Civil Engineering, University of Minho, Portugal

ABSTRACT: This article is based on a study carried out in different small houses located along the margins of the Tua River, in the county of Alijó and Carrazeda de Ansiães, in order to perform a characterization of constructive techniques and materials. It is considered as a constant goal throughout this study the appreciation of natural stone, in this case granite and schist, as construction materials that were used in large scale in this region in the past and continue to be applied in the present, encouraging and valuing its use as a construction material.

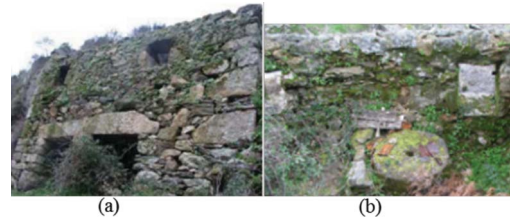
Figure 2. Construction 39 (Mill): (a) North elevation; (b) millstone. Credits: Authors.

The watermills take advantage of the kinetic energy of moving water, whose original function was to grind the cereal grains, turning them into flour. The flow of water moves wooden casters that are attached to a grindstone (see Figure 2).

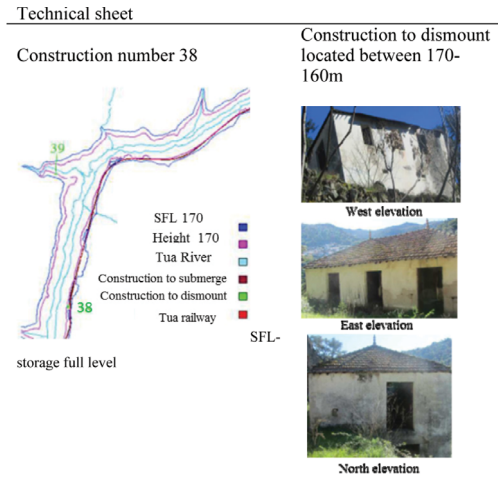
Table 2. Technical data sheet of the selected constructions. Credits: The authors.

Toponym (origin)	Santa Luzia
Coordinates	x 62085.48
	y 179417.52
Datum	73
Altitude	165m
Location	District Bragança
	County Carrazeda de Ansiães
	Civil parish Pombal
	Place Santa Luzia
Typology	House
Conservation	AD
Protection state	Without protection
Owner	Not determined
Patrimonial value	Medium-high
Structures visibility	High
Structures artefacts	Medium-low
Position regarding impactful infrastructure	Direct incidence area
Impactful infrastructure	Dam to a height of 170 +1
Impact evaluation	Submersion due the filling of dam
Access	From Santa Luzia Station.

House with one floor and cellar with rectangular plan. Presents hipped roof, laid by a wooden continuous liner, supported by beams and two triangular wooden trusses. The ground floor has three entrances facing east and in the cellar there exist one entrance in the north facade. Masonry walls with granite blocks of irregular size and shape, with mortar coating (plaster) at the ground floor characterize the structural system. In the cellar, in each of the extremities of the east facade, the plaster has outlined in black ink and the pillars are type Doric. The edges of the lintels are represented in the same way.

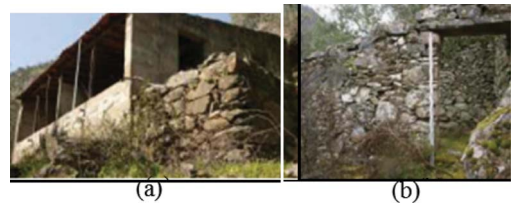
Figure 3. Dwelling houses: (a) house 6; (b) house 55. Credits: Authors.

Housing and/or shelters' constructive typology was also identified. The shelters have a lower layout area. The dwelling houses have a layout area of about 50 m² and a ceiling of approximately 3 m. In Figure 3a, a house of vernacular architecture with single floor and rectangular layout is presented. The house presents roof with marseille tile and lean-to roof east oriented and two entrances north oriented. The house has regular granite masonry with cement mortar. In Figure 3b it is represented one house of vernacular architecture of a single floor with "L" plan view. This house has no roof anymore, which should be a lean-to roof. Two entrances exist oriented at north and one entrance

oriented at south. The masonry walls are built with schist, without mortar in between the stones and with varied irregular stones to reasonably carved stones.

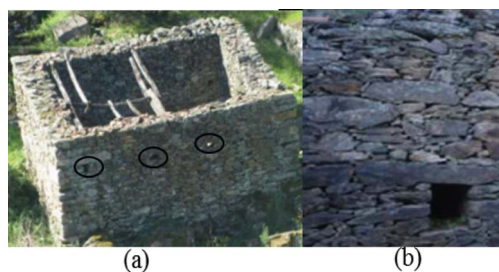
Figure 4. (a) Holes/openings: (a) house 14; (b) house 10. Credits: The authors.

At the corners and wedges of the walls it was observed the presence of carved elements with larger stones, for strengthening these spaces. At the windows and door lintels, as well as, on the side of doors and windows, big stones are applied. This technique aimed at promoting enough resistance to bending stresses at lintels, even if the openings of the windows and doors have reduced size and are made only in places critically needed, see Figure 4.

As the glass was an expensive material, the windows and doors were entirely in wood, allowing only illuminating the space when open. In other situations the openings in the walls are reduced to small holes, whose function was to ventilate and illuminate the space (see Figure 4).

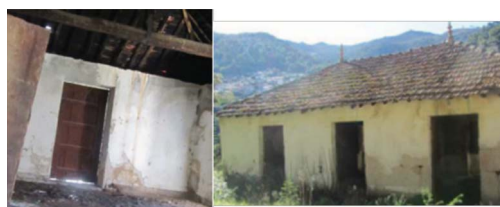
Figure 5. Construction 38 (house) – roof with tile. Credits: Authors.

these beams (wooden beams) and two triangular wooden trusses. It is under this structure that clay tiles are applied with or without bedding mortar (Figure 5). In some cases, simple timber trusses are also applied.

A fundamental element of the roof shown in Figure 5 is the eave, whose function is the routing of the water into a zone spaced from the walls. The roof shown in this figure is a hip roof, but the most common situation identified is a gable roof, which terminates in an eave sufficiently protruding from the outer walls. This technique proves to be effective as the coating below the eaves was found to be in relatively good state of preservation, which is a visible signal that the water does not focus directly on this site, nor runs down the wall.
