Assessment of the Bond Quality Degradation in FRP-strengthened Masonry using IR Thermography Technique

B. Ghiassi¹, S.M. Silva², D.V. Oliveira³, P.B. Lourenço⁴, L. Bragança⁵

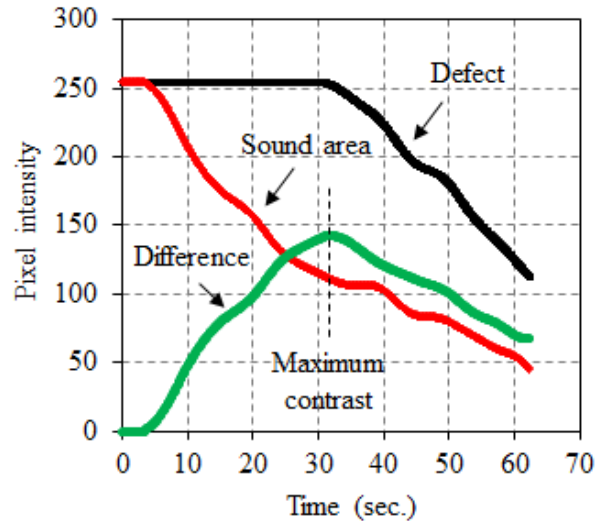
An as example, the time history curve of a sound and defected area together with the calculated thermal contrast are shown in Figure 3. The thermogram corresponding to the peak value of the thermal contrast curve is selected as the most suitable one for quantitatively assessment of the defect.

Figure 3: Thermal history curve of a sound and delaminated area.

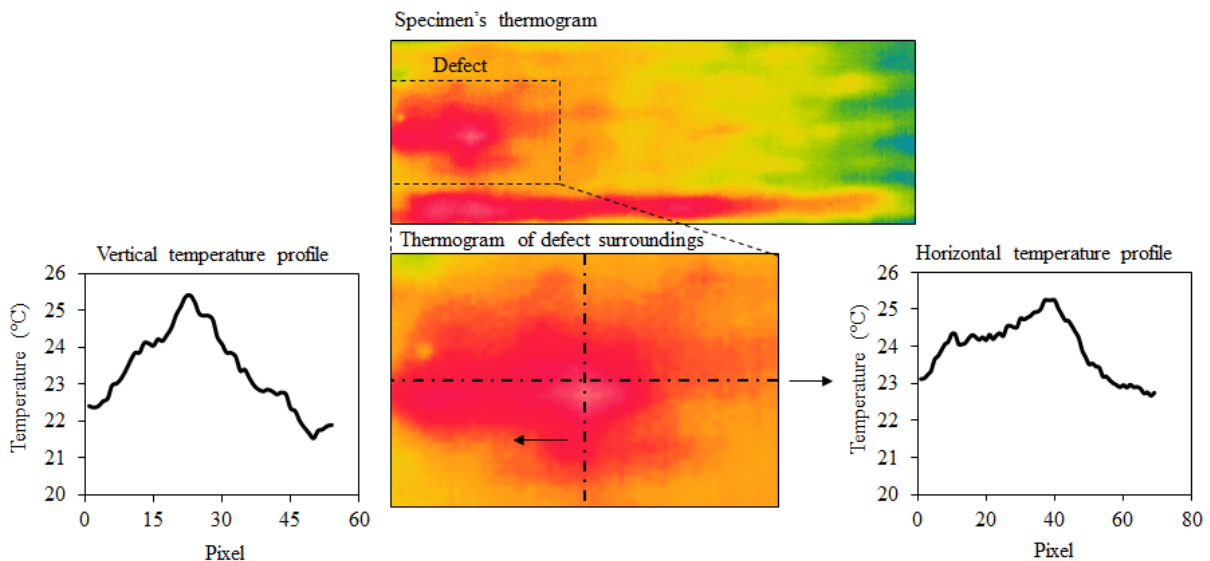
Figure 4 shows the longitudinal and vertical temperature profiles of a defect in a sample thermogram. The defect can be recognized as the hot spot observed in the thermogram and temperature profiles. Once the temperature profile is obtained, it can be divided into two parts from its center point as shown in Figure 5. Each part can be estimated with a 4th order polynomial curve. Two times differentiating the obtained polynomial gives the inflection point which is assumed to be the respective defect boundary. Therefore, the total length of the defect along the section under investigation is the distance between the two calculated boundaries. Following this procedure in different sections and directions, the shape and size of the defect can be obtained.

Figure 4: Thermogram of a defect.

In this method, it is assumed that the boundaries of a defect are the inflection points of a 4th order polynomial curve which has been fitted through the temperature profile along the defect [5].

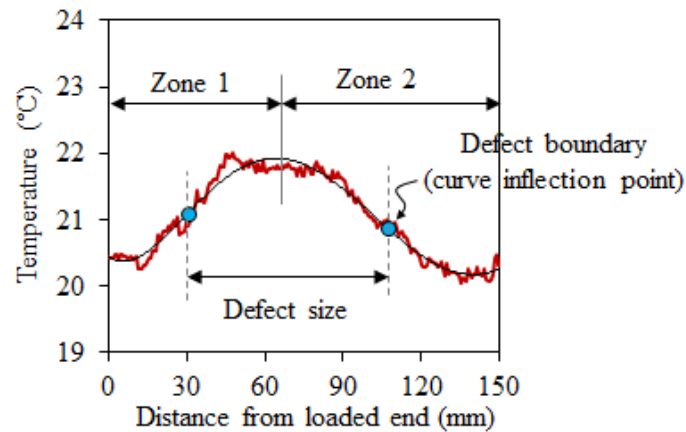
Figure 5: Defect boundaries identification.

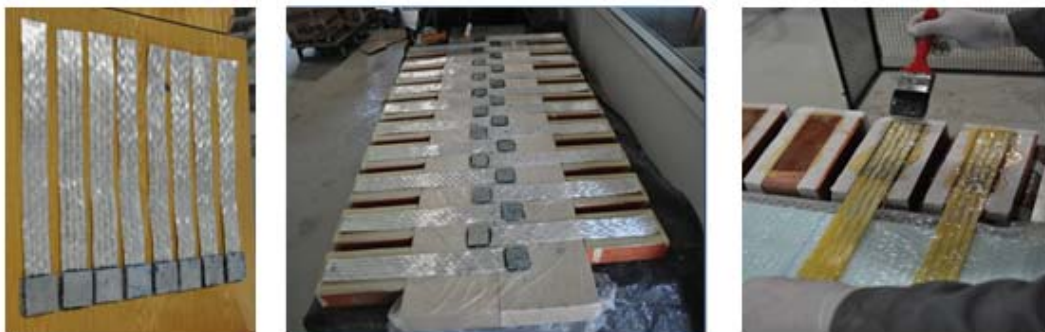
GFRP-strengthened brick specimens were prepared for performing the durability tests. GFRP sheets with 50 mm width were applied to the brick surface following the wet lay-up procedure, see Figure 6. The masonry bricks were dried in the oven before application of the GFRP sheets. After cleaning the brick surface, a two-part epoxy primer was applied to the brick surface for preparation of the substrate surface before GFRP application. Finally, a two-part epoxy resin was used as the matrix of the composite material and also for adhesion to the masonry substrate. [11]

Figure 6: Specimens preparation.

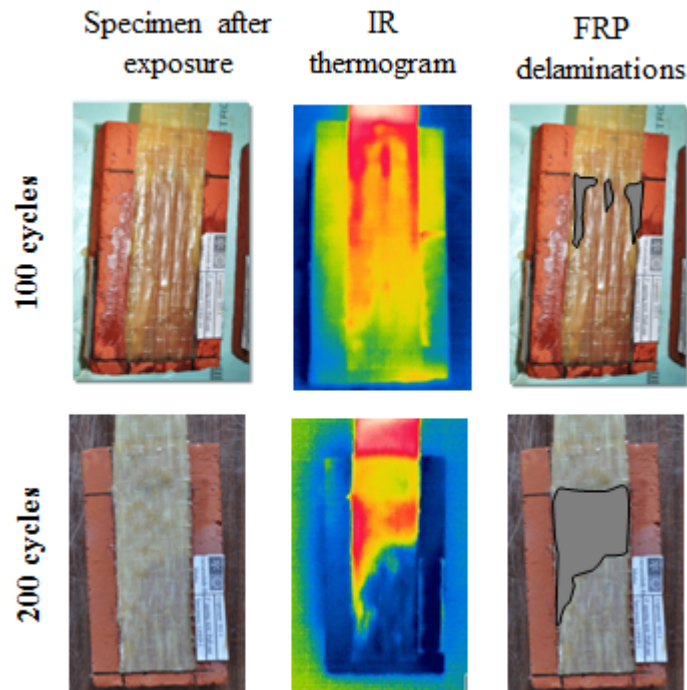
Figure 10: FRP delaminations in specimens after exposure to environmental conditions.

Figure 10 shows one representative specimen after exposure to 100 and 200 cycles of environmental conditions. The corresponding thermogram of the specimens at the maximum thermal contrast is also presented in this figure. The FRP delaminated areas have been highlighted according to the visual inspection and IR thermography analysis results.

Visual inspection and IR thermography tests showed that some FRP detachments have occurred in the specimens after exposure to accelerated hygrothermal conditions. Moreover, it was observed that the size of the detached areas increased progressively with increment of exposure cycles, see Figure 10. This progressive delamination of FRP from the masonry surface can be attributed to the thermal incompatibility problem which should be studied more extensively.

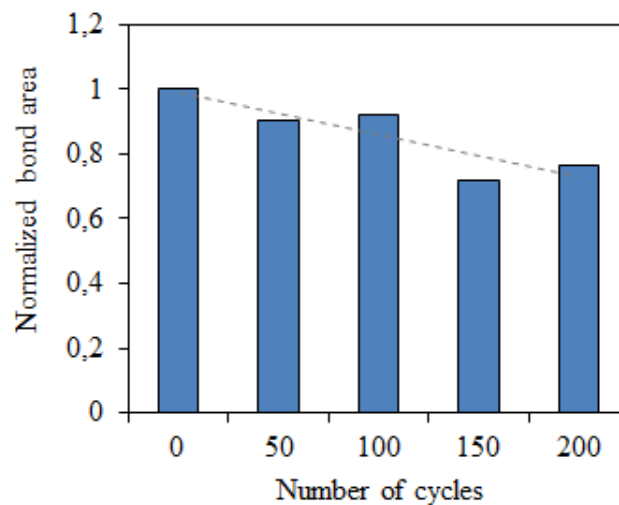
For quantitative analysis of the defects, the temperature profiles have been obtained along the bonded length at different longitudinal and transverse sections. Then, the temperature profiles near the detached areas were fitted with a 4th order polynomial curve as described in sec. 2.1. The inflection point of the estimated curve was selected as the boundary of the FRP delamination. This process has been done for five specimens at each period of exposure and the remaining bonded area in each specimen has been calculated. The results are presented in Figure 11 as the average of the five inspected specimens. This figure presents the remaining bonded area of the specimens in each period of exposure normalized to the initial bonded area. As an example, the value of 0.7 in the specimens exposed to 150 cycles of environmental conditions means that 30% of the initial bonded area has been delaminated at this stage of exposure.

Figure 11: Reduction of the bonded area due to hygrothermal exposure.
