DEVELOPMENT OF HYBRID COMPOSITE PLATE (HCP) FOR THE REPAIR AND STRENGTHENING OF RC ELEMENTS

Esmaeel Esmaeeli, Joaquim A.O. Barros, Hadi Baghi and José Sena-Cruz

ISISE, Dept. of Civil Engineering, University of Minho, Guimarães, Portugal

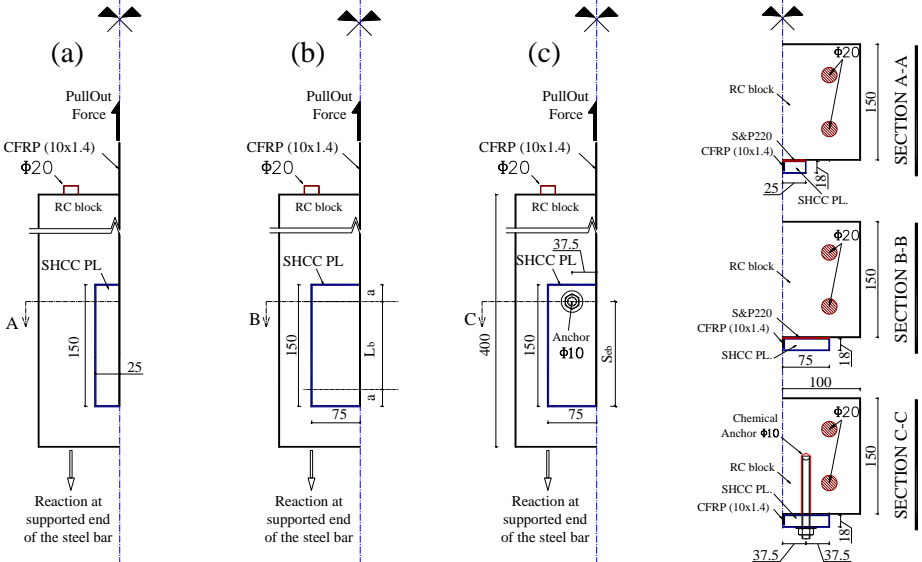
Figure 2 : Idealized test setup and details of the specimens for the pull tests (“ L_b ” is the bonded length of CFRP laminate into the groove of SHCC and “ a ” is the unbonded part; $f'_c = 38.2 \text{ MPa}$).

To assess the potential retrofitting capacity of this prefabricated panel, pullout tests on HCP^(L) attached to RC blocks were executed. These RC blocks were fixed to a steel frame at their bottom face by constraining their longitudinal steel bars. Three sets of specimens were tested, by differing on their attaching configuration to the RC block. Details of these specimens along with the idealized test setups are shown in Figure 2.

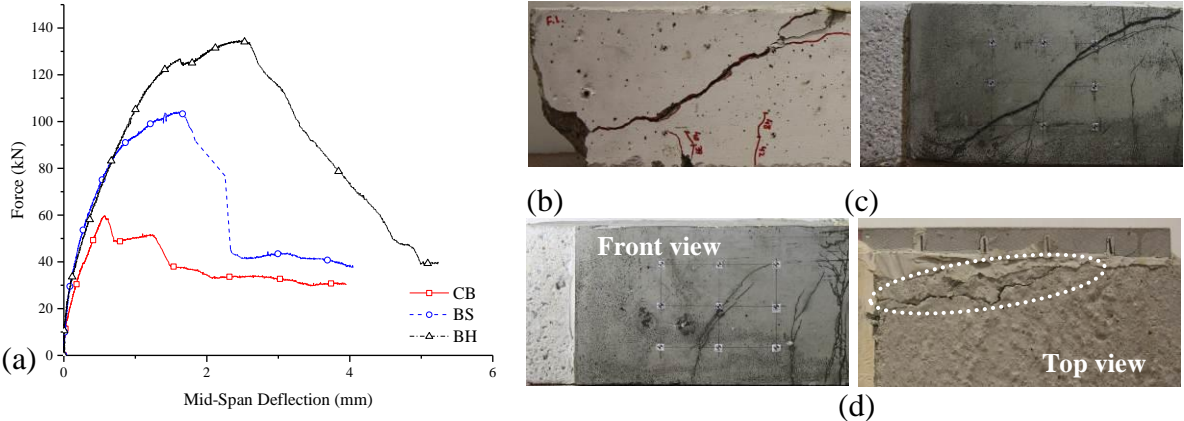
Figure 5 : Results of three-point bending tests with RC beams (a) load *versus* mid-span deflection, failure of compressive strut in (b) “CB” and (c) “BS”, and (d) lateral concrete cover detachment in “BH”

strengthened with SHCC plates and HCP^(L)s attached to their lateral faces. Details of these strengthening schemes along with designations attributed to each of these beams are shown in Figure 4. The obtained results in terms of load *versus* mid-span deflection relationship are presented in Figure 5a. In comparison to the maximum load carrying capacity of the reference beam (CB), the SHCC plates bonded to the lateral faces of the beam (BS) provided an increase of 74%. This increase was 126% in the BH beam where HCP^(L)s were used. The CB and BS beams presented a diagonal-tension failure of the compressive strut formed between the loading point and the left support (Figure 5b and Figure 5c), while the BH beam failed by the detachment of the concrete cover of the lateral faces of the beam that was maintained bonded to the HCP^(L) (Figure 5d).

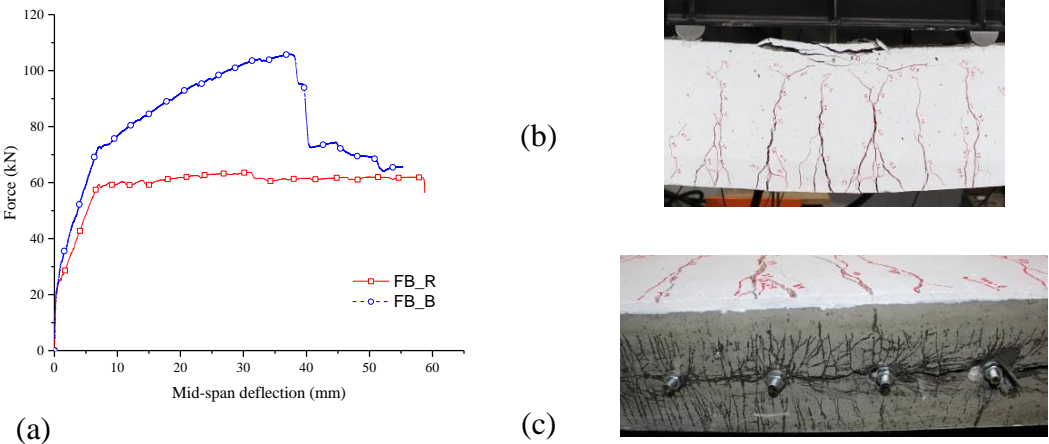
Figure 7 : Results of four-point bending tests (a) load versus mid-span deflection, (b) crushing of concrete of the reference beam (FB_R) and (c) splitting crack along the anchors in strengthened beam (FB_B).

Test results of these beams in terms of load *versus* mid-span deflection are presented in Figure 7a. The strengthening technique assured an increment of 66% in terms of maximum load carrying capacity and an increase of 23% of the load carrying capacity corresponding to the yield initiation of the longitudinal steel bars. Although the strengthening technique did not alter the deflection corresponding to the yield initiation of the steel rebars, there was no visible crack on the surface of HCP^(L) up to 10 mm of deflection, which corresponds to serviceability limit state. In fact, macro-cracks formed in the RC beams were transformed in a diffuse micro-crack pattern at the corresponding region on the HCP^(L). Failure mode and crack pattern of each of the beams at the end of their tests are shown in Figure 7b and Figure 7c. According to these figures yielding of longitudinal rebars followed by compressive failure of concrete was the dominant failure of FB_R. For the case of FB_B, after yielding of longitudinal steel a splitting crack in the alignment of the anchors was formed.

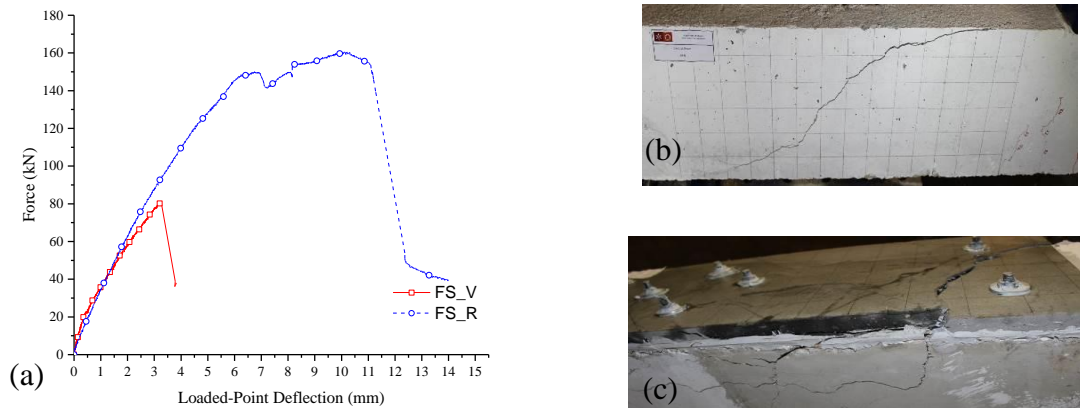
Figure 9 : Results of three-point bending tests (a) load *versus* loaded-point deflection, (b) shear failure of the virgin specimen (FS_V), (c) lateral concrete cover detachment (FS_R)

A repairing scheme based on attaching HCP^(L)s to the lateral faces of a shear-damaged RC beam was investigated. The virgin beam (FS_V) was subjected to a three point bending test, and after failing in shear was unloaded. Two HCP^(L)s were then attached to its lateral faces in the damaged region using a combination of epoxy adhesive and through bolts. The repaired beam, designated as FS_R, was subjected to the same test configuration adopted in its virgin state. Details of the beam, test setup and repairing scheme are shown in Figure 8. The load *versus* loaded-point deflection relationships for the virgin and repaired state are presented in Figure 9a. According to this figure the adopted repairing strategy provided an increase of 99% in terms of maximum load carrying capacity. This strengthening scheme has contributed for the recovering of 62% of the initial stiffness (measured as the slope of the initial linear portion of the load-deflection curves) of the beam in its virgin state. Failure modes of both virgin and repaired specimens are shown in Figure 9b and Figure 9c. Lateral concrete cover detachment was the governing failure mode for the repaired specimen.

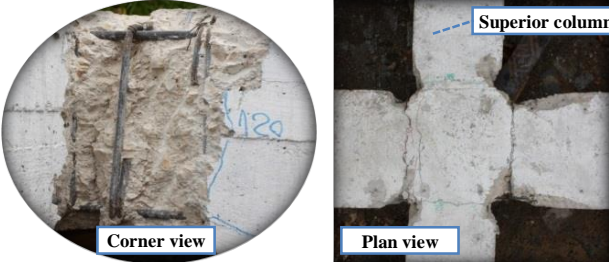
Figure 10 : Level of damage in the prototype before its repairing

elements. The state of the damages in this specimen, before the repair, is illustrated in Figure 10. The damage in the specimen was due to the experimental test performed using a simultaneous constant axial load and cyclic lateral displacement history applied to the top of the superior column when it was in virgin state. Pre-seismic oriented code practices were used to design this full-scale specimen, therefore only gravity loading considerations were taken into account, and the reinforcement was constituted by plain steel bars. The geometry and the steel reinforcement arrangement of this specimen are presented in Figure 11. Additional details on test setup, loading history, material properties, geometry and steel detailing can be found elsewhere [4].

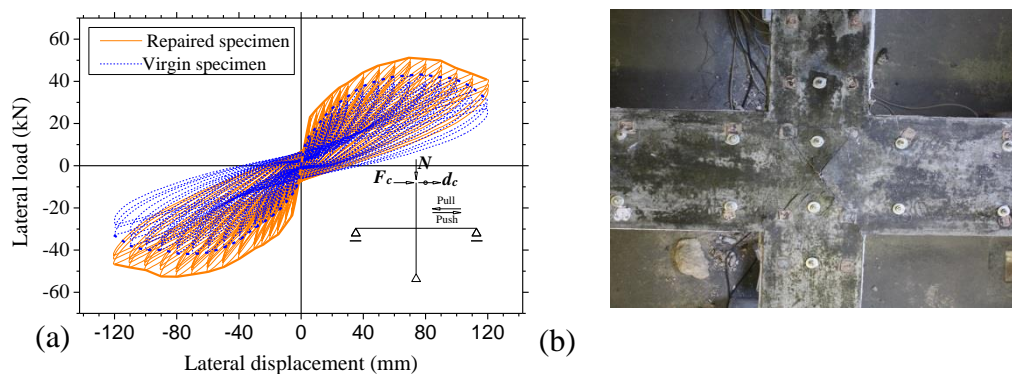
Figure 12 : Results of cyclic tests (a) Hysteretic responses and (b) damage state at the end of the test of repaired specimen

The repaired specimen was tested using the same test setup and loading pattern used when testing it in the virgin state. The hysteresis responses and the corresponding envelope curves for the specimen in the repaired and virgin states are presented in Figure 12a. The idealized test setup is also shown in this figure. According to these results, the repaired specimen presented a superior response with an average increase of 21% in the maximum lateral load carrying capacity (considering the push and pull loading directions). When repaired, the specimen has dissipated more energy (the areas enclosed inside the hysteretic loops) than when in its virgin state. For instance, for a lateral displacement of 120mm (corresponding to a drift of 4%) the repaired specimen has dissipated 23% more energy than its virgin state. The specimen was failed with diagonal cracking and bulging of the HCP^(L) at the joint region (Figure 12b).
