# Durability of FRP-strengthening masonry bricks under hygrothermal conditions

**ABSTRACT:** Nowadays, there is an increasing interest in using fibre reinforced polymers (FRP) for strengthening masonry elements. It has been observed that these materials, when used for externally bonded reinforcement (EBR), improve the performance of masonry components. However, issues such as durability and long-term performance of strengthened elements are still open. The bond between composite material and masonry substrate is a critical mechanism in EBR strengthening techniques, and therefore its durability and long-term performance should be deeply investigated and characterized. In the present study, the influence of hygrothermal conditions (combined effect of moisture and temperature) on the bond performance is investigated by performing single-lap shear bond tests on two sets of GFRP-strengthened specimens. Different surface preparation techniques are used for each set of specimens to study their effects on the bond degradation. The effect of boundary conditions on FRP delamination is also investigated through visual inspection. The results showed surface grinding significantly improves the

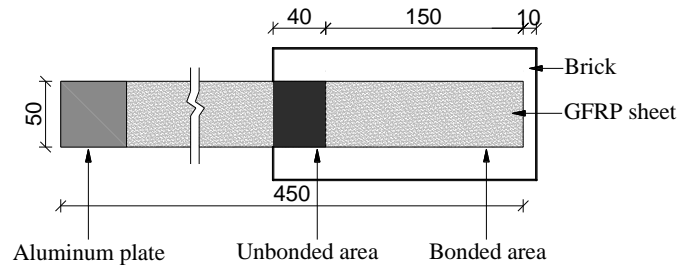
Two sets of specimens were prepared for single-lap shear bond tests to investigate the effect of surface mechanical preparation on durability of the bond between FRP and masonry substrate. The first set was made of bricks with their original condition (denoted as ORG-specimens). In the second set, however, the bricks' surfaces were grinded for about 5 mm with a mechanical saw before application of the GFRP (denoted as GR-specimens). A total number of 70 specimens was prepared for single-lap shear debonding tests. The GFRP sheets were bonded over a 150×50 mm<sup>2</sup> area, leaving a 40 mm unbonded length at the loaded end. The geometrical details of the specimens are shown in Figure 1.

Figure 1. Geometry of the specimens prepared for single-lap shear tests.

Another set of specimens was also prepared for investigating the effect of boundary conditions on FRP delamination. Previous studies have shown that hygrothermal conditions may lead to extensive FRP delamination from the bricks' surfaces in specimens prepared for single-lap shear bond tests (same geometrical details as shown in Figure 1) (Ghiassi et al. 2014, 2015).

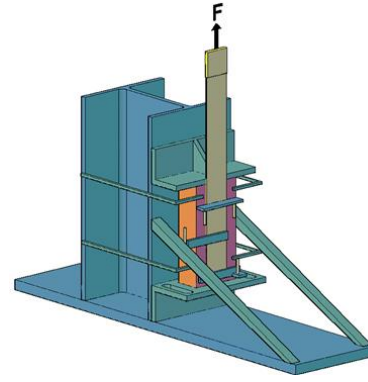
The test setup for single-lap shear debonding tests included a rigid steel frame and one rigid steel support placing on the top of the specimen. The specimens were clamped to the frame firmly to avoid any misalignment during the load application, see Figure 3. The tensile load was applied at a displacement rate of 0.3 mm/min using a closed-loop servo-controlled testing machine. The relative slip between GFRP sheet and brick was monitored by LVDTs.

Figure 3. Schematic of test setups for single-lap shear test.

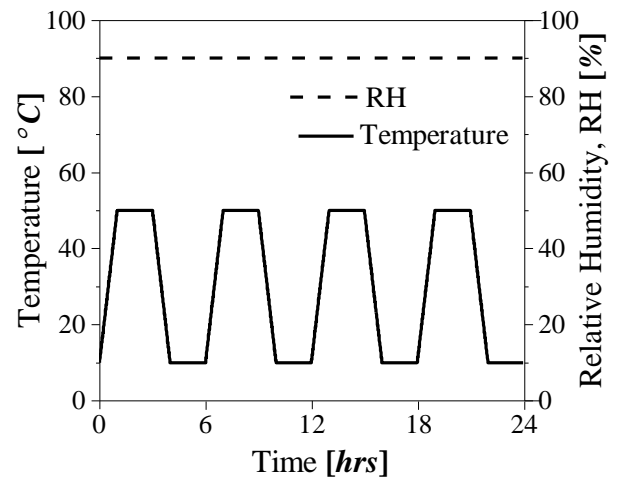
Specimens were exposed to hygrothermal conditions in a climatic chamber after 100 days of curing in laboratory conditions. The exposure included 6-hours temperature cycles ranging from +10°C to +50°C with constant relative humidity of 90%, see figure 4. A drop of relative humidity, inside the climatic chamber, to 60% was observed when the temperature reached +10°C, followed by recovering to 90% after a short period. This is a usual situation and happens due to the complexity of controlling the relative humidity at low temperatures.

Figure 4. Hygrothermal exposure test condition.

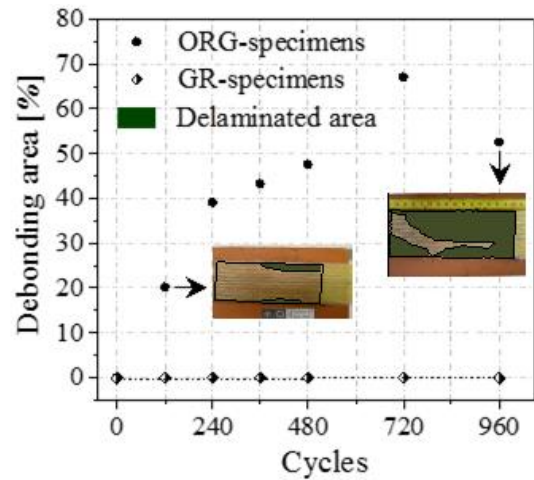
The specimens for single-lap shear tests were also visually inspected before performing the tests. The progression of delamination area in ORG- and GR-specimens is shown in Figure 6. While, the ORG-specimens were progressively delaminated along the tests, no delamination was observed in GR-specimens.

Figure 6. Variation of debonding area in ORG- and GR-specimens.

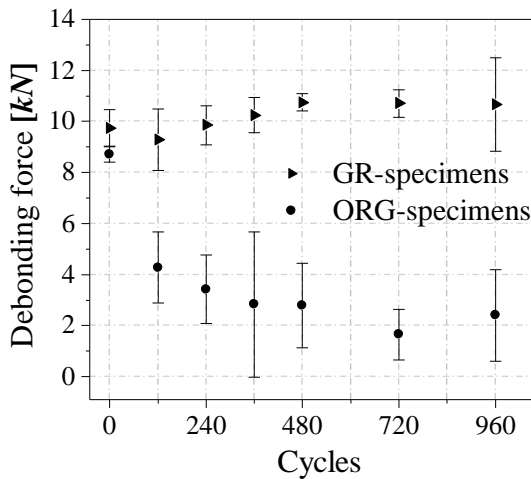
The changes in debonding force in ORG- and GR-specimens are shown in Figure 7. A significant reduction of debonding force was observed in ORG-specimens during the first 120 cycles (about 50%). The degradation in ORG-specimens continued with a lower rate reaching 72% at the end of the exposure. Despite no degradation in the bond performance in GR-specimens, a slight increase was observed in their debonding force. This increment can be due to curing time, post-curing of epoxy resin at the interface level or variability of the specimens. The results show the significant effect of surface treatment on improving the bond performance and durability. The typical failure mode of ORG-specimens before exposure was adhesive failure mode with detachment of a thin layer of a brick. After exposure to hygrothermal conditions, the failure mode changed to adhesive failure mode with detachment at FRP-brick interface. The observed failure mode in unconditioned GR-specimens was cohesive failure mode with the fracture inside the brick substrate and remained the same after the exposure, see Figure 8.

Figure 7. Variation of debonding force in ORG and GR specimens.

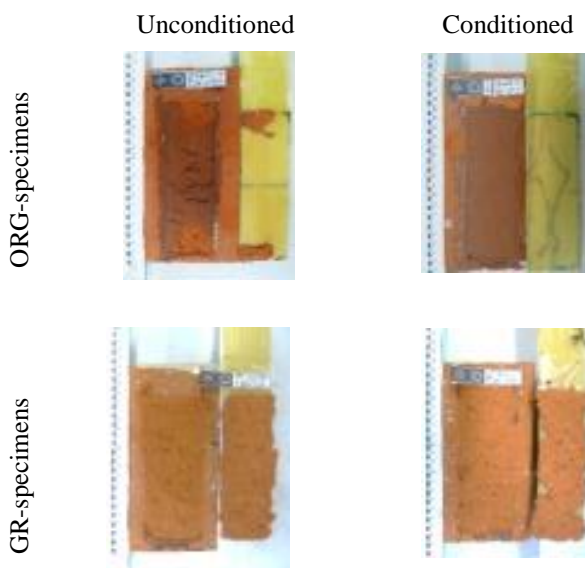
Figure 8. Failure modes before and after exposure.
