ASSESSMENT OF THE INJECTION OF GROUTS TO REPAIR CRACKS IN RAMMED EARTH

**Rui A. Silva ⁽¹⁾, Oriol Domínguez Martínez ⁽²⁾, Daniel V. Oliveira ⁽¹⁾, Eduardo Pereira ⁽¹⁾,
Edgar Soares ⁽¹⁾**

(1) ISISE – University of Minho, Guimarães, Portugal

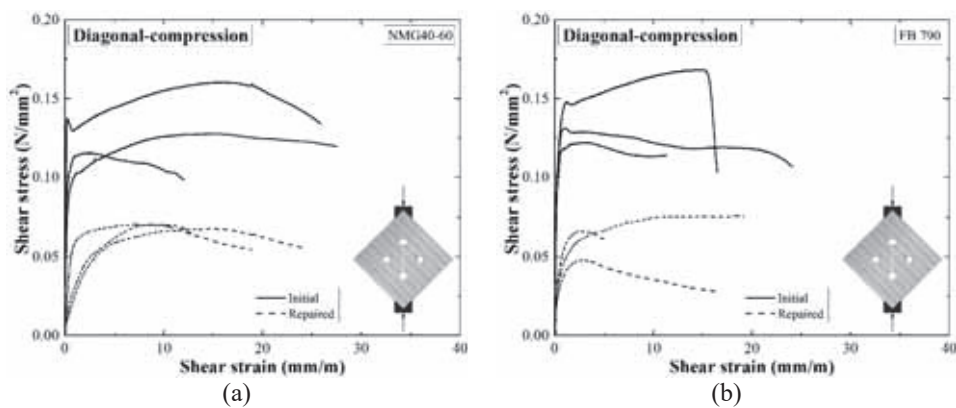
Figure 4. Shear stress-strain curves of the wallets in the first and second tests: (a) grout NMG40-60; (b) grout FB 790.

The wallets injected with the grout NMG40-60 showed shear strength values in the range of 0.05 and 0.08 N/mm² with an average value of 0.06 N/mm², while the wallets injected with FB 790 showed values of about 0.07 N/mm². In average, it was possible to recover about 44% and 51% of the initial shear bearing capacity for grout NMG40-60 and FB790, respectively. Both rates of repair effectiveness are similar, which seems to show that a commercial grout may have similar performance to that of a mud grout. It should be noted that, similar values of repair effectiveness were reported by Silva [13]. Furthermore, it was again observed the incapability of the grout injection in recovering the initial shear stiffness, confirming the inefficiency of this technique in recovering the friction and interlocking effect of the coarse particles, even that a stiffer grout (FB 790) is used. In fact, grout FB 970 presented higher shear stiffness recovery (about 3 times) than that of grout NMG40-60. Still, the values of the shear stiffness after repair are marginal when compared with the initial shear stiffness.

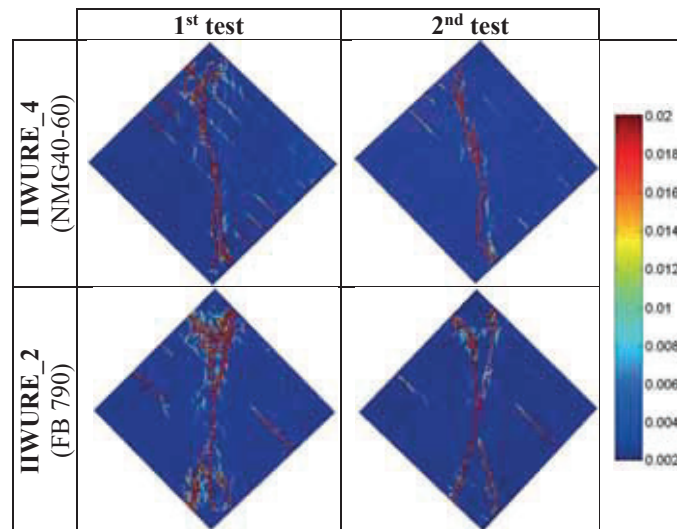
Figure 5. Maximum principal strains (near collapse stage) obtained from DIC analysis for IIWURE_4 and IIWURE_2 in the first and second tests.

Figure 5 presents the maximum principal strains obtained from DIC analysis for wallets IIWURE_4 (grout NMG40-60) and IIWURE_2 (grout FB 790) in the first and second tests. These images were obtained, for each test, in a near collapse stage of the wallets. Despite the DIC analysis being resumed to this stage, it allowed to follow the development of the strain field of the specimens during the tests. In general, the failure of the wallets in the first test is characterized by the formation of a main crack or set of cracks with diagonal orientation that cross the entire specimen. The formation of these cracks occurs suddenly at the middle of

specimens just before the peak load, and then progresses towards the supports. Cracks at the interfaces between layers are also formed, where the interfaces of IIWURE_4 seem to be weaker than those of IIWURE_2. With respect to the second test, the development of the diagonal crack was progressive since the beginning of the test. For all repaired wallets, the development of the main crack seems to occur in some regions coincident with the original crack. This situation occurs do to the fact that the rammed earth is damaged in the region adjacent to the crack and not because any of the grouts present little adhesion capacity. In fact, the inspection of the wallets after testing as shown a good adhesion of both grouts, since failure occurred mostly by the rammed earth.
