Seismic behavior of an old masonry building in Vila Real de Santo António, Portugal

ABSTRACT: Vila Real de Santo António is located in the Algarve region and was erected *ex novo* at the end of the 18th Century, after the 1755 Lisbon earthquake, following a *Pombaline* development that showed seismic concern at an urban and architectural level. However, most of the original constructions have been subjected to continuous alterations or even substituted for new ones. The first building built in the town was the *Alfândega* or Customs House and was selected as a case study because it still preserves most of its original characteristics. It was studied through historical survey, visual inspection and experimental *in-situ* characterization. As a result, a detailed finite element model was constructed and pushover analyses were carried out to assess its seismic vulnerability. The main goals of the paper are to understand the resisting mechanisms and seismic behavior of the building, as well as to evaluate the influence of structural alterations.

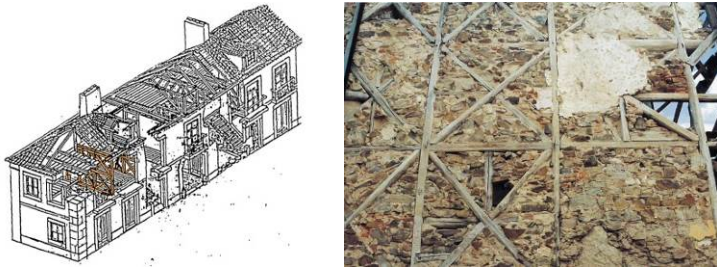
Figure 2. (left) Use of frontal walls in two-story buildings in Vila Real de Santo António (Mascarenhas 1996); (right) *Frontal* wall in Vila Real de Santo António (Figueiras 1999).

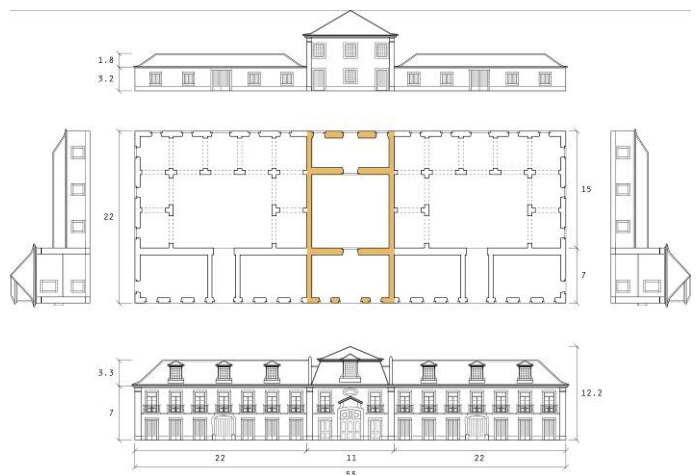
Figure 3. Original plans and elevations of the block. The *Alfândega* building is marked in orange (dimensions in meters).

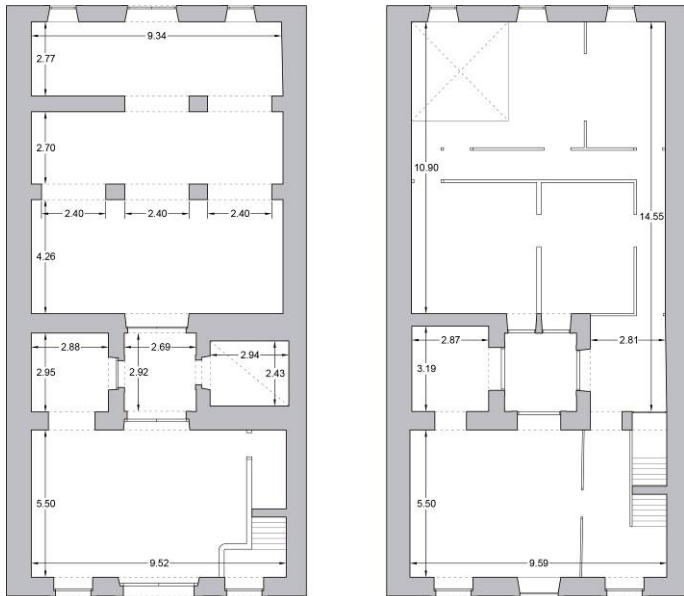
Figure 5. Current plans of the *Alfândega* building (left) Ground floor plan; (right) First floor plan (dimensions in meters).

The architectural survey allowed sketching the current plans of the building that will be used to prepare the numerical model, see Figure 5. The main alteration done in the building has been the occupation of the original patio and the construction of a much smaller courtyard. The building has still two well-differentiated parts. The main façade body is mostly untouched and has two floors and an attic, while the rest of the building is composed only by the ground and the first floor. There are brick masonry arcades at the back part of the ground floor, which are in a good state of conservation (Figure 6). There is also a brick masonry barrel vault covering one of the small

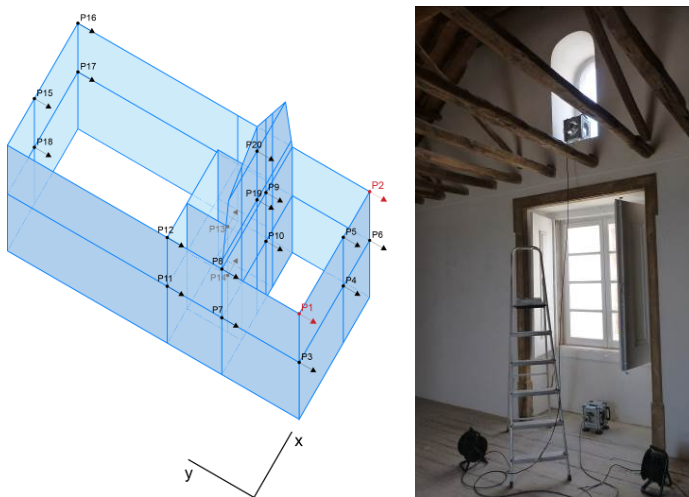
Figure 11. (left) Axonometric scheme of the location of the accelerometers; (right) Sensors.

records were taken in 20 different points within five test setups, the layout of the sensors is shown in Figure 11. Two reference accelerometers were common in all the setups (marked in red in the figure). They were chosen to be placed at the top of the façade wall because the expected mode shapes to be captured mainly involve out-of-plane displacements of the façade and the two parallel walls. Therefore, most of the locations of measurement points are located in upper points of these three walls. Two points were chosen in the perpendicular direction in one of the patio walls, aiming at capturing other unexpected mode shapes.

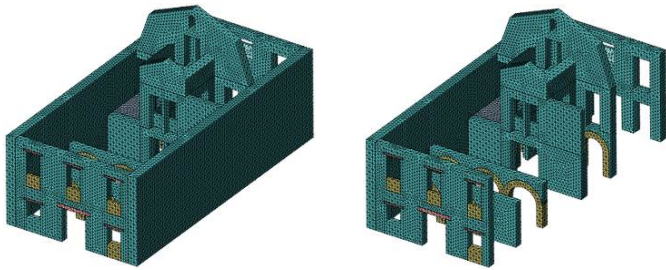
Figure 13. Different views of the first model considered.

The geometry of the reference model was obtained through the architectural survey carried out *in-situ* and available plans of the original *Alfândega* building. The first model was constructed with DIANA software (TNO 2009), using 3D CTE30 ten-node solid tetrahedron elements with a 4-point integration scheme over the volume. The elements have an average side of 0.25 m. Four different materials were considered at the beginning: (a) good quality stone regular masonry for the walls; (b) brick masonry for the arches and ground floor vault; (c) coarse rubble masonry for the infill of the vault, which is assumed to be made by rubble because this is the common practice in historic buildings; and (d) reinforced concrete for some elements of the back wall, since it was partially reconstructed and the presence of RC elements such as lintels was confirmed during the visual inspection. Figure 13 shows the model initially constructed.

The influence of the adjacent buildings that confine the *Alfândega* was initially simulated by constructing the two existing longitudinal walls and restraining their movement in the X direction (Figure 13). Nevertheless, these two longitudinal walls were finally not modeled because of two reasons: (i) the thickness of the walls is unknown; and (ii) the level of connection between perpendicular walls was also unknown and could vary from wall to wall, since, for example, part of the back wall was reconstructed at the connection between the walls (Figure 14). In addition, the modelling of the longitudinal walls involved the addition of many elements which are not very significant in the global structural behavior and highly increased the computing time. The effect of the longitudinal walls was instead simulated by restraining the movement in the X direction at the connections and using one-node translation springs to restrain their movement in the Y direction. Linear elastic springs were also considered because it was assumed that these longitudinal walls were not going to fail in their in-plane direction.

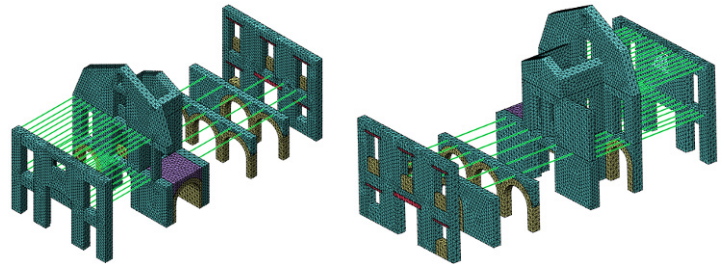
Figure 15. Different views of the final model.

The displacement of all the elements is fully restrained at their base. The final resulting generated mesh has 146,137 nodes and 84,998 elements (see Figure 15). The total mass of the model is 425 tons. A total strain rotating crack model was selected to simulate the nonlinear behavior of all the masonry types. This model follows a smeared approach for the fracture energy and assumes that the crack direction rotates with the principal strain axes (TNO 2009). It has been widely applied to model complex historical masonry structures because it is very well suited for analyses predominantly governed by cracking or crushing of the material. It describes the
