First International Symposium on Risk and Safety of Complex Structures and Components

## Study of historical value mortars

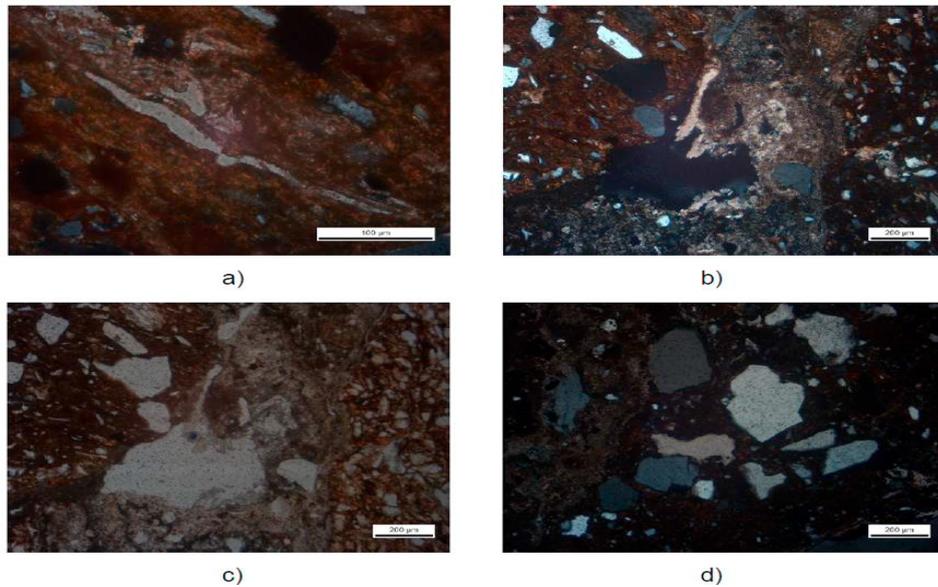
Fig.2 – Petrographic analysis of sample 5.

The sample was collected at a Conimbriga swimming pool, South Baths, sample number 5. It consists of brick and quartz fragments, but also contains traces of muscovite, calcite, and potassium and chalcosodic feldspars. The binder consists of clay minerals and micritic calcite (particle size less than 5  $\mu\text{m}$ ). The brick fragments are essentially made up of quartz, muscovite, tourmaline and calcite. The petrographic analysis may be seen in Fig. 2.

All fragments are angular in shape. The brick binder is made of clay minerals closely associated with micritic calcite and iron hydroxides.
