Typology based Methodology for In situ Testing of Masonry

ADVANCED MASTERS IN STRUCTURAL ANALYSIS
OF MONUMENTS AND HISTORICAL CONSTRUCTIONS

Master's Thesis

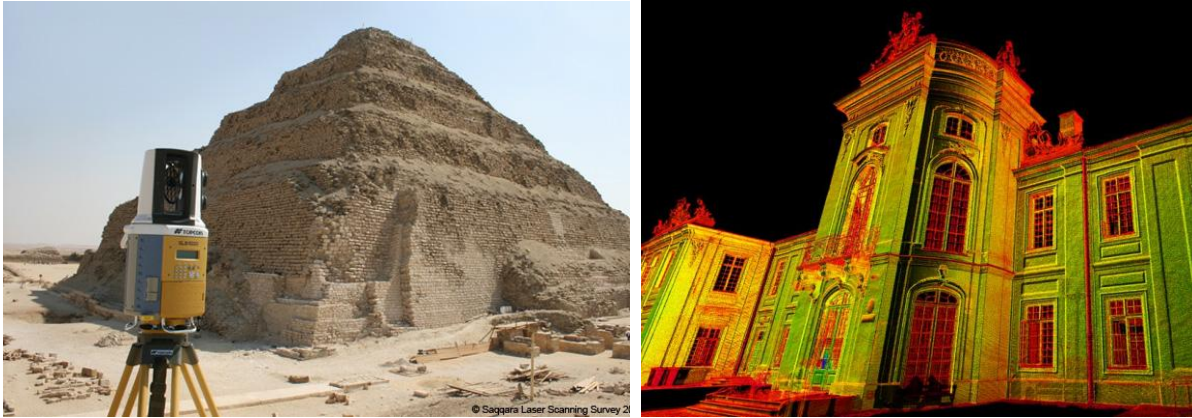
Figure 2. 1- Mechanical scanner in archeological survey in Egypt. Figure 2. 2- 3D Laser Scanning of Palac Potockich Radzyn Podlaski, Poland.

A typical laser scanner can be subdivided into the following key units: laser ranging unit, optic mechanical scanner (as seen in Fig 2.1) and control and processing unit. Developed laser scanners can reach a very high accuracy and be activated from a distance to the examined structure. Recent studies and practices exploit the benefits of 3D laser survey for the production of damage maps and for identification of crack patterns and other surface deteriorations. An example of the method is presented in Fig 2.2.

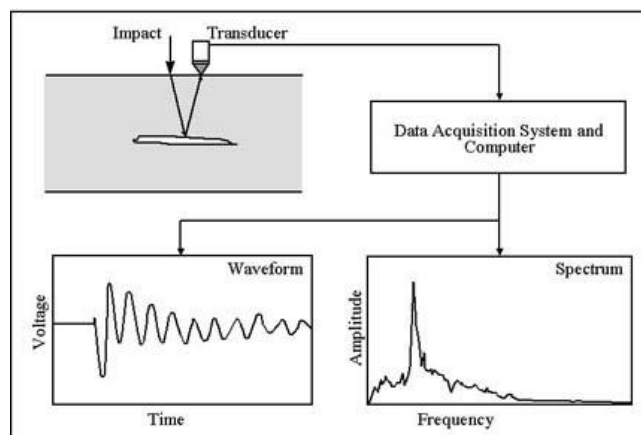
Figure 2. 5- Work principle of the Impact Echo Method

The method is activated by a short-duration mechanical impact, produced by tapping a small steel sphere against surface, which produces low-frequency stress waves (up to about 80 kHz) that propagate into the structure and are reflected by flaws and/or external surfaces. Multiple reflections of these waves within the structure excite local modes of vibration, and the resulting surface displacements are recorded by a transducer located adjacent to the impact. The piezoelectric crystal in the transducer produces a voltage proportional to displacement, and the resulting voltage-time signal (called a waveform) is digitized and transferred to the memory of a computer, where it is transformed mathematically into a spectrum of amplitude vs. frequency. Both the waveform and spectrum are plotted on the computer screen (Tikal'sky, 2006). The dominant frequencies, which appear as peaks in the spectrum, are associated with multiple reflections of stress waves within the structure, or with flexural vibrations in thin or delaminated layers. The work principle can be seen schematically in Fig.2.5.

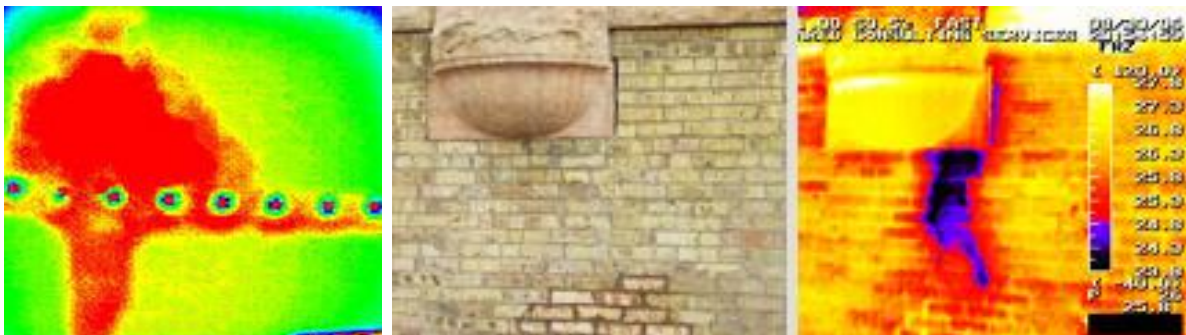
Figure 2. 6- Detection of interior metal bars via infrared thermography, Figure 2. 7-Inspected wall geometry, Figure 2. 8- Moisture detection of the inspected wall via infrared thermography

- (i) Survey of cavities,
- (ii) Detection of inclusions of different materials (Fig. 2.6),
- (iii) Detection of water and heating systems,
- (iv) Moisture presence. (Figs. 2.7, 2.8)

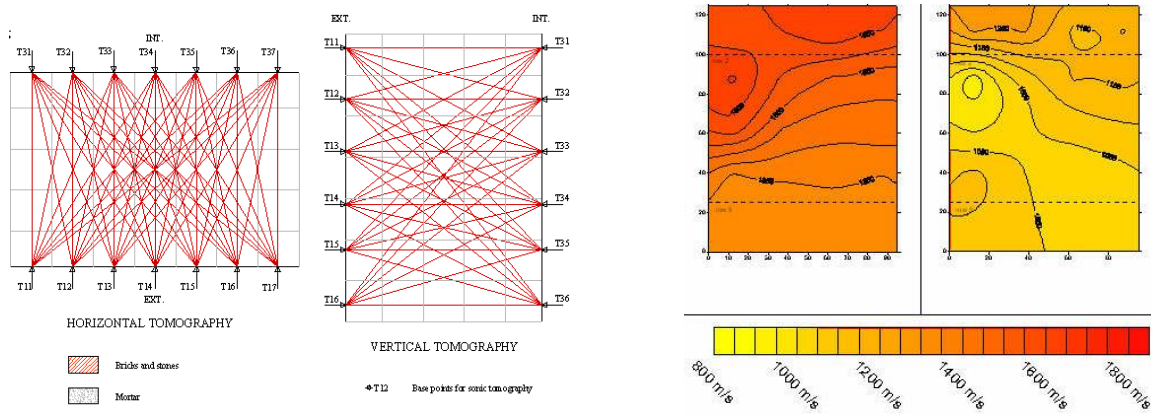
Figure 2. 11- Vertical and horizontal sonic tomography of a masonry wall, Figure 2. 12- Contour sonic tomography of a masonry wall

The method was developed originally for the field of Geophysics, but has been adapted for the use of analysis of masonry and stone, and has shown reasonable approximations of size and extent of internal abnormalities. The tomographic analysis methods require a large amount of data acquisition in order to portray results of entire cross sections. Location and size of hidden cracks, voids and other deterioration processes can be tracked in the output data. Explanatory output is presented in Figures 2.11 and 2.12.

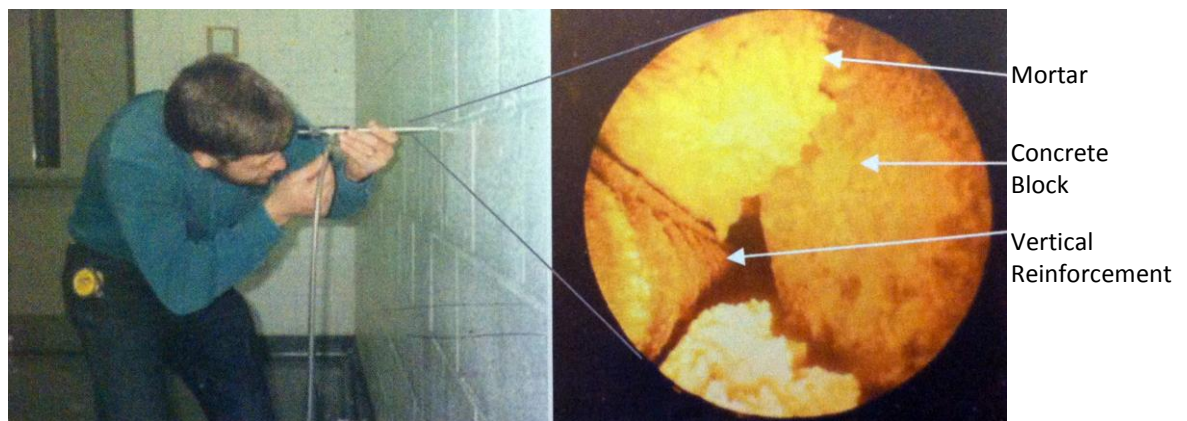
Figure 2. 14- Boroscopy test execution and real-time graphic output

Figure 2.14 shows the execution and the possible output of the boroscopy test.

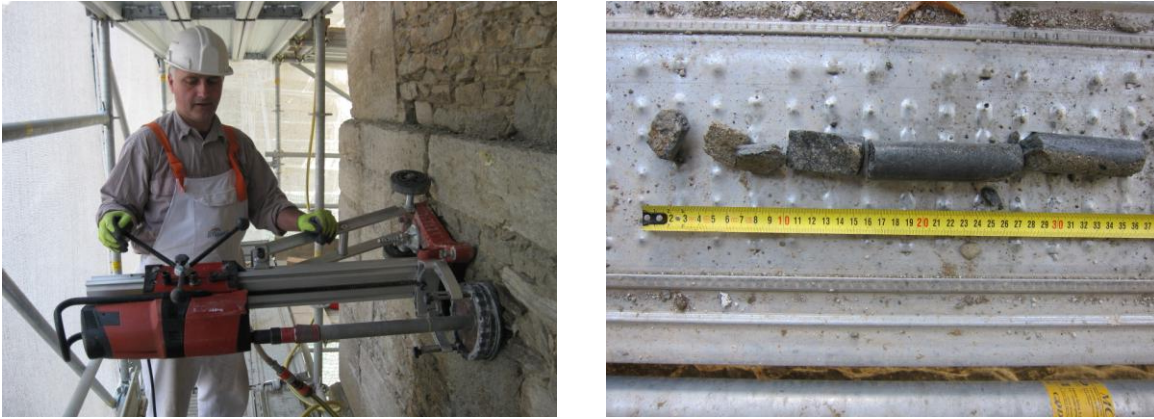
Figure 2. 15- The coring process, Figure 2. 16- Drilled core from a masonry wall

Coring extraction is done by a drilling saw activated with water (Fig. 2.15). Thus, it can be somewhat harming for the masonry and this should be considered before application. As the operation is complex and involves both in situ and laboratory work, protocol must be followed to avoid confusion and misinterpretation of results. All cores shall be submitted to the laboratory for examination regardless of whether the core specimens failed during cutting operation. The laboratory shall report the location where each core was taken, the findings of their visual examination of each core, identify which cores were selected for shear testing and the results of the shear tests (Californian building code, 2010). A drilled core can be seen in Figure 2.16.

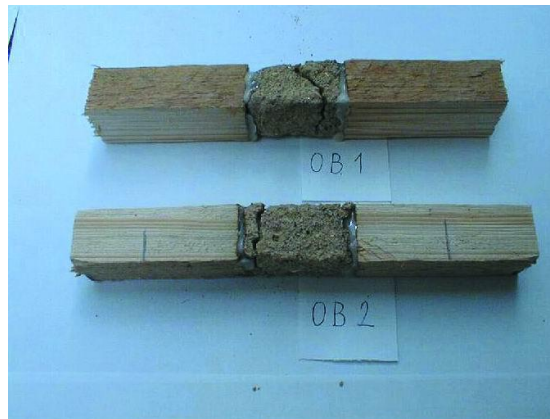
Figure 2. 17- Micro samples of mortar with wooden prosthesis

The testing of non-standards samples was studied in the ONSITEFORMASONRY project, developing techniques to evaluate and test micro samples. Eventually, the research showed that testing mechanical properties in bending on non-standard mortar samples which were supplemented symmetrically on both ends with two “prostheses”(see Fig.2.17); the influence of prosthesization was negligible (Drdacky et al., 2004).

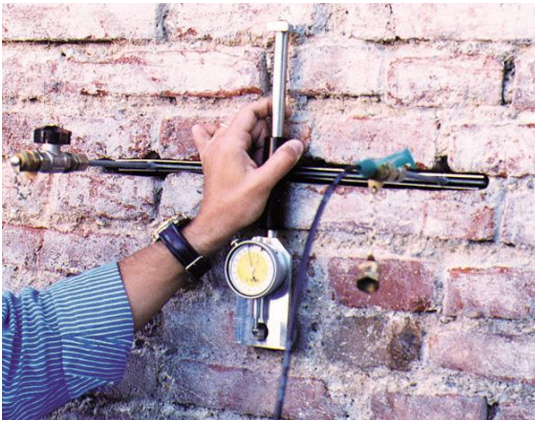
Figure 2. 18- Single flat jack inserted into cut, Figure 2. 19- Deformation stress diagram presenting results of single flat jack tests

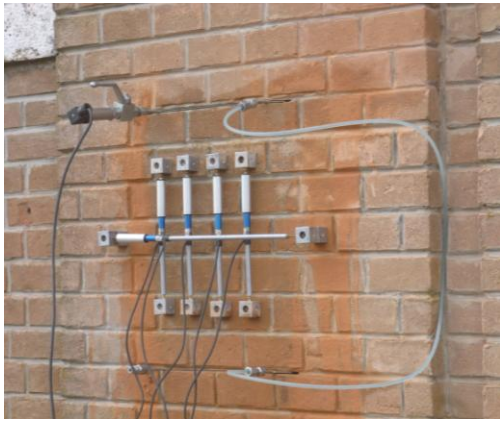
Figure 2. 20- Double flat jack test configuration on a brick masonry wall, Figure 2. 21- Stress strain diagram presenting results of double flat jack tests

Another possibility that the flat jack provides is the measurement of deformability. By making another cut, 40-50 cm below the first one, a sample of masonry is isolated and can be tested in uniaxial loading. The test configuration is shown in Fig. 2.20. Loading cycles are performed in increasing rates and deformations are measured. A deformability modulus of the masonry related to the stress levels can be obtained. Results from testing are presented as a stress strain diagram (see Fig. 2.21) from which the Elastic Modulus (E) of the masonry can be obtained by constitutive law.

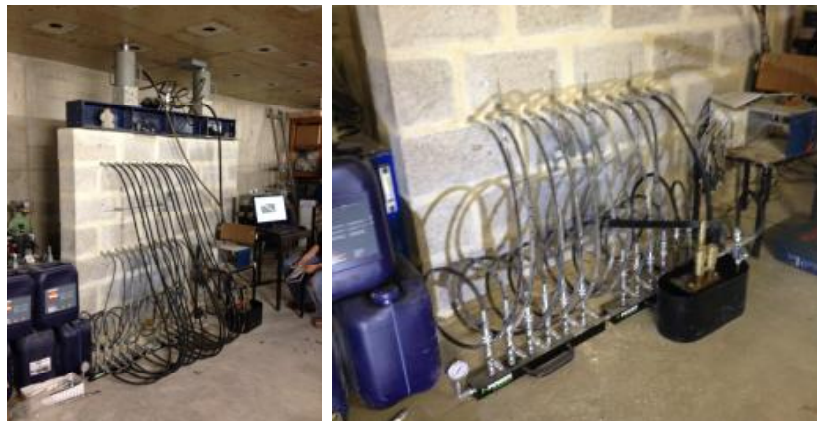
Figure 2. 22- tube jacks implicated on a masonry wall in laboratory at Minho University.

In order to overcome the limitations of applying a flat jack test on irregular masonry walls, the tube jack technique is now being developed at the University of Minho, Portugal. The tube jack test is carried out by insertion of a series of cylindrical hydraulic jacks into the inspected masonry wall, instead of the flat jack (presented in Fig. 2.22). With the fruition of this system, significant improvements in the in situ evaluation of the mechanical properties of masonry walls are expected.

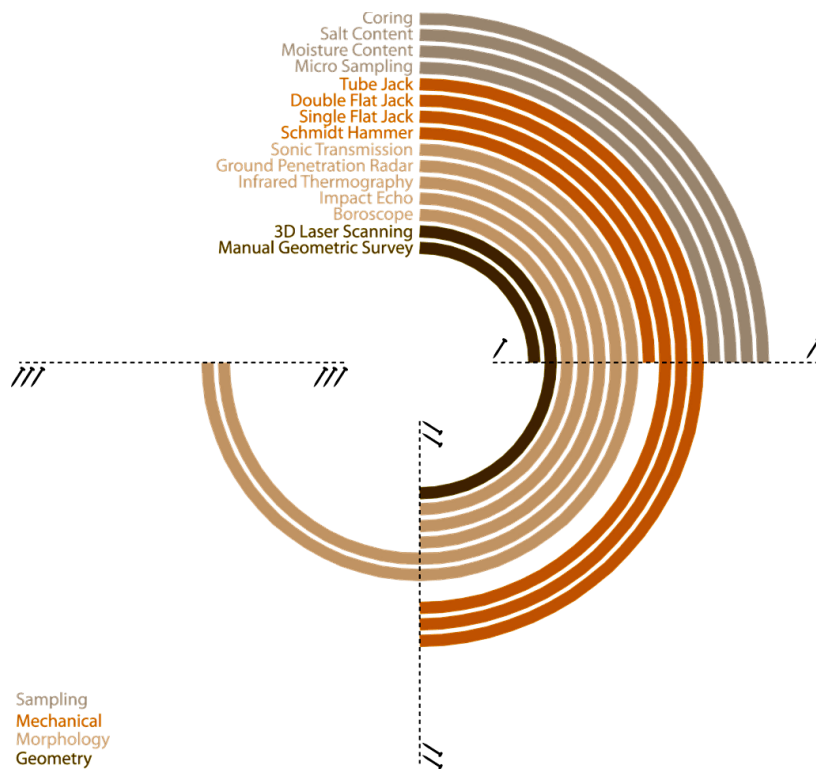
Figure 2. 24- Estimated relative execution complexity of NDT/MDT
 (Adapted from: Harvey et al., 2010)

When planning an intervention for a historical monument the designer must consider numerous factors. The mentioned tests are available for his dispense but many other factors must be taken into consideration during the decision making process. These factors may regard the building under consideration, as the type of the building (private housing, public or civic, religious etc.), its size, uniqueness, and even level of significance to the cultural heritage. This must be considered as the available tests often have elevated costs, and complicated execution processes. In addition, several testing methods involve long term monitoring. Figures 2.23 and 2.24 present indicative relative costs and complexity of execution.

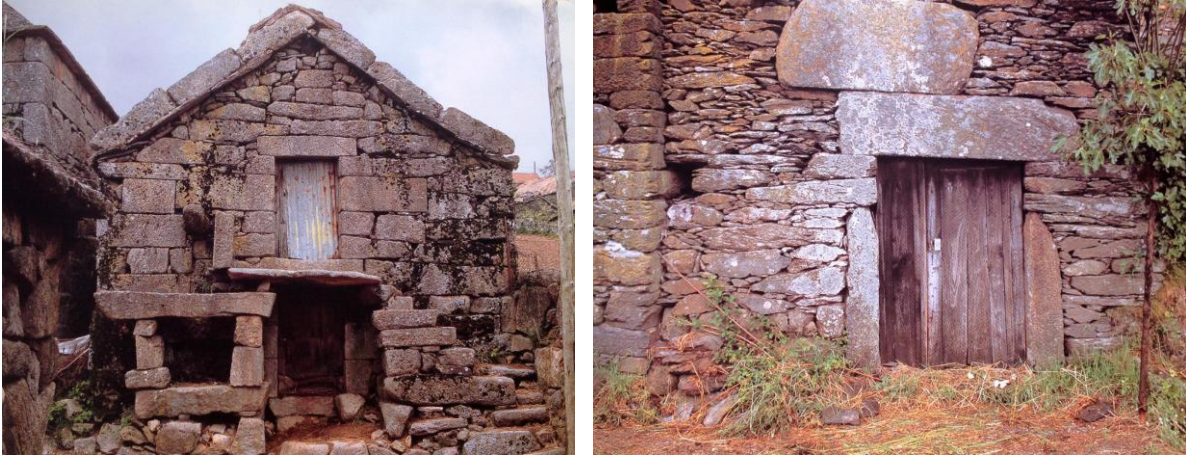
Figure 3. 2- Northern house built in granite. Figure 3. 3- Northern house built in mixed schist and granite
(From: Casella, 2003)

In areas where granite was predominant, independent walls are commonly two leaved of outer and inner veneers promptly connected together by transversal stones, or alternatively, the walls consist of a single block stones throughout the thickness, which are arranged in horizontal rows. This type of wall is commonly referred to as “perpianho” (see Fig 3.2).

In shale predominant areas, walls are built by overlapping laminar stones. Wooden beams or granite blocks are occasionally placed near the openings to increase stability (see Fig 3.3). Similarly, wherever possible, the corners are carried out with large stone blocks arranged alternately to ensure stability. In certain areas of the country, the roofs and eaves are also made with plates of shale, which accentuate the originality.

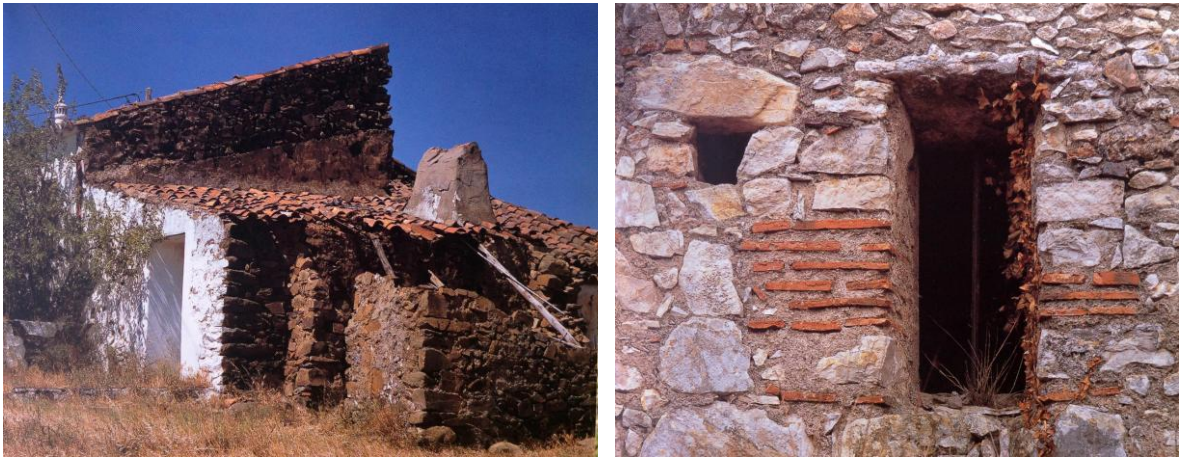
Figure 3. 4- Southern house built in limestone and earth, Figure 3. 5- Southern house built in limestone and brick. (From: Casella, 2003)

In typical houses in the South, ground floors and are intended for housing. Agricultural necessities are habituated in independent buildings (Oliveira et al., 2003). The materials used in these constructions range from adobe, rammed earth, brick and limestone (see Figures 3.4, 3.5). The simplicity of molding these materials allowed obtaining various architectural forms such as chimneys. The marginal construction in stone is related to the scarcity of the material in these regions. The walls are usually whitewashed and roofing can be gabled or flat.

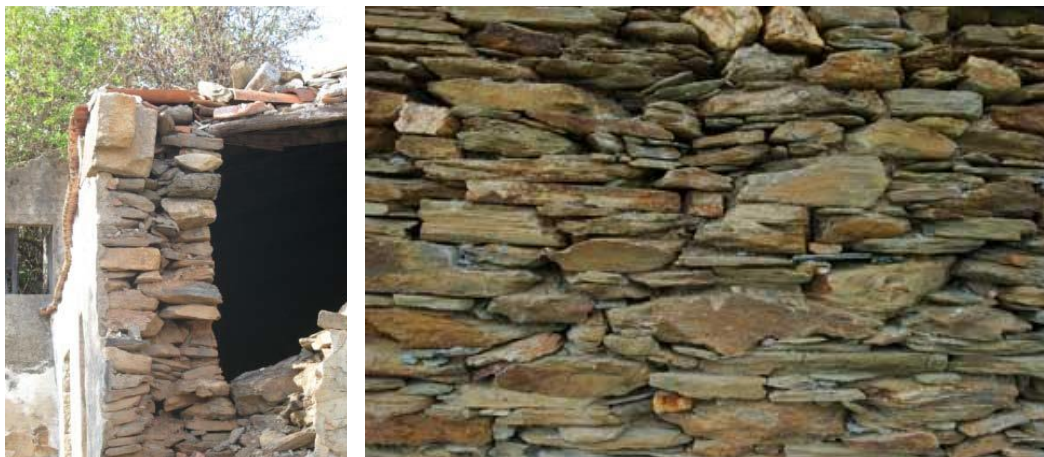
Figure 3. 6- Section of a double leaf schist masonry wall with connectors, Figure 3. 7- Elevation of a schist masonry wall (From: Oliveira, 2003)

Geometry and morphology of the walls are closely related to the type of stone. In the case of schist constructions for example, walls are constructed of two leaves, as can be seen in Figures 3.6 and 3.7. In these cases, the schist stones are neatly arranged and wood or stone connectors can be found throughout the section and play a fundamental role for the monolithic behavior of the walls (Barros et al., 2010). In other cases, such as granite rural constructions, walls are generally single leaved. Thickness of the walls can range from 40-80 cm, and elevation is normally not higher than 5m and is often lower (Casella, 2003).

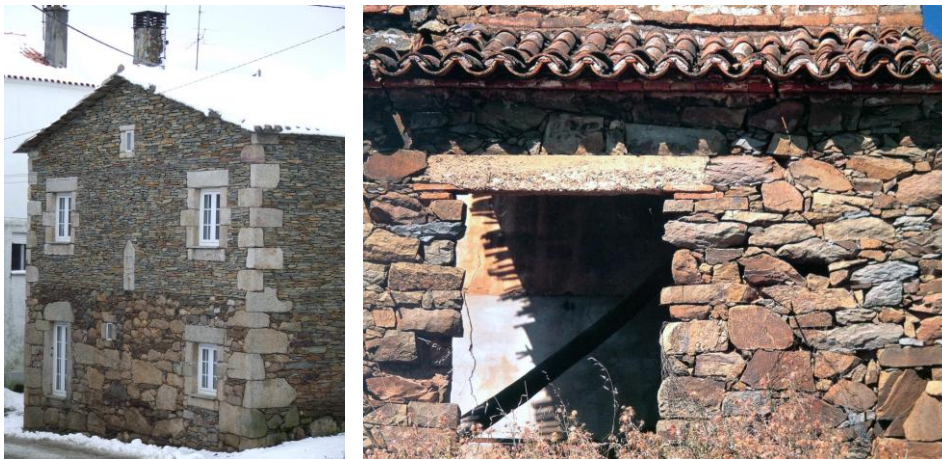
Figure 3. 8- Supporting granite elements in corners of schist constructions, Figure 3. 9- Supporting granite elements over openings. (From: Casella, 2003)

In many rural houses, larger stone elements are used to strengthen corners and spans, as seen in Figures 3.8 and 3.9.

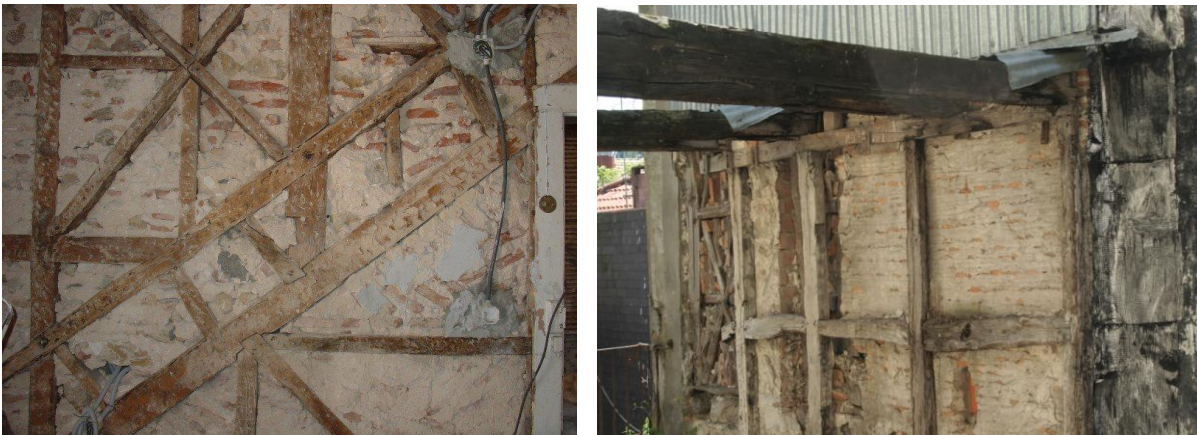
Figure 3. 15- Brick masonry between timber elements in Gaioleiro walls, Figure 3. 16- 'Tabique' exterior walls with no diagonal timber frame, (From: forumdacasa.com, sjoaohostel.wordpress.com)

During the nineteenth century, the cage structure characteristic of the ‘Pombalino’ buildings was progressively simplified. The diagonal elements from the ‘frontal’ walls started to be removed, conditioning the bracing of the timber structure. The rubble infill between the timber elements was then replaced by brick masonry (see Figure 3.15), solid on the lower floors and hollow on the upper, or by ‘tabique’ walls (see Figure 3.16), originally used on ‘Pombalino’ buildings as partition walls. The thickness of the brick masonry walls decreases along the height of the building by changing the position of the bricks. The variation of strength of the walls is also related with the transition between solid masonry bricks in the lower floors and hollow bricks on the upper floors or the replacement of the brick masonry walls by ‘tabique’ walls. The light wells and side walls, originally built in rubble stone masonry, were also replaced by brick masonry walls.

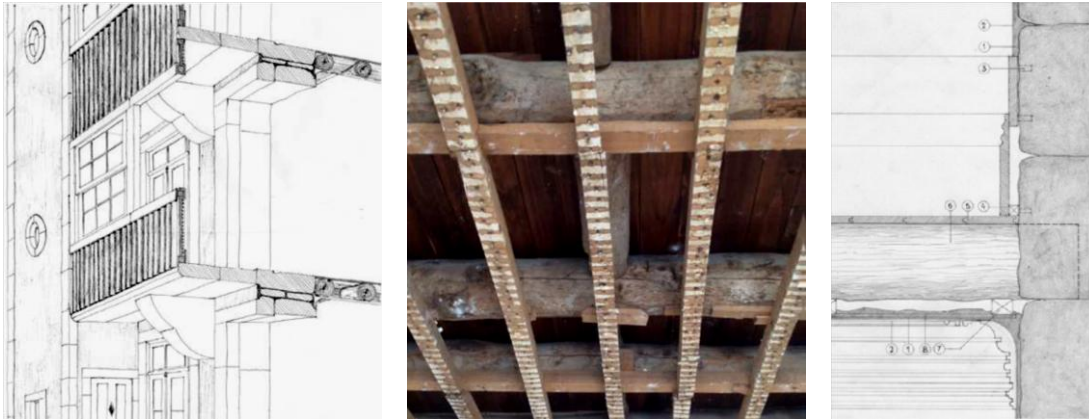
Figure 3. 17- Schematic axonometric representation of a typical 19th century Porto House's façade, Figure 3. 18-Picture of a typical wooden beam pavement, Figure 3. 19- Connection between wooden beams and the lateral granite wall

thickness of 60 cm and 30 cm respectively, interlocked by ashlar granite units and supporting the horizontal wooden elements of floors and roofs (see Figures 3.17 and 3.18). The lateral walls (see Figure 3.19) are single-leaf walls laid with lime mortar, permanent in thickness and structurally shared with the adjacent buildings, whereas the façades are double-leaf walls, decreasing in thickness from the bottom upwards. (Betzer et al., 2013)

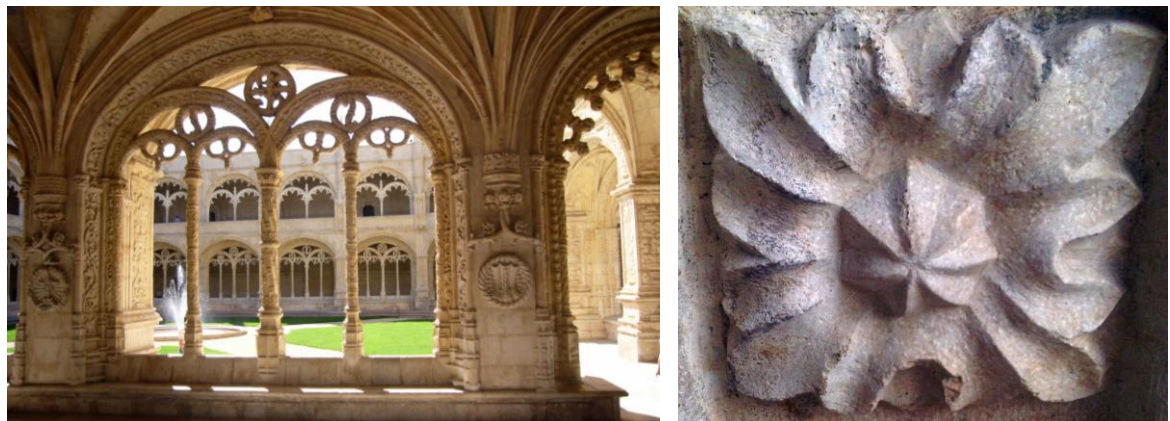
Figure 3. 25- Detail in Limestone (from: http://en.wikipedia.org/wiki/Jer%C3%B3nimos_Monastery), Figure 3. 26- Detail in Limestone (from: www.thebrooklynscribbler.blogspot.com)

The monastery church exhibits different typologies in masonry; the south wall has a thickness of around 1.9 m and possesses very large openings. Three large trapezoidal buttresses ensure the stability of the wall; the north wall is extremely robust (with an average thickness of around 3.5 m) and includes an internal staircase that provides access to the cloister. The chancel walls are also rather thick (around 2.5-2.65 m) (Lourenço, et al., 2004). The masonry used is well cut ashlar stones with a vast amount of decoration elements carved in stone (see Figures 3.25, 3.26). The bright stone, typical to the southern Portugal architecture, is local golden Limestone.

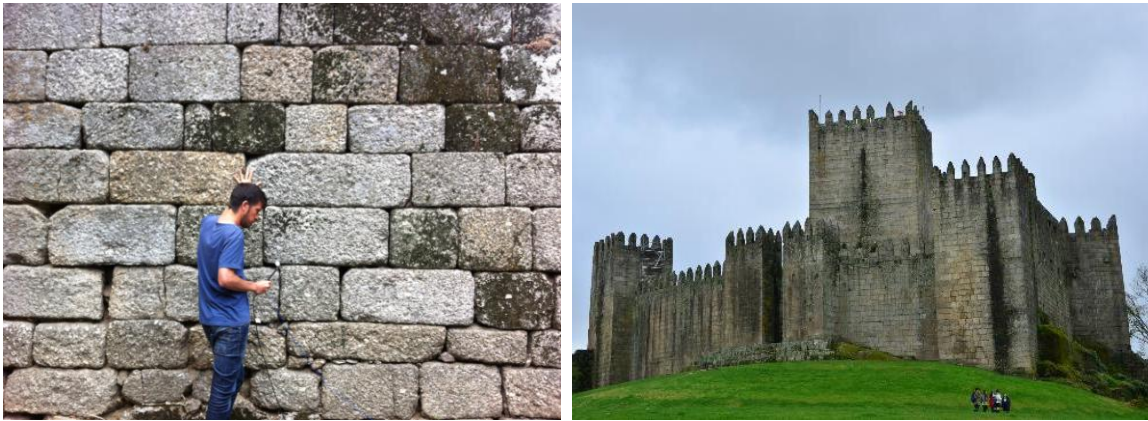
Figure 3. 32- Masonry of Guimarães castle, Figure 3. 33- Guimarães castle current condition

An important example of a regional medieval military structure is the Guimarães Castle, which dates back to the 10th century and the battles against the Moors in the Iberian Peninsula. The masonry work of the castle consists of single and three leaf walls with granite stone ashlar on the external. The masonry features horizontal courses and is relatively regular, despite the fact that the height of the courses is not constant and that the length of the units is rather variable (see Figure 3.32). Several investigation and research works were carried out in the castle, including laser scan survey, which allowed the documentation of the regularity and assemblage of the masonry.

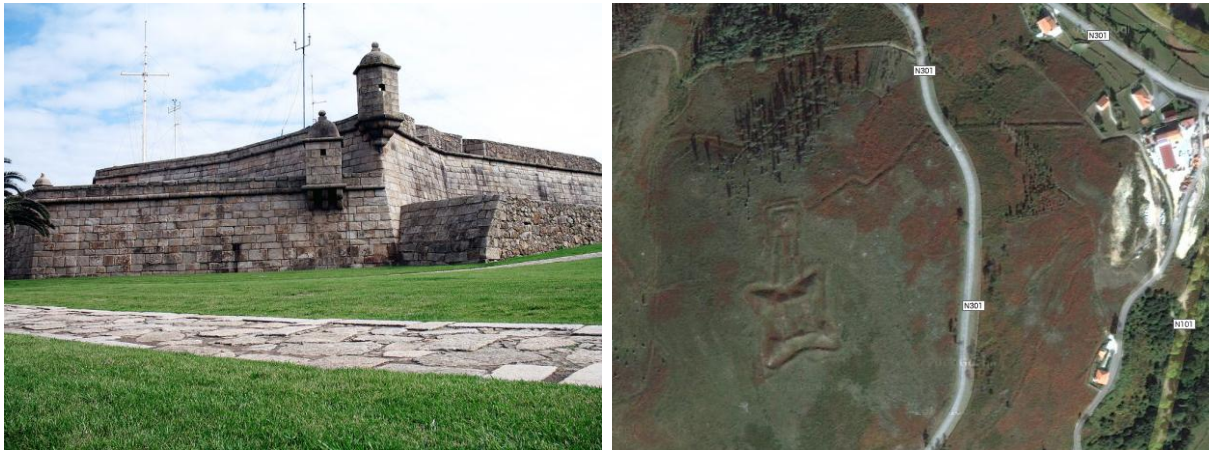
Figure 3. 34- Fort of Leca de Palmeira (from:http://en.wikipedia.org/wiki/Fort_of_Le%C3%A7a_de_Palmeira),
 Figure 3. 35- Aerial map of Bragandelo Fort (from: www.maps.google.com)

The fort of Leça de Palmeira - Bulwarked granite fort built in the 17th century in order to reinforce the sandbar of the mouth of the Douro. The fort has a four pointed star plan, protected by sloping curtains and watch towers (see Figure 3.34).

Bragandelo Fort - Rurally located fort that was made up of ditches and embankments, using earth and granite blocks. Granite used is essentially small to medium in size, and not perfect in shape. The plan is almost a square, with some angularity in the corners, with a 40 m corridor leading to the north facing entrance (see Figure 3.35).

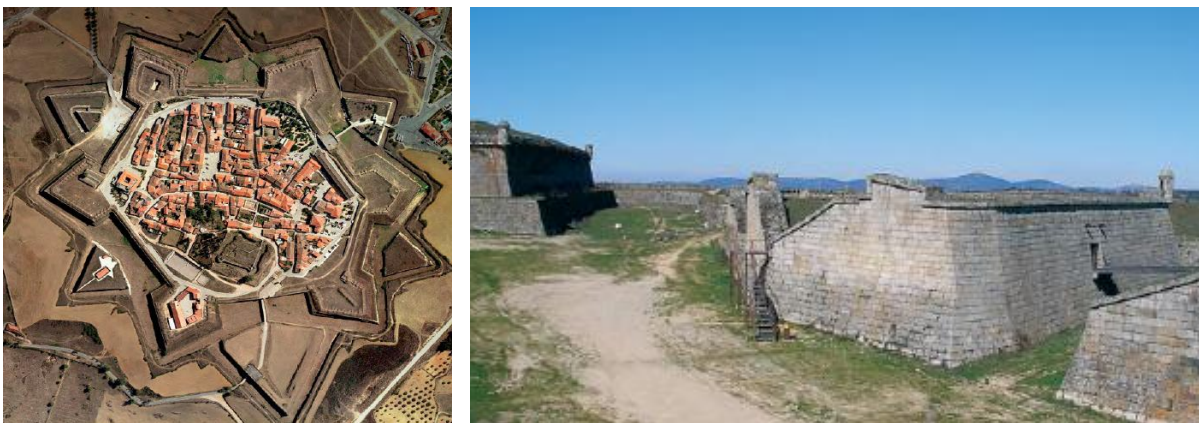
Figure 3. 36- Aerial view of the Almeida fortifications, Figure 3. 37- Picture of the Almeida fortifications
 (From: Campos, J, 2009)

The fortifications exhibit different architectural periods and styles, nested in possible Muslim or Leonese origins from the 10th century, followed by recurring reconstructions and additions beginning in the 12th century and forward. The current ruins of the fortress allow recognizing an irregular quadrangular floor plan (see Figure 3.36), surrounded by a ditch with a slab pavement and with a counterscarp lined with ashlar masonry (see Figure 3.37), presenting, at the angles, the foundations of four circular towers (Campos, 2009).

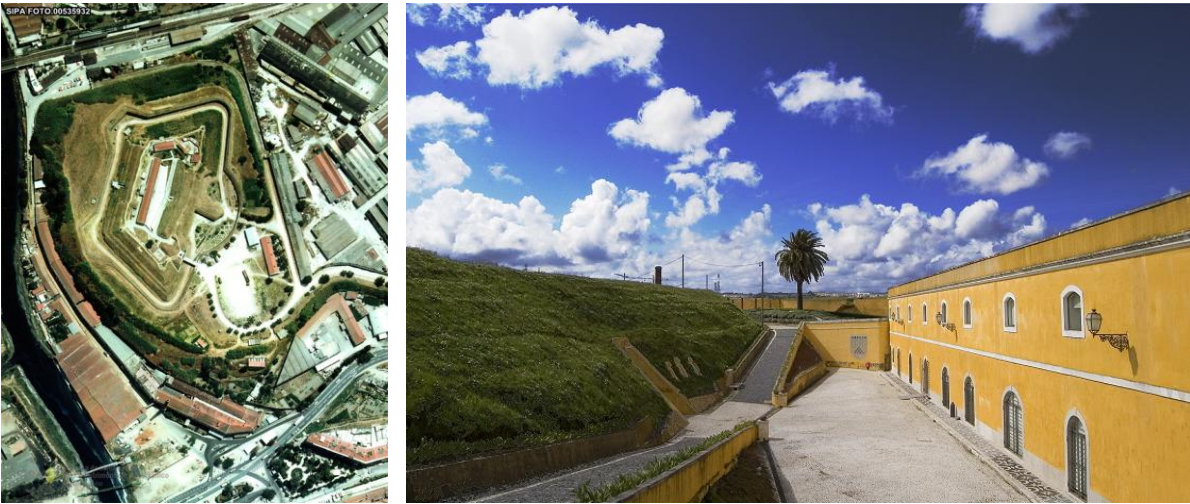
Continuing south, in the region of Lisbon we find the example of the 19th century Sacavem Fort in the mountains of Sintra. It is situated on the right bank of the river Trancão, and has an irregular pentagonal plan, surrounded by a moat and is partially buried in the soil, which makes it hardly noticeable when viewed from a lower altitude. It is built of plastered limestone masonry, with more recent additions in concrete. An aerial plan and one of the fortress walls can be seen in Figures 3.38 and 3.39.

Figure 3. 38- Aerial view of the Sacavem fortifications, Figure 3. 39- Typical walls of the Sacavem fortifications, (From: <http://www.monumentos.pt/>)

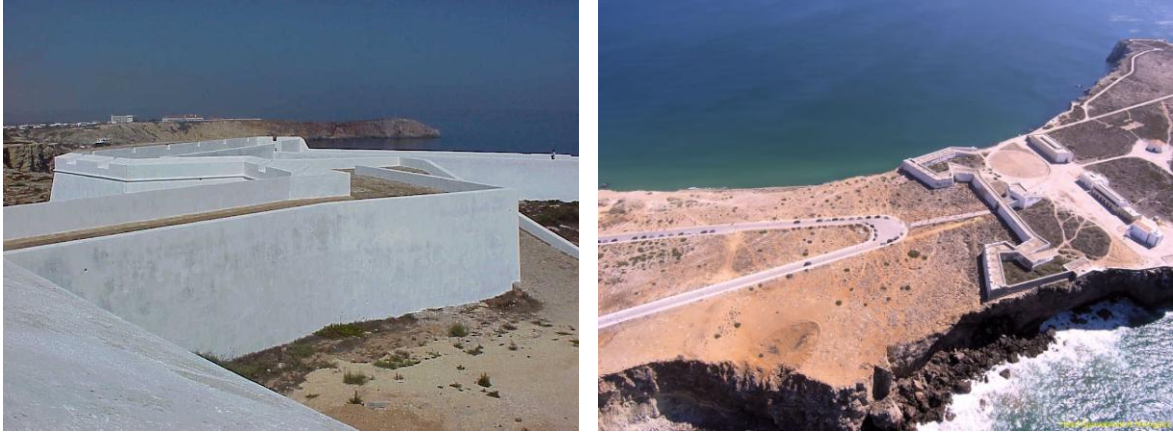
The fortress is built with plastered limestone (see Figure 3.40), typical to the area. The plan is configured from six strategically placed batteries and watch towers (see Figure 3.41). The shore side is closed by curtain walls that extend beyond the shore to the west.

Figure 3. 40- Walls of the Fort of Sagres, Figure 3. 41- Aerial view of the Fort of Sagres

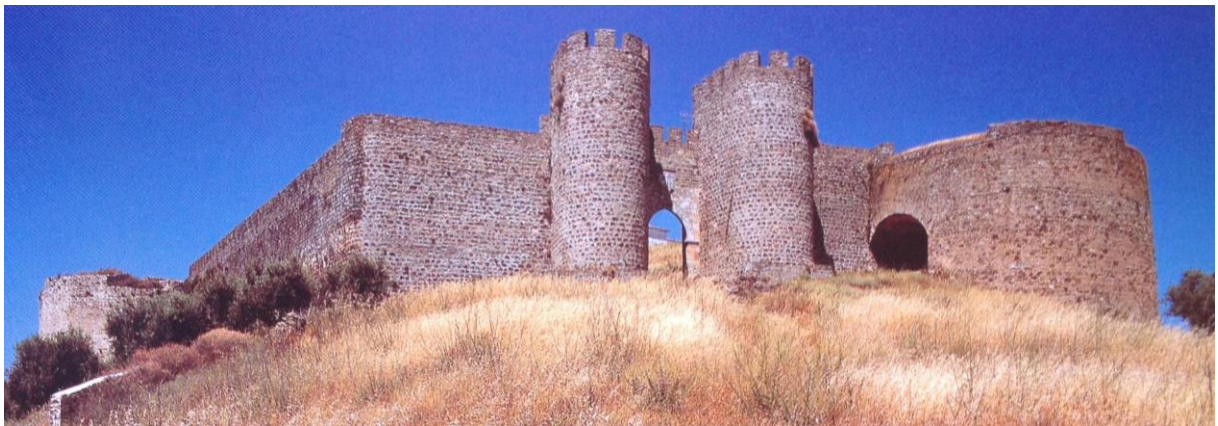
Other southern examples are found in the large region of Alentejo. The Fortress of Evoramonte, shown in Figure 3.42, and the Fortress of Estremoz, constructed both with limestone and not plastered. The fortresses walls are built from different stone techniques varying from irregular to highly regular cut. Walls can have a thickness of up to 3-4 m in towers and retaining walls.

Figure 3. 42- The fortress of Evoramonte in Alentejo.

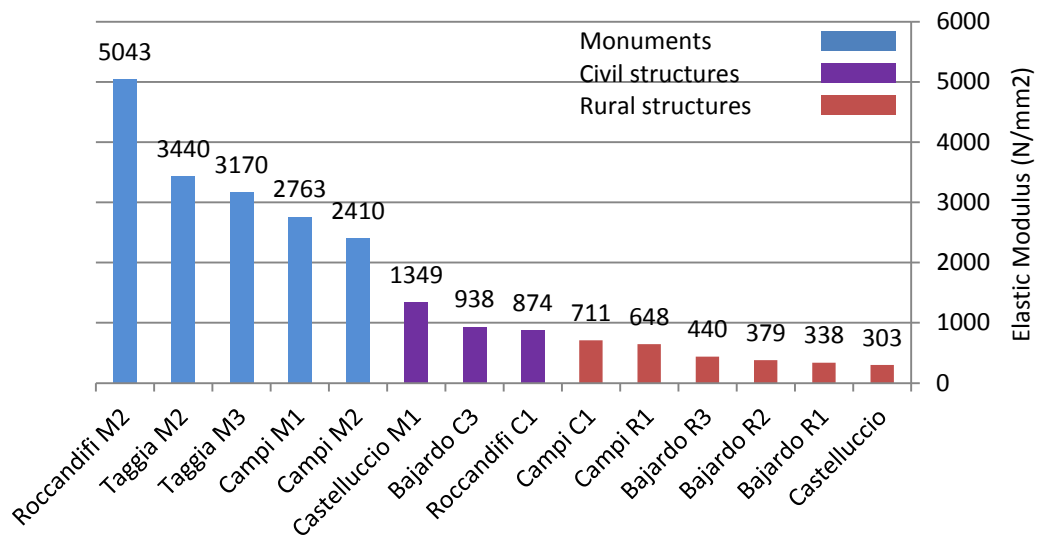
In the larger scale of building typologies, comparing between different case studies in the Umbria and Liguria regions, they find that the mechanical behavior of the stone is better in monument structures, showing higher results of elastic modulus (E). This indicates the elevated stone quality used in this typology. Moreover, they find higher elastic modulus in civic buildings, and low results in rural structures. Results are presented in the Figure 3.45.

Figure 3. 45- Elastic Modulus related to different building typologies

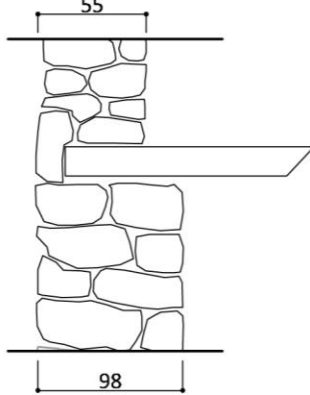
MILITARY TYPOLOGIES		
[6] Triple leaf limestone- Retaining wall	[7] Triple leaf limestone- Standing wall	[8] Single leaf granite Standing wall

[6]- **Military triple leaf limestone retaining wall, found in Setubal.** Thin rubble middle leaf with thicker exterior leaves (Casella, 2003).

[7]- **Military triple leaf limestone standing wall, found in Alentejo.** Ashlar and cut stone construction with air lime mortar (Casella, 2003).

[8]- **Military single leaf granite standing wall (thick wall), found in Guimarães Castle.** Ashlar construction with nearly empty joints. Regular horizontal courses in different heights, uneven vertical joints.

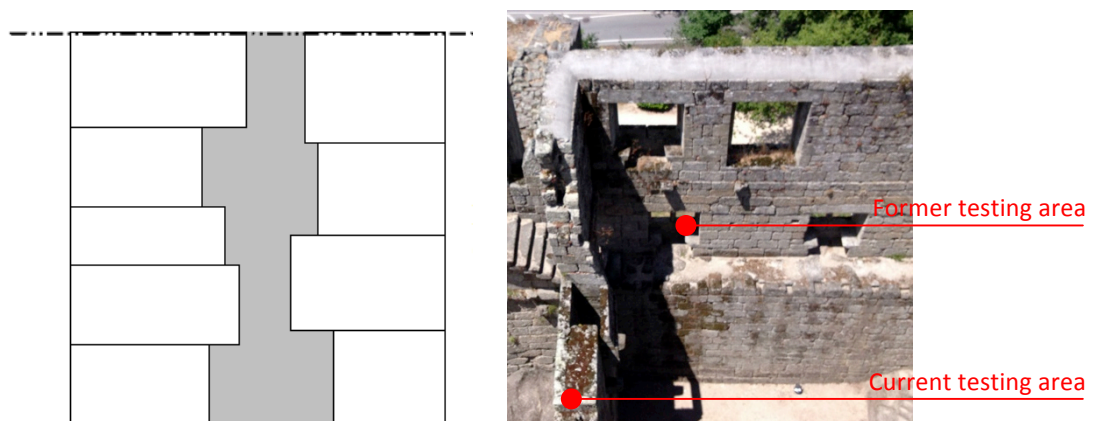
In order to assess the morphology of the granite walls, without compromising their physical integrity, several techniques were considered. A former study of the castle, carried out in the upper part of the Alcáçova wall (the northern battlement wall), found a supposed 3 leaved morphology by means of boroscopy and sonic transmissions (see Figure 7.1). Most data collected was related to thickness of the exterior leaves, which was estimated to be 0.3-0.4 meters. However, in a visual survey conducted as a preliminary step of the present campaign, it was evident that the former tested area was not necessarily constructed in the same manner of the chosen locations for the current study. The upper part of the wall, tested before, is different in width as well as exhibits singular architectural elements (windows etc.); this can be seen in Figure 7.2. More information regarding the testing locations of the current study will follow.

Figure 7. 1- Estimated morphology from former study. Figure 7. 2- Locations of former and current campaigns

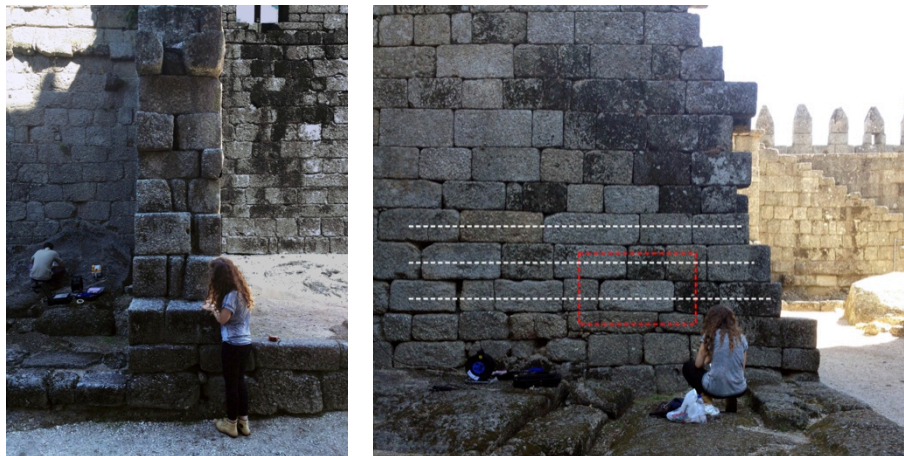
The first wall to be tested was an interior battlement wall with an apparent thickness of 0.93 m (see Figure 7.4). The wall is composed of ashlar granite stones assembled in continuous horizontal courses of different heights. Its position allowed carrying out direct sonic tests which were preferable for the case of morphology detection. Figure 7.5 presents the testing areas in the wall. The aim of the campaign was to learn more of its internal structure. Testing plan included direct sonic transmission and impact echo reflection testing, as well as GPR scanning.

Figure 7. 4- Apparent section of the wall. Figure 7. 5- General layout of the tested wall (GPR profiles in with, sonic tested area in red)

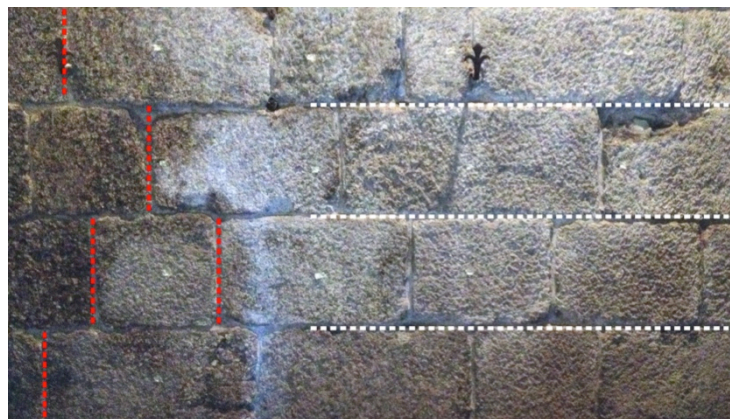
As can be seen in Figure 7.6 the wall exhibits ashlar granite stone units with thin mortar joints. The stone units share a recurring height of 40 cm, and have regular horizontal joints and irregular vertical joints. As it is perforated by windows its depth can be measured, and is approximately 1.80m. Testing plan included horizontal and vertical profiles tested both by indirect sonic transmission and for GPR scan.

Figure 7. 6- Geometric characteristics of the inspected wall

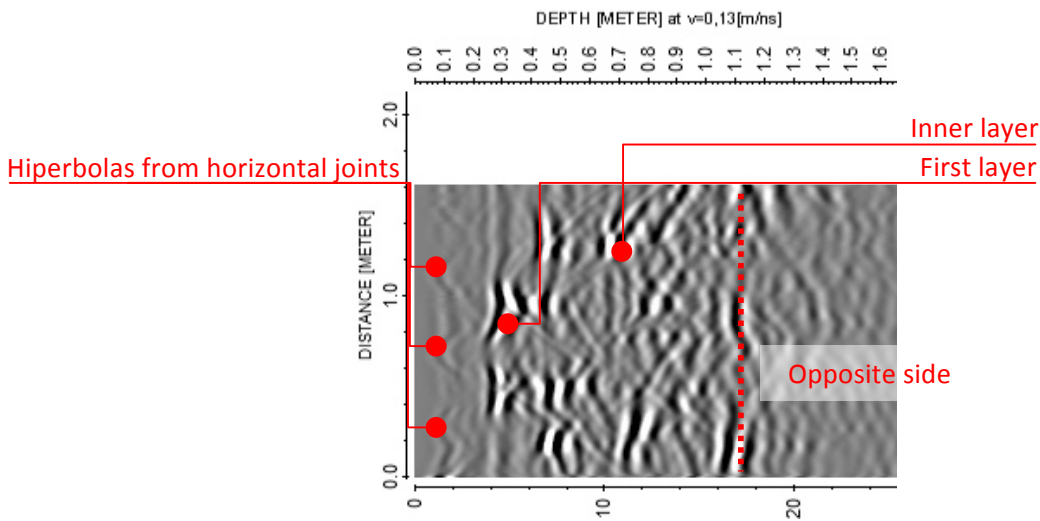
The additional horizontal profiles that were obtained from the 5th and 6th rows of the wall showed similar results, which did point to a distinguished morphology, yet further indicated of a non-uniform section. In the vertical profile collected, illustrated in Figure 7.10, the inner structure can further be observed. A first layer is evident, with a rather irregular thickness, an inner layer, which apparently is larger than the first layer, and the opposite side. The irregularity of the leaves can suggest a certain interconnection of the units to provide stiffness to the section.

Figure 7. 10- Vertical radargram from battlement wall

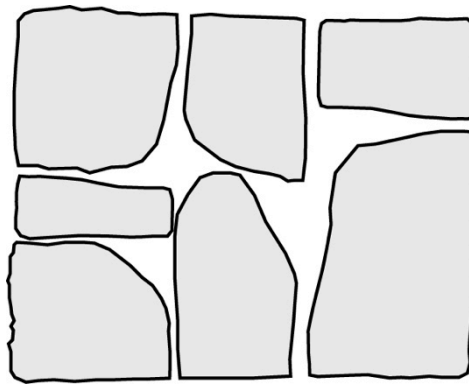
Average velocity through the wall, obtained from the tests was: 533.7 m/sec, with a variation coefficient of 15%. This velocity is essentially lower than the reference velocity through a single stone (2775 m/sec, See Chapter 7.3.1), pointing at a 19% velocity capacity in the wall. This result can indicate the presence of voids and damage within the section. The stones were recognized as partially damaged in their apparent vision, and are evidently damaged also in the interior. Another possible explanation can be the shape of the masonry units; although they seem quite regular in the façade, they may be irregular in their inner surfaces. This construction method, illustrated in Fig 7.12, was widely used in historic times. Full results can be found in Annex 2.

Figure 7. 12- Horizontal plan of masonry section illustrating exterior regular joints with irregular interior shape

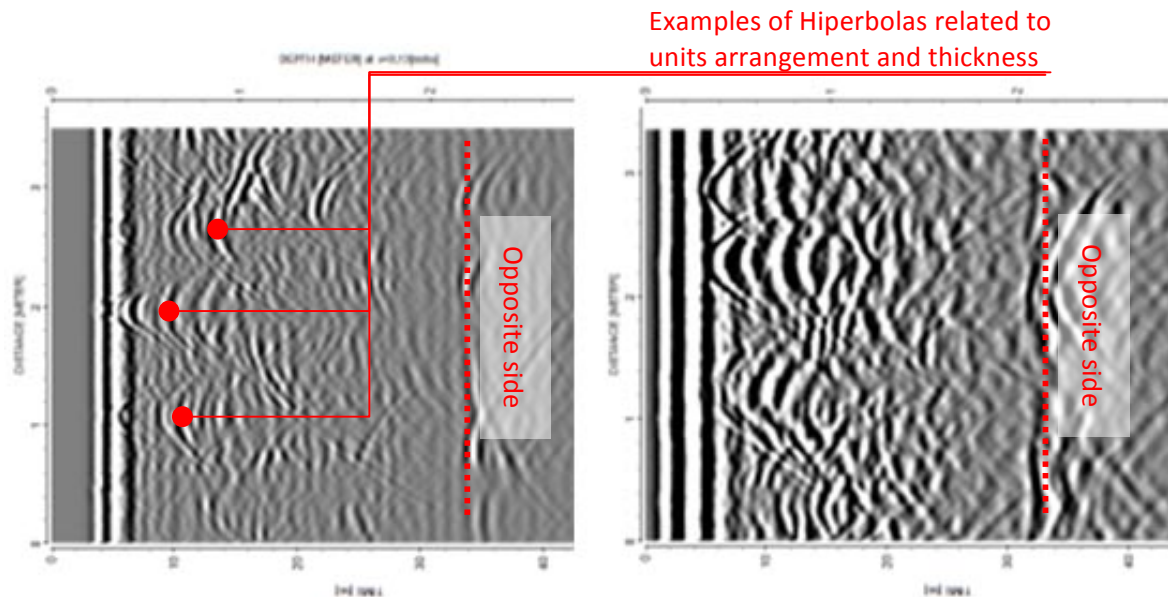
The external wall of the tower was surveyed with the 800 and the 500 MHz antennas. The result showed that both the antennas were capable of penetrating the wall, which means that the wall was rather homogeneous in composition. However, the unit's arrangement produced a rather poor result, resulting in poor geometrical definition. Both frequencies were used to take advantage of the better resolution of the 800 MHz and the better penetration depth of the 500 MHz. Figure 7.19 shows an example of a horizontal profile executed with the 800 MHz antenna. While it shows a very weak signal from the opposite side, it shows a lot of hyperbolas related with joints inside the wall. No interface between blocks was directly measured, which implies that the units are very close from each other. Figure 7.20 shows a similar profile but with the 500 MHz antenna. Although the signal from the opposite side is stronger, the internal events generate even stronger hyperbolas, making interpretation difficult.

Figure 7. 19- Radargram from tower wall with 800 MHz antenna. Figure 7. 20- Radargram from tower wall with 500 MHz antenna

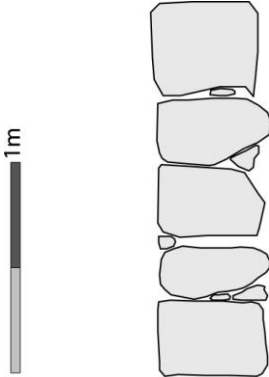
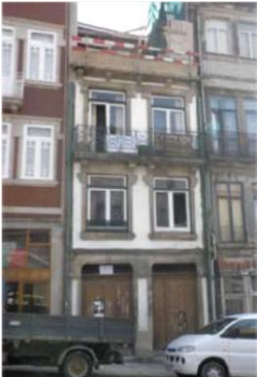
URBAN- Single leaf Granite		Material	Mortar

Granite	Air lime
		Thickness	Height
		55 cm	25m ~3.5 m per floor
		Unit size (h) 23-37 cm With small shims	Geometry
		Ordinary Stone	
Finish	Found in	Bare	Porto

MORPHOLOGY SURVEY
Single leaf granite wall

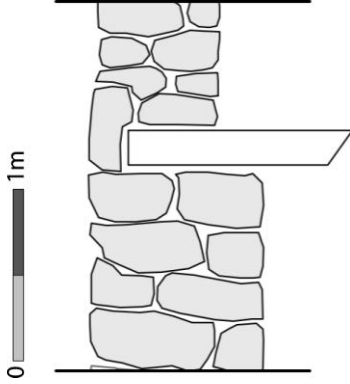
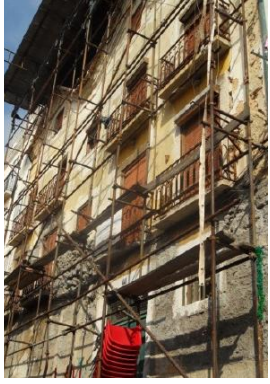
URBAN- Single leaf Limestone		Material	Mortar

Limestone	Air lime
		Thickness	Height
		30-100 cm Decrease with height	25m ~3.5 m per floor
		Unit size (h)	Geometry
		20-30 cm	Ordinary Stone
Finish	Found in	Lime	Lisbon

DAMAGE SURVEY
Single leaf plastered limestone wall

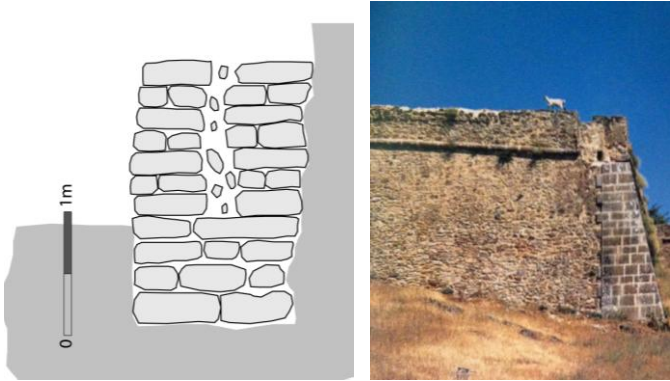
MILITARY- Triple leaf Limestone - Retaining wall		Material	Mortar

Limestone	Air lime		
	Thickness	130 cm	Height	6m
	Unit size (h)	Ext- 20 cm Int- rubble	Geometry	Cut Stone
	Finish	Bare	Found in	Setubal

GEOMETRY/ MORPHOLOGY SURVEY
Triple leaf limestone retaining wall

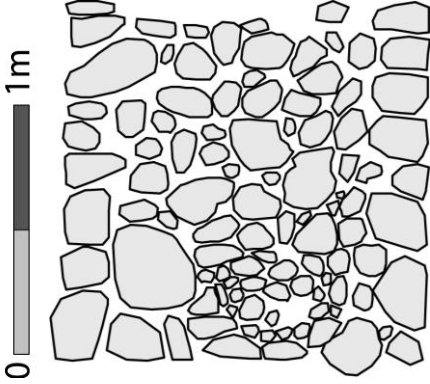
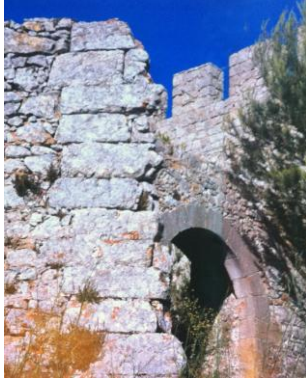
MILITARY- Triple leaf Limestone - Standing wall		Material	Mortar

Limestone	Air lime
		Thickness	Height
		142 cm	10m
		Unit size (h)	Geometry
		20-30 cm	Ashlar and cut stone
Finish	Found in	Lime	Alentejo

GEOMETRY/MORPHOLOGY SURVEY
Triple leaf limestone plastered standing wall

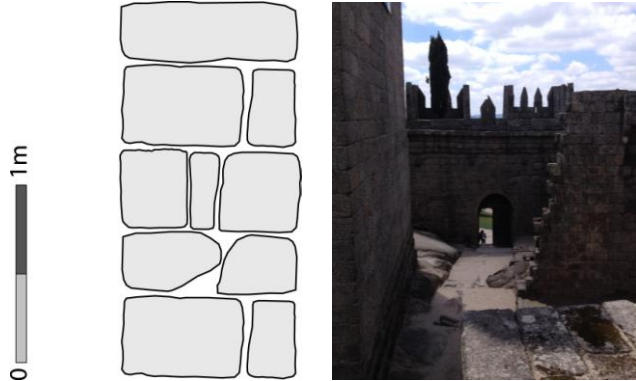
MILITARY- Single leaf Granite - Standing wall		Material	Mortar

Granite	Dry stone
		Thickness	Height
		93 cm	6m
		Unit size (h)	Geometry
		30-45 cm	Ashlar
	Finish	Found in	
	Bare	Guimarães

GEOMETRY/MORPHOLOGY SURVEY
Thick-wall granite standing wall

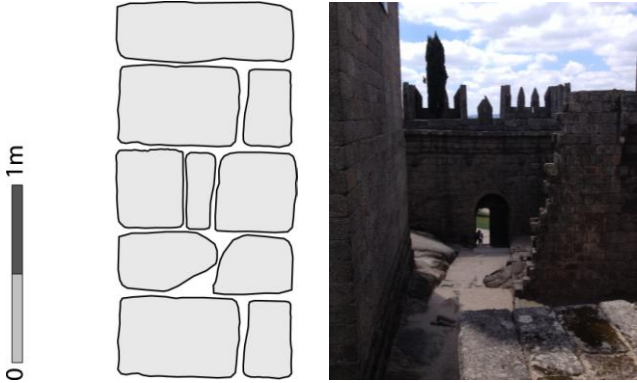
MILITARY- Single leaf Granite - Standing wall		Material	Mortar

<p>The diagram shows several irregularly shaped granite blocks stacked vertically. To the left of the diagram is a vertical scale bar labeled '0' at the bottom and '1m' at the top. To the right of the diagram is a photograph of a thick stone wall with an arched opening, showing the texture and color of the granite in situ.</p>	Granite	Dry stone		
	Thickness	93 cm	Height	6m
	Unit size (h)	30-45 cm	Geometry	Ashlar
	Finish	Bare	Found in	Guimarães
