Shear behaviour of rammed earth walls repaired by means of grouting

SILVA, R.A.¹; OLIVEIRA, D.V.²; SCHUEREMANS, L.³; MIRANDA, T.⁴; MACHADO, J.⁵

Keywords: Rammed earth, shear-behaviour, repair, injection, mud grout

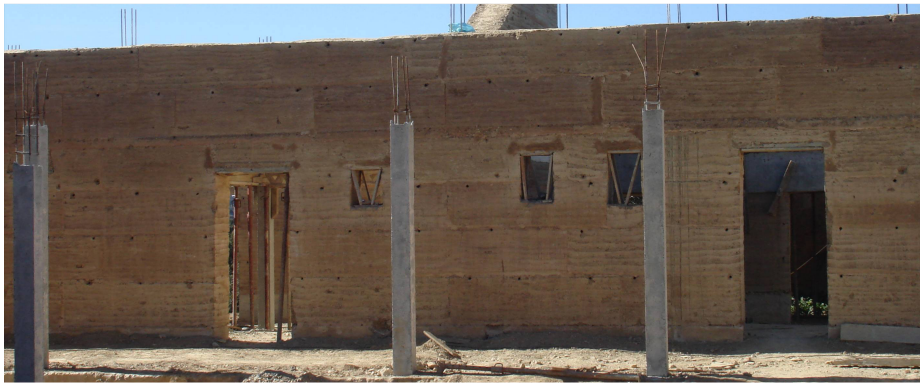
Figure 1. Rammed earth house being built in Odemira, Portugal.

Rammed earth, also known as “*taipa*”, “*taipa de pilão*” “*tapial*”, “*pise de terre*”, “*pisé*” or “*stampflehm*”, consists in compacting moist earth by layers inside a removable formwork to build monolithic walls (see Figure 1). In fact, the formwork constitutes a key feature that differentiates this technique from others. The conception and design of the formwork have suffered an evolving process, which resulted in several configurations. The construction of a traditional wall is carried out by courses (like masonry), where the formwork runs horizontally along the perimeter of the construction and then is

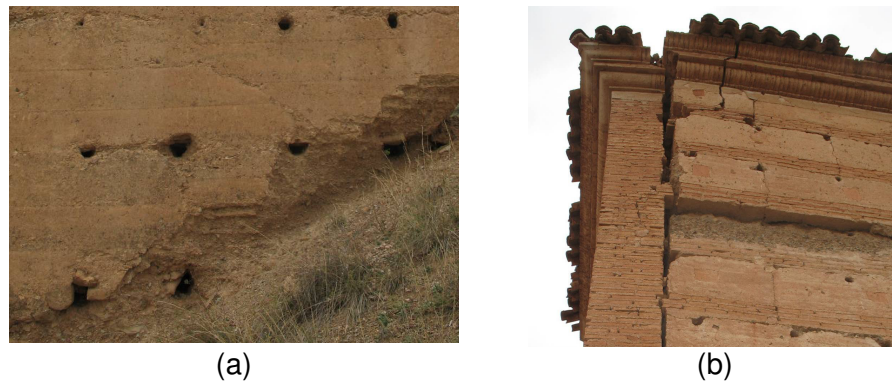
Figure 2. Structural damage in earth constructions [15]: (a) basal erosion; (b) cracking.

Basal erosion in rammed earth walls results in the reduction of the bearing section, which may lead to failure due to excessive compression stresses or, most probably, in overturning of the wall. This type of damage results from the long-term exposure of the walls to rainfall impact, wind erosion and biological activity. The repair of this type damage involves refilling the lost volume of material. A

The presence of structural cracks in rammed earth walls decreases their bearing capacity and stiffness, and disrupts the overall monolithic behaviour of the structure. Furthermore, cracks constitute preferential paths for further decay caused by rainfall infiltration. In this case, the water can more easily access to the material inside the wall, decreasing substantially its mechanical properties. The formation of structural cracks in rammed earth walls is normally associated to settlements of the foundations, to concentrated loads, to horizontal thrusts applied by the roofs or to earthquakes. Several techniques are used to repair these cracks, but whose efficiency greatly varies from case to case. The most basic technique used to repair structural cracks consists in simply filling them with earth mortar. However, this technique fails in establishing the continuity and in the case where the crack is thin (less than ~ 30 mm), the wall needs to be cut back. Stitching the crack is another possible solution and consists in creating a mechanical connection between the two sides of the crack (“stapling” the crack). According to Keefe [16], this is carried out by cutting horizontal chases in the wall with a specific spacing along the crack, which are then filled with mud bricks and earth mortar prepared with a soil similar to that of the original rammed earth. Another technique being evidenced and studied in the last years is the grout injection [17]. In this case, the requirement for compatibility between materials has lead to the adoption of grouts incorporating earth, termed as mud grouts.

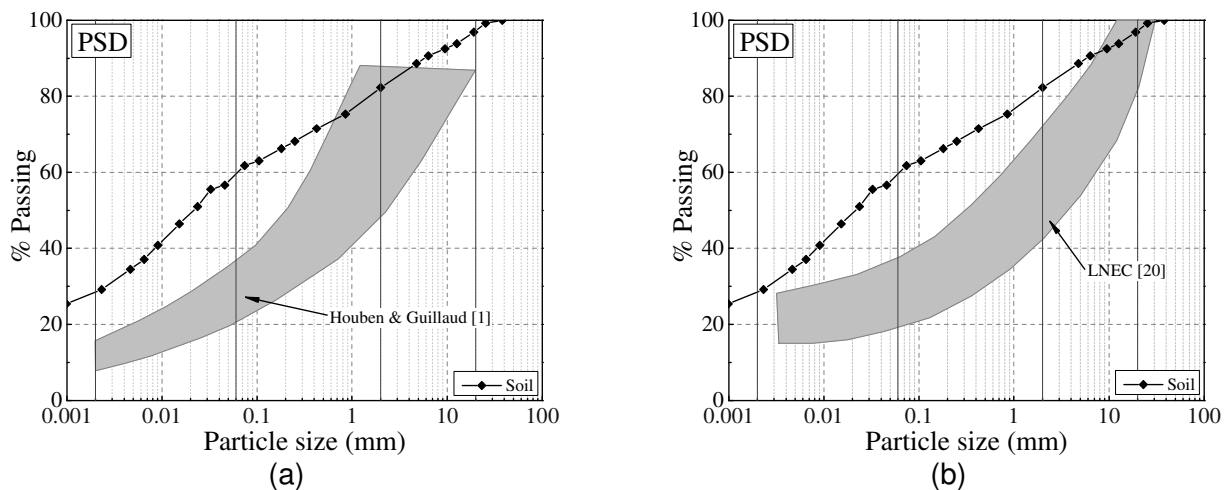
Figure 3. Comparison between the PSD curves of the soil and the envelopes for rammed earth construction recommended by: Houben and Guillaud [1]; (b); Portuguese National Laboratory of Civil Engineering [20].

In general, the expeditious tests revealed that the clay content of the soil was excessively high for being considering suitable for URE construction. This was confirmed by the PSD curve of the soil obtained by means of sieving a sedimentation analysis [19]. This curve is depicted in Figure 3 and compared against the PSD envelopes recommended by Houben and Guillaud [1] and by the Portuguese National Laboratory of Civil Engineering [20]. In both cases, the clay content of the soil (about 28%) is shown to be excessively high for URE.

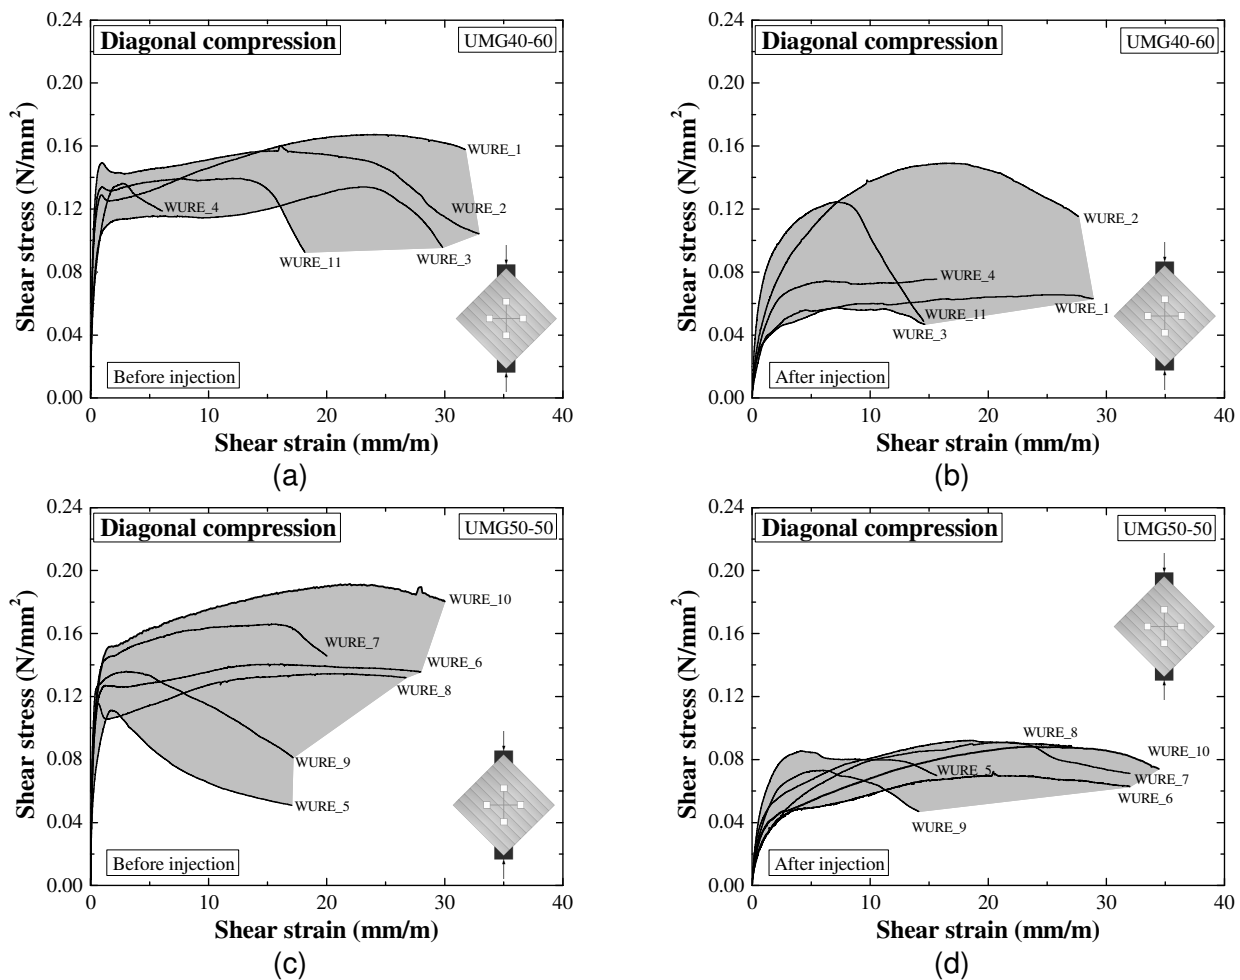
Figure 10. Shear stress-strain curves of the wallets: (a) set repaired with grout UMG40-60 before injection; (b) set repaired with grout UMG40-60 after injection; (c) set repaired with grout UMG50-50 before injection; (d) set repaired with grout UMG50-50 before injection.

The shear stress-strain curves of the wallets before and after injection are presented in Figure 10. With respect to the behaviour of both sets of wallets before repair, it is observed that most of the wallets present an early peak shear stress, after which the shear strain has a fast increase. This early peak shear stress is thought to be related to cohesion (i.e. to the binding capacity) promoted by the clay fraction. In fact, the shear behaviour of the wallets up to this peak stress results from the contribution of the clay fraction cohesion, and friction and interlocking capacity of the coarse aggregates. After this point, the contribution of the cohesion is lost and the shear behaviour of the wallets relies only on the friction and interlocking. Moreover, some wallets present a hardening behaviour after this stress, which can be explained by a superior interlocking occurring in these wallets. Another important contribution of the friction and interlocking to the shear behaviour of the wallets is that all wallets (with exception of WURE_4) present large shear deformation capacity, and thus ductility. This is an important feature for rammed earth in the case of a seismic event, which is expected to contribute for the energy dissipation.

With respect to the shear stress-strain curves of the wallets after injection, it is observed a substantial decrease in stiffness relative to the performance before injection, no matter the grout used. The average G_{og} corresponds to an overall decrease of about one order of magnitude with respect to G_{oi} . This important decrease may be explained by less efficient interlocking and friction mechanisms in the wallets after repair. In fact, the interlocking at the failure surface in the first test of the wallets was provided by coarse aggregates, which were then lost in the reassembling of the specimens and not reintroduced by the injection. Therefore, this potential failure surface was smoothed by the first test
