Modelling an asphalt pavement in Portugal

Andrei Gabriel Ionescu¹, Elisabete Fraga Freitas²

Summary

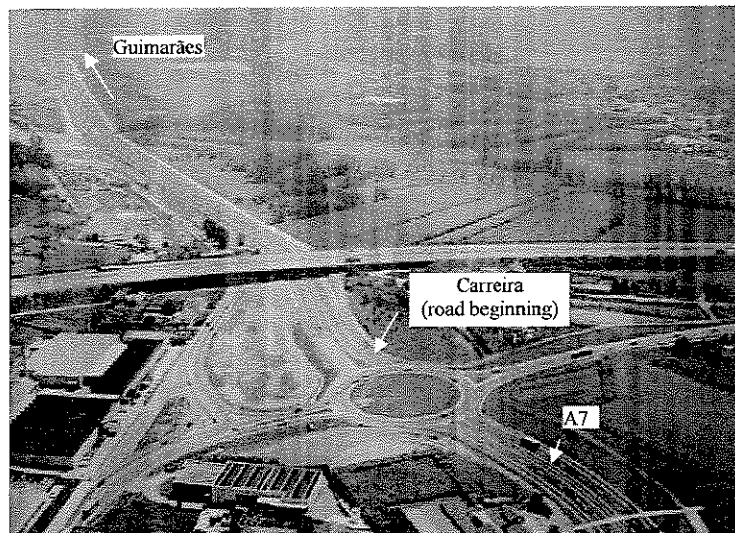
The EN 206 Variant between Carreira and Guimarães, shown in Figure 1, is 2 km long and it is constituted by 2 lanes per direction (3.5 m each), a 3 m separation between carriageways, 2 service lanes (2.5 m each), and shoulders (1 m each). The current cross-section has a transversal slope of 2.5 % to both sides.

Figure1. General view of the EN 206 Variant

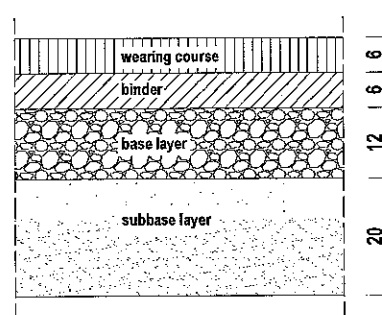
The design structure of the pavement is shown in Figure 2. It is constituted by 3 asphalt layers (wearing course – 6 cm; binder course – 6 cm; base layer – 12 cm) and an unbound sub base (graded aggregates – 20 cm).

Figure2. Pavement structure

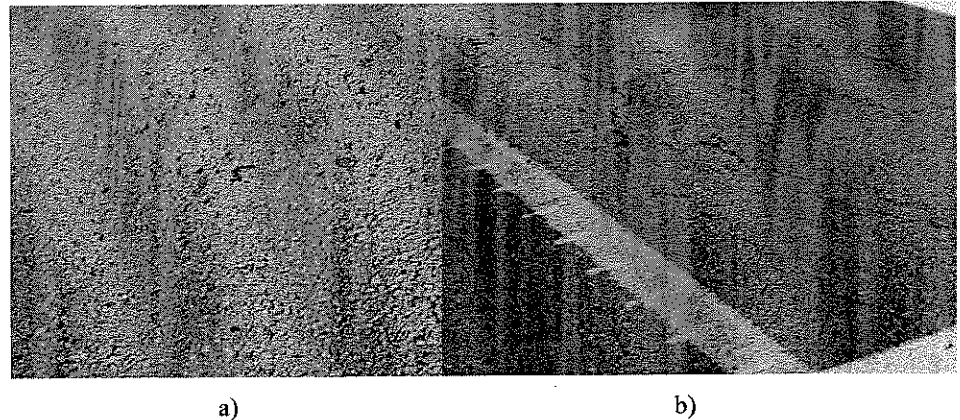
The ravelling observed on the surface of the road exhibits different levels of severity (Figure 3a). Some possible causes for the appearance of ravelling are: loss of bond between the aggregate particles and the asphalt binder; aggregate segregation; inadequate compaction during construction; mechanical dislodging by certain types of traffic such as vehicles with studded tires.

The cracking observed also exhibits different levels of severity as shown in Figure 3b.

Under repeated loading, longitudinal cracks begin to form at the base of the asphalt and propagate upwards (usually in the wheel paths). Then, these longitudinal

cracks connect forming many-sided sharp-angled pieces that develop into a pattern resembling the back of an alligator or crocodile (alligator cracking). This leads to roughness, indicator of structural failure, cracks allow moisture infiltration into the base and subgrade and eventually results in potholes and pavement disintegration if not treated.

Figure 3. Distresses on EN 206 VARIANT: a) ravelling; b) cracking

Alligator cracking occurs when there is an inadequate structural support for the given loading, which can be caused by many factors. Some of the most common are: decrease in pavement load supporting characteristics; stripping on the bottom of the hot mix asphalt layer; increase in loading (the pavement might loaded more heavily than anticipated in design); inadequate structural design; poor construction. Longitudinal cracking, transversal cracking and potholes were also found. These distresses are clearly the result of poor construction.

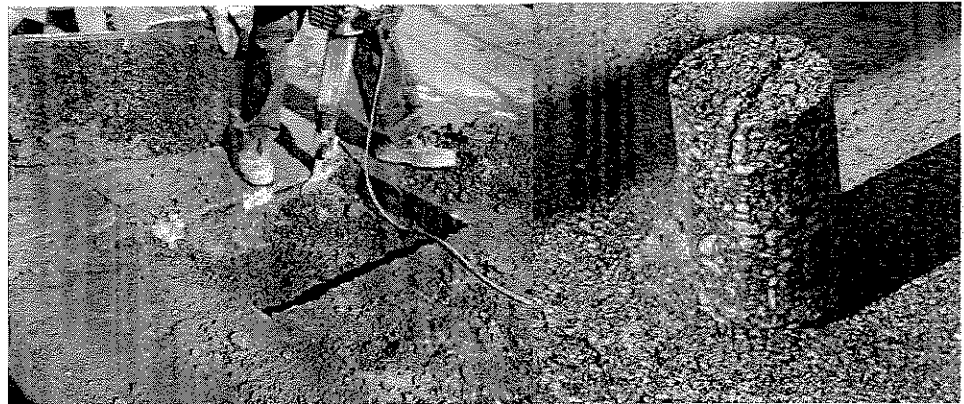
It was found that layers thickness is similar to the one assumed in the design, nevertheless a severe reduction of the thickness near the right wheel path towards the shoulder was observed. This might partly explain the distress observed on the right lane. In addition to that, poor quality of top layers (wearing and binder coarse) was observed (Figure 4 a).

As a consequence of the surface poor quality, cracking started at the top of the asphalt layer and progressed downwards. This was stated in all cores extracted over cracks (Figure 4 b).

Figure 4. Coring: a) splitting of the asphalt layer; b) top-down cracking

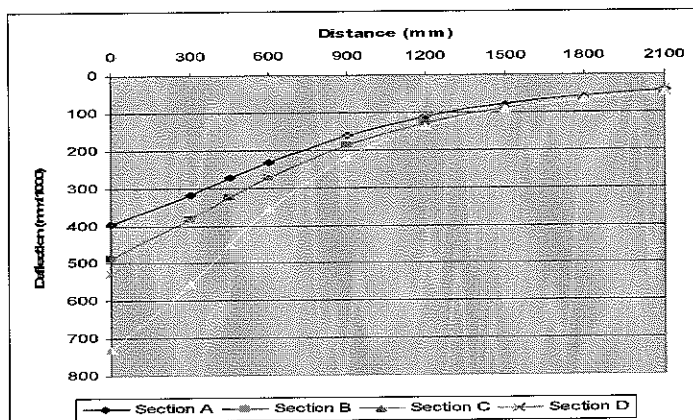
homogeneous subsections and Table 4 and Figure 5 present the representative deflection for each subsection.

These results correlate with the surface condition assessment: Section A, (Guimarães - Carreira, PK 0+000 to 1+340) presented less distress than the other sections, and also presented the smaller deflections.

Section C (Carreira - Guimarães, PK 0+000 to 0+640), the most damaged section, presented the highest deflection which is nearly twice the deflection of section A. Deflection on sections B and D do not seem significantly different and they are slightly higher than in section A.

Figure 4 - Representative deflection bowls for each road section

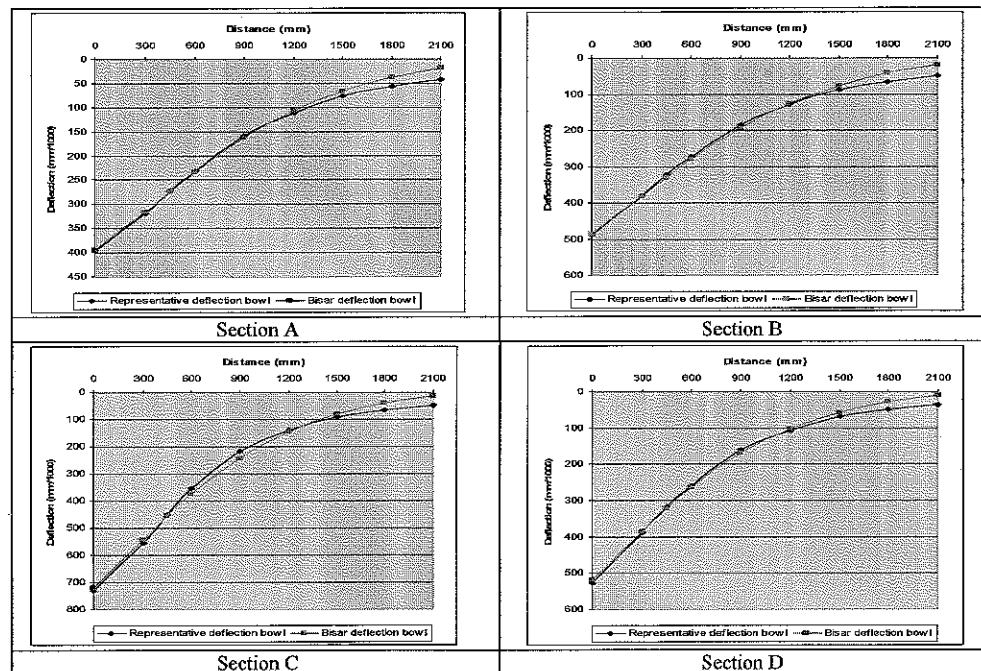
Figure 4 presents both the representative deflection bowl and the one obtained with BISAR for sections A to D.

Figure 4. Measured and calculated deflection bowls

As it can be observed in Figure 4, from the centre of the loading plate to 1200 mm a good match has been achieved. From 1200 mm to 2100 mm, the deviation between bowls increases with a higher value for the measured deflection. The end part of the deflection bowl is representative of the response of the subgrade to loading. This means that linear elastic programs are not reliable when the subgrade is concerned and back analysis procedure should be reviewed in order to take into account the effect of the increase of asphalt layers thickness on stress distribution.
